River Drive, South Shields
Remediation Strategy
For
Galliford Try Partnerships North Ltd

Report Ref	Issue	Prepared by	Date	Reviewed by	Date
14643/RS	1	C Brewster	30/9/15	A Coverdale	30/9/15

**River Drive, South Shields
Remediation Strategy
For Galliford Try Partnerships North**

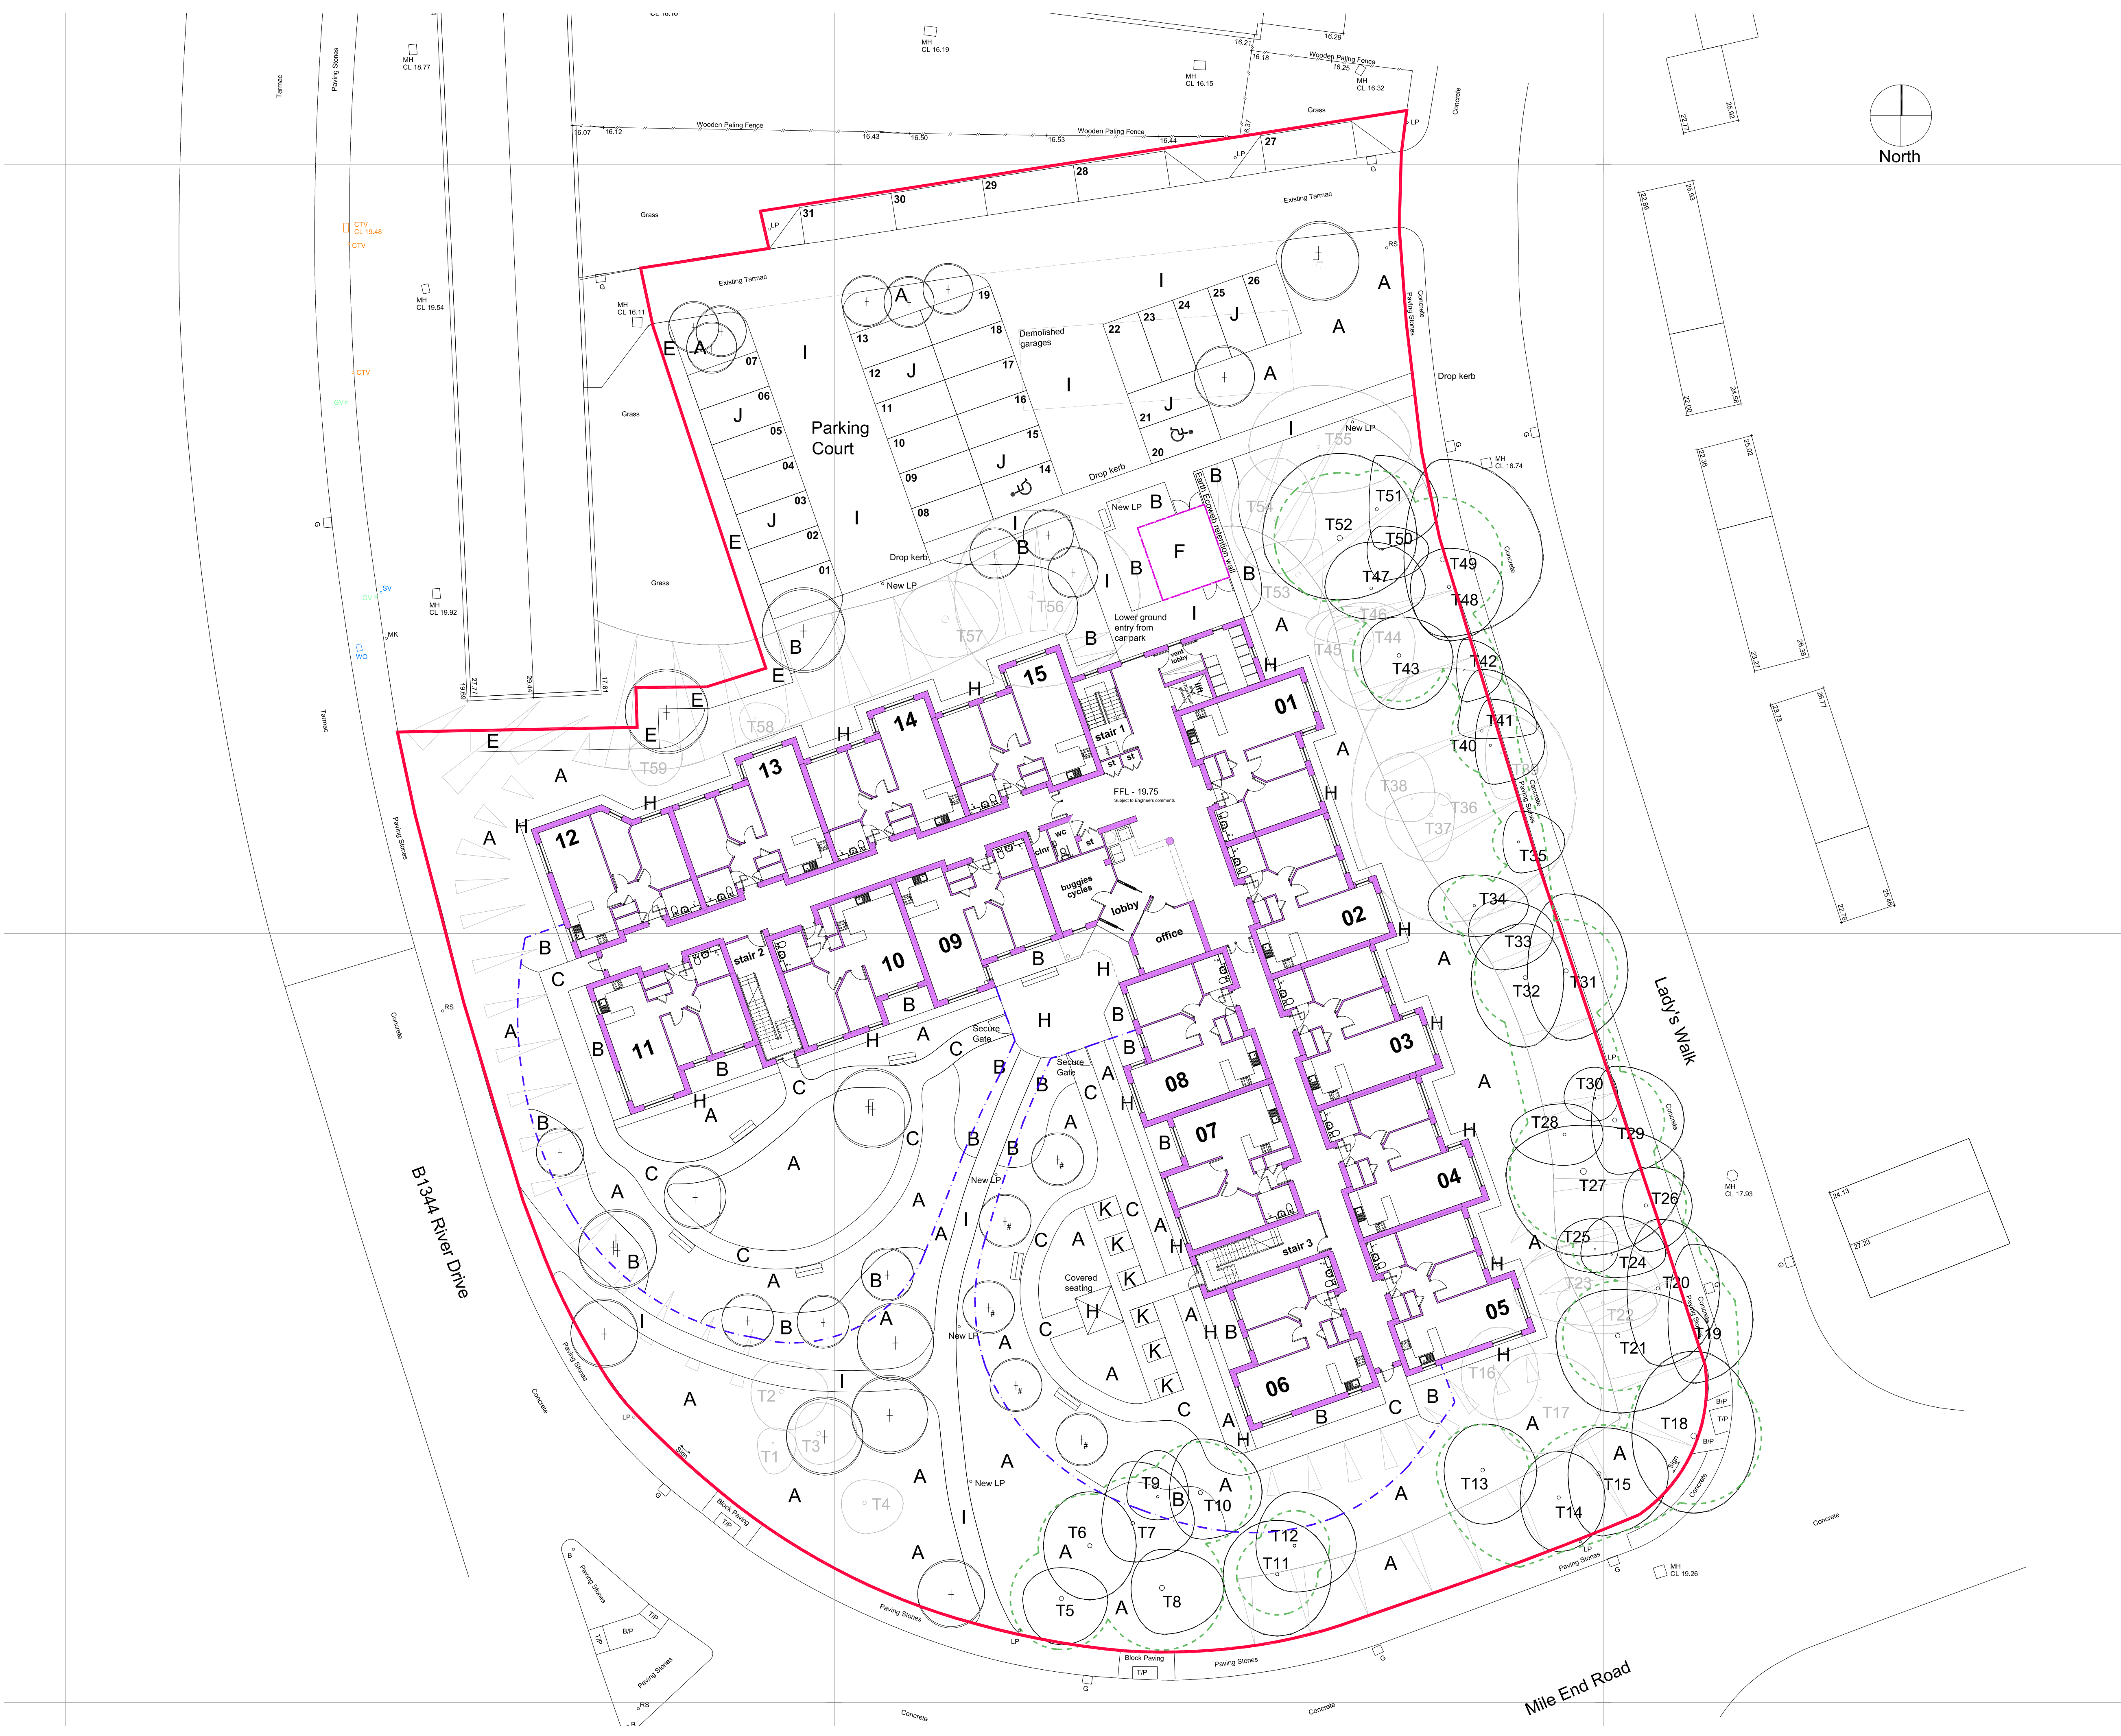
Proposed Development Plan

1.1 Following the completion of a series of intrusive fieldworks 3e Consulting Engineers Ltd (3e) were commissioned by Galliford Try Partnerships North Ltd to carry out a Remediation Strategy for land located off River Drive in South Shields. The proposed development includes the construction of a new over-55's Apartment Building, with associated car parking and areas of soft landscaping, details of which are provided in **Appendix A**.

PROJECT
River Drive
South Shields
Care Ready Apartments

DRAWING TITLE
Site Layout
