JOB / CLIENT **South Tyneside Homes
Edhill Avenue**

DWG TITLE **Site Plan Proposed**

PROJECT NO.	DRAWING NO.	REVISION	STATUS
14.06	ED.SP.01	B	P

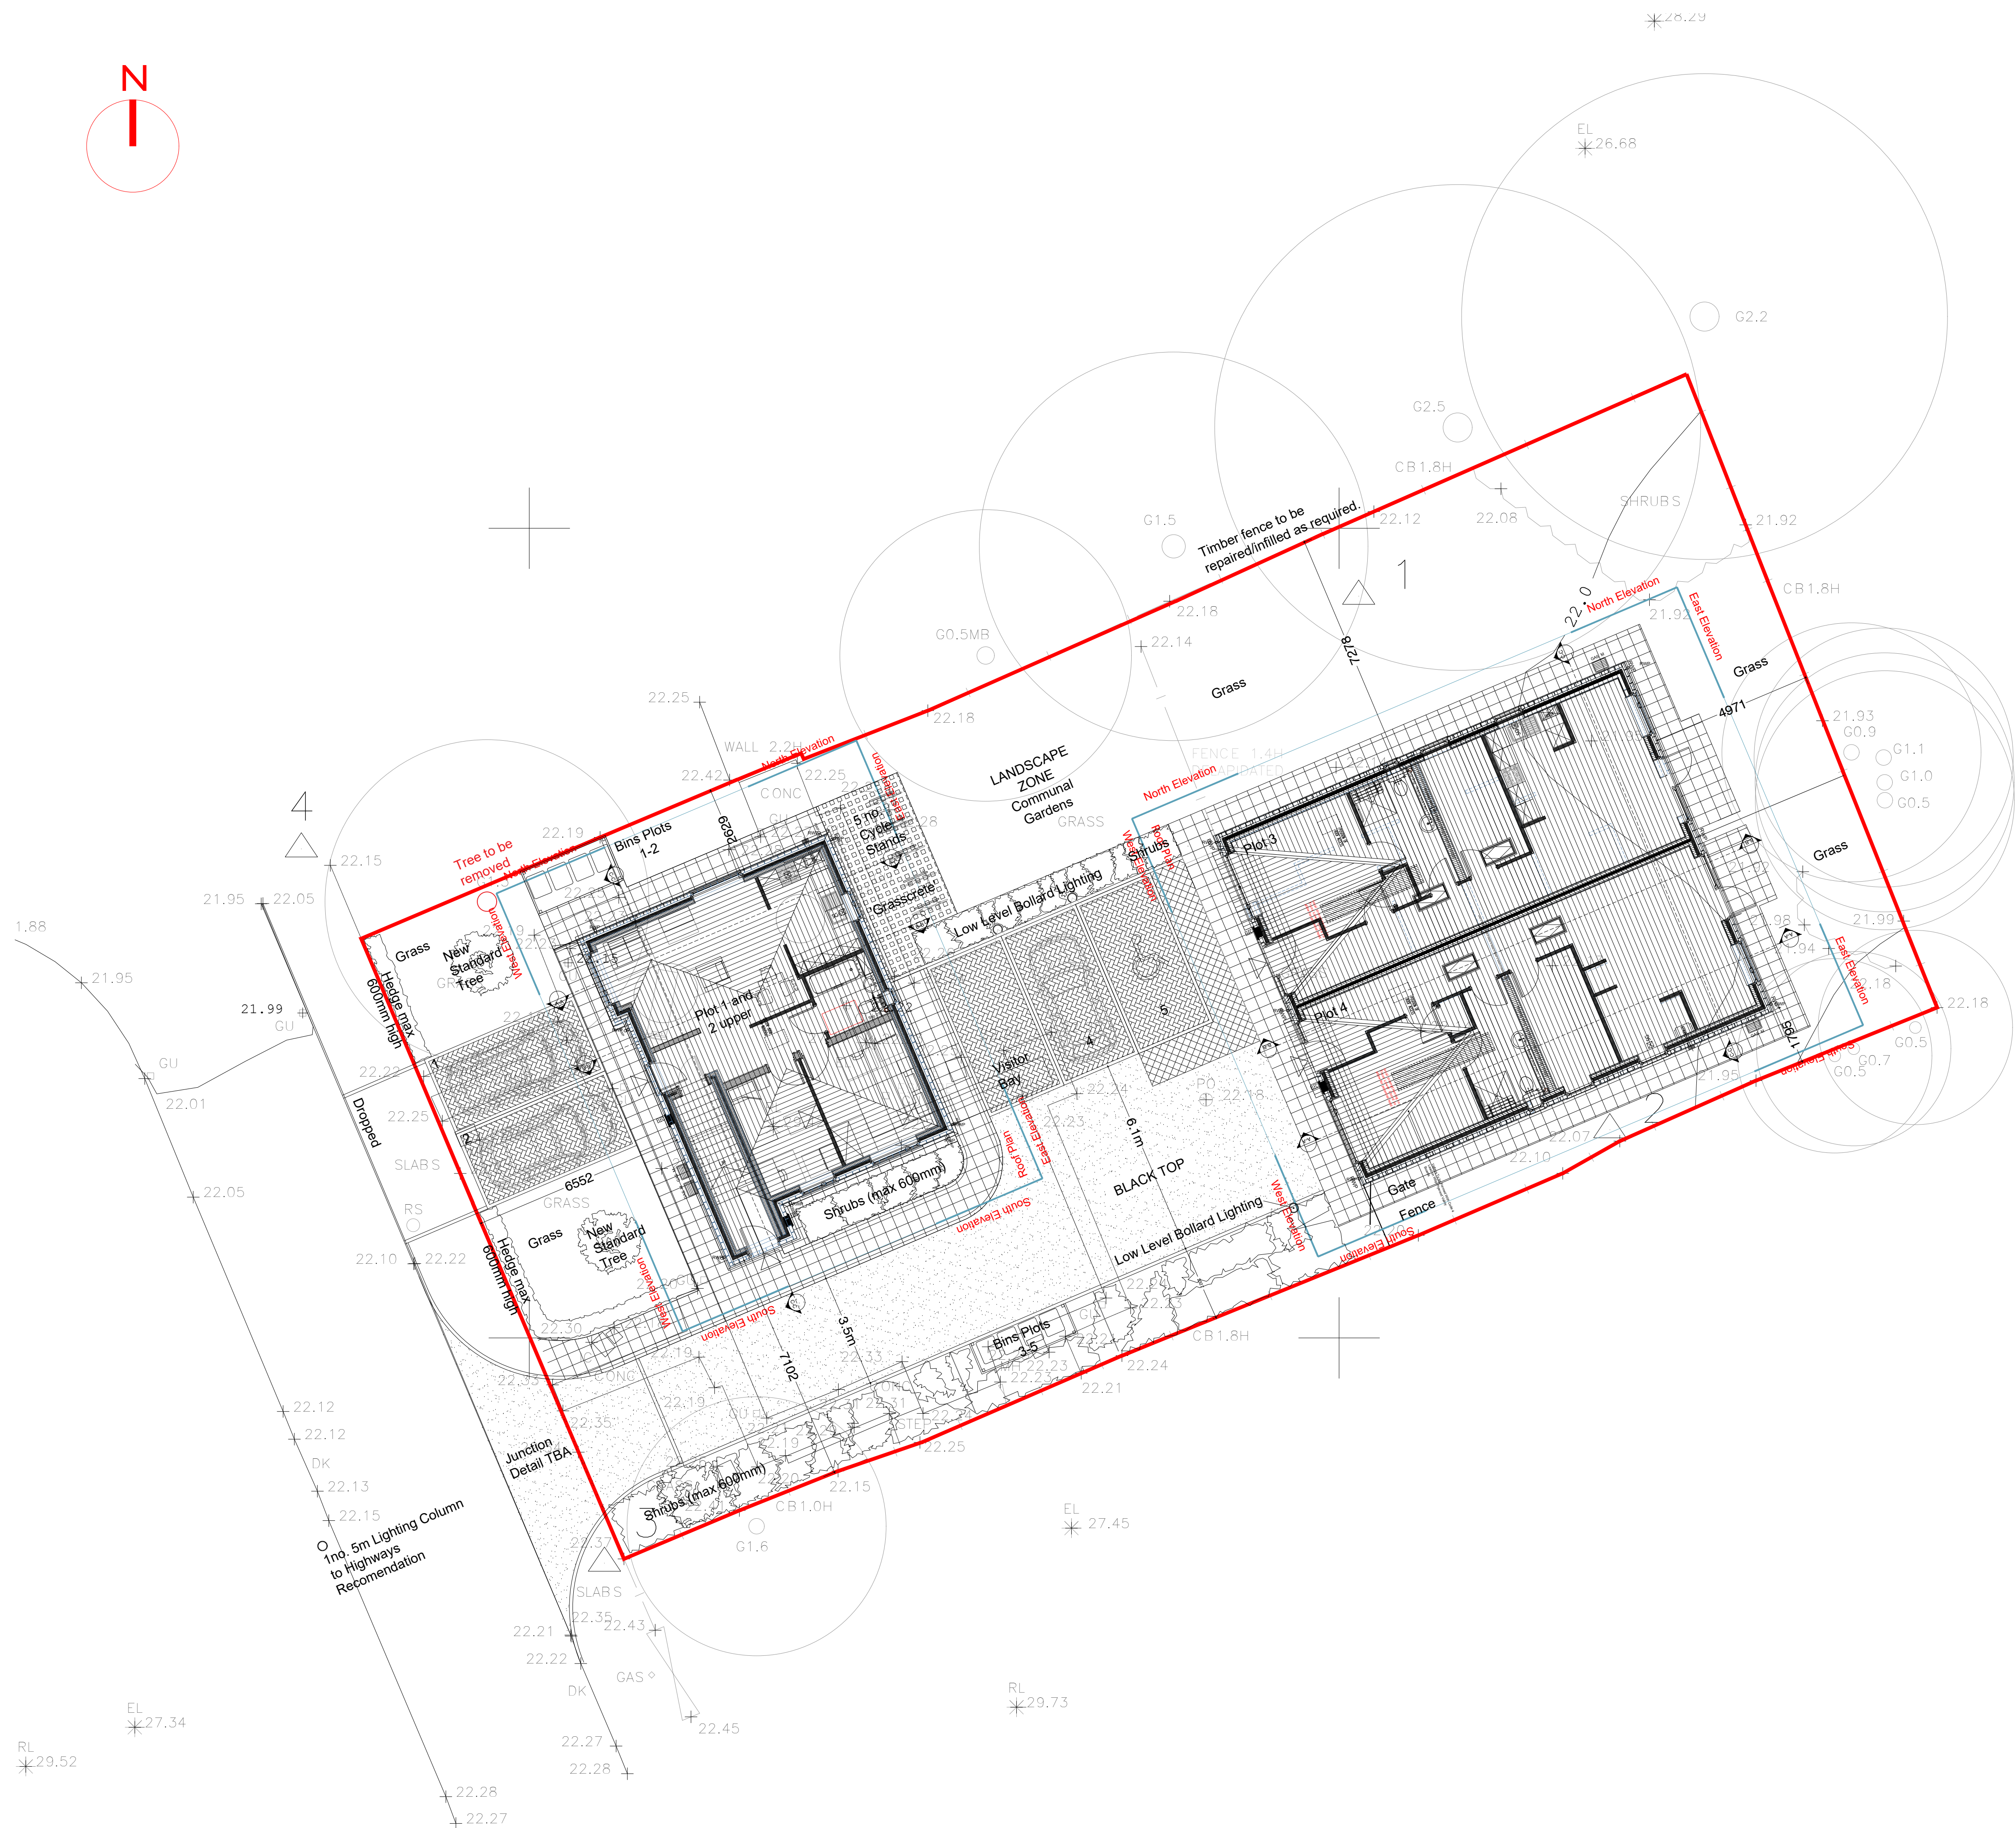
RESIDUAL RISKS		
Description	Action	
1. Risk of falling branches or unstable large trees. See tree survey.	Consult arboriculturist prior to any tree pruning or works to root zone. All protection measures to be followed as per Tree Survey.

2. Concrete or other materials not grubbed up as part of demolition works.	Mark out zone of previous building. Verify certifications for demolition/clearance. Use appropriate excavation equipment/protection.

3. Existing services.	Obtain services drawings and verify location prior to excavations. All services should be stripped back to pavement or as specified in the demolition contract. Confirm with Client.

4. Proximity to sub-station	There is an existing sub station in the south-east corner of the site on adjoining land. This is to be factored in in terms of any craneage on site or removal of trees in the area.

5. Large trusses on restricted site.	Although the roof truss design has not been finalised there is potential for large truss sizes. A method statement should be produced for manoeuvring large trusses into place. Particular risks are adjacent trees and overhead lines.

B 11JUL16 Moved bins to 15m from back of footpath.
