JOB / CLIENT South Tyneside Homes  
 Wark Crescent

DWG TITLE Proposed Site Plan

PROJECT NO.	DRAWING NO.	REVISION	STATUS
14.06	EA. SP02	B	P

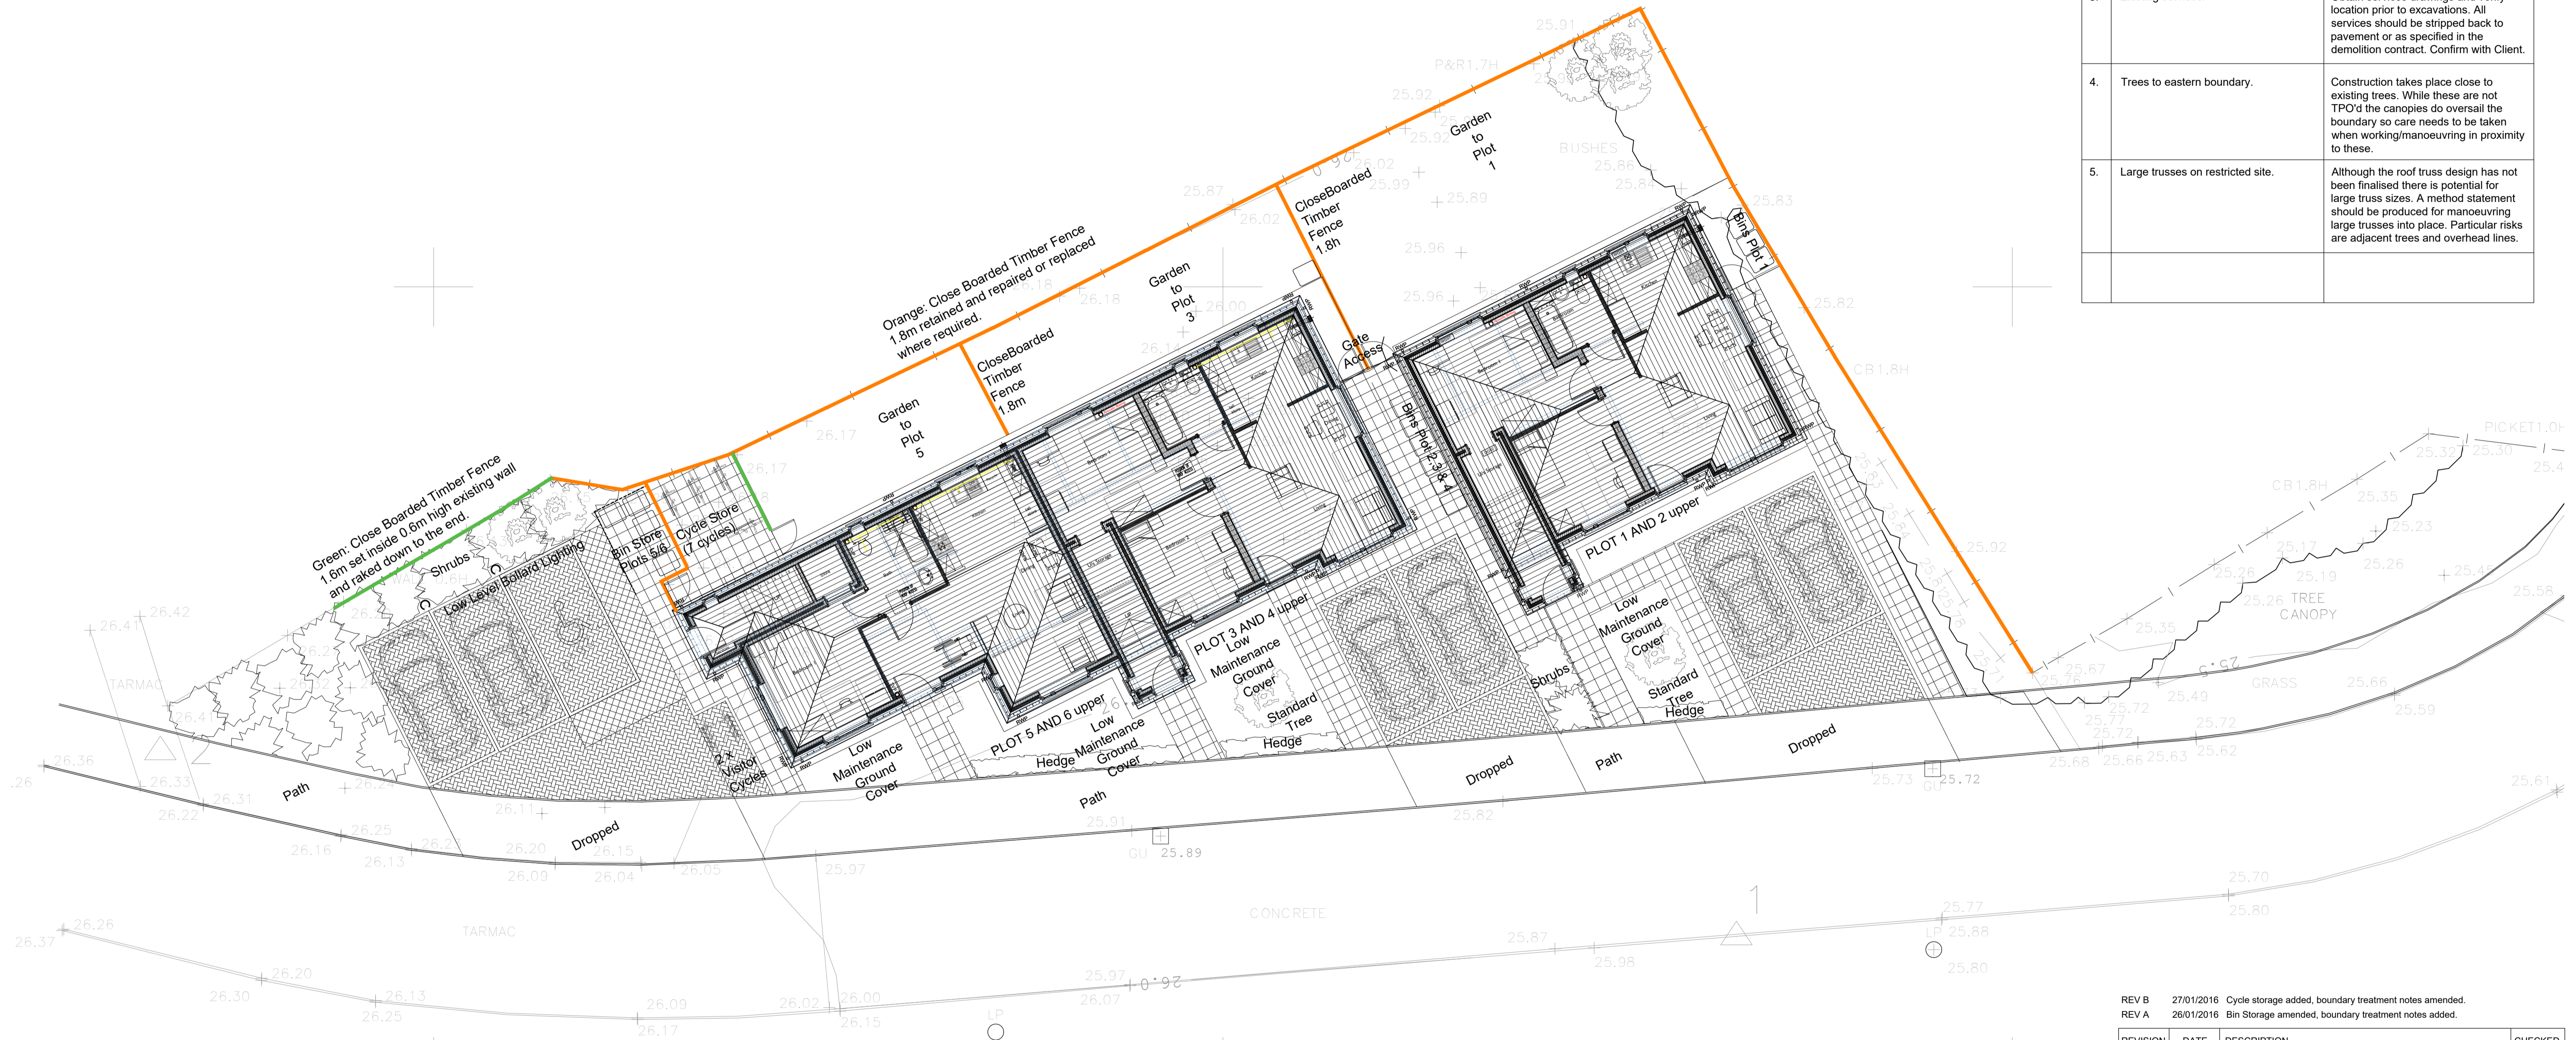
RESIDUAL RISKS		
Description	Action	
1. Previous site use was likely a garage so significant risk of ground contamination.	Full desktop survey and SI required. Remediation strategy to be put in place as required with appropriate monitoring and certification.

2. Existing concrete slabs on site.	Demolition/grubbing up required. Check state of current service disconnections. Appropriate method statement required.

3. Existing services.	Obtain services drawings and verify location prior to excavations. All services should be stripped back to pavement or as specified in the demolition contract. Confirm with Client.

4. Trees to eastern boundary.	Construction takes place close to existing trees. While these are not TPO'd the canopies do overhail the boundary so care needs to be taken when working/manoeuvring in proximity to these.

5. Large trusses on restricted site.	Although the roof truss design has not been finalised there is potential for large truss sizes. A method statement should be produced for manoeuvring large trusses into place. Particular risks are adjacent trees and overhead lines.
