**REPORT: D7064  
December 2015**

**GEOENVIRONMENTAL APPRAISAL  
for  
CHURCH LANE, WHITBURN  
Prepared for  
STELLA PROPERTY INVESTMENTS**

## CHURCH LANE, WHITBURN – EXECUTIVE SUMMARY

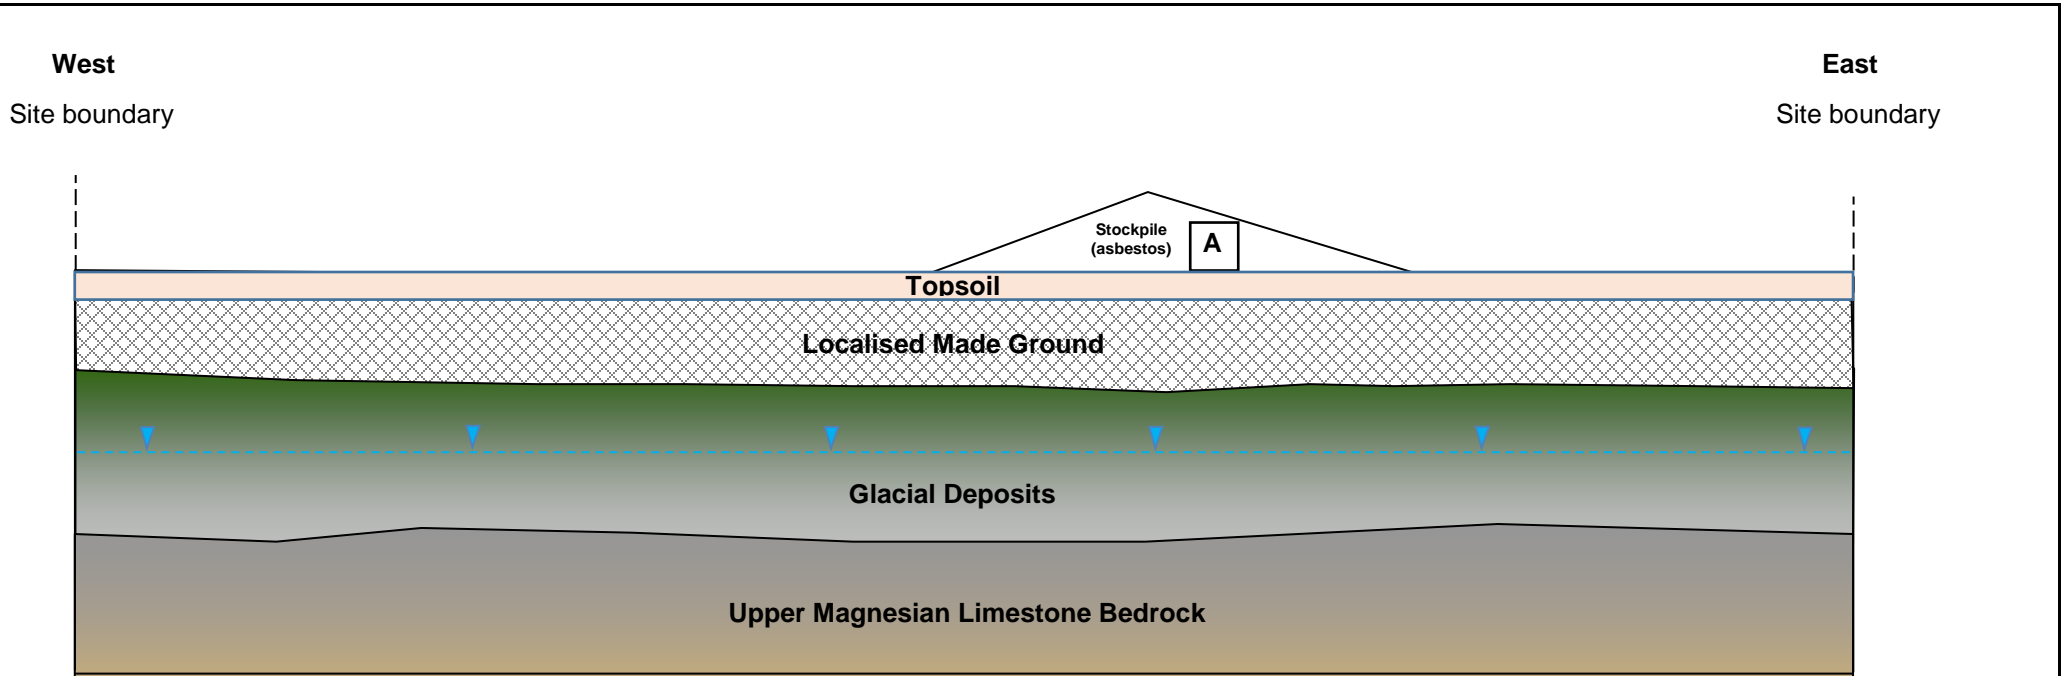
The results of the 'Hazard Identification' process for significant sources of contamination in accordance with CLR11 are summarised above. The following section describes the results of the 'Hazard Assessment' process in which unacceptable risks are identified. Pathways and receptors are considered below. Contamination sources and pollutant linkages are shown in the revised Conceptual Site Model presented as Drawing No. D7064/03 in Appendix A.

Potential Contamination linkages:  
 A. Inhalation of contamination within stockpile. Removal offsite advised.

The stockpile has been found to contain asbestos; due to the site's intended use for residential development it is recommended that the stockpile should be removed from the site.

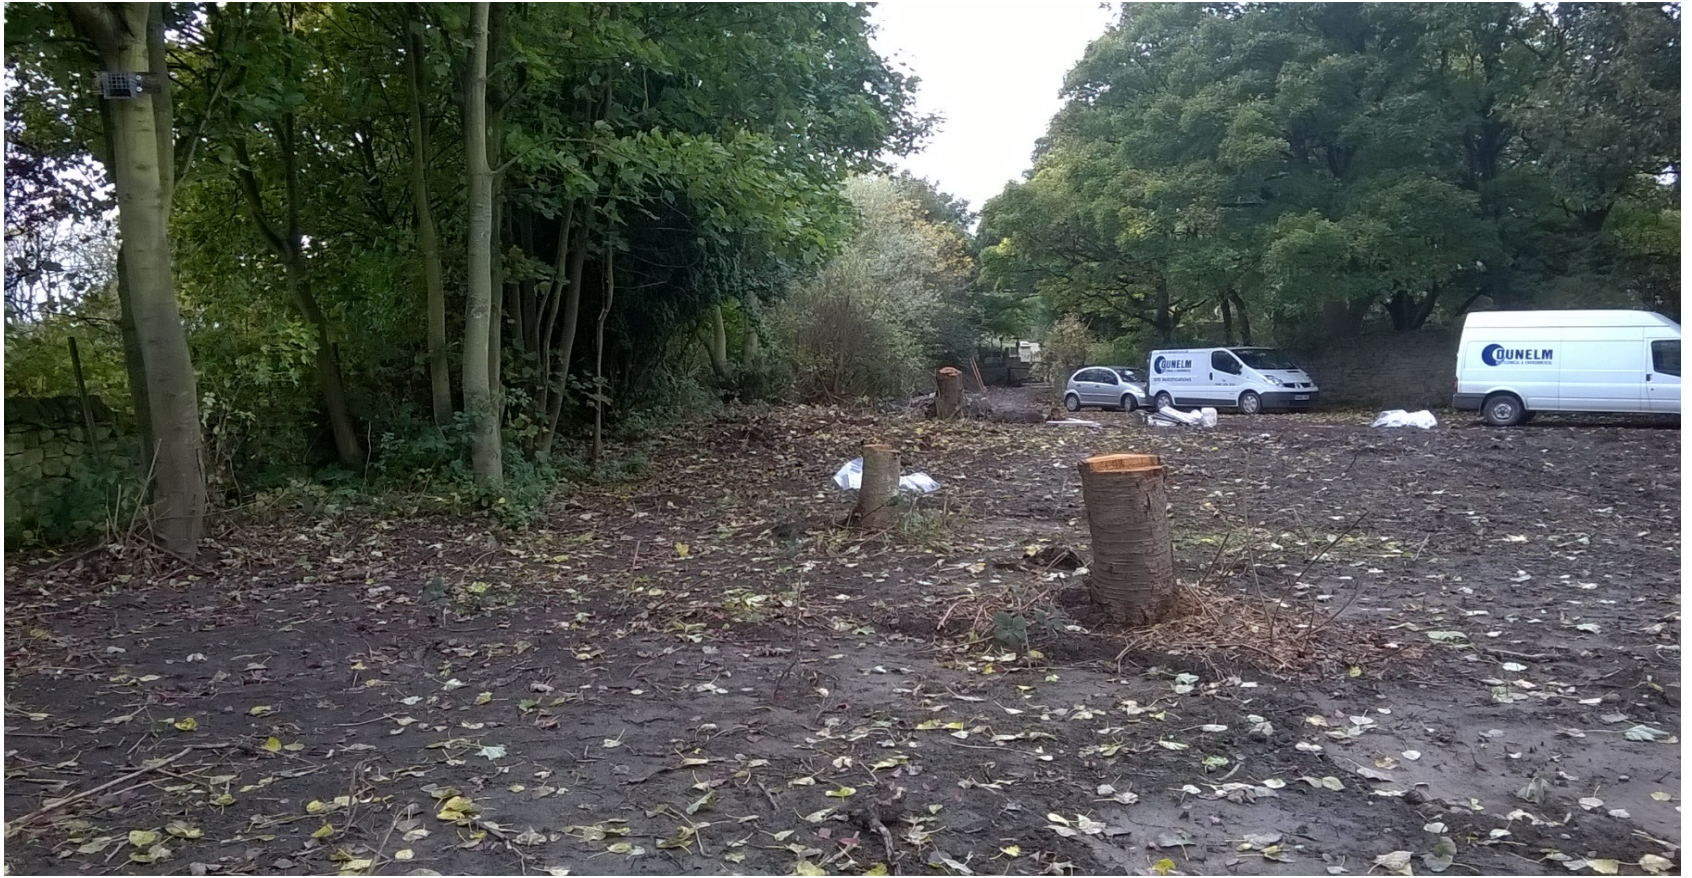
Mature trees border the site on all sides and there are approximately 6 to 7 mature tree stumps on the site itself.

Photograph 1: View of site with retained and removed trees noted.

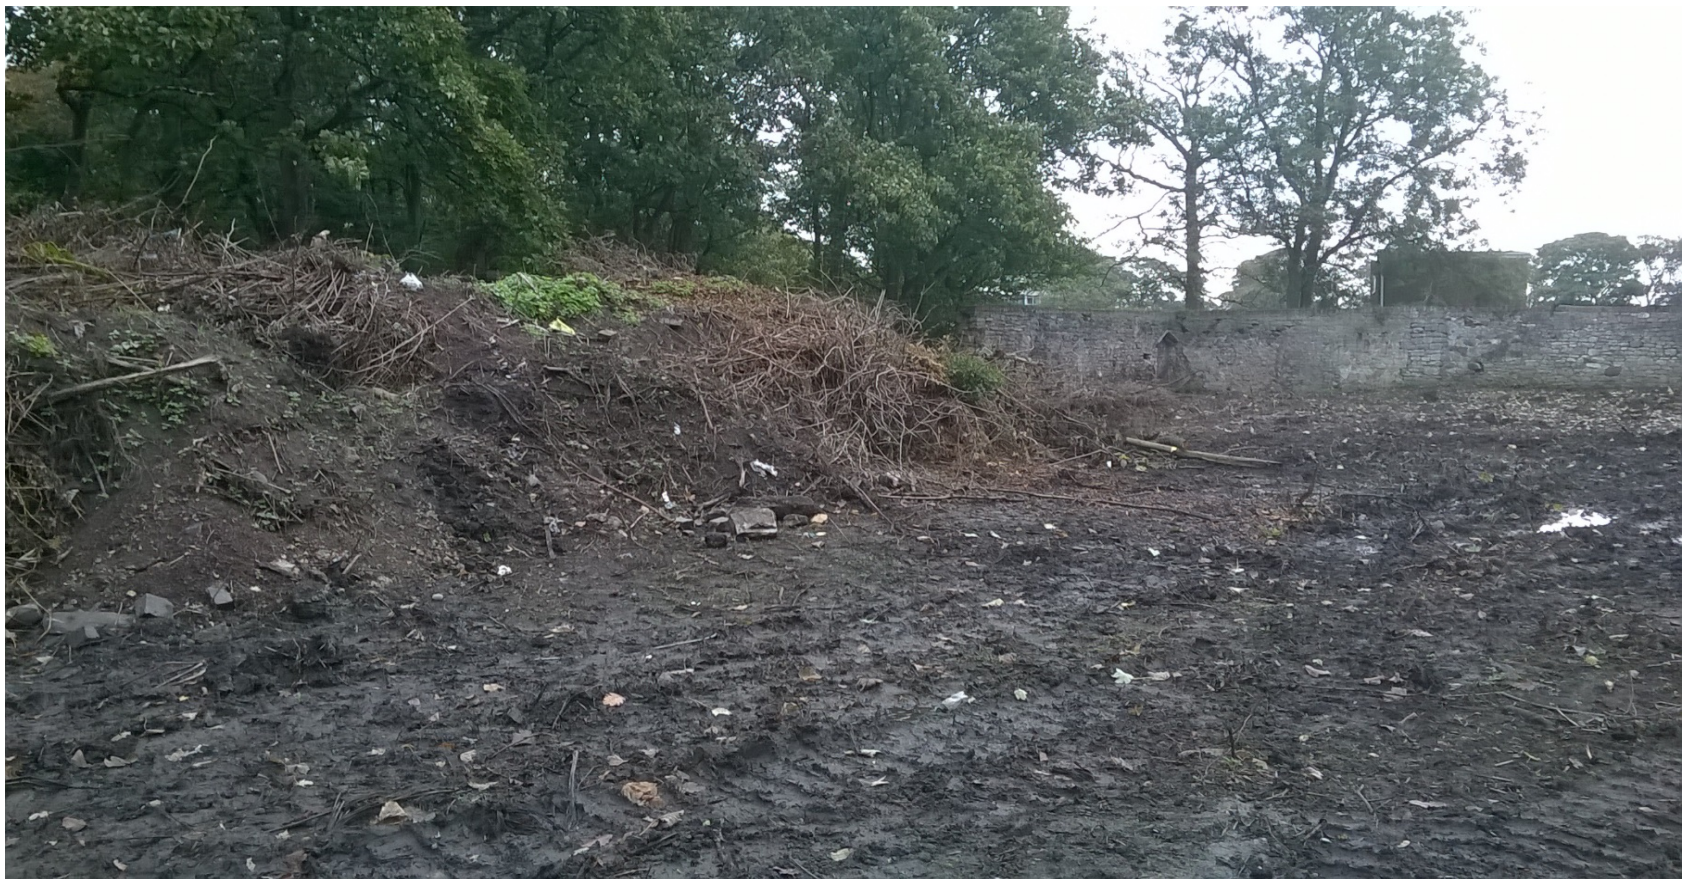
Made ground was noted in the stockpile and based on visual inspection comprised predominantly wood, topsoil with some natural blockstone masonry.

Asbestos was detected in the onsite stockpile. Although asbestos was absent from the soil samples in the exploratory holes, the possibility exists that asbestos may lie presently undetected at the site. It is therefore advised that a 'watching brief' is undertaken during the construction works and advice sought if asbestos is found or suspected.

Photograph 2: View of on site stockpile

Waste Acceptance Criteria testing was carried out on a sample taken from the on site stockpile. The results suggest the materials could be accepted at land fill as stable non-reactive hazardous waste. The laboratory certificates should be forwarded on to the landfill operator.
