Bat Risk Assessment of:

108 Cambridge Avenue
Hebburn
NE31 2RT

Job Ref: Wardale_108CambridgeAve_Bat1.1

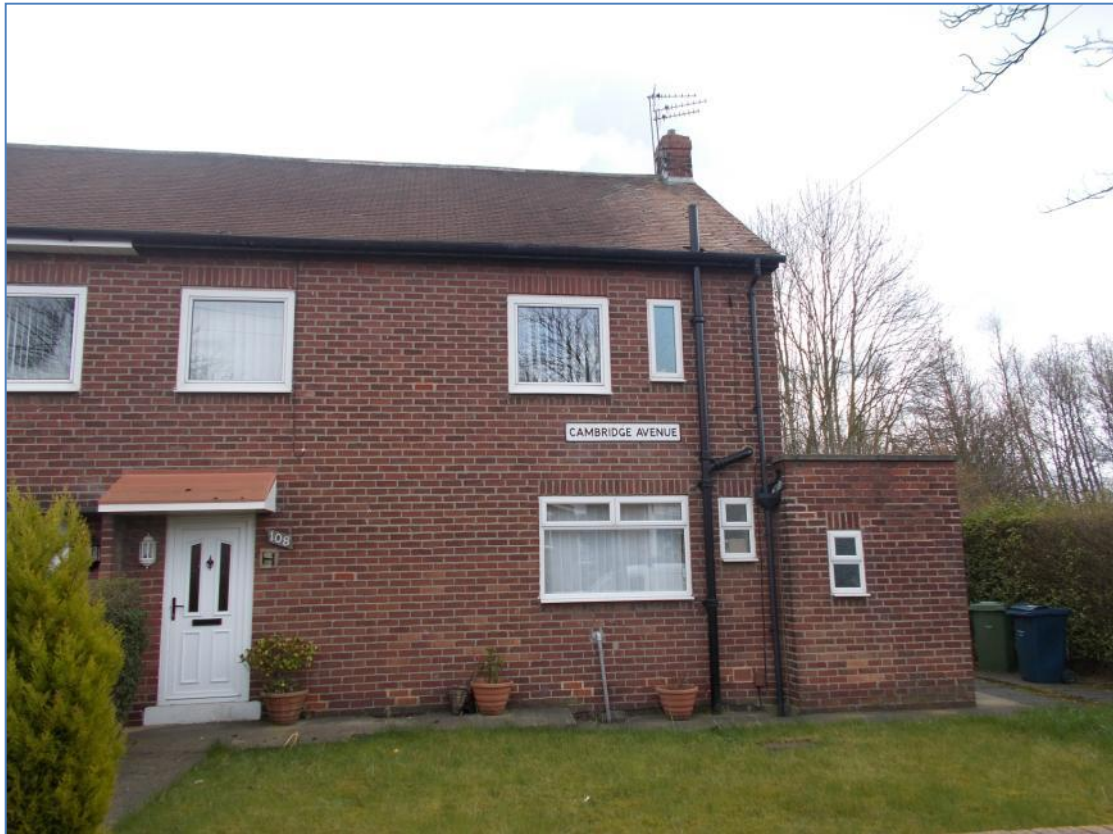
2.4.1 The property consists of a two storey brick built semi-detached dwelling with pitched, tiled roof (Photographs 1 and 2). Brickwork is well pointed and the roof is in good condition, with no lifted tiles or potential access gaps beneath ridge tiles. Lead flashing provides a good seal at the base of the chimney. All windows and door frames are uPVC and are well sealed to the brickwork. Guttering is supported on wooden soffit boxes to the front and rear of the property and a small number of potential access points were noted at the base of the soffits on both elevations. An area of absent mortar was also noted along the roof edge at the south-western gable (Photograph 3), providing access into the baton space between the roof tiles and membrane beneath. However, each of these potential access points will not be affected

Photograph 1 – North-west elevation of 108 Cambridge Avenue.

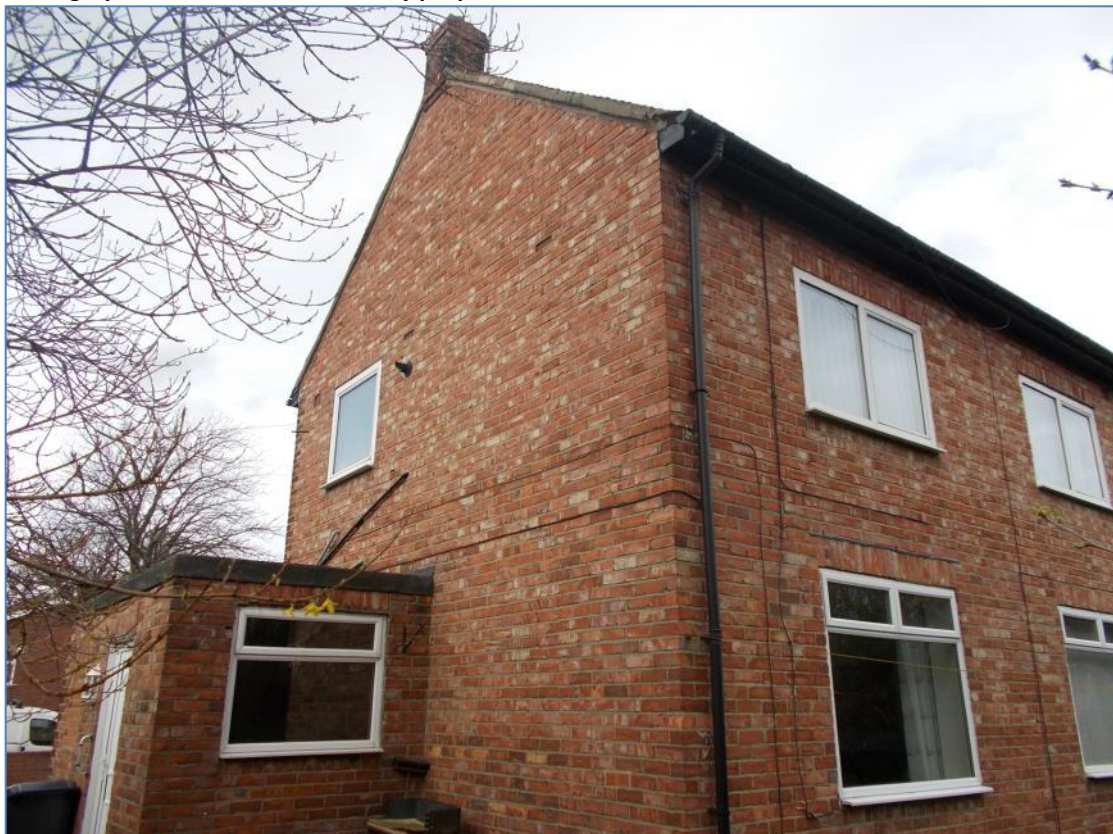
by the proposals as the extension to the rear is single storey so will not affect the soffits, and plans show that the extension to the side of the property will not meet the existing roof at the point of the mortar gap. Overall, opportunities for roosting bats are limited. No evidence of bats, such as droppings or staining was noted during the external inspection.

Photograph 2- Area to be affected by proposals.

3.2.2 The proposed works involve the extension of the property to the side and rear. Despite the presence of a small number of potential access points into the soffits and baton space of the roof, it is considered that the proposals do not pose a potential risk to bats or their roosts as the designs show that the soffits and existing roof edge will not be affected.

4.1 The area of the building to be affected by the proposals has been classified as having a negligible risk of containing roosting bats under current industry guidelines and therefore no further survey work is recommended. No restrictions on the timing of the works are deemed necessary with regards to bats.

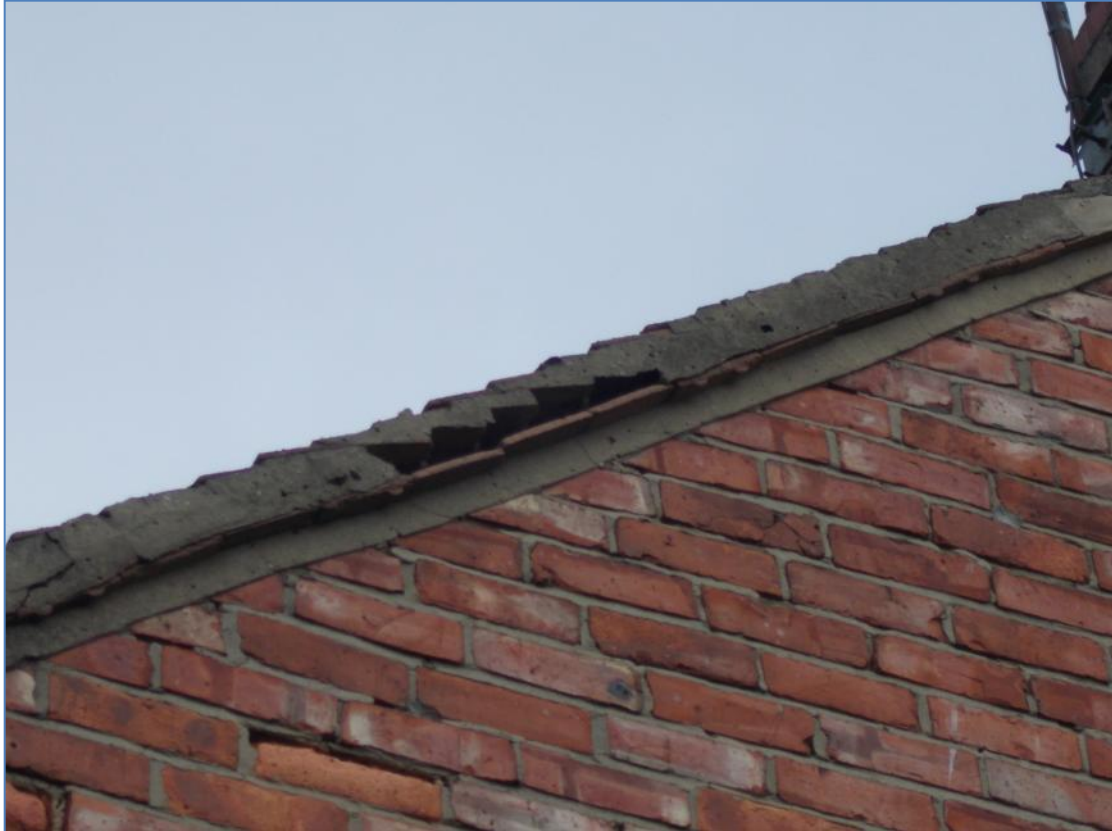
Photograph 3 - Section of absent mortar on south-west elevation.

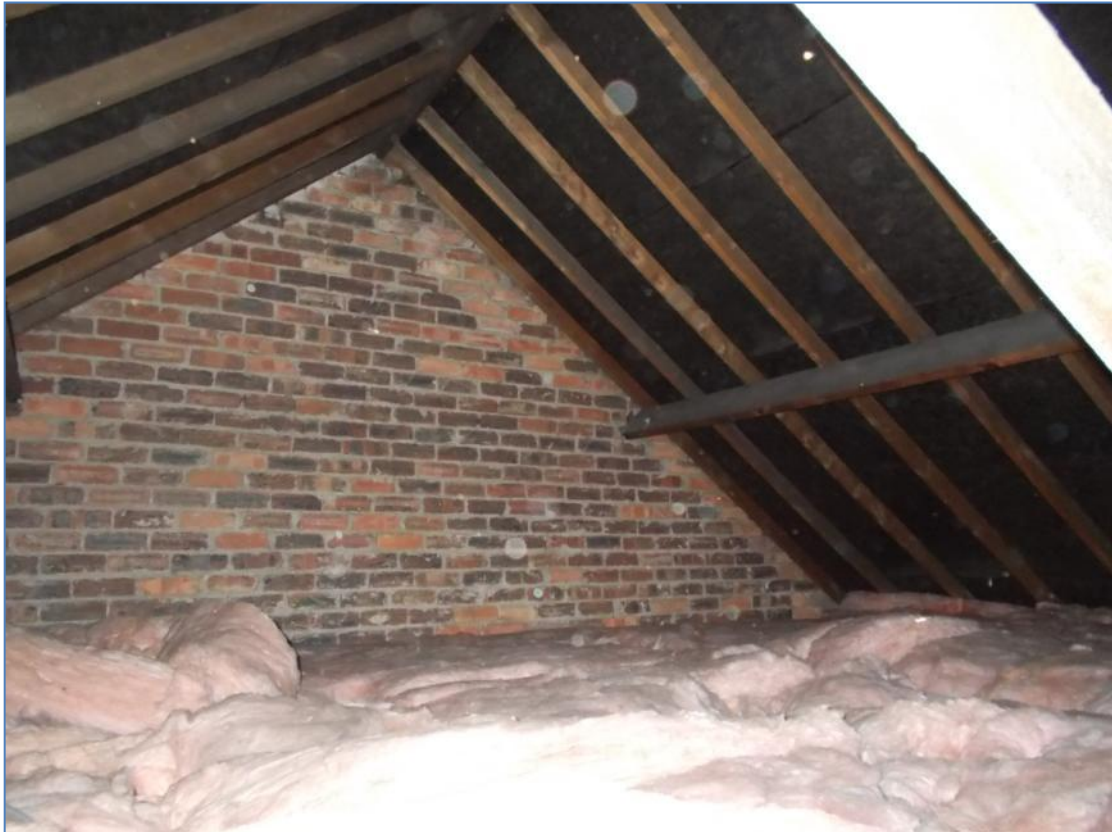
2.4.2 Internally, the loft space is open and uncluttered and is unused (Photograph 4). The tiles are lined internally with a bitumen type membrane which appears in very good condition. Light penetrates into the void from a mortar gap towards the top of the gable wall. Wasps were heard within the mortar gap. Fibre glass insulation is present on the floor of the void. Conditions within the void are clean, cold and airy and no evidence of use by bats was found, such as staining, droppings or live/dead bats.

Photograph 4 - Interior of 108 Cambridge Avenue.
