FINAL REPORT
SOUTH SHIELDS TOWN HALL COMMITTEE ROOMS A & B
ANALYSIS OF HISTORIC PAINT SCHEMES

REPORT AUTHOR: PAUL CROFT (RESEARCH FELLOW)
CLIENT: WILLMOTT DIXON CONSTRUCTION LIMITED

APRIL 2016

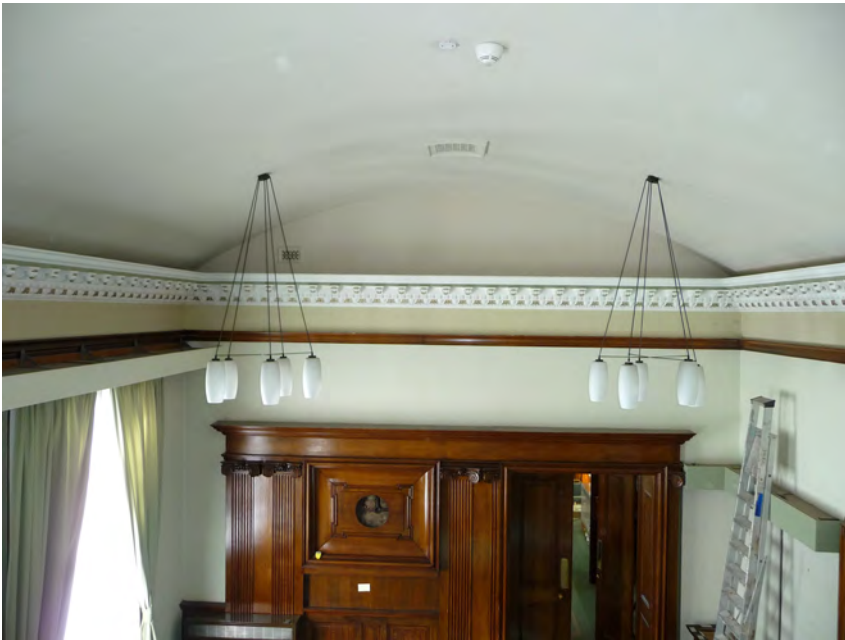
Fig.2: Committee Room B

There is a timber rail running the perimeter of both rooms, just below the frieze. It is painted white in Room A and varnished in Room B. At first glance this appears to be a later insertion due to a lack of apparent decorative finishes. However, the frieze in both rooms has never been painted in with the walls, so we must assume a frieze has always been defined and painted as a separate feature. The evidence suggests that both rails were originally varnished, and this has been retained in Room B. The rail in Room A appears to have been thoroughly rubbed down in the relatively recent past and painted white, or alternatively replaced.

The paints applied to the walls were very different, with a dark Brunswick Green on the walls in Room A and a paler green on the walls in Room B. The overall effect in Room A would have been quite dark, particularly set against the dark varnished joinery. Arguably, this doesn't suit modern tastes. We have become conditioned and used to the pale magnolias and white so ubiquitous in homes and buildings today.

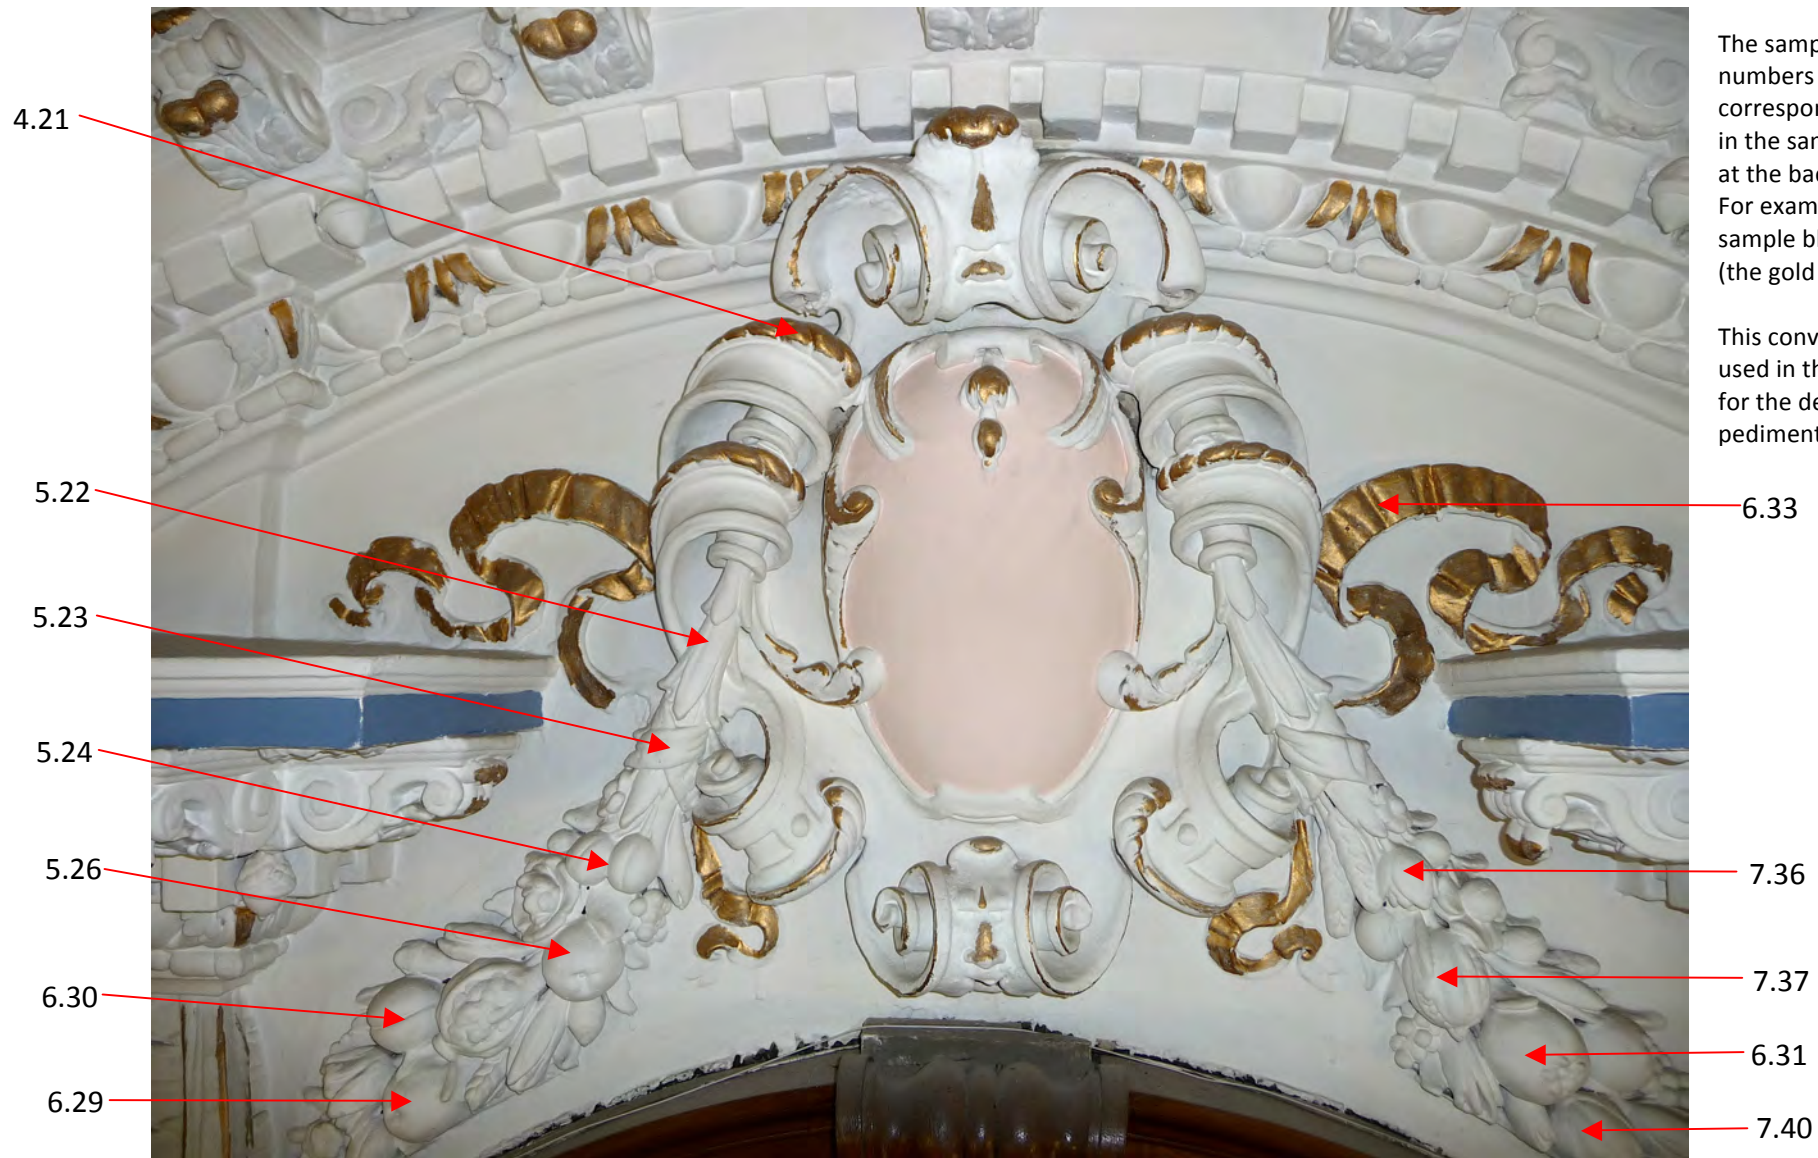
4.0: Sample locations, decorative pediment (sample numbers correspond to scheme chart & sample location list)

The sample location numbers provided here correspond to those listed in the sample location list at the back of this report. For example 6.33 refers to sample block 6, number 33 (the gold ribbon).

This convention is also used in the scheme chart for the decorative pediment.

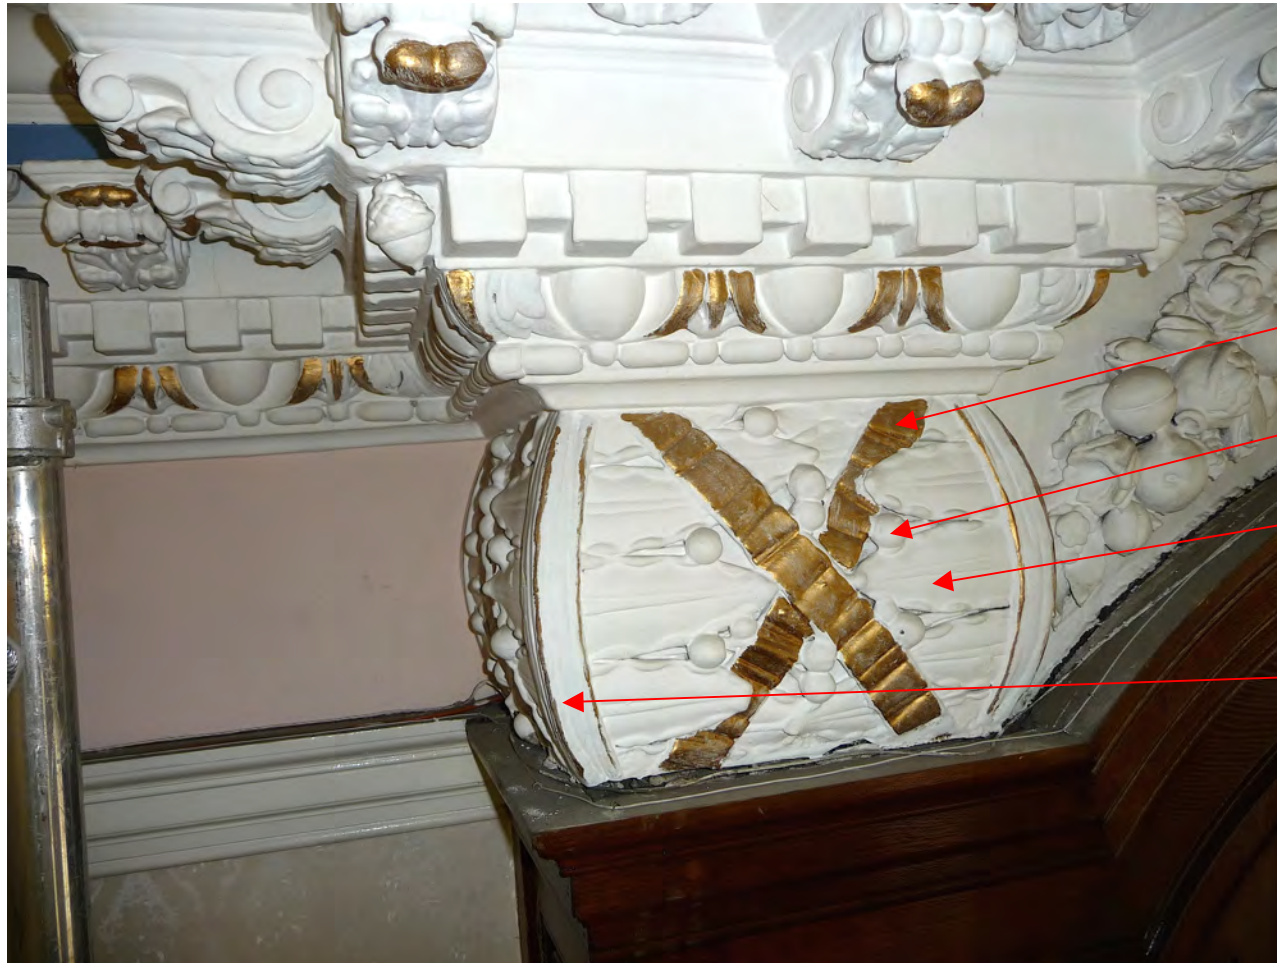
4.1: Sample locations, Pediment cont

3.15 (strap)

4.17 (fruit)

4.16 (leaf)

4.18 (corner)
