Our Ref: D3817/APT
Linda Worthing
Bellway House
Kings Park
Kingsway North
Gateshead
Tyne and Wear
NE11 0JH

Date: 28th October 2016

Inspection of Topsoil thickness – Bellway Apartments Cleadon Vale, King George Road, South Shields.

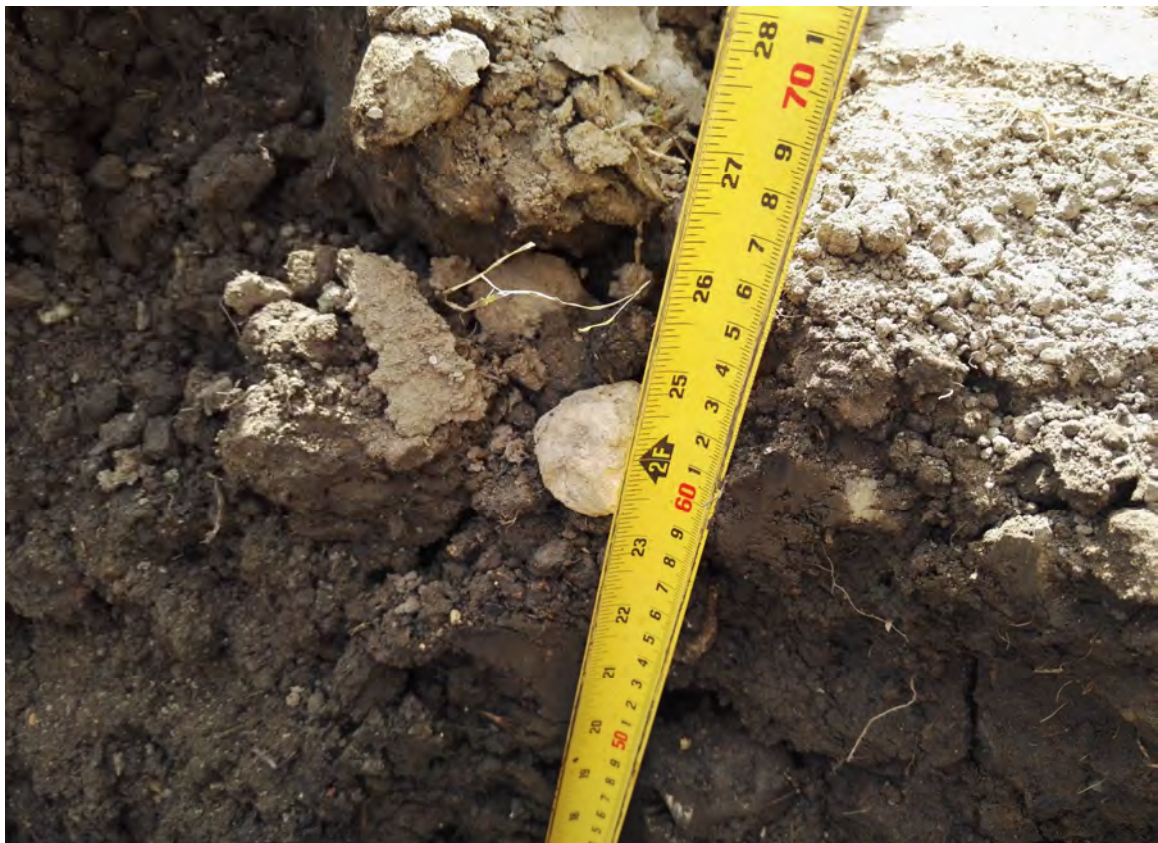
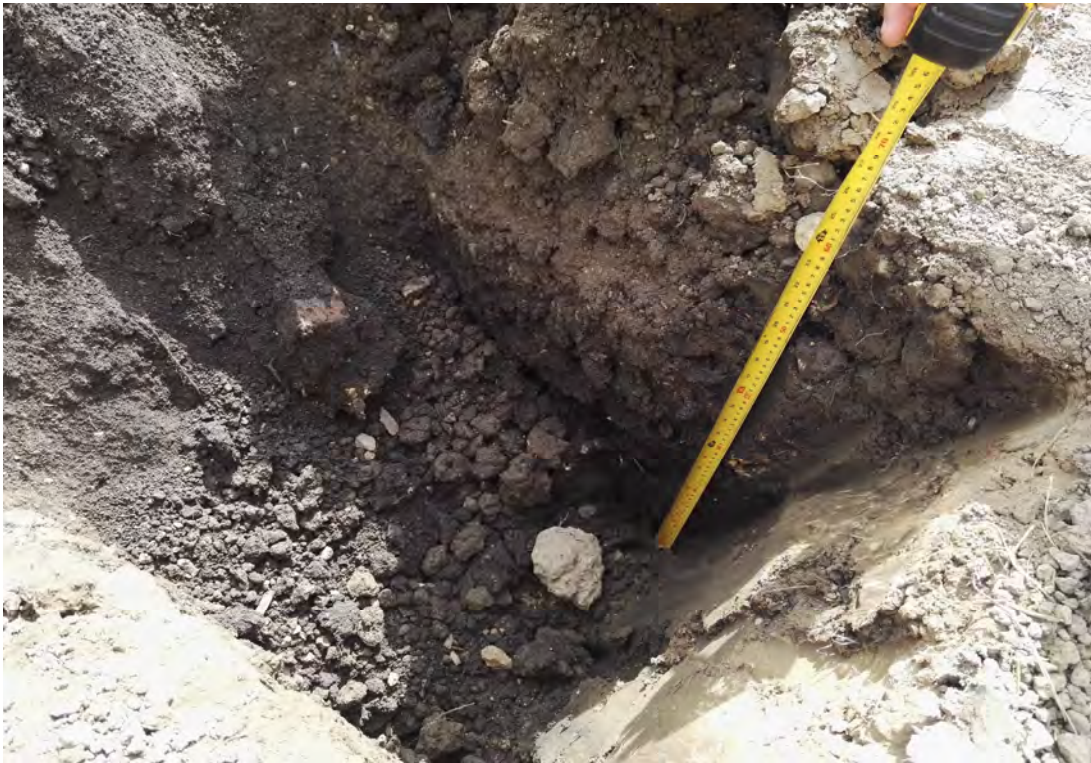
Photograph 1: Validation Pit 1

- Trial Pit 1: 150mm of Topsoil onto at least 450mm of subsoil.
- Trial Pit 2: 200mm of Topsoil onto at least 450mm of subsoil.
- Trial Pit 3: 150mm of Topsoil onto at least 450mm of subsoil.
- Trial Pit 4: 500mm of Topsoil onto at least 150mm of clay subsoil.
- Trial Pit 5: 450mm of Topsoil onto at least 100m of clay subsoil.
- Trial Pit 6: 600mm of Topsoil onto clay subsoil.
- Trial Pit 7: 600mm of Topsoil onto clay subsoil.
- Trial Pit 8: 600mm of Topsoil onto clay subsoil.
- Trial Pit 9: 600mm of Topsoil onto clay subsoil.
- Trial Pit 10: 600mm of Topsoil onto clay subsoil.
