**Inspection of Topsoil thickness – Bellway Apartments Cleadon Vale, King George Road, South Shields.**

**Drawing Title:**  
Validation Trial Pit Location Plan

**Drawing No:**  
D3817-02

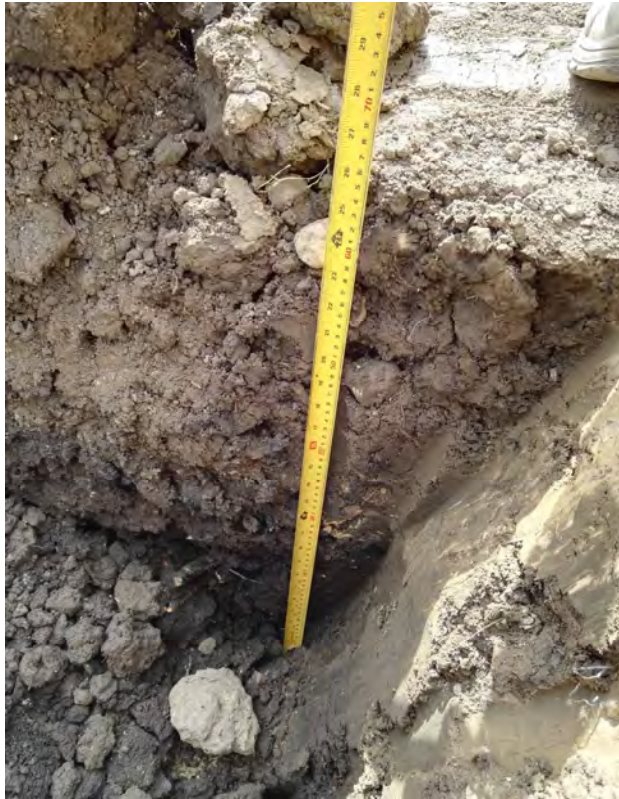
Photograph 1: Validation Pit 1

- Trial Pit 1: 150mm of Topsoil onto at least 450mm of subsoil.
- Trial Pit 2: 200mm of Topsoil onto at least 450mm of subsoil.
- Trial Pit 3: 150mm of Topsoil onto at least 450mm of subsoil.
- Trial Pit 4: 500mm of Topsoil onto at least 150mm of clay subsoil.
- Trial Pit 5: 450mm of Topsoil onto at least 100m of clay subsoil.
- Trial Pit 6: 600mm of Topsoil onto clay subsoil.
- Trial Pit 7: 600mm of Topsoil onto clay subsoil.
- Trial Pit 8: 600mm of Topsoil onto clay subsoil.
- Trial Pit 9: 600mm of Topsoil onto clay subsoil.
- Trial Pit 10: 600mm of Topsoil onto clay subsoil.
