South Drive Footpath Level Crossing

Level Crossing Risk Assessment

B91246-RAS-LXG0001

March 2017

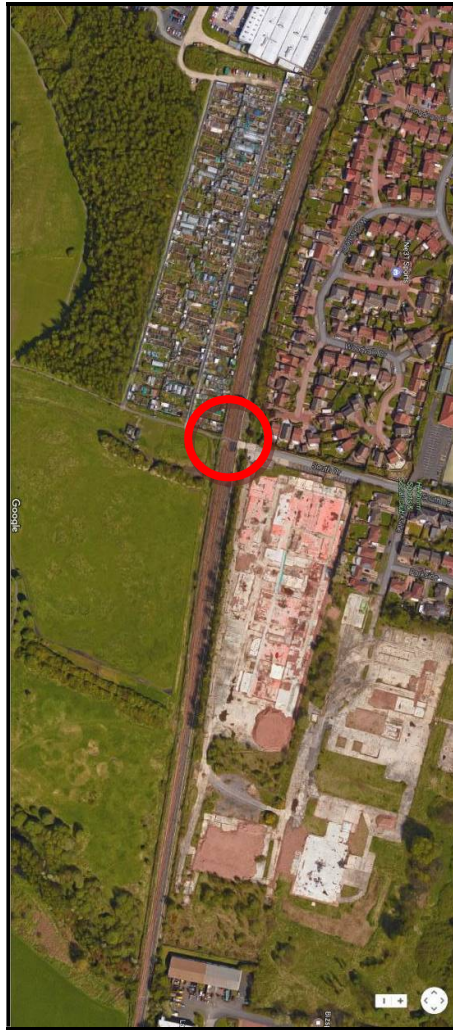
Figure 3: South Drive Footpath Level Crossing (circled) in relation to proposed development site (bottom right), allotments and Riverside Park (top left).

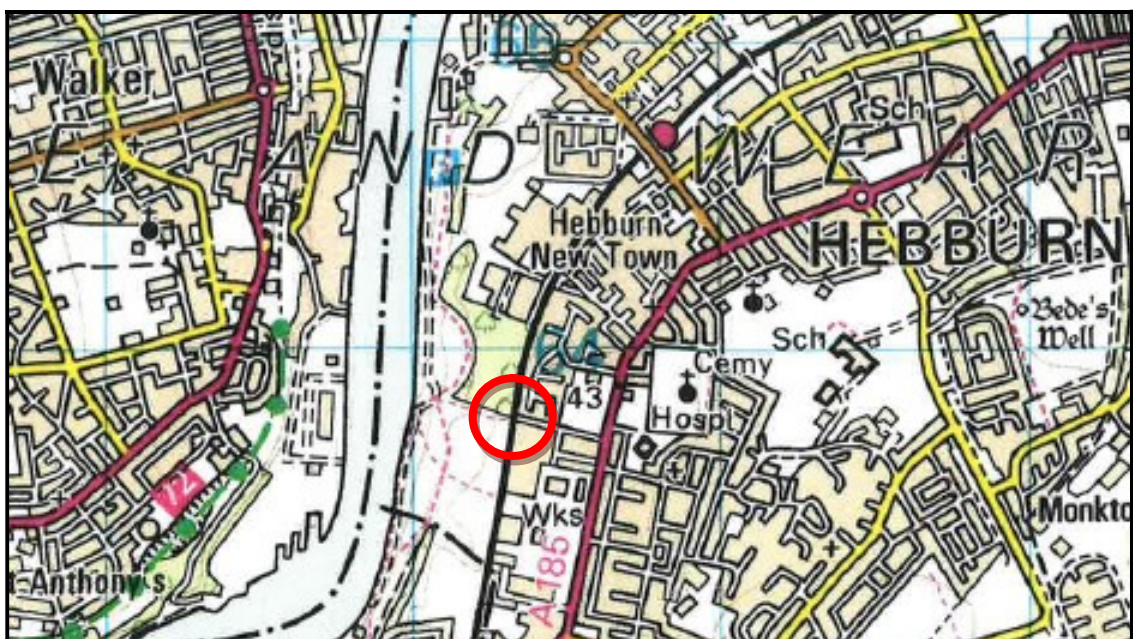
Figure 4: Extract from OS Map illustrating crossing in relation to surrounding area.

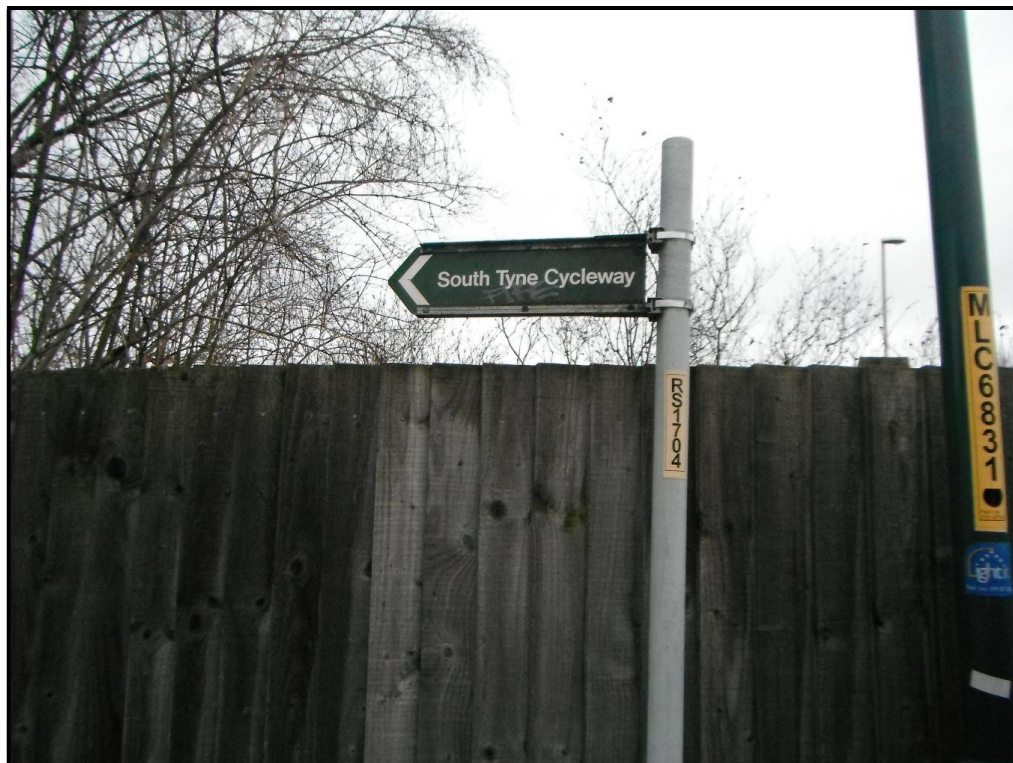
Figure 5: Direction to cycleway sign – no signs at crossing to instruct cyclists to dismount. There is a risk that cyclists could attempt to open the gates and traverse the crossing without getting off the bicycle. Use of the crossing by mounted cyclists was confirmed by the Census of Pedestrian and Rail Users.

This form of protection involves Miniature Stop Lights (MSL) and audible warning devices linked to the Signalling and initiated by approaching trains. The crossing could also be improved through localised safety improvements such as the removal of existing trip hazards and relocating the crossing gates to the decision points (with associated fence alterations). TSP Projects would strongly recommend the installation of 'Cyclists Dismount' signage.

4. Localised safety improvements at the crossing – These should include the removal of existing trip hazards, relocating the decision point signage on the Riverside Park side of the crossing to increase the users view of approaching trains, install anti-trespass guards and relocating the crossing gates to the decision points (with associated fence alterations). The instructions for 'The Hebburn Stroll' should also be updated to more accurately reflect the operating instructions for the crossing. TSP Projects strongly recommend the installation of 'Cyclists Dismount' signage.

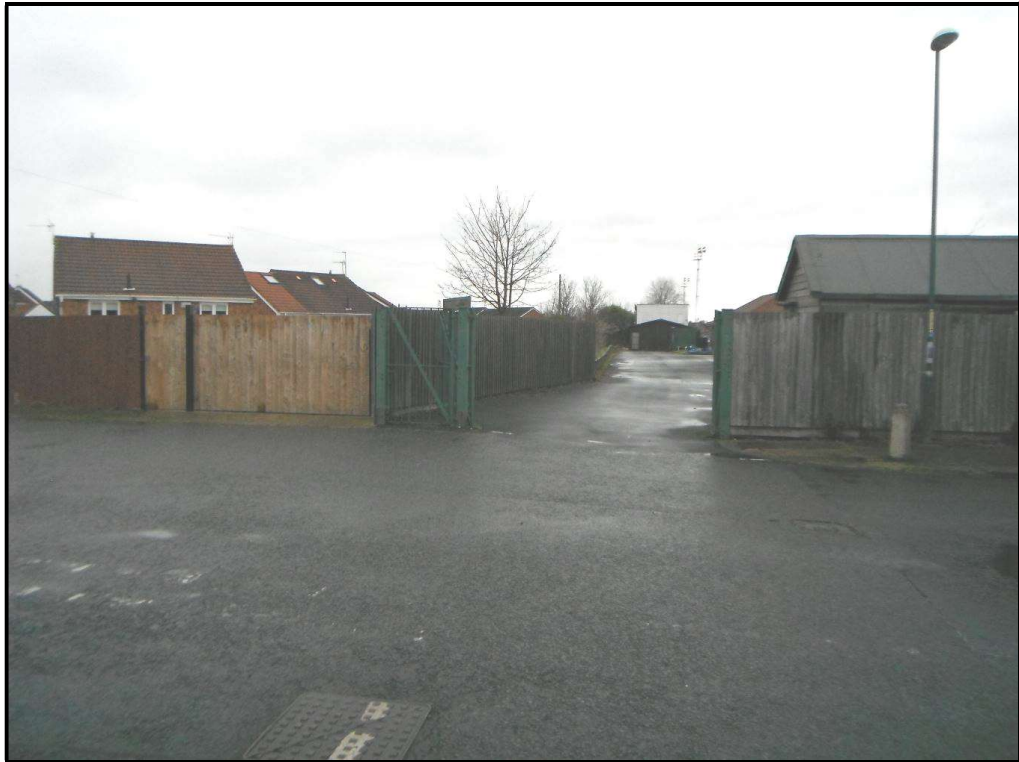
Figure 6: Entrance to Hebburn Sports and Social Club – possibility of increased traffic (both vehicular and foot) on match days.

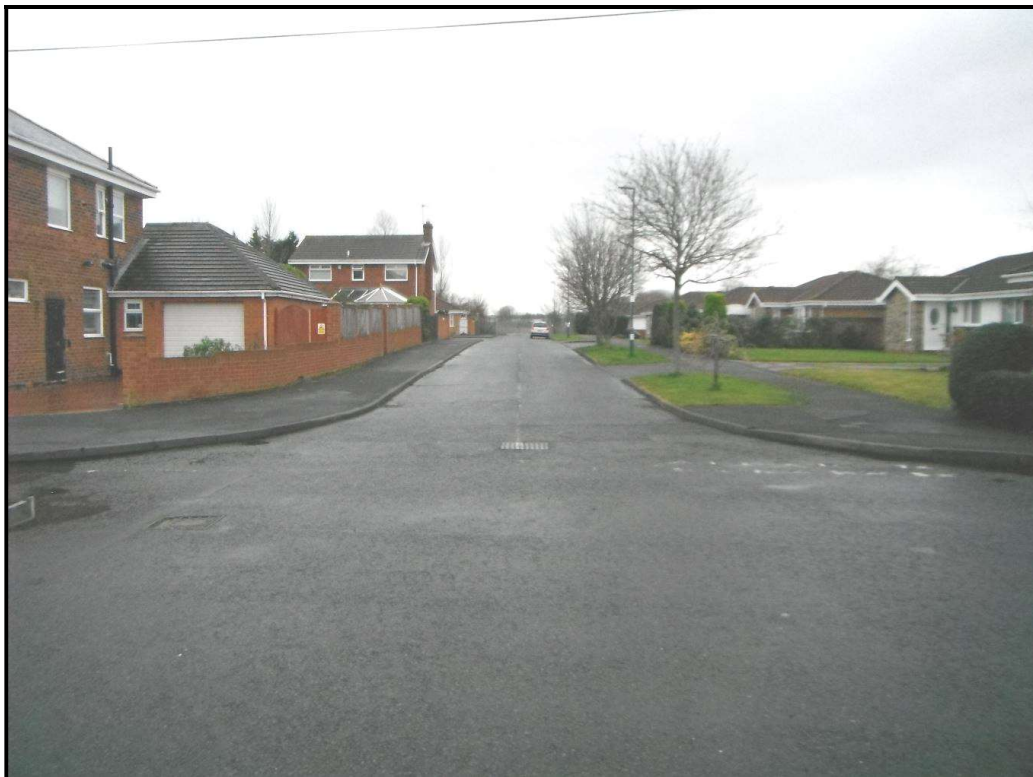
Figure 7: Access into residential properties on Parkside – entrance is opposite the entrance to the Hebburn Sports and Social Club.

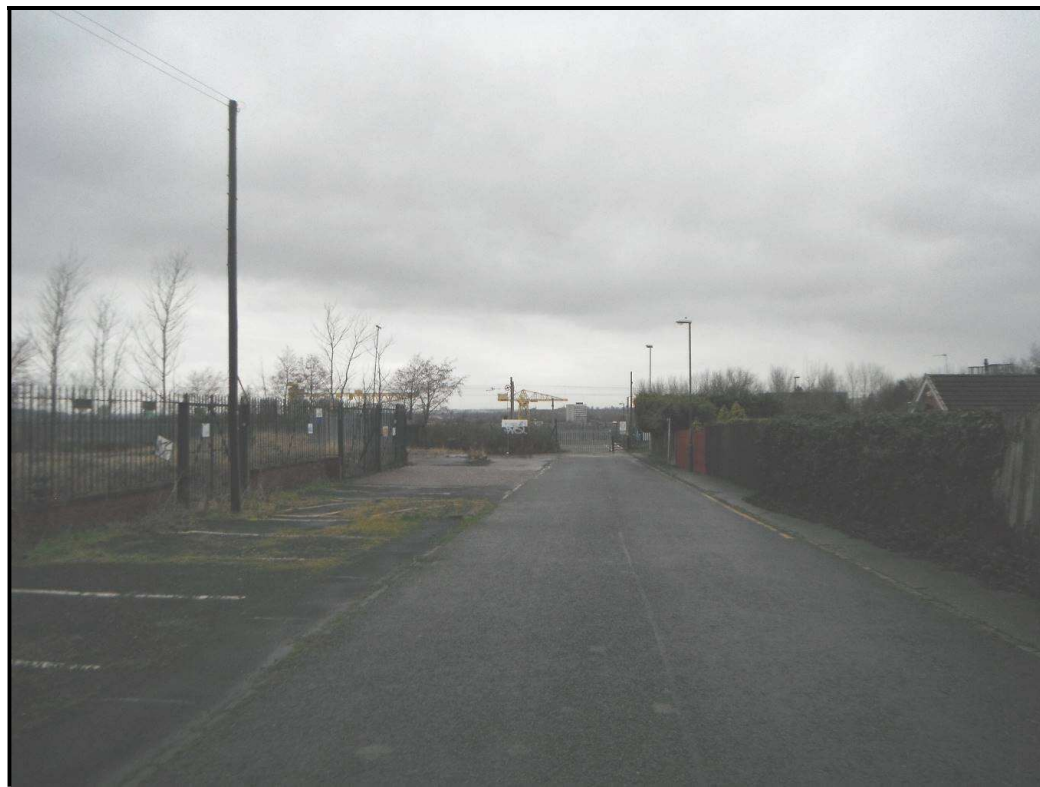
Figure 8: Public parking spaces on approach to South Drive Footpath Level Crossing – on site visit it was witnessed that these spaces were utilised by dog walkers and users of the allotments. Vehicles parked in the spaces and the occupants used the crossing to gain access to the Riverside Park area. It is also thought that this area may be used as informal parking for the nearby Hebburn Sports and Social Club during peak times. This parking area appears to be part of the land to be redeveloped by the Miller Homes scheme. Therefore, it can be expected that any vehicles currently utilising this parking area will park on the kerbside, potentially reducing the usable width of the carriageway. It is likely that vehicles may then utilise the area designated as ‘visitor parking’ (for the Miller Homes development) adjacent to the crossing for turning vehicles around which could increase the risks to users of the crossing. The alternative route for vehicles to access the allotments and/or fields (refer to figure 28) is via the Siemens complex as described in Figures 29, 30 and 32. There are a number of vehicular parking spaces available in Riverside Park for dog walkers to utilise as an alternative. This parking area is a 1.5 mile diversion from the existing parking area on South Drive (approximately 6 minutes by car).

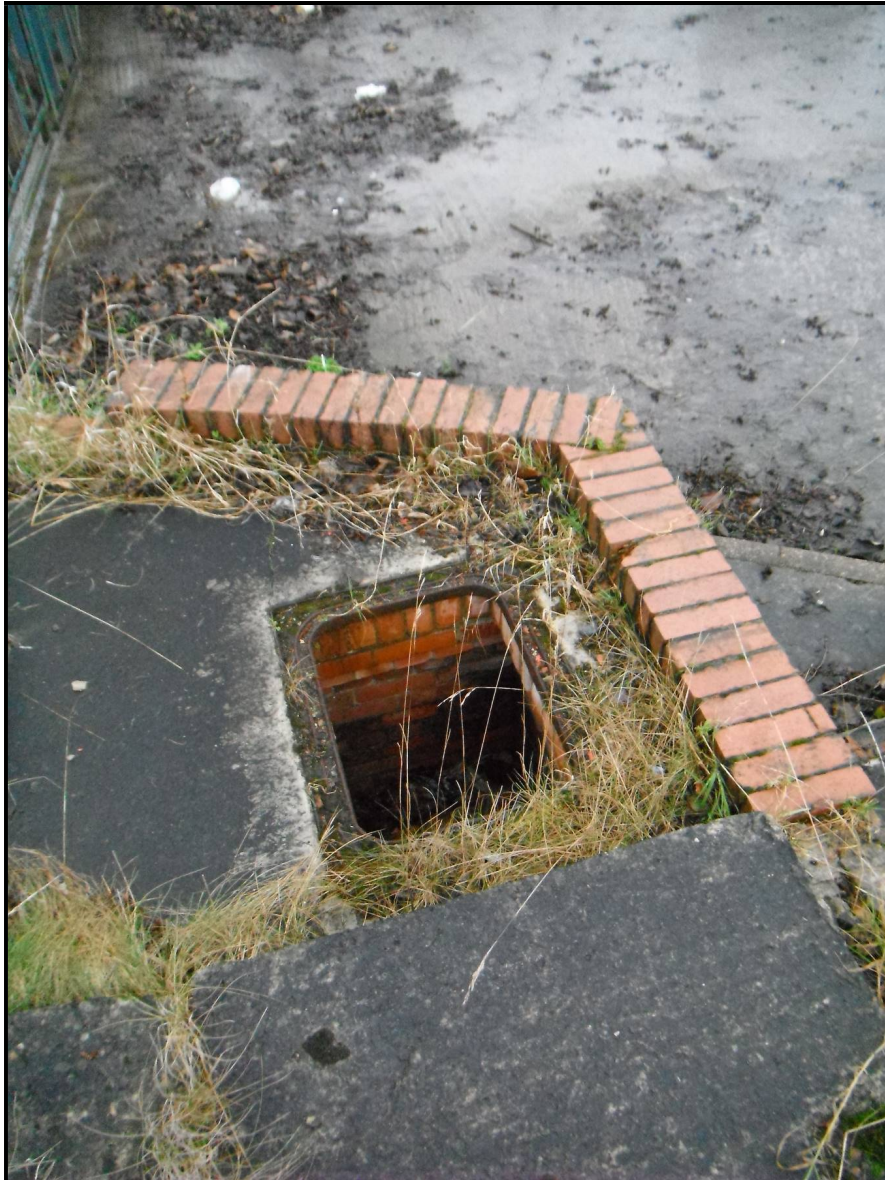
Figure 9: A manhole cover was missing in the south east corner of the crossing – although members of the public are unlikely to utilise this area, there is still a significant risk of physical harm to members of the public. This was subsequently reported to South Tyneside Council via their website reporting system.

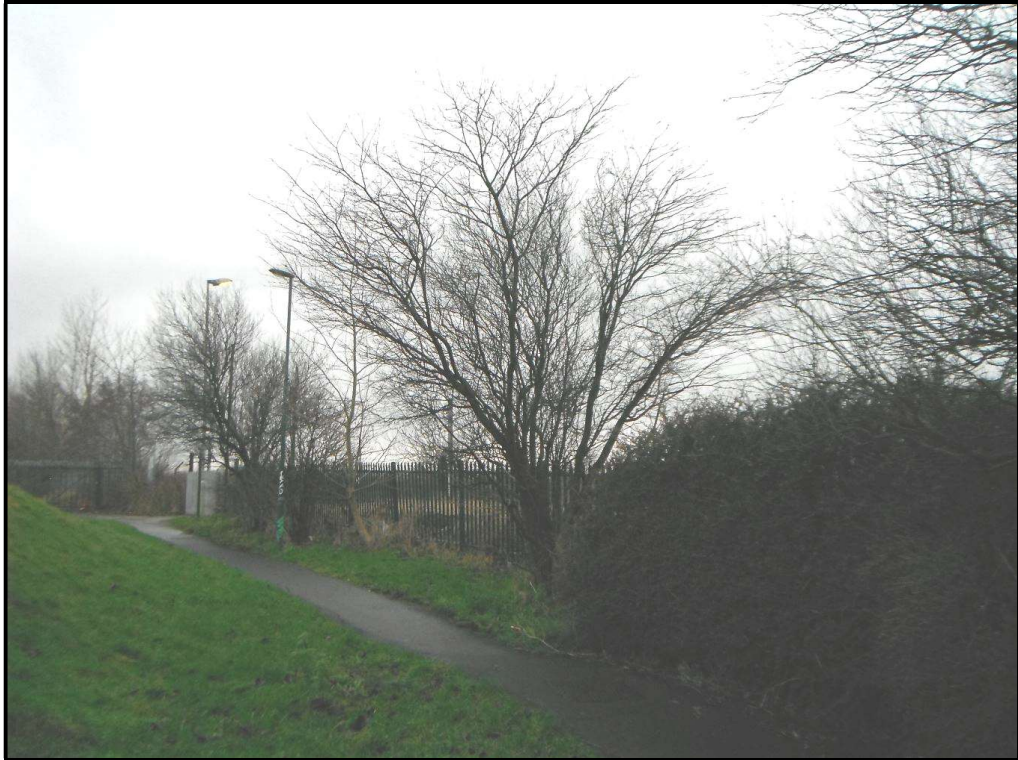
Figure 10: Pedestrian access towards the crossing from Woodvale Drive. The asphalt path provides good underfoot conditions and is illuminated by street lighting provided by South Tyneside Council. The railway boundary fence appears to be in good condition and of a suitable height/type to deter unwanted access.

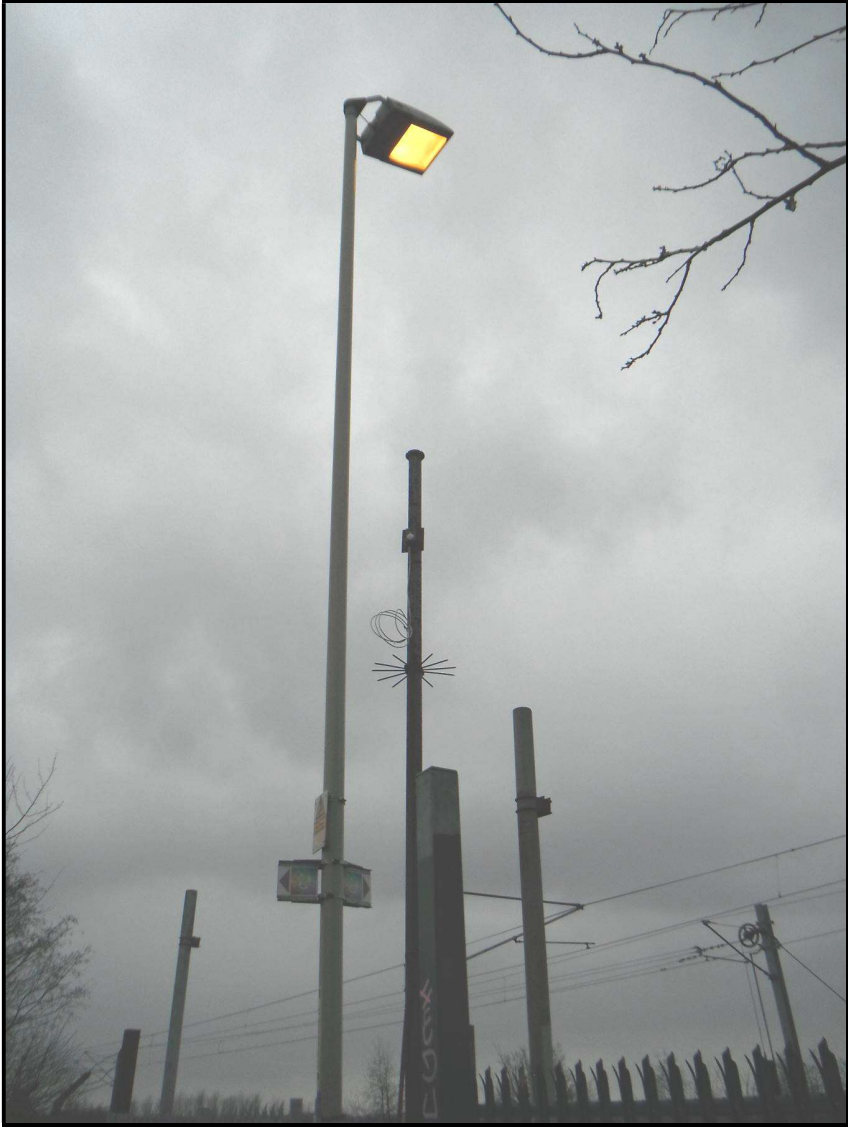
Figure 11: South Drive Footpath Level Crossing is illuminated by lighting provided by the railway. It appears to be sodium based lighting. The lux levels across the deck were not tested during the site visit so it is unknown whether the existing level of illumination is compliant across the whole footway surface.

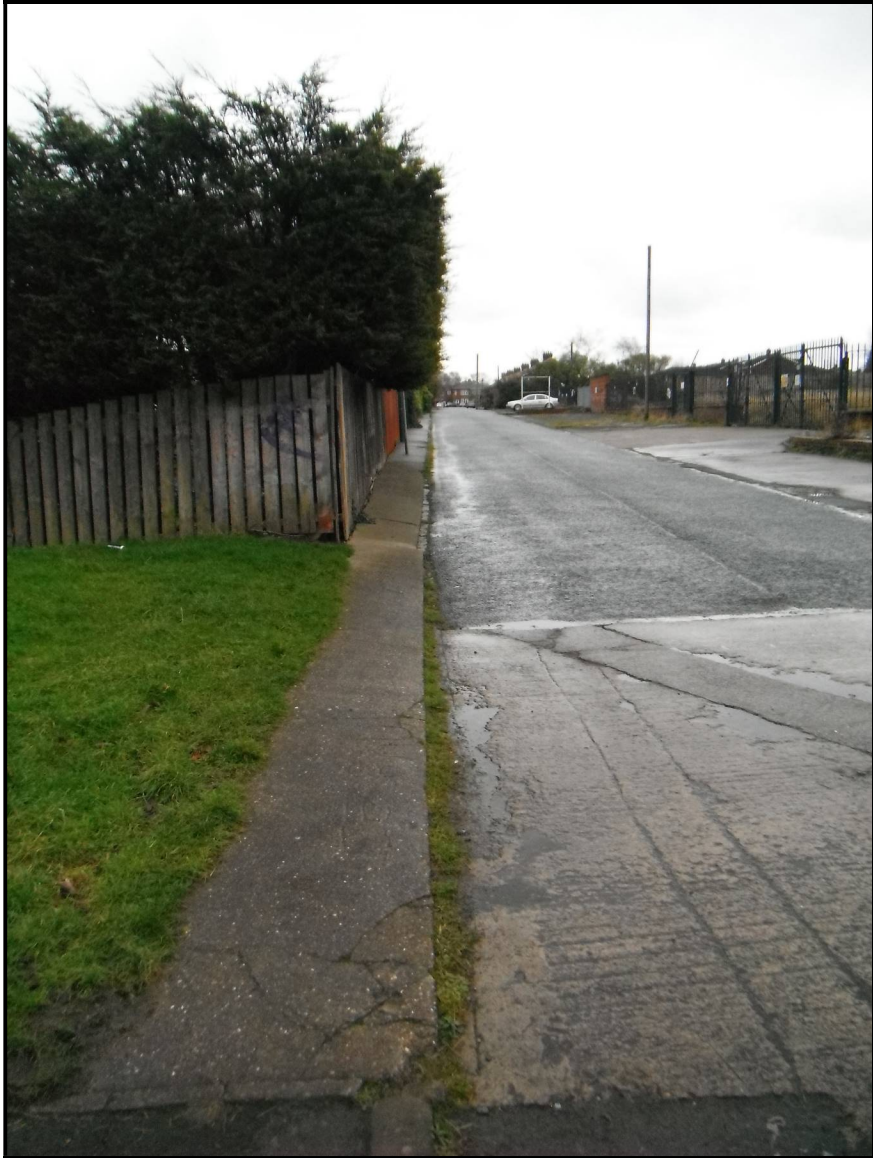
Figure 12: The designated footway on South Drive is of concrete construction and slopes towards the carriageway. It is also overhung by trees from the adjacent property, reducing available head room to pedestrians. Both of these factors contribute to forcing pedestrians to walk in the carriageway.

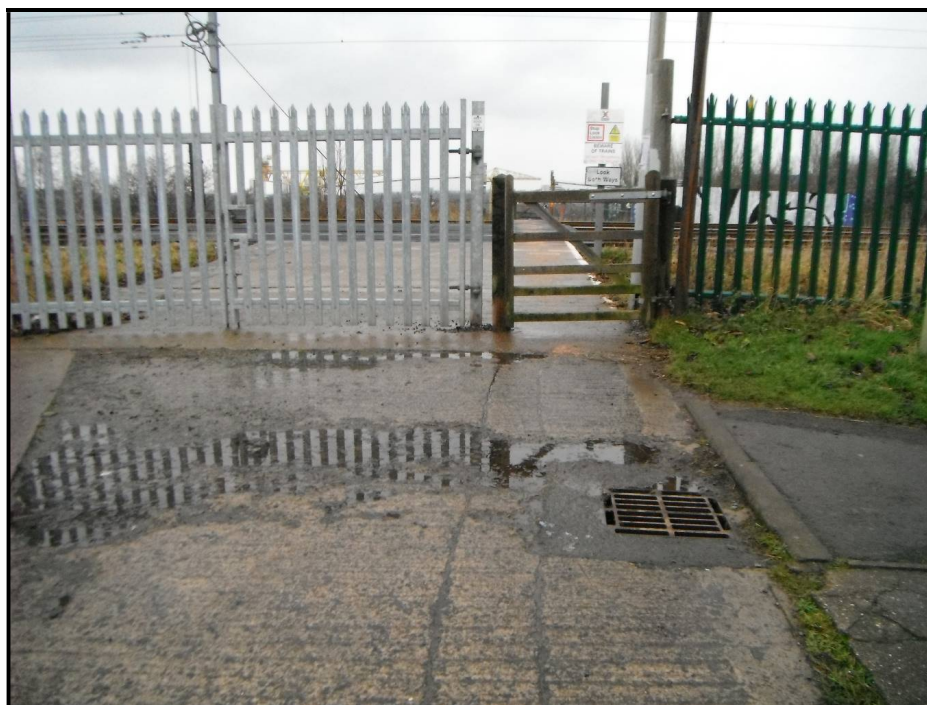
Figure 13: Despite the provision of a drainage gully, surface water pools on the entrance to the crossing. In freezing temperatures, this will become icy and result in hazardous underfoot conditions. There is a Road/Rail Access Point (RRAP) adjacent to the crossing gate. It is assumed that the RRAP will only be utilised with the appropriate safe system of work, therefore the increased risk to crossing users is thought to be negligible. As confirmed with David Guy (Network Rail Level Crossing Manager) on 17th February 2017, the RRAP is for the use of Nexus staff only as no vehicular deck is present on the Network Rail freight line.

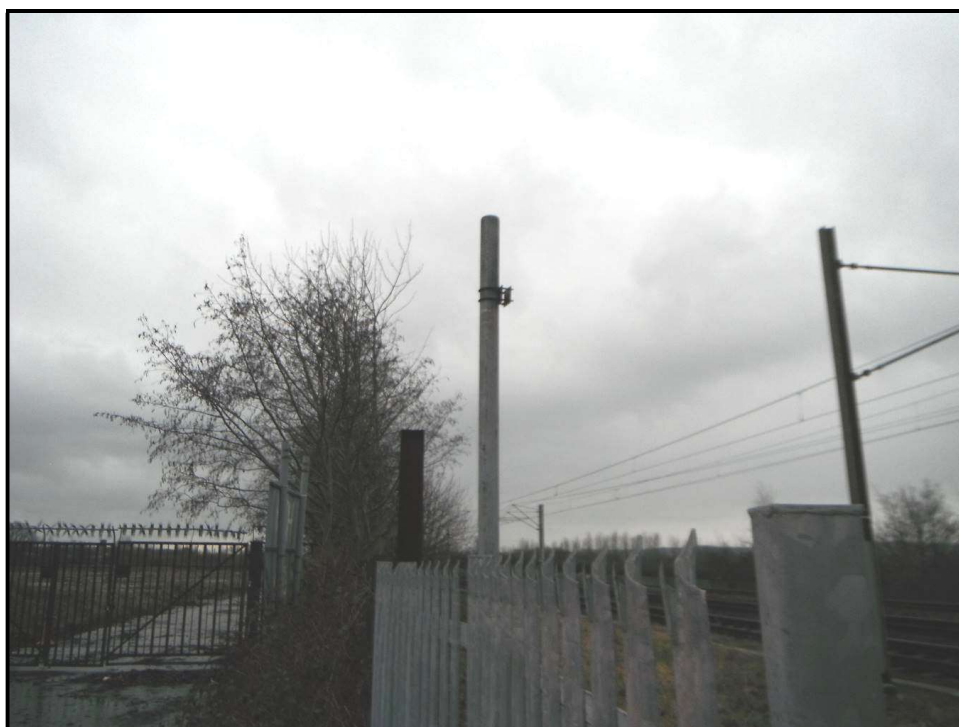
Figure 14: There is evidence of a previously installed height gauge above the RRAP – presumably to provide a safe height for vehicles due to the presence of existing overhead electrification equipment. There is an existing post and bracket installed on each side of the vehicular access

gates but the actual height gauge itself is missing. This increases the risk of tall vehicles contacting live overhead cables although it is assumed that any use of the RRAP will be supported by a safe system of work.

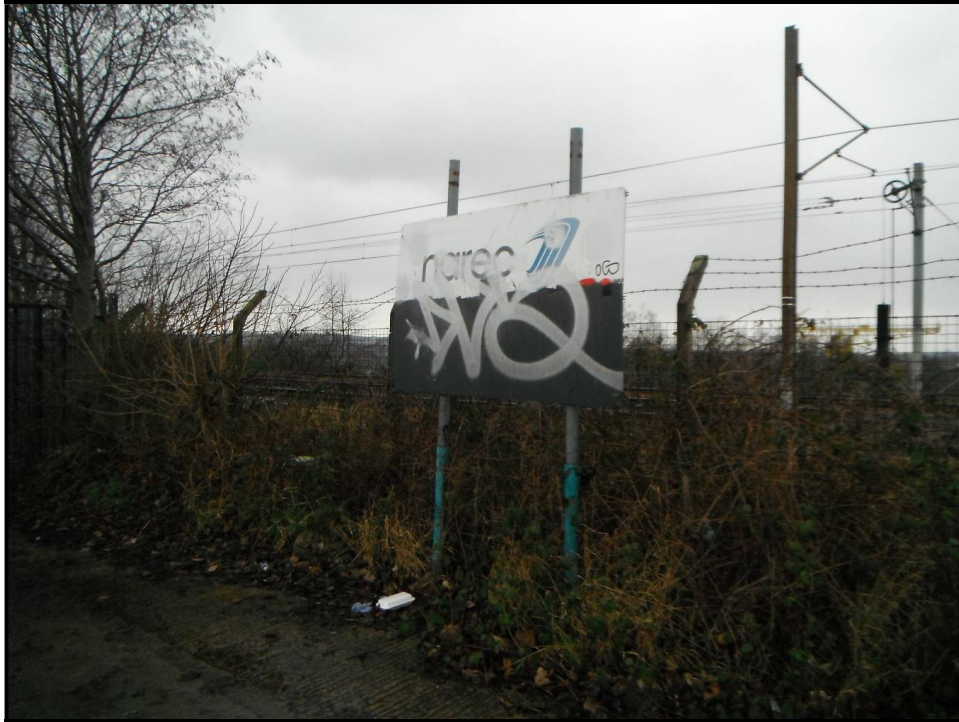
Figure 15: There is a large amount of evidence to suggest that the crossing is in a high vandalism area – there is a proliferation of graffiti around the site.

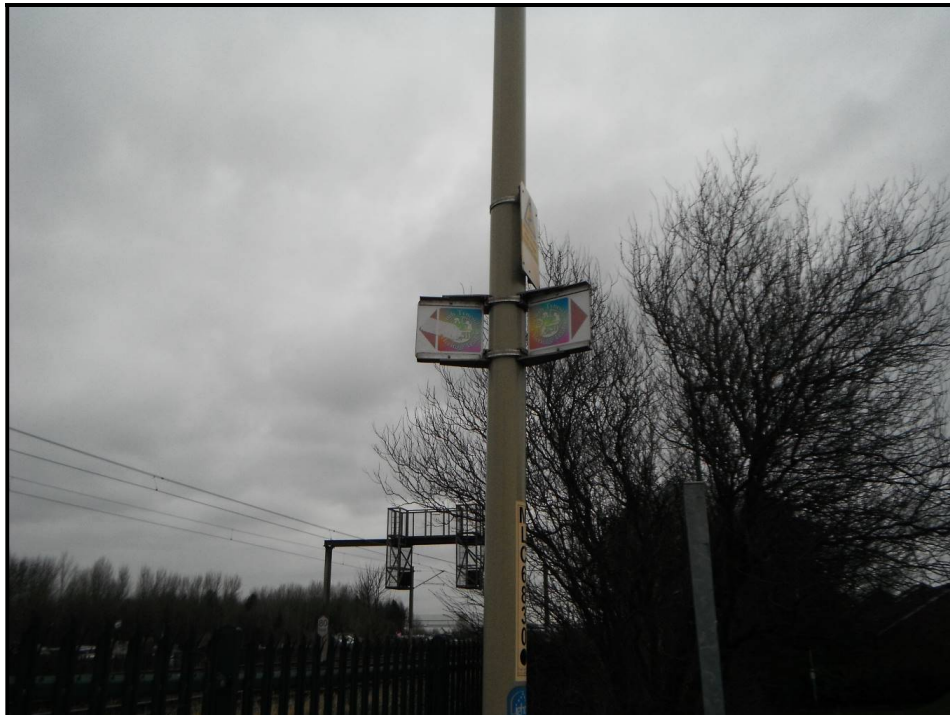
Figure 16: The crossing lies on the documented route of the South Tyneside Heritage Trail, the route that encompasses the crossing is known as 'The Hebburn Stroll'. On the route map, there is a hazard triangle and the following text "...cross the stile and across the Metro Line, (Care must be

taken when crossing) this will bring you out on to South Drive.” The guidance is out of date as the stiles have been replaced at the crossing – perhaps the guidance could be improved to inform the users of how to use the crossing safely.

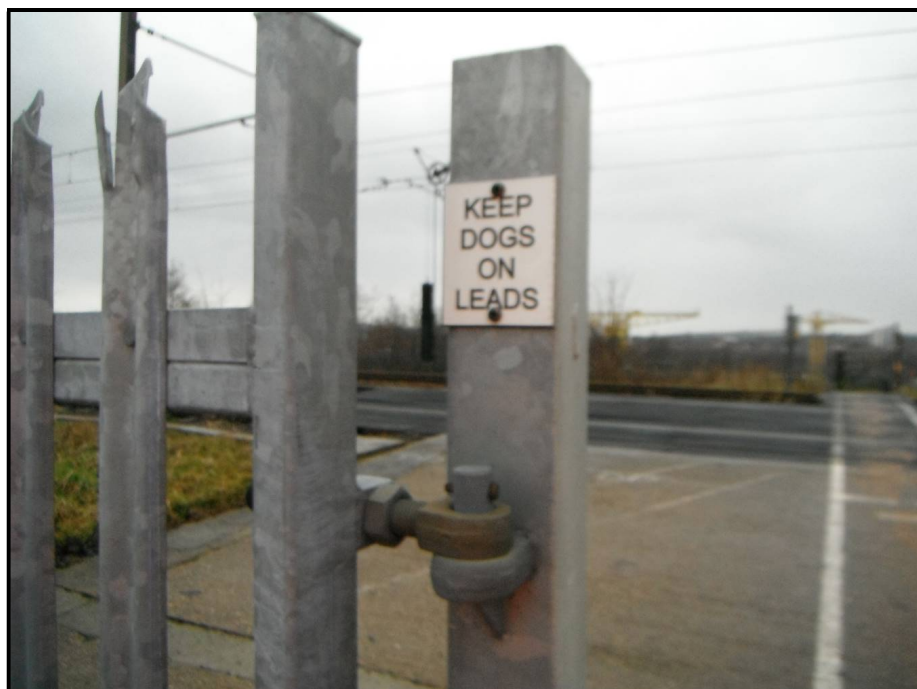
Figure 17: The existing sign infers a high usage of the crossing by dog walkers. During the site visit, a dog on an extendable lead walked off the decking and into the four foot of the Network Rail line. The 9 day Census of Rail and Pedestrian Users concluded that an average of 63 dog walkers use the crossing per day (maximum of 106 on Monday 4th February 2017).

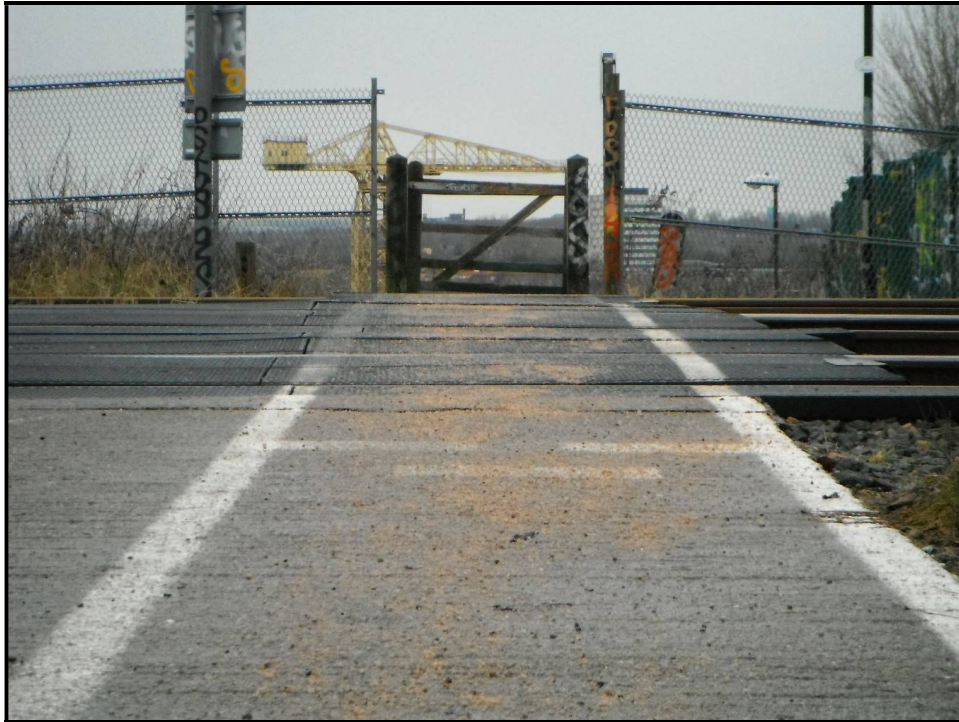
Figure 18: Temperatures on the day of the site visit were very low. The crossing surface had been recently salted which gives a good indication of regular maintenance attendance. It may also point to a history of hazardous underfoot conditions in freezing temperatures. The white lining over the deck itself on the left side of the photo is beginning to wear off. It is not clear who is responsible for salting the deck, an operation which in itself is presumably subject to an agreed method of working.

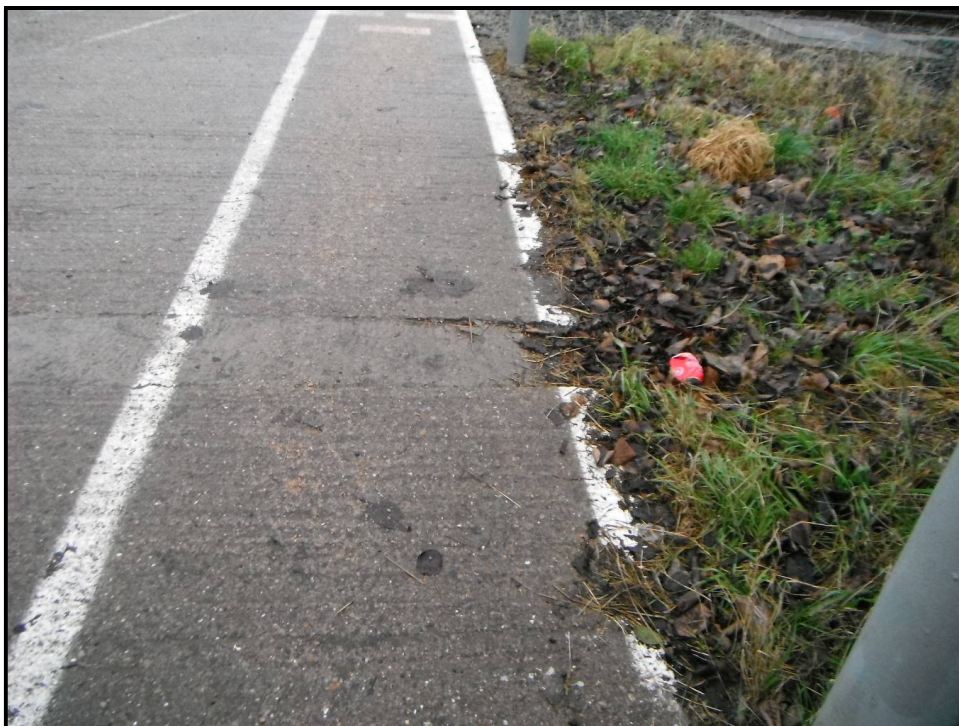
Figure 19: There is an existing trip hazard in the footway where the concrete surface has been patched. The white lining on the right of the photo that demarcates the outermost edge of the footway is on the edge of the concrete surface itself. It is beginning to be overgrown by vegetation and there is a chance of someone walking close to the edge of the footway and stumbling off the

crossing surface. The severity of this is increased where the concrete surface meets the deck on the South Drive side of the crossing as there is a greater drop from the concrete to the surrounding land level. A pushchair wheel could easily drop off the concrete surface if the user is startled by an errant dog.

The crossing could be improved through localised safety improvements such as the removal of existing trip hazards, relocating the decision point signage on the Riverside Park side of the crossing to increase the users view of approaching trains, install anti-trespass guards and relocating the crossing gates to the decision points (with associated fence alterations). TSP Projects would strongly recommend the installation of 'Cyclists Dismount' signage. The instructions for 'The Hebburn Stroll' should also be updated to more accurately reflect the operating instructions for the crossing.

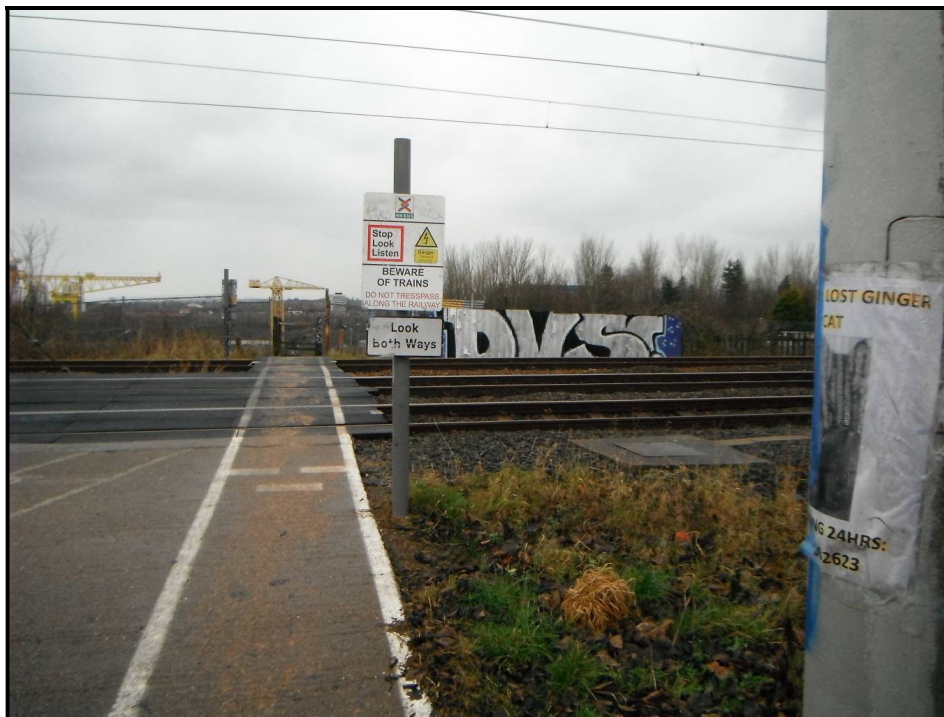
Figure 20: There are two decision points marked on the footpath which could be confusing to users. As the gate is located in the boundary fence, approximately 6.0m from the crossing guidance signage/decision point, there is a risk that users look both ways to ensure no trains are approaching as they open the gate but then continue to cross without any further checks. At a traverse speed of 1.2m/s, it would take approximately 5 seconds to walk from the gate to the decision point. The signage also physically overhangs the footpath white lining, increasing the likelihood of users heads contacting the edge of the signs. During the site visit, it was noted that the view from the decision point was obscured by the overhead line stanchions when looking towards Pelaw.

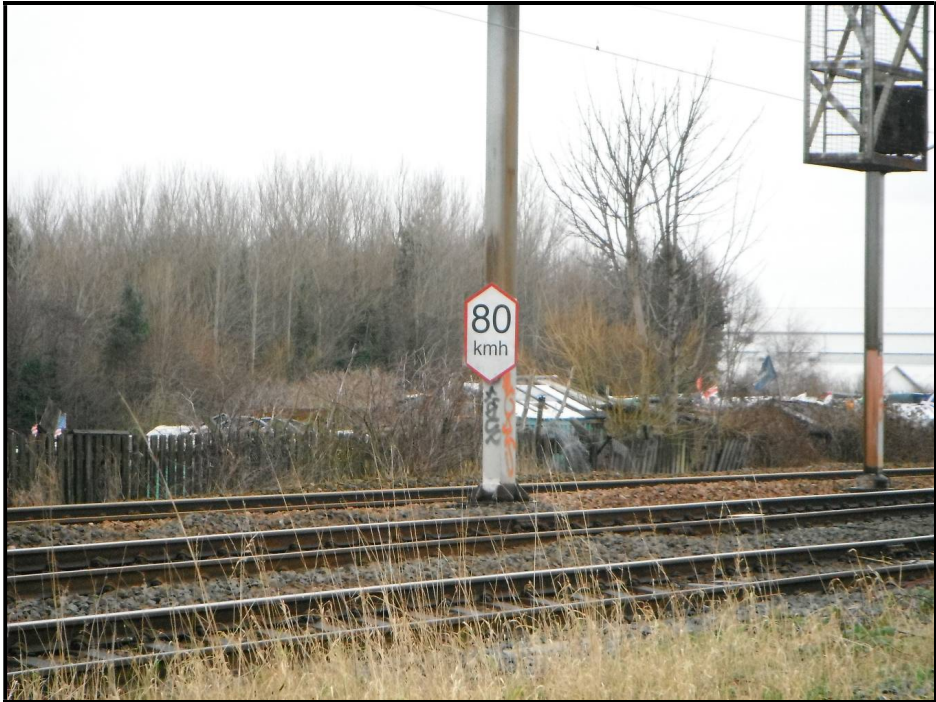
Figure 21: The presence of graffiti below the speed board in the ten foot shows that there are instances of trespass, most likely accessed from the crossing itself. No anti-trespass guards are installed at the crossing to act as a deterrent.

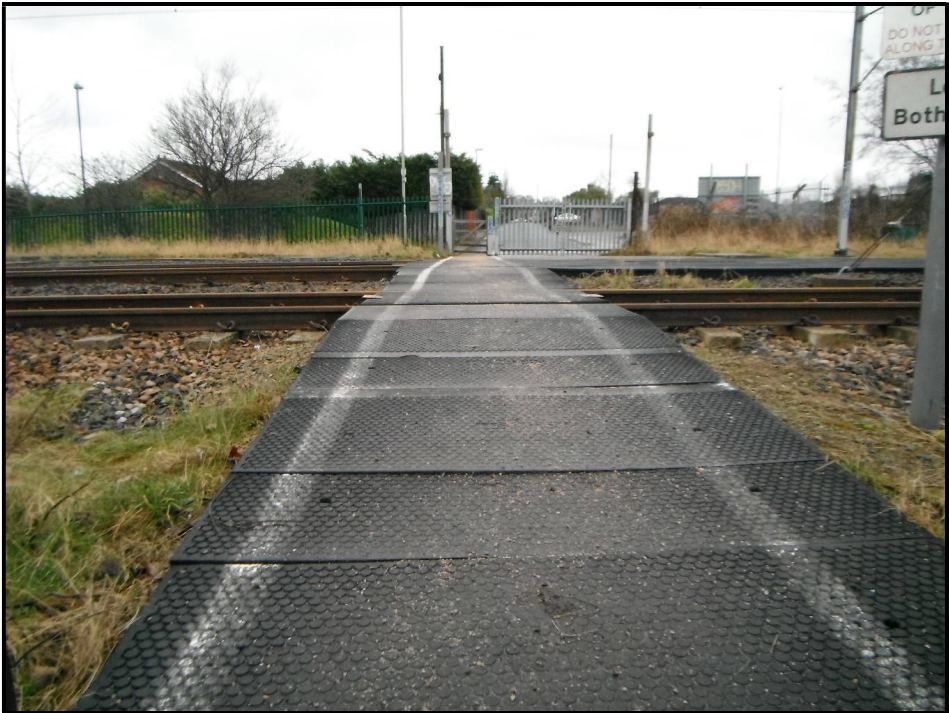
Figure 22: Holdfast deck panels are installed up to the crossing gate on the Riverside Park side of the crossing. The surface is anti-slip but it is uneven and the edges of the panels present a trip hazard to users. The footway appears to be of sufficient width (based on the width of the crossing gates) with sufficient distance from the white lining to the edge of the deck surface. However, the white lining that demarcates the footway and the decision point is beginning to wear off.

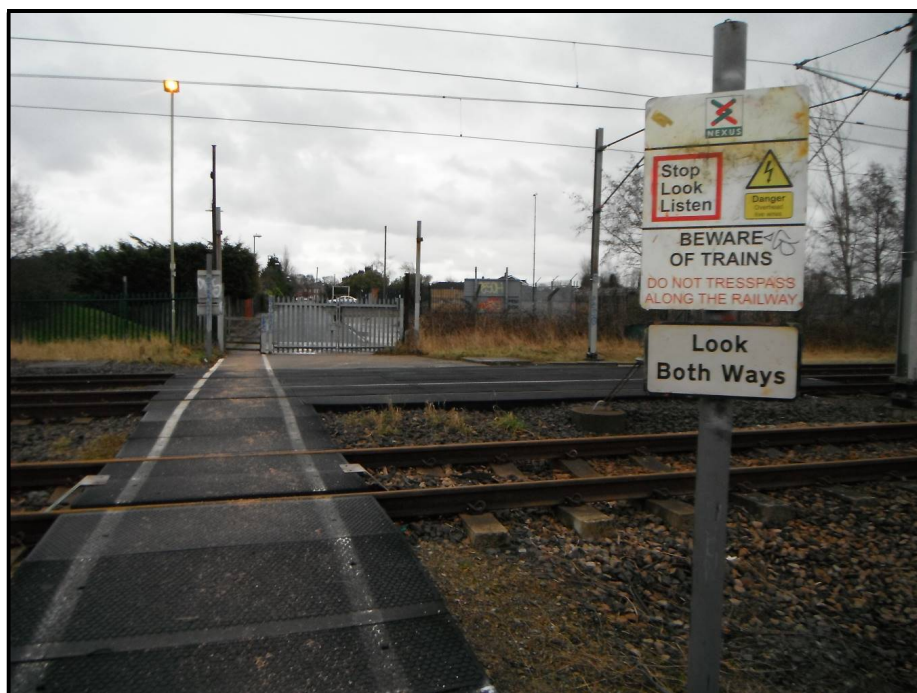
Figure 23: If stood at the marked decision point on the Riverside Park side of the crossing (which has predominantly worn off), the crossing guidance signage is directly in the line of sight when looking in a southern direction towards Pelaw (to the right of the photo) which could prevent safe usage of the crossing. The word 'trespass' has been spelled incorrectly on both sides of the crossing. The crossing guidance signage itself is not as depicted in The Private Crossings (Signs and Barriers) Regulations 1996 although it can be argued that they convey the same message. David Guy (Network Rail Level Crossing Manager) has confirmed that this is to ensure consistency with other crossings on the route, although there is a shared safety responsibility at the crossing (between Network Rail and Nexus). The signs themselves have recently had graffiti removed that obscured the instructions (this obscuration was noted during a previous site visit on 24th January 2017).

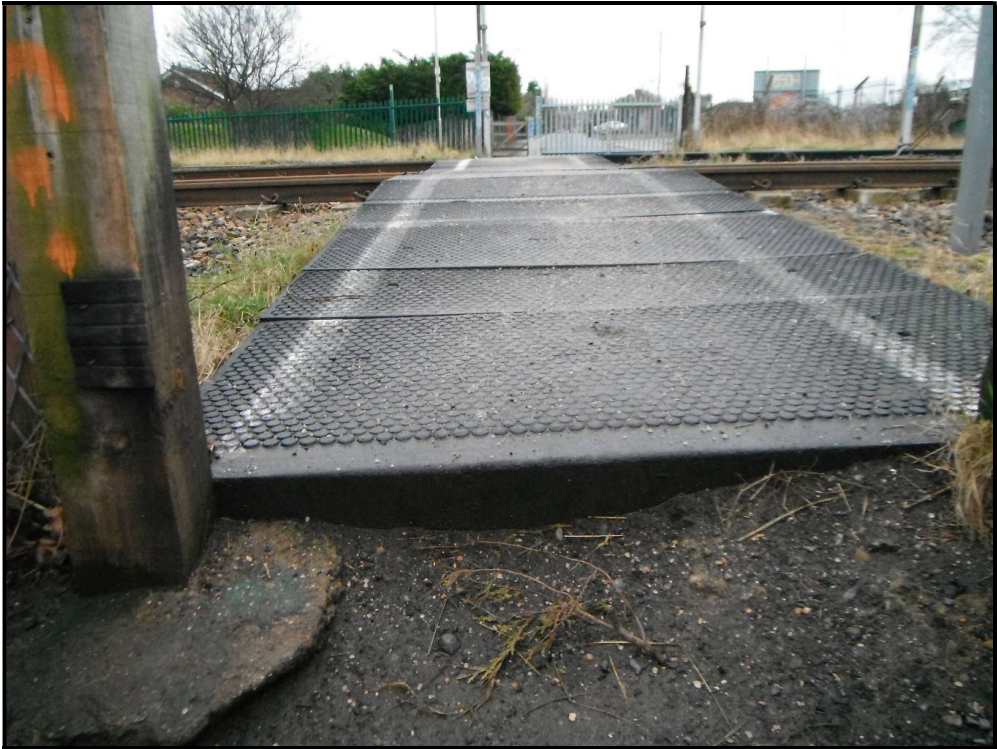
Figure 24: There is a significant trip hazard formed by the edge of the outermost deck panel. This edge is normally obscured by the closed gate which increases the likelihood of tripping. The overspill from the gate post concrete also presents a trip hazard to crossing users.

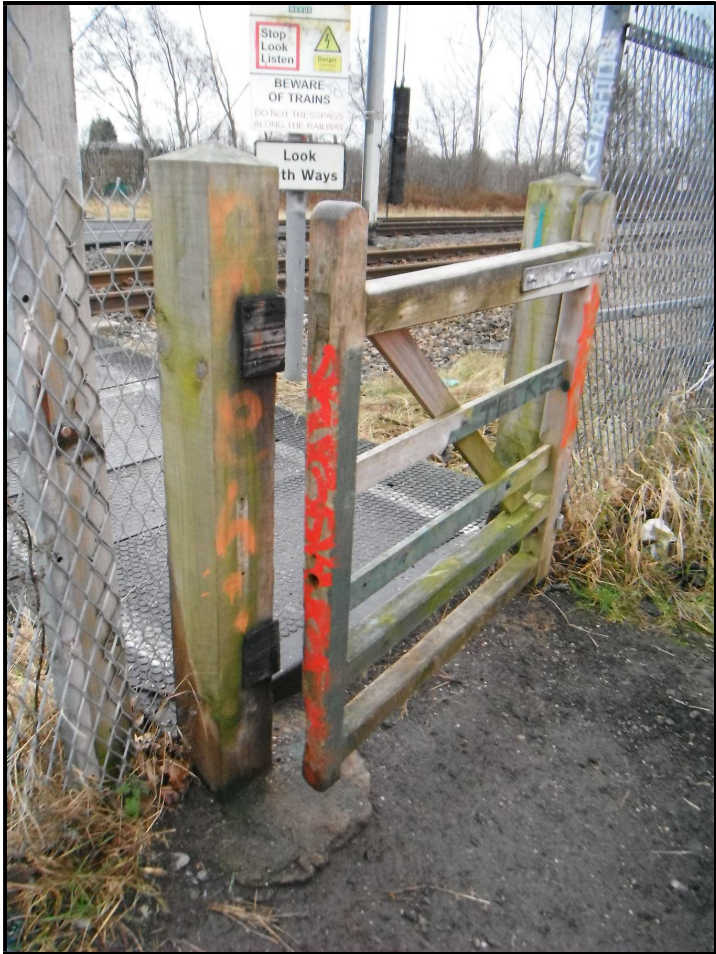
Figure 25: During strong winds it was noted that the access gate did not fully close, despite being self-closing. This has been reported to Network Rail (reference: 170213-000138). In light winds, the self-closing mechanism was found to work correctly.

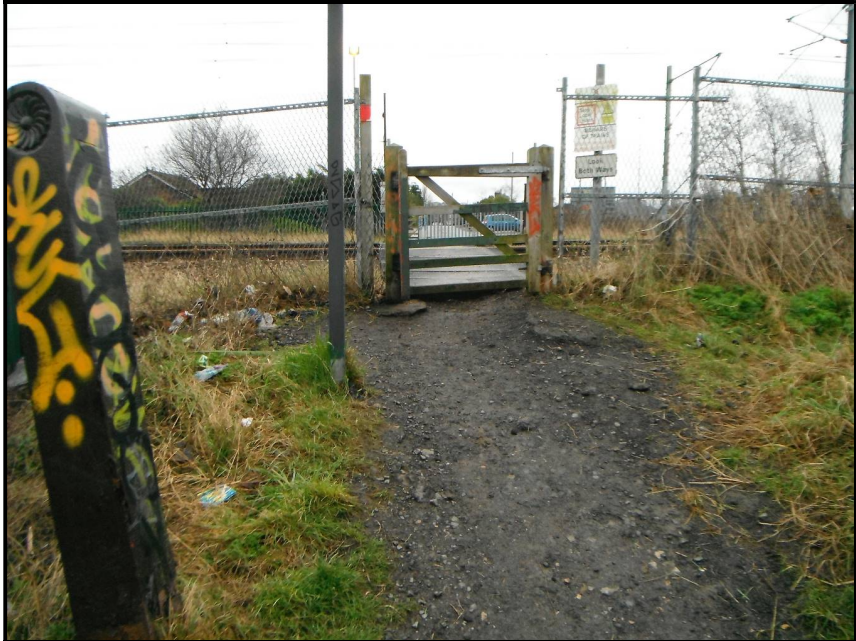
Figure 26: The immediate approach to the crossing is un-metalled, uneven and slopes down towards the river. There is an increased likelihood of slips, trips and falls for members of the public.

Although the level crossing is accessible for all mobility impaired persons from South Drive, users who have difficulty taking a step of more than 12-15cm would be unable to use the Riverside Park access gate.

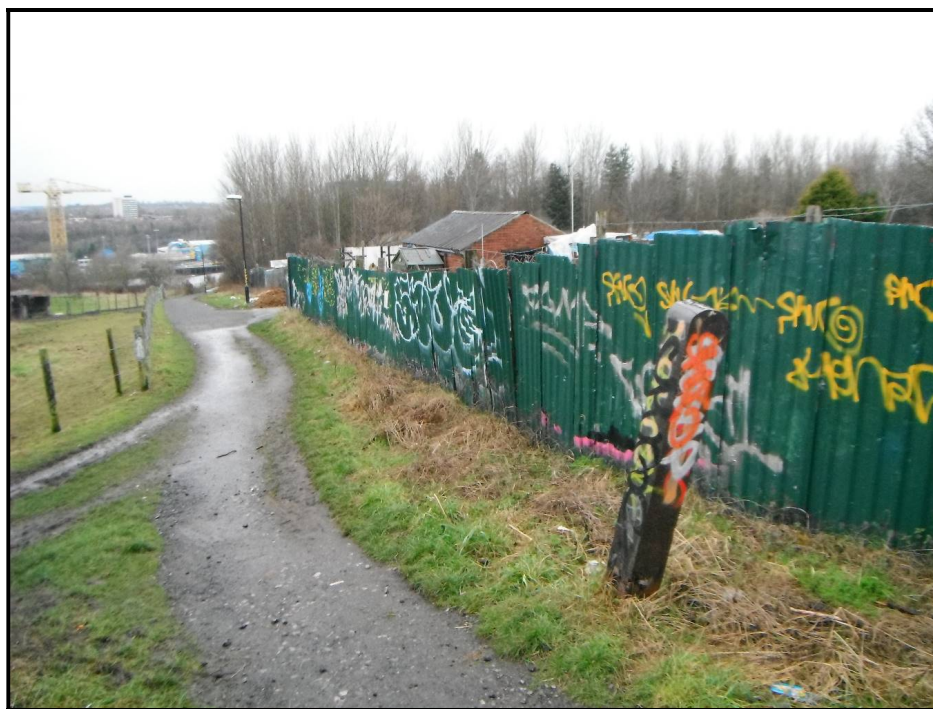
Figure 27: The un-metalled footpath surface leads to the main allotment access gates, where the footpath becomes metalled. The footpath is illuminated by street lighting provided by South Tyneside Council. There is an abundance of graffiti that reinforces the assumption that the crossing is in a high vandalism area.

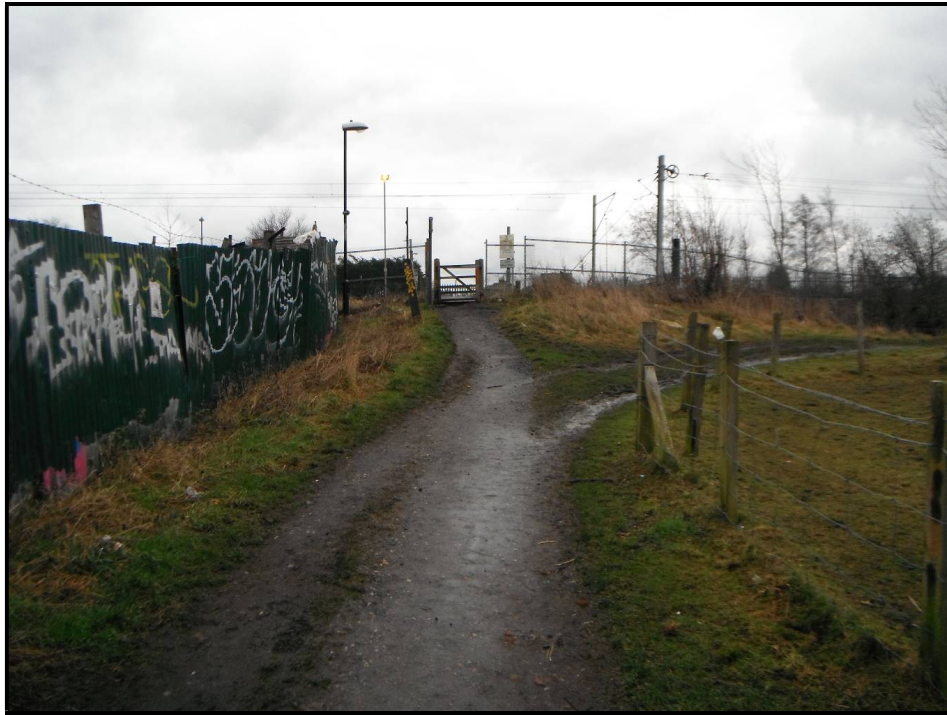
Figure 28: The un-metalled access track that runs in parallel with the railway shows signs of vehicular use. This is most likely to gain access to the adjacent fields. Horses were in the fields at the time of the site visit. Vehicular use of the access track is an additional risk for users of the crossing. The Census of Rail and Pedestrian Users records daily use of the crossing by someone with a wheelbarrow moving horse feed to this side of the railway.
