South Drive Footpath Level Crossing

Level Crossing Risk Assessment

B91246-RAS-LXG0001

March 2017

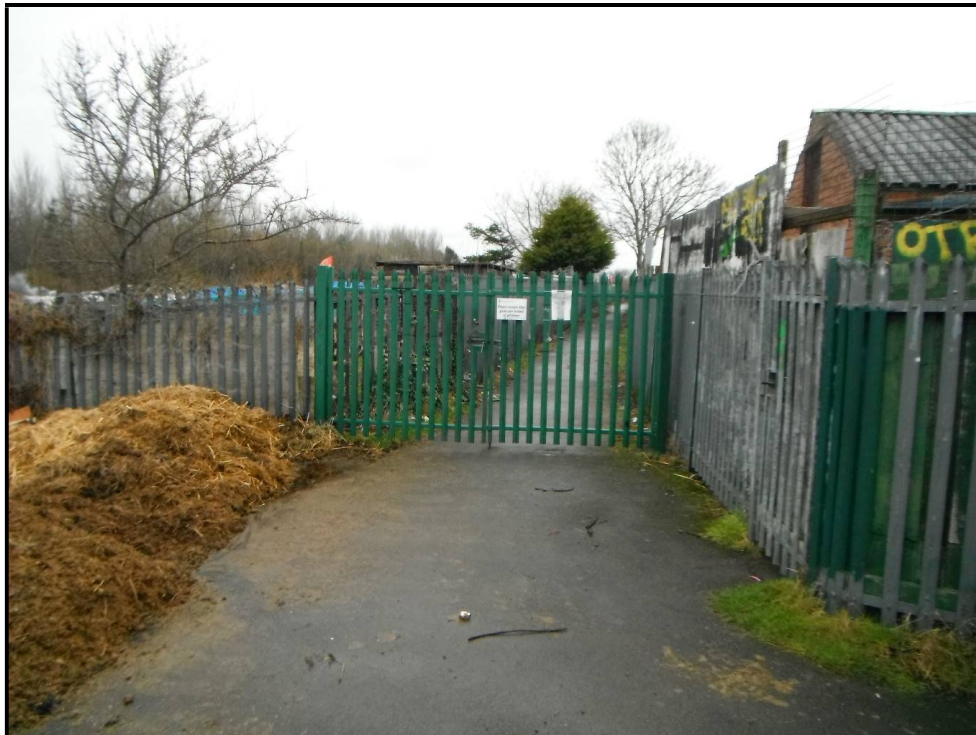
Figure 29: Locked access gates to the allotments – there are approximately 96 individual plots. Vehicular access is via the Siemens complex which then gives two alternative routes to access the allotments (dependant on the location of the plot). It is thought that the gates above would rarely be

unlocked for vehicular use as the alternative route is ungated. Fresh manure is evident in the photo so the gates are likely to be unlocked more regularly for wheelbarrow use.

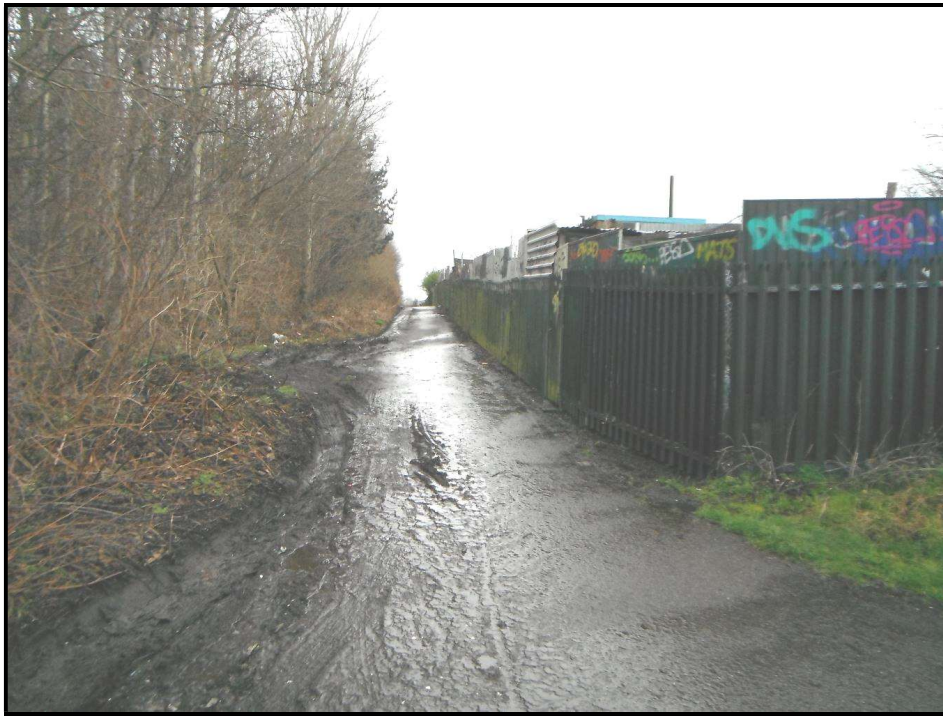
Figure 30: Ungated alternative vehicular access to the allotments. The area appears to have an issue with fly-tipping.

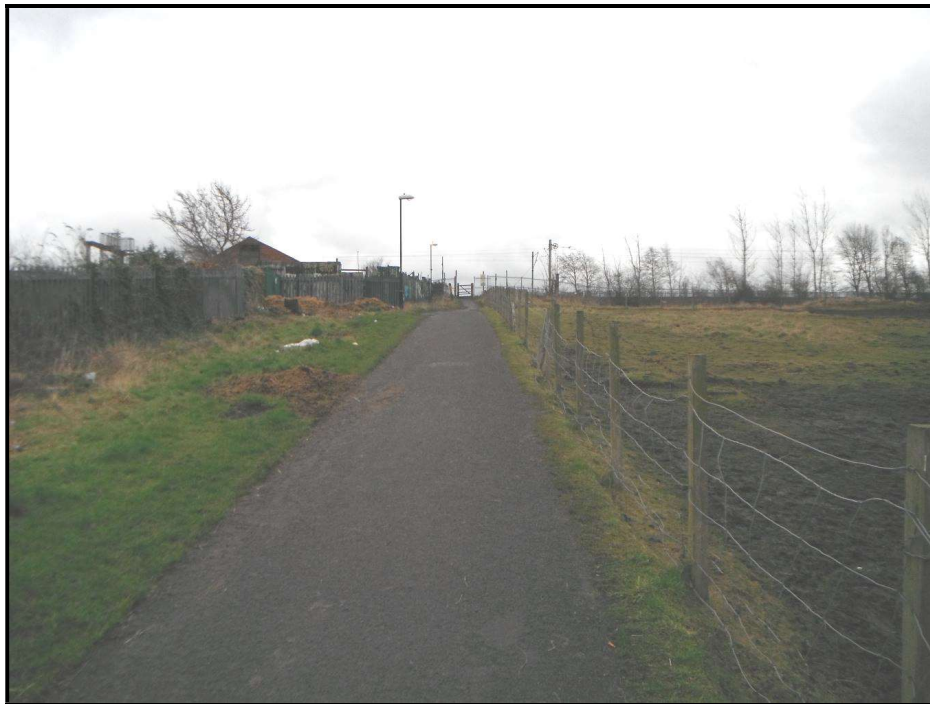
Figure 31: The approach to the crossing is via a long, steady incline. The footpath is metalled. Having traversed the crossing from the South Drive direction, the footpath leads to the main area of Riverside Park, the River Tyne and National Cycle Network number 14. The path is also part of the South Tyneside Heritage Trail.

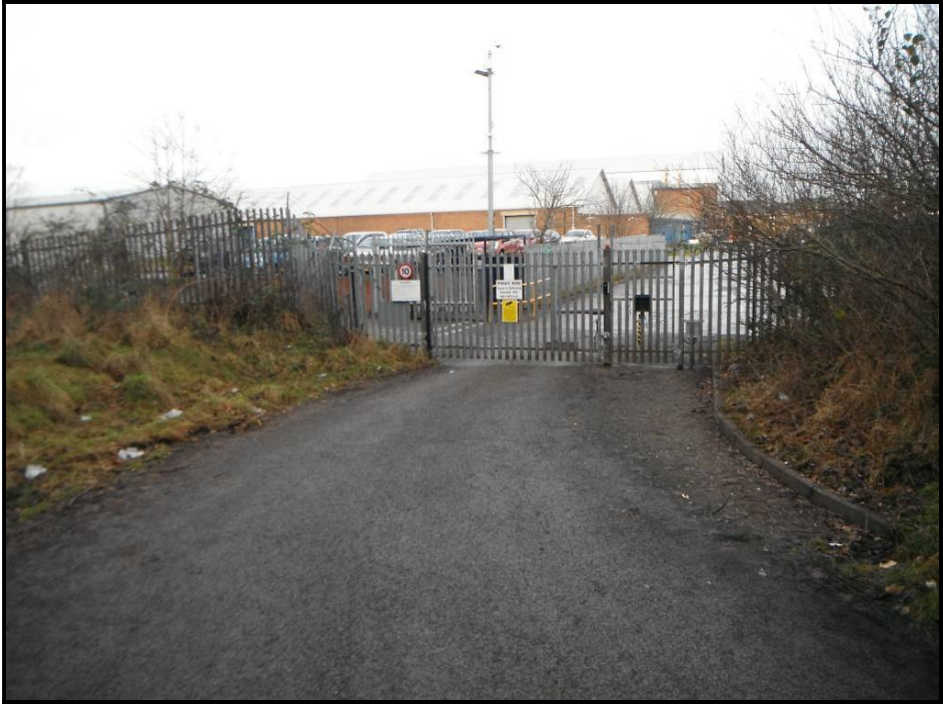
Figure 32: The primary road access to the allotments is from North Farm Road, through the Siemens site and then exiting via a gate giving access to the Riverside Park. By definition, it would be possible for Siemens staff to walk over the level crossing, via the Riverside Park and then through the gates to the Siemens site. It is not known how much this route is used by Siemens staff given there is a large staff car park on the site.

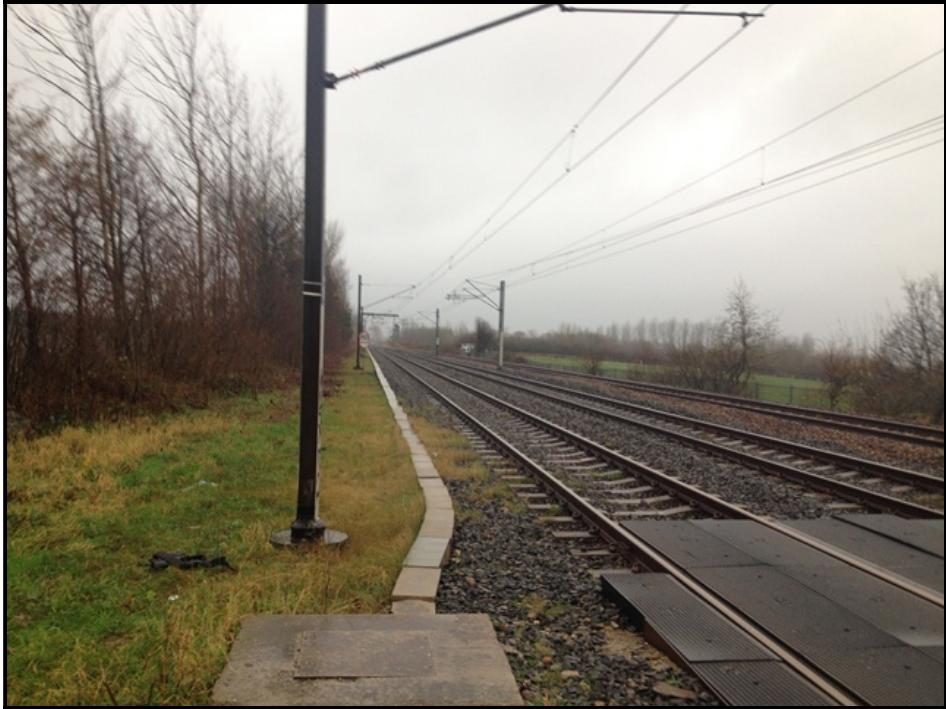
Figure 35: View from South Drive side decision point looking towards Pelaw Station (photograph provided by Network Rail) – Network Rail’s ALCRM report records the sighting distance as 780 metres.

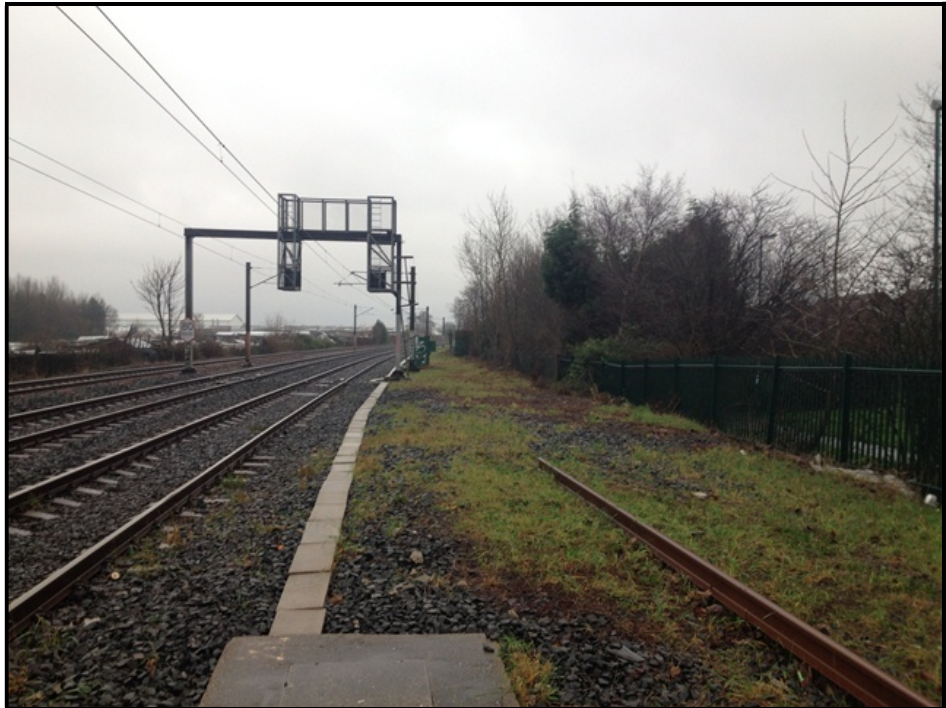
Figure 36: View from South Drive side decision point looking towards Hebburn Station (photograph provided by Network Rail) – Network Rail’s ALCRM report records the sighting distance as 317 metres.

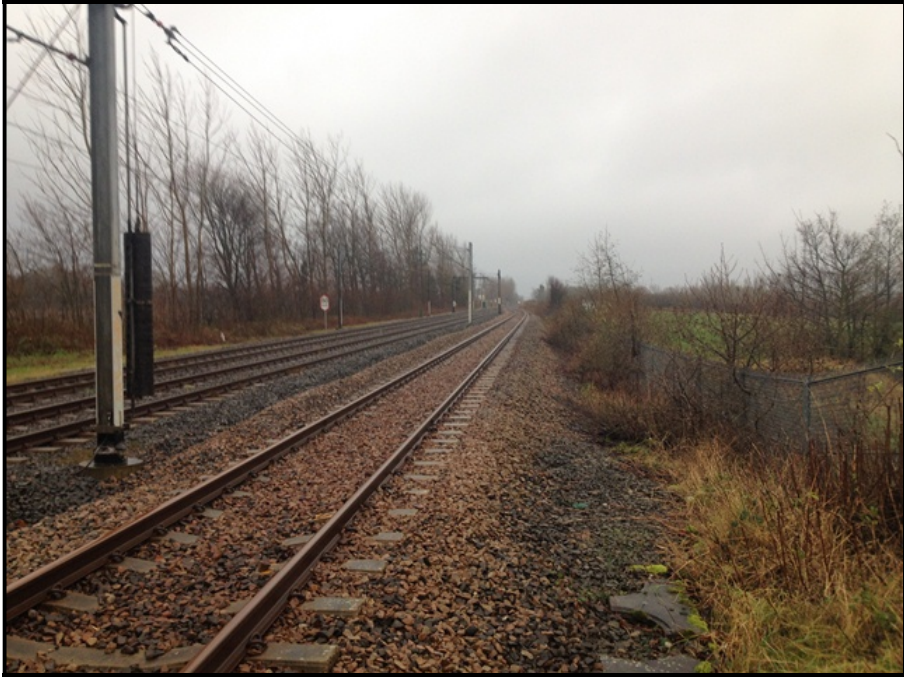
Figure 37: View from Riverside Park side decision point looking towards Pelaw Station (photograph provided by Network Rail) – Network Rail’s ALCRM report records the sighting distance as 585 metres. TSP Projects believe this photograph and sighting distance was taken before the crossing signage was relocated to the decision point. Currently, the sighting at the decision point is obscured by the crossing signage.

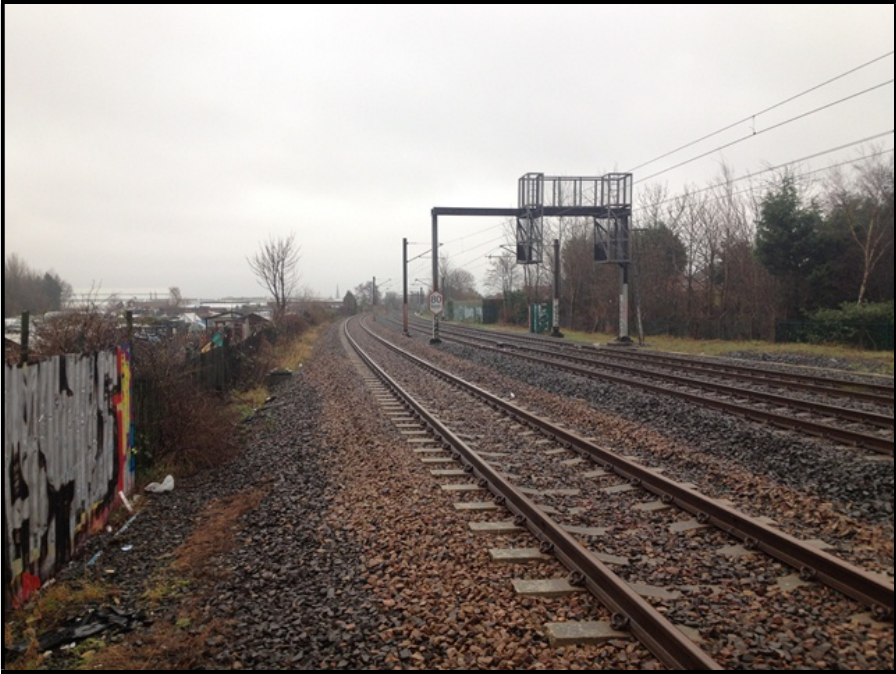
Figure 38: View from Riverside Park side decision point looking towards Hebburn Station (photograph provided by Network Rail) – Network Rail’s ALCRM report records the sighting distance as 417 metres.

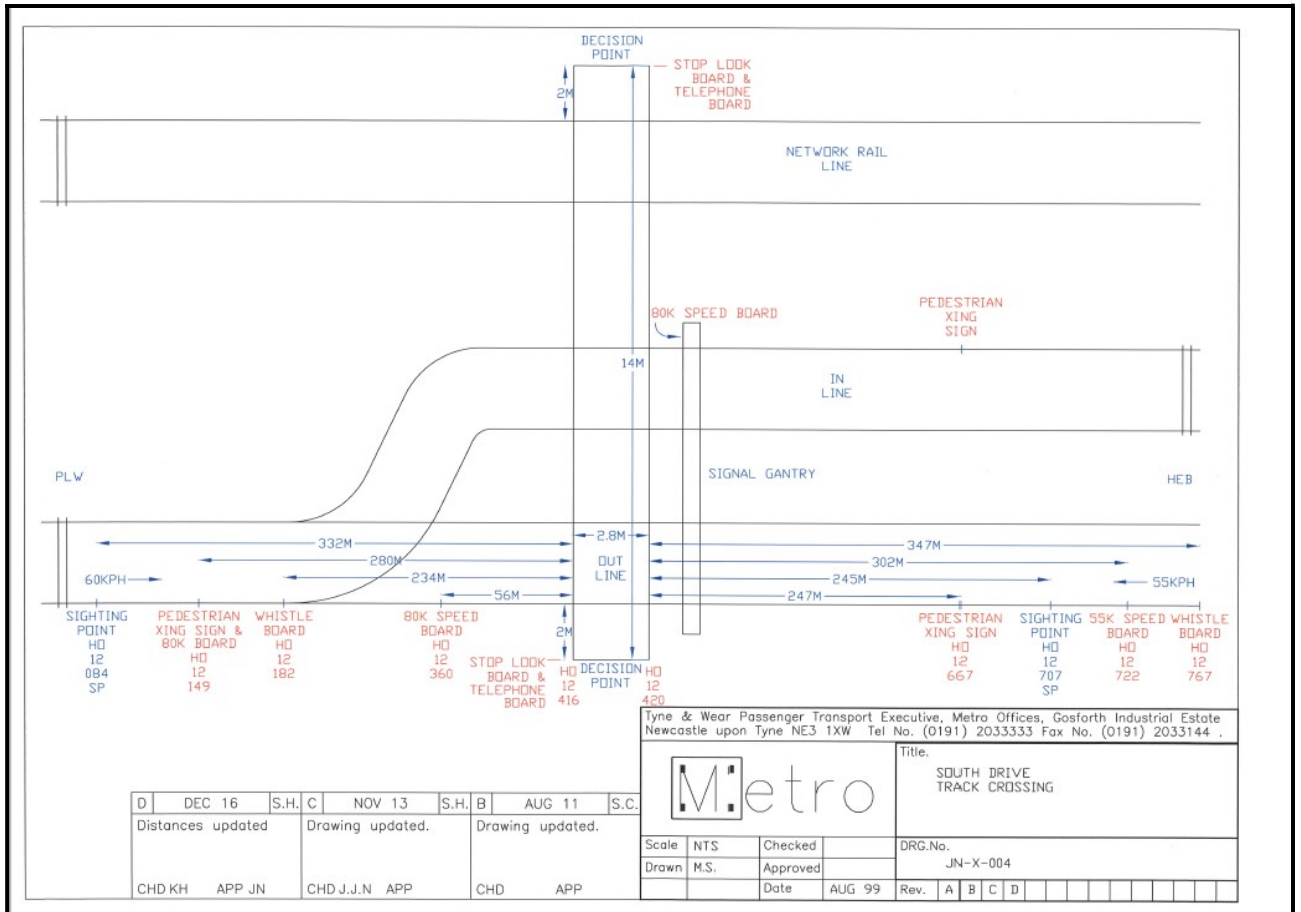
Figure 39: Summary of designed protection arrangements at the crossing (drawing provided by Nexus on 6 March 2017). The Network Rail ALCRM data infers that the actual sighting distances at the decision points are greater than those recorded in the above design. It should also be noted that the design drawing states 'STOP LOOK BOARD & TELEPHONE BOARD' on each side of the crossing but no telephones are installed on site.

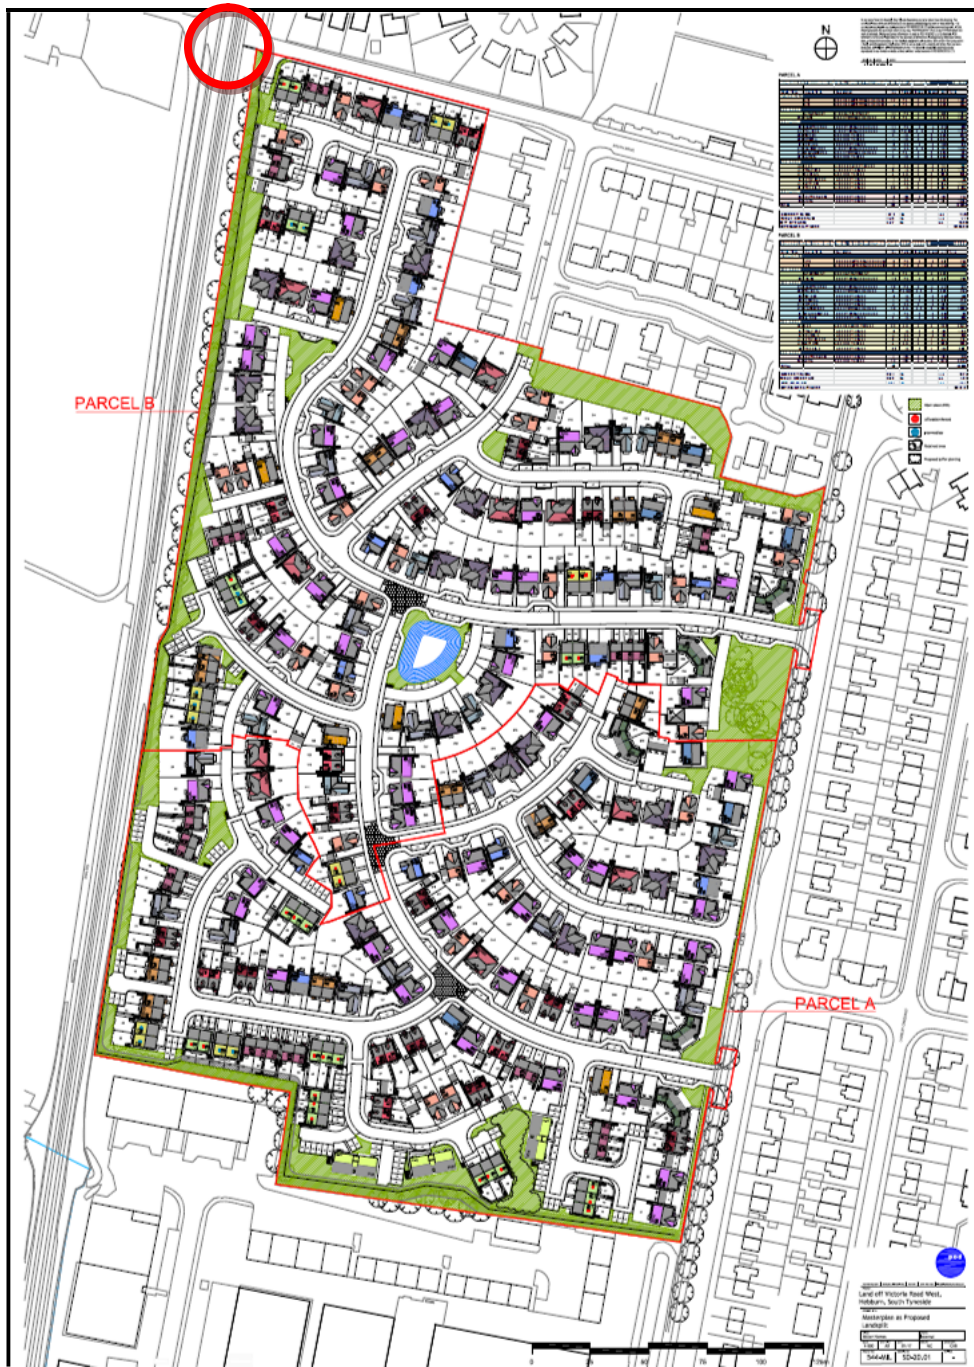
Figure 44 - Miller Homes Masterplan Detailing Proposed Land Split. The location of the existing footpath crossing is circled.

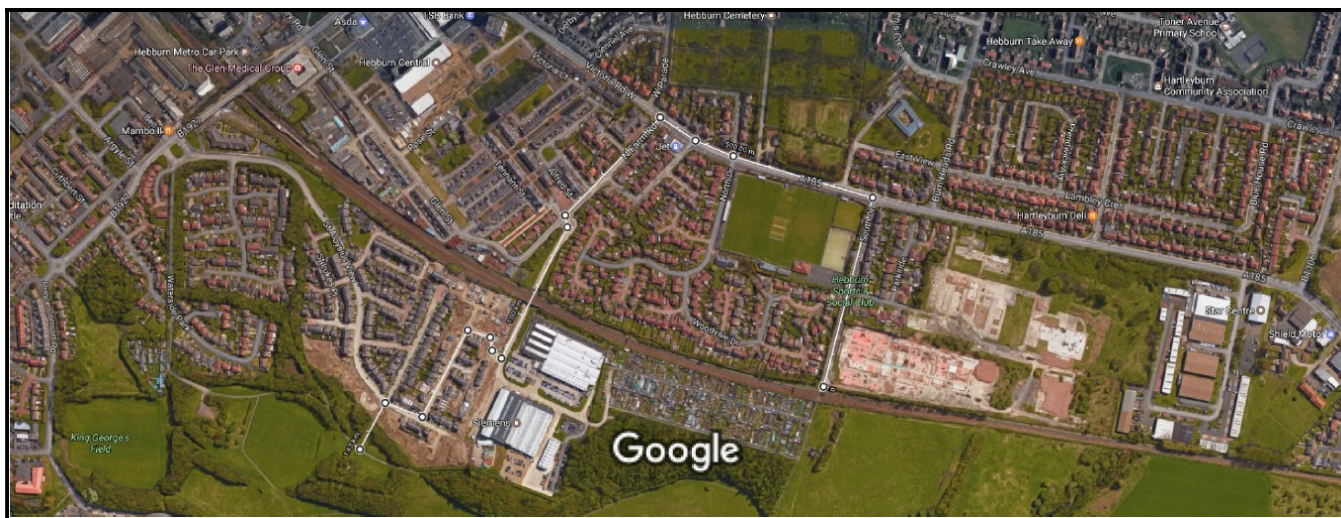
Figure 45 – Possible Alternative Route

The alternative route between the level crossing and Riverside Park would be via Victoria Road West and North Farm Road. The distance would be approximately 1.4km as shown in the diagram below. The entire route would be on a segregated footway. If this option was chosen it is anticipated that the Persimmon development would be completed by the time the footpath diversion came into operation.
