ST/1366/12/FUL

**An Archaeological Building Recording
at Cleadon Infant's School, Cleadon, South
Shields.**

Archaeological Research Services Ltd
Report No. 2012/39
June 2012

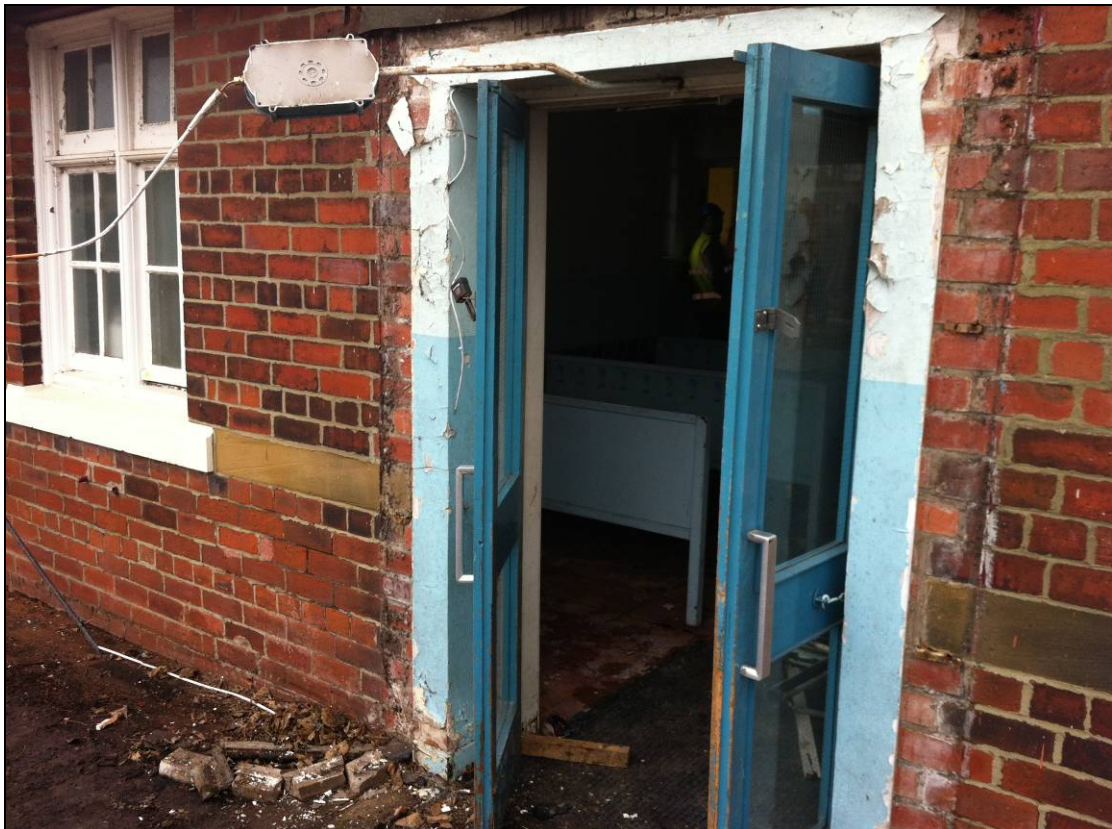
Figure 7: The western front porch, after demolition. Note coat hooks inside.

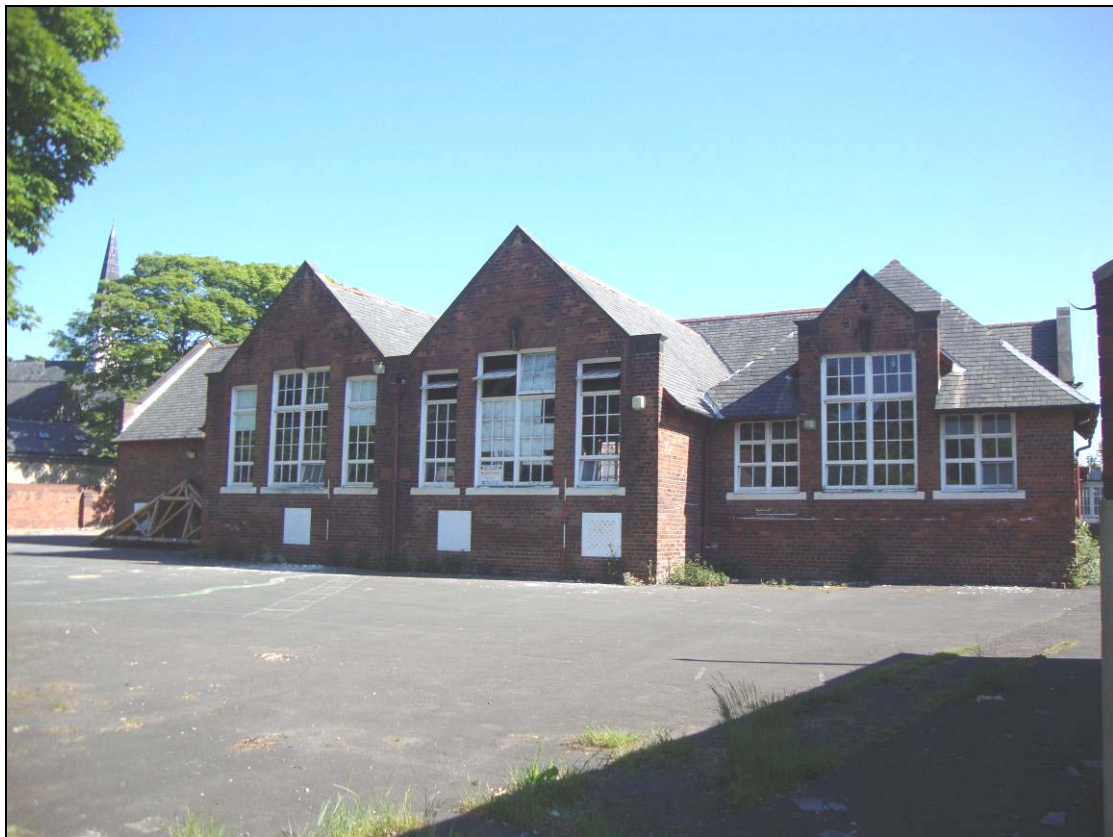
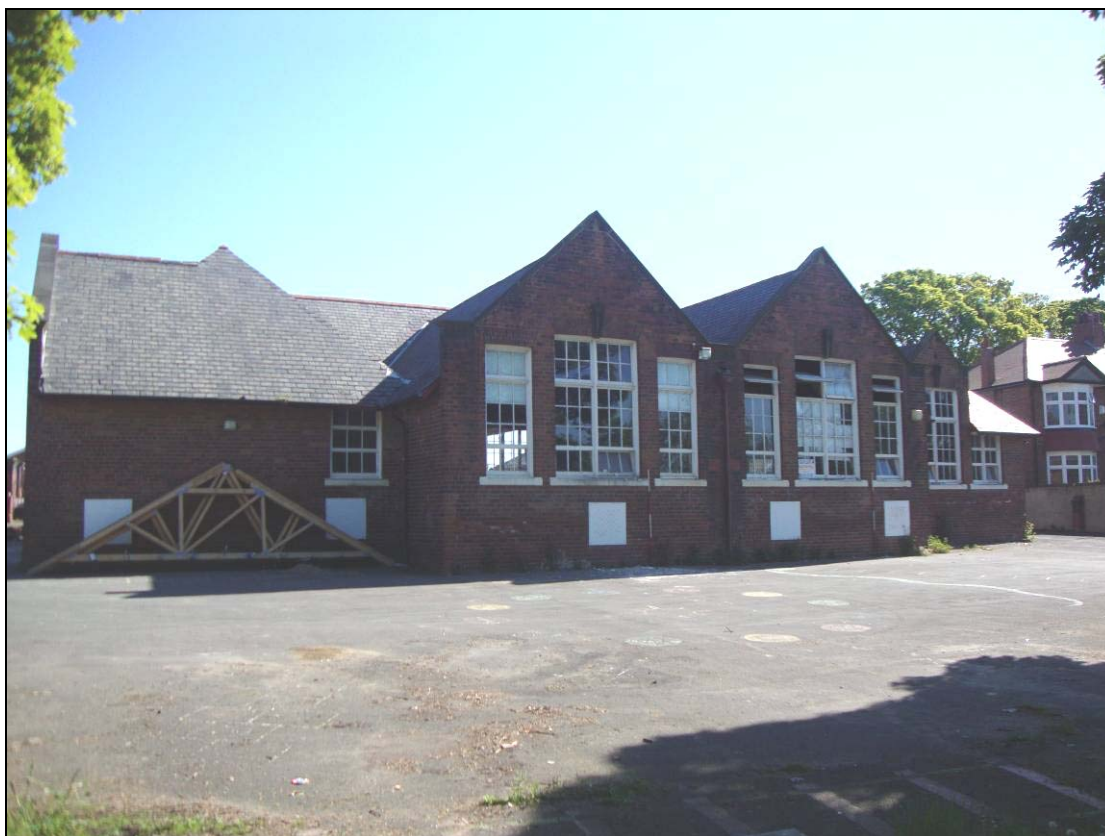
this manner. The window openings are formed with flat arches, in place of lintels, constructed in brick, with decorative sandstone keystones at the centre of the large double windows. The sills of the openings are in chamfered stone and have all been painted. It was therefore not possible to ascertain whether they were cast stone or natural. To the centre of this elevation two matching joined bays project southward from the building effectively forming a double gable topped by parapet walls with flat sandstone coping (see Fig. 15). To the eastern extent of the elevation a matching double window forms a dormer as it projects above the surrounding roofline, with a smaller flanking window to either side. There are also two metal grilles centred on this elevation for internal vents located in the walls of Rooms 7 and 8. This elevation does not exhibit any construction breaks and appears to have been constructed in one phase with no later alteration.

Figure 15: South facing elevation, looking north. Scale = 2m

Figure 16: South facing elevation, looking north east. Scale = 2m

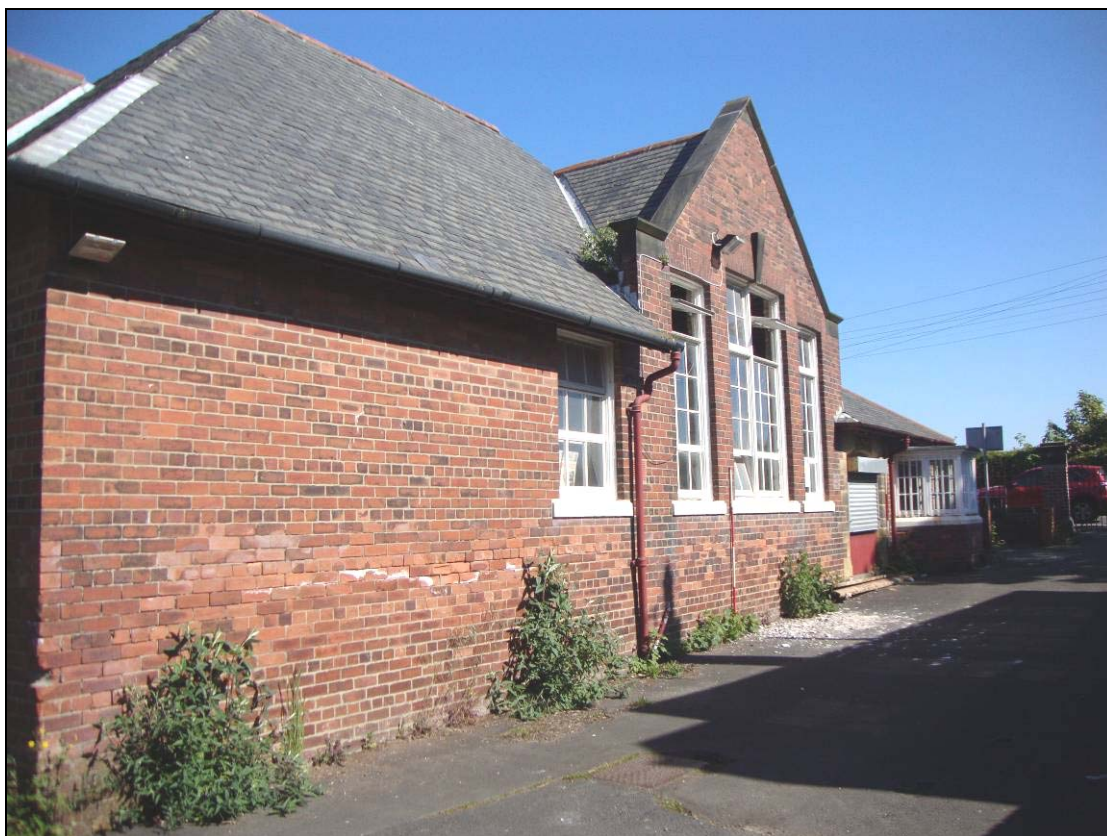
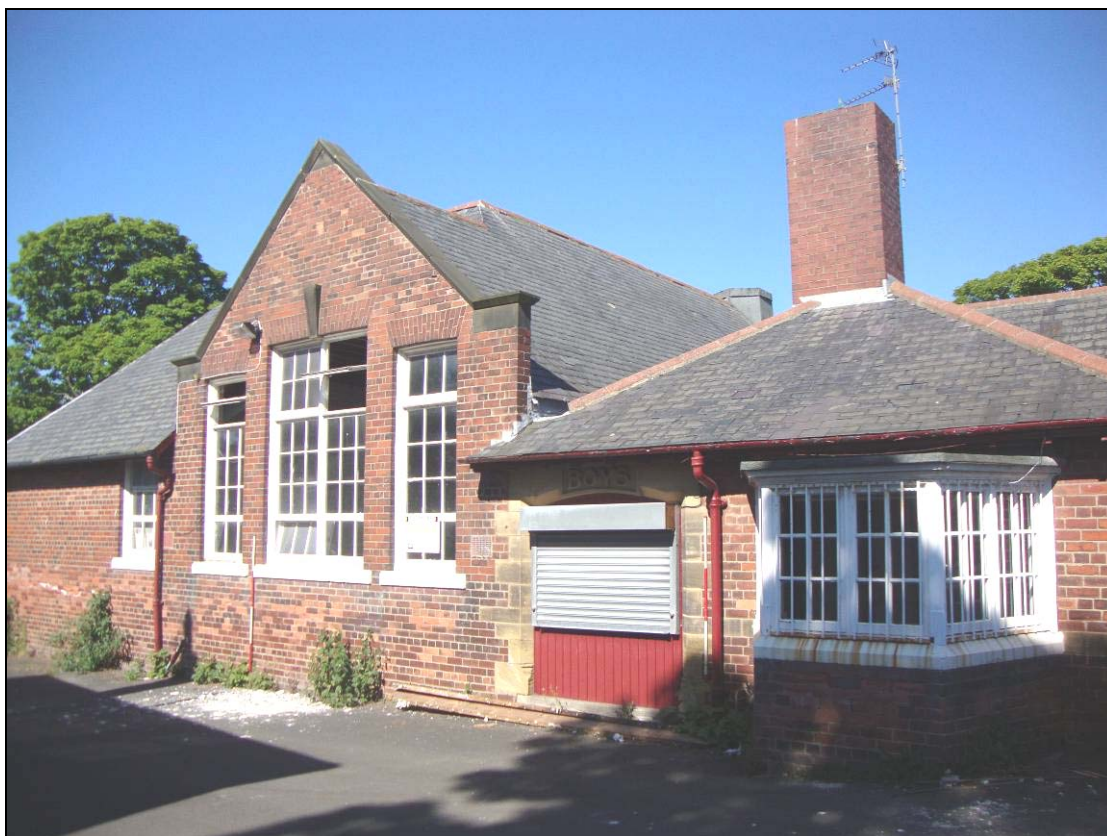
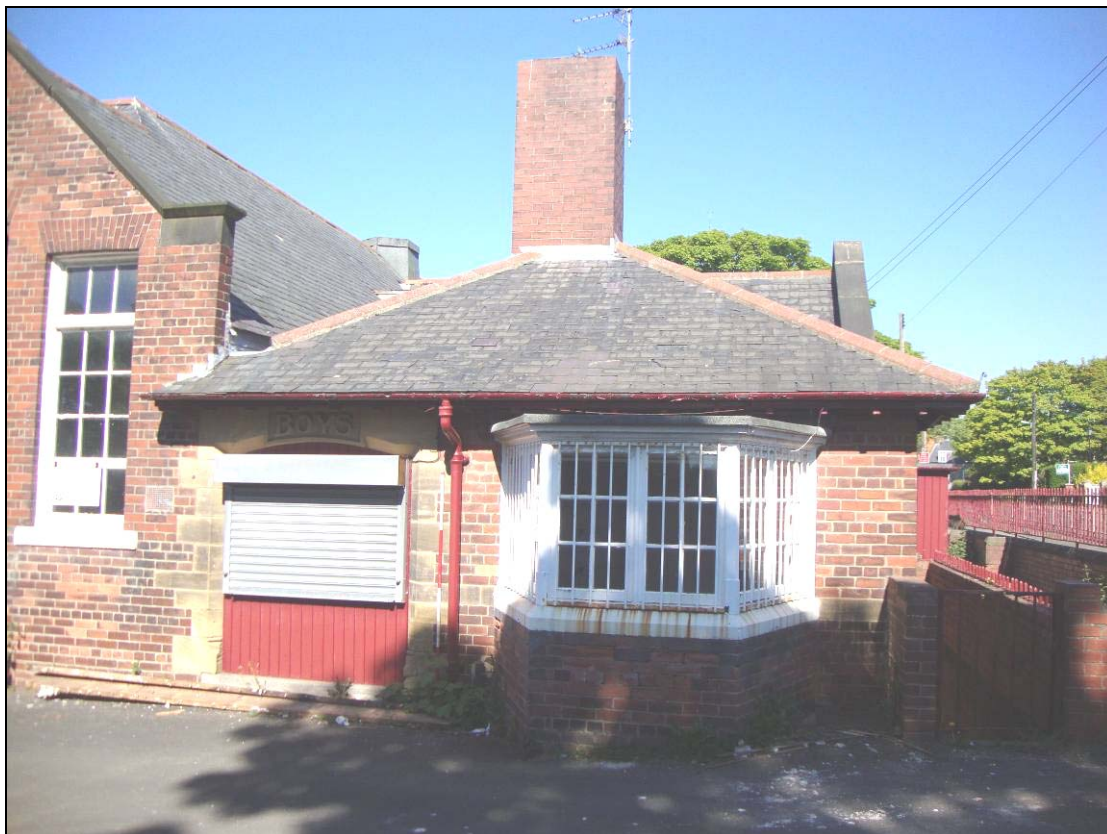
This elevation comprises the east facing elevation of the school building (see Fig. 80). The elevation is constructed of red imperial brick laid in three-course English Garden Wall bond, completed at the roofline of the central projecting gable by flat sandstone coping with sandstone kneelers and decorative keystone in the flat arch over the centre of the large paired window (see Fig. 17). The elevation also comprises five window openings, arranged with a large central window and two smaller flanking windows, a small single window to the south of these, and a canted bay window to the northern extent of the elevation. This arrangement reflects the layout of the rooms within, with Room 10, being a classroom, provided with a set of three windows arranged with a large central window and two smaller flanking windows. The canted bay window would originally have been mirrored at the northern extent of the western elevation, where a blocked opening shows it has been removed, and is placed here to provide wide views from a probable male Masters Room within. This would have been likely due to the position of the room next to the Boys entrance. The opening for the Boys entrance on this elevation is constructed of chamfered sandstone long and short quoins with a moulded step and decorative lintel inscribed with “Boys”, all framing a wide opening that could be seen internally to give access to a small porch area, finished in brown glazed brick. This elevation does not exhibit any construction breaks and appears to have been constructed in one phase with only minor later alterations.

Figure 17: East facing elevation, looking north west. Scale = 2m

Figure 18: East facing elevation, looking south west. Scale = 2m

Figure 19: Northern extent of east facing elevation, looking west. Scale = 2m

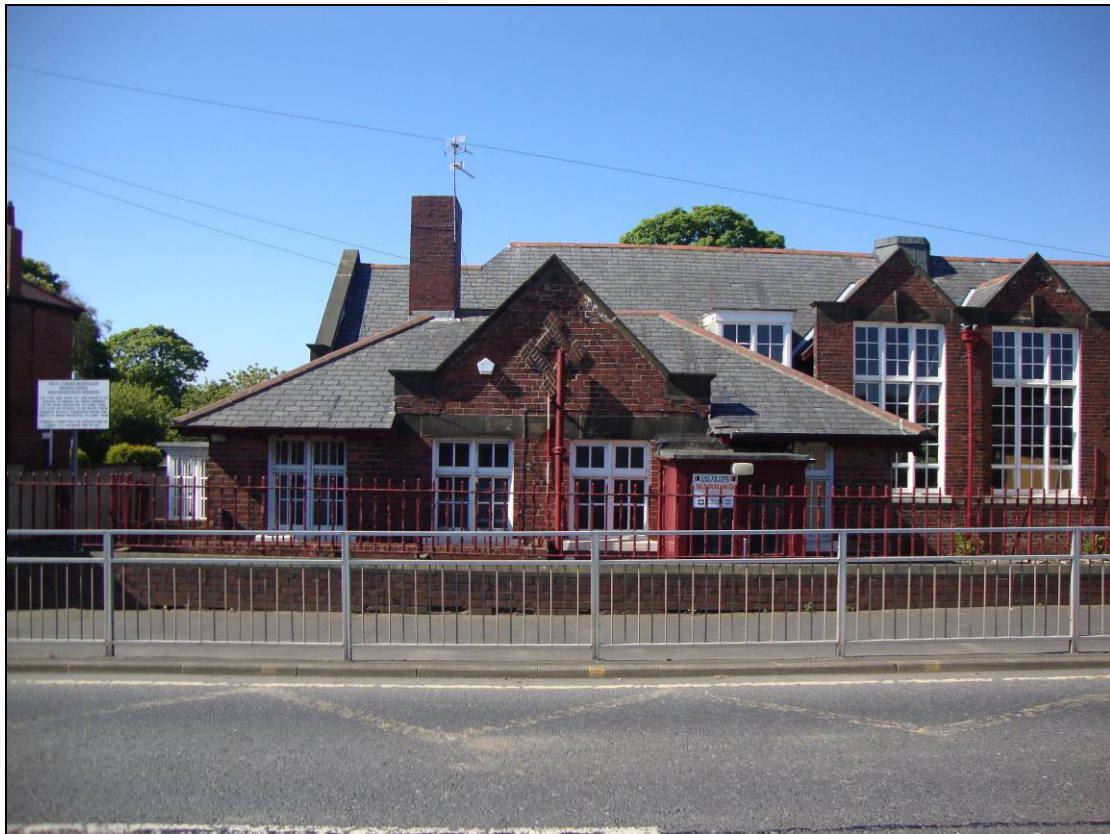
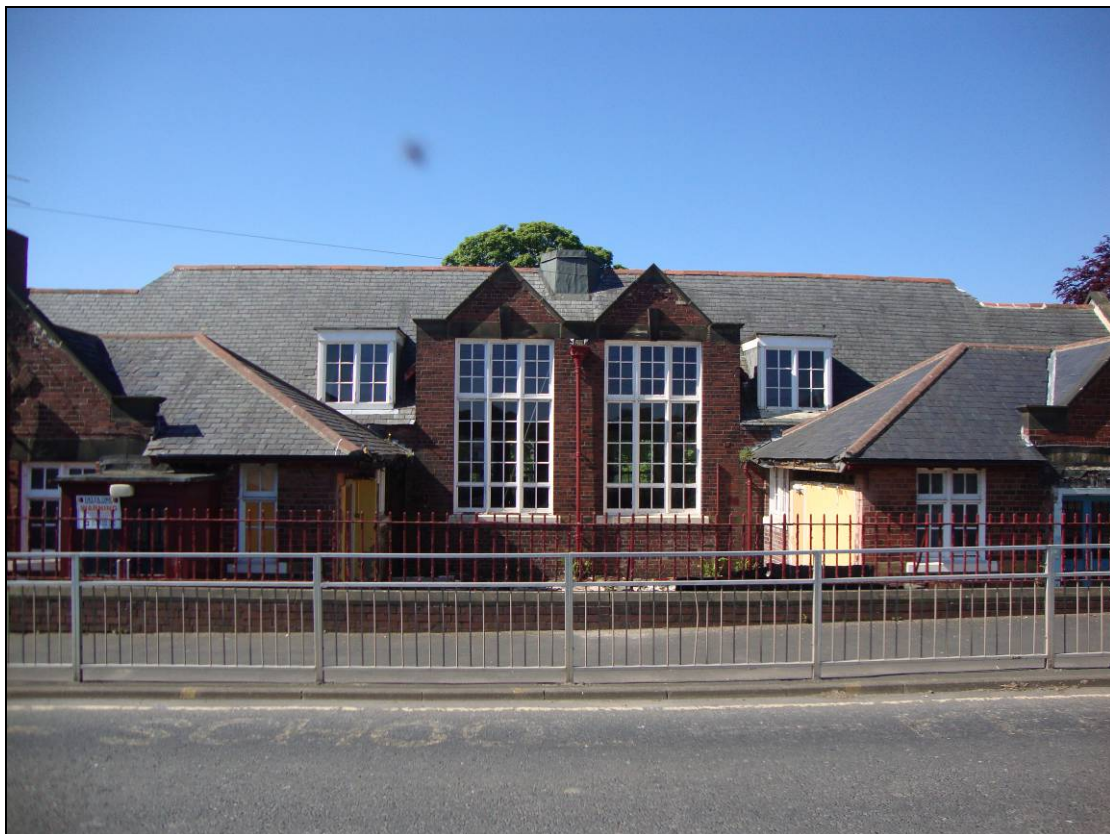
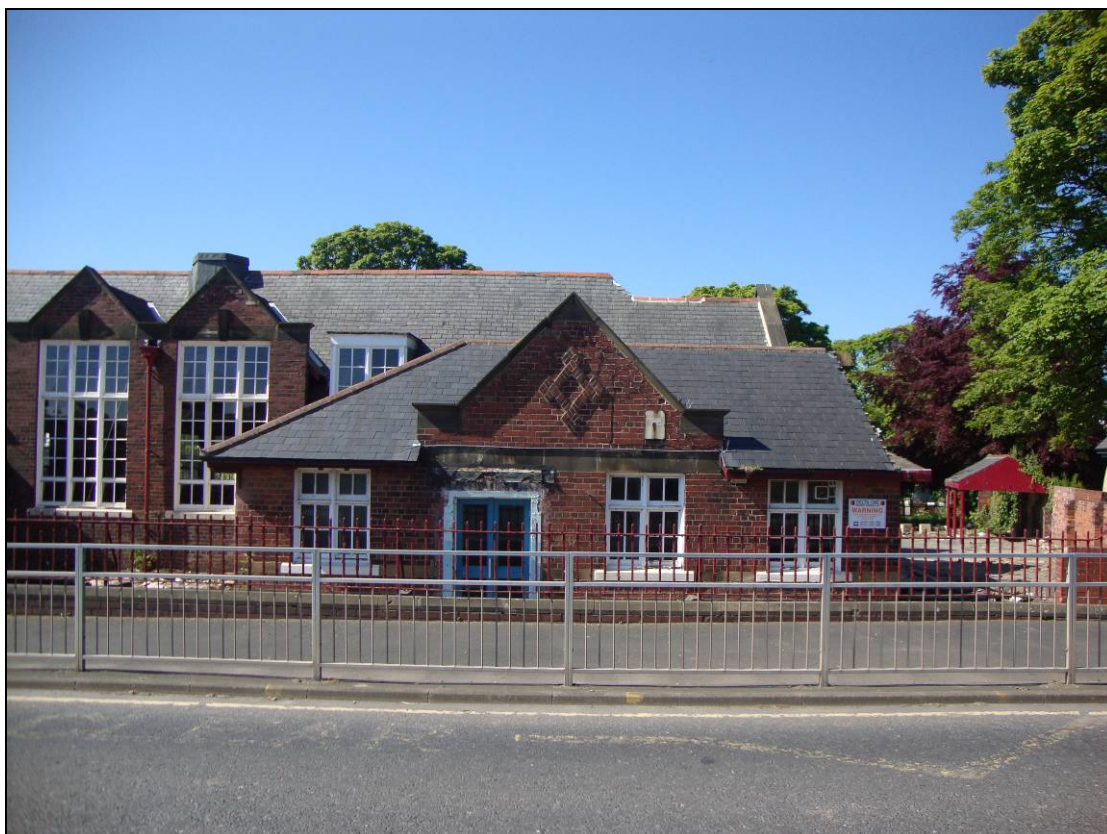
This highly symmetrical elevation comprises the north facing elevation of the school building (see Fig. 80). The elevation is constructed of red imperial brick laid in three-course English Garden Wall bond, completed in part at the roofline by flat sandstone coping with sandstone kneelers and decorative keystones over the centres of the large paired windows (see Figs. 22 and 24). Unlike the other elevations of the building, this principal elevation also comprises two sandstone string courses at sill level and at lintel level. The elevation also comprises 11 window openings, arranged almost completely symmetrically with a large pair of windows to the centre of the elevation, with flanking flat-roofed dormer windows to either side, and four windows to the eastern projecting wing, with three windows to the western projecting wing. The asymmetry in the window openings of the two projecting wings has been caused by the later insertion of a double door with projecting porch to both of these wings (see Fig. 80). The double door to the western projecting wing has made use of a previous window opening to create the opening for the door, whereas the double door to the eastern projecting wing has been inserted between two window openings. At the time of survey the porch to the western projecting wing had been demolished, as had a later extension to the western elevation at its northern extent, which had previously masked the former Girls entrance on that side. Also demolished was a later infill toilet extension to the centre of the north elevation, making use of the recess created by the two projecting wings on this side (see Figs. 25 and 26). This demolition revealed part of the original internally facing elevations of the projecting wings, and allowed the matching windows located here to be viewed (see Figs. 25 and 26). Also noted was the extensive damage caused by the later extension to these elevations, caused by the creation of access to the toilet extension (see Figs. 25 and 26).

Figure 21: North facing elevation, looking south west. Scale = 2m

Figure 22: Eastern extent of north facing elevation, looking south. Scale = 2m

Figure 23: Central section of the north facing elevation, looking south.

Figure 24: Western extent of the north facing elevation, looking south.

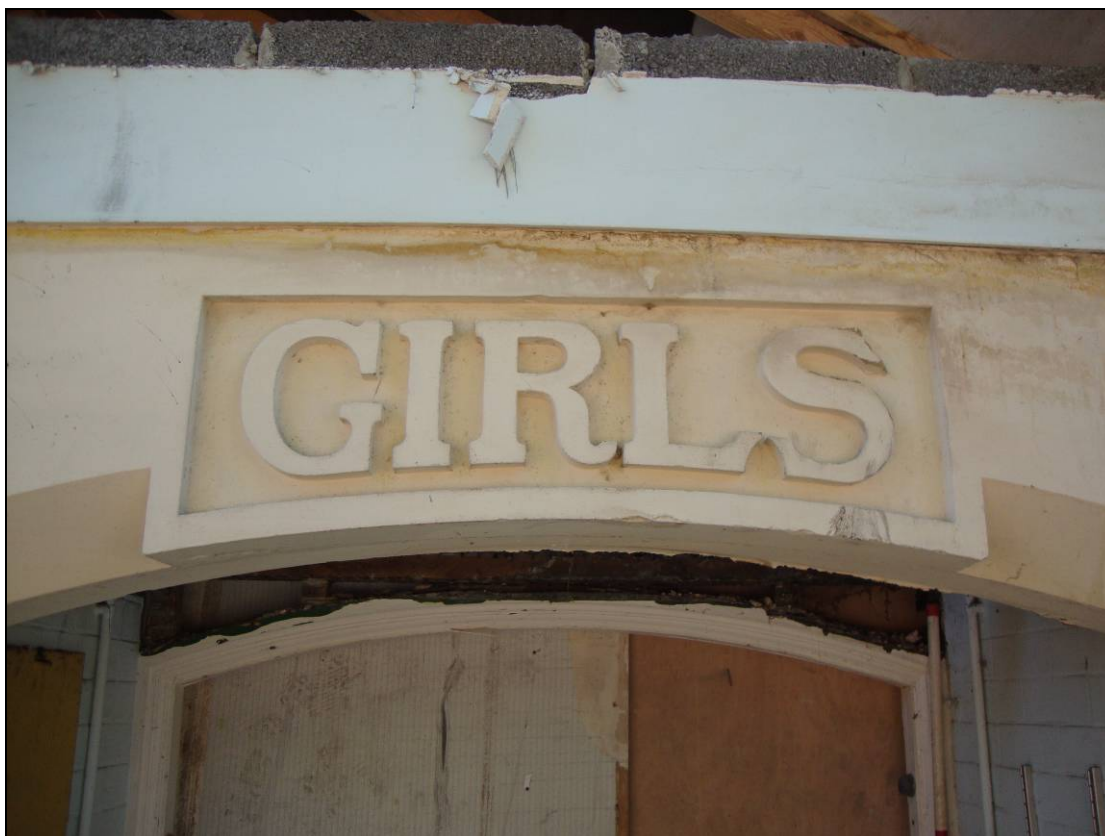
Figure 29: 'Girls' inscription above the original entrance in to the girls' cloakroom.

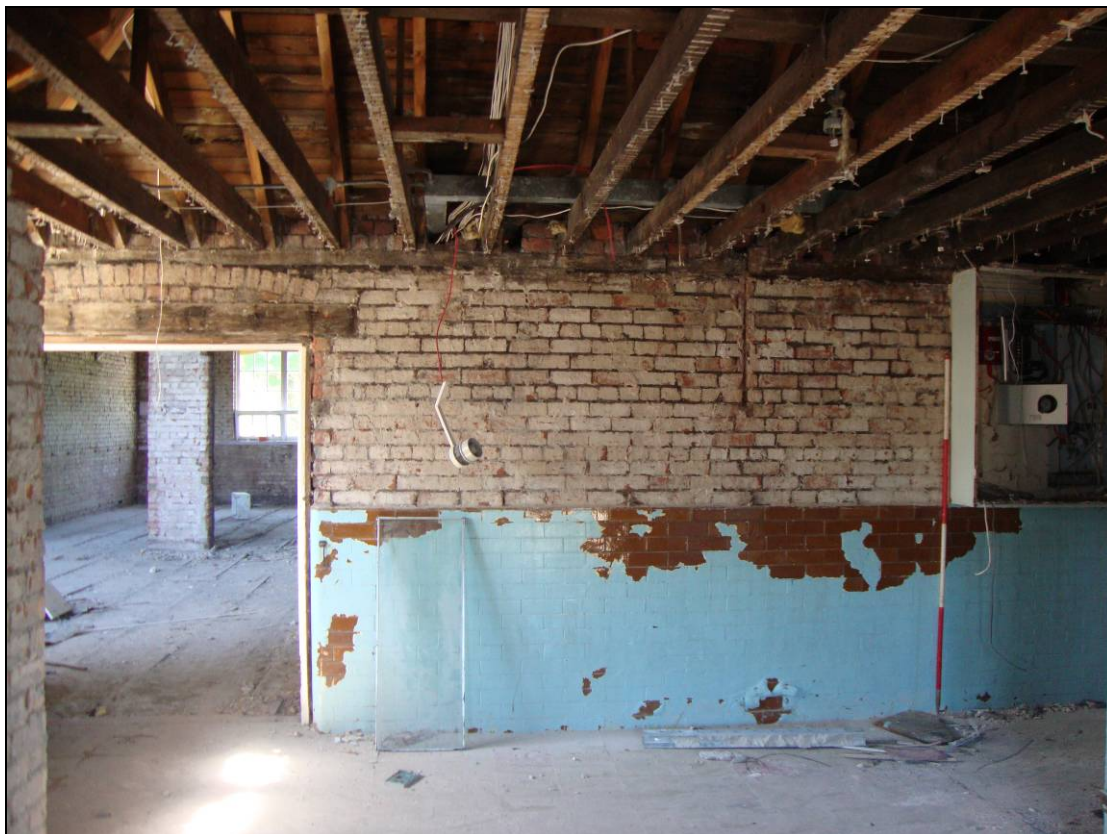
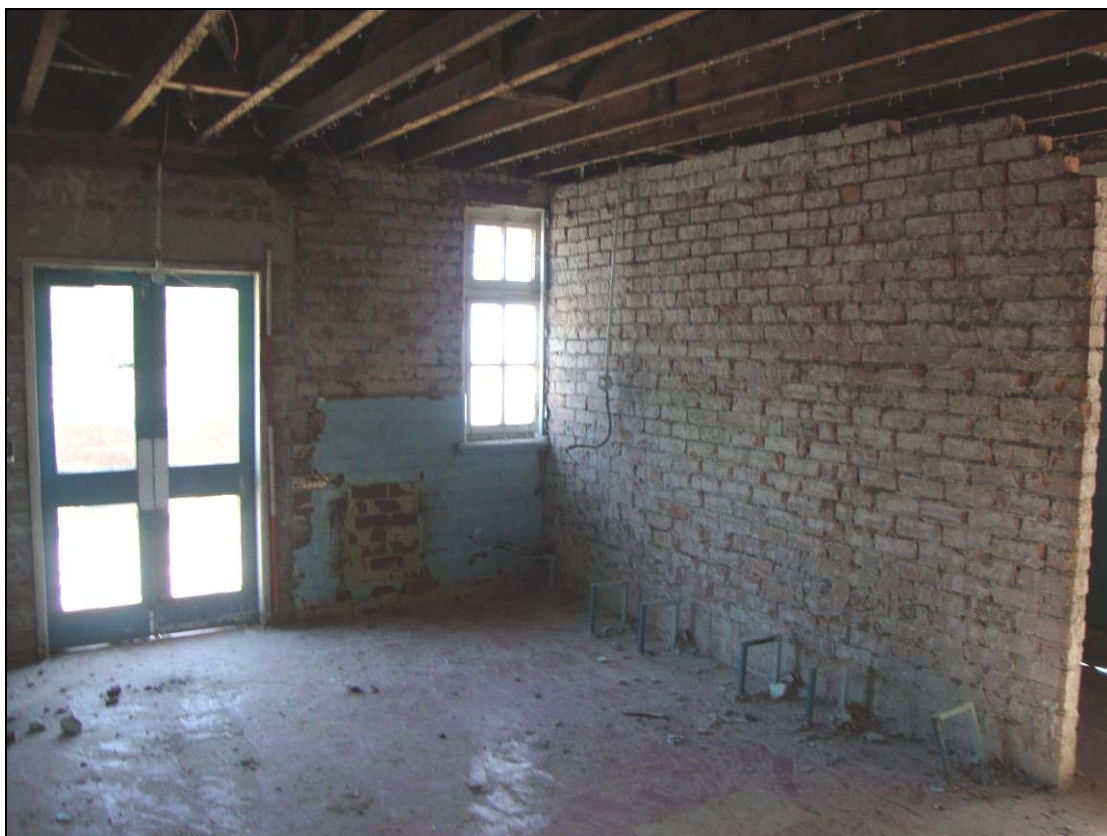
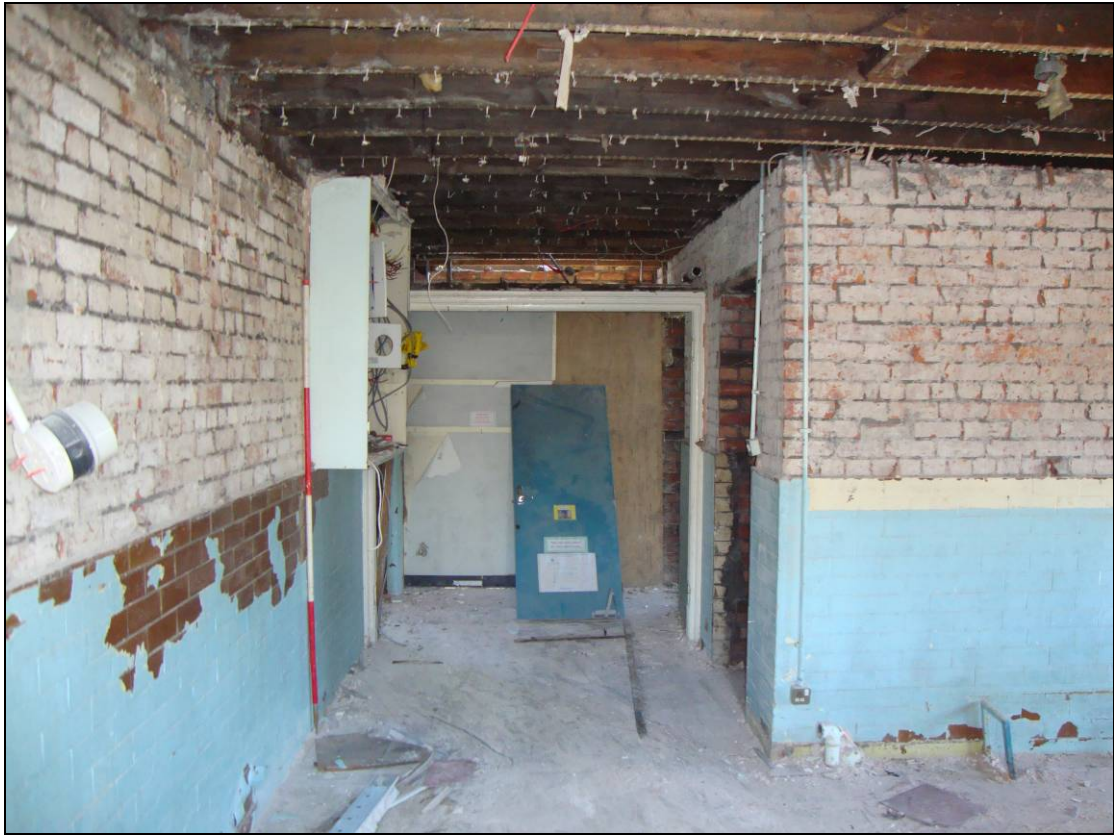
Room 1 consists of an 'L' shaped room that would have originally been the girls' entranceway into the school and their and cloakroom. There is an opening, with a relieving arch, to the south elevation, leading into Room4, as well as a door leading into Room 5. To the north is a door leading to the exterior of the building. The east elevation comprises a brick-built partition wall that was inserted at a later date in order to create an access corridor to the later toilet block extension. The evidence for the wall being inserted can be seen in the way in which it cuts one of the windows on the north elevation in half. This window, only half of which is actually within Room 1, is the only window in the room. The 'L' shape of the room is created by Rooms 2 and 3 in the corner of Room 1. There are no fixtures or fittings remaining in this room. The walls are constructed of brown glazed bricks from the floor to dado rail height (see Fig. 30). These bricks, alongside the plan and location of the room, indicate its use as a cloakroom.

Figure 30: South elevation of Room 1, looking south. Scale = 2m

Figure 31: North elevation of Room 1, looking east. Scale = 2m

Figure 32: West elevation of Room 1, looking west. Scale = 2m

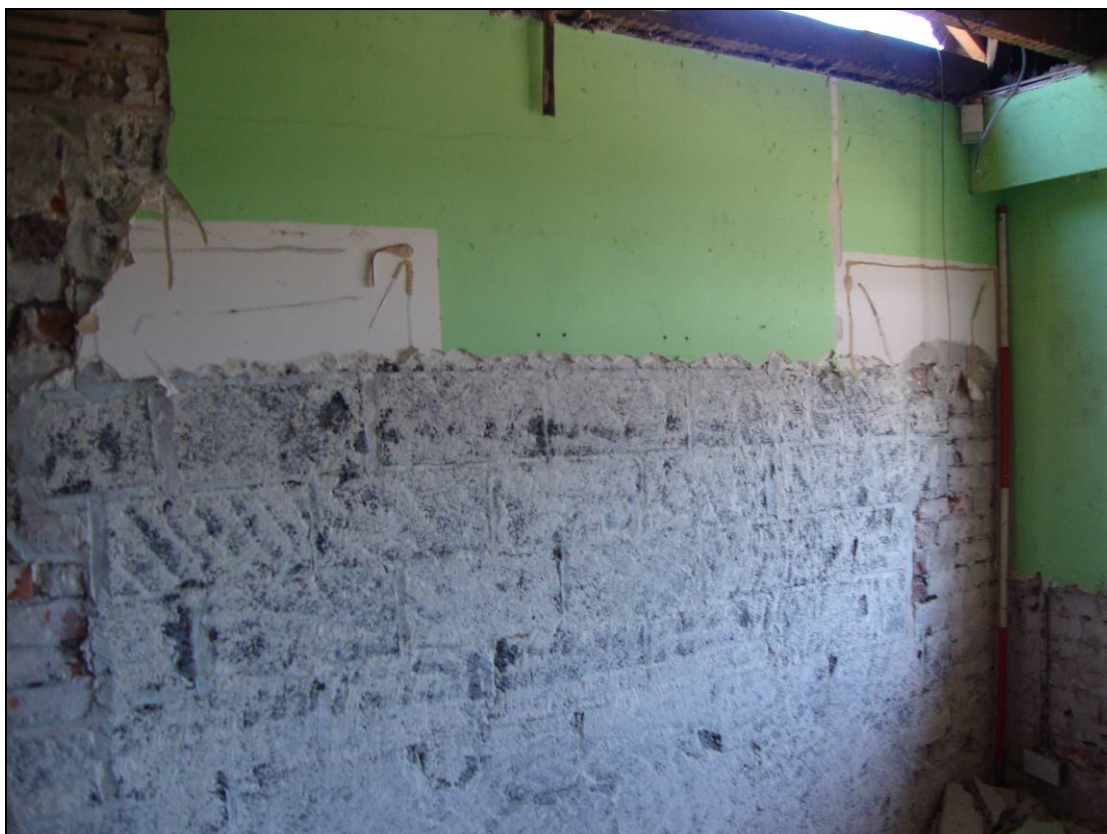
Room 2 is accessed from the south by a door that leads from Room 1. This room would have been the Mistresses' Room due to its location next to the girls' entrance. The room is 'L' shaped and runs from south to north and then west to east. At some point after the initial construction of the school, an extra room was created by inserting a partition wall and separating the 'L' shaped room in to two small rectangular rooms (both referred to as Room 2 for the purpose of this report). The extra room had a toilet and washbasin inserted with a small brick partition and a door to separate them (Figs. 35 and 36). The north elevation of the room has two windows; however one of these has been cut in half by the later inserted partition wall that separated off the wash basin and toilet. The west elevation of the room would have originally had a bay window; however this was later blocked in order to add an extension on to the west elevation of the building. Evidence of this blocking can be seen in the wall (Fig. 33). The east elevation of the room has an arched niche, possibly intended for shelving, and a blocked fireplace (Fig. 34).

Figure 33: West elevation of Room 2, looking north west. Scale = 2m

Figure 34: East elevation of Room 2, looking south. Scale = 2m

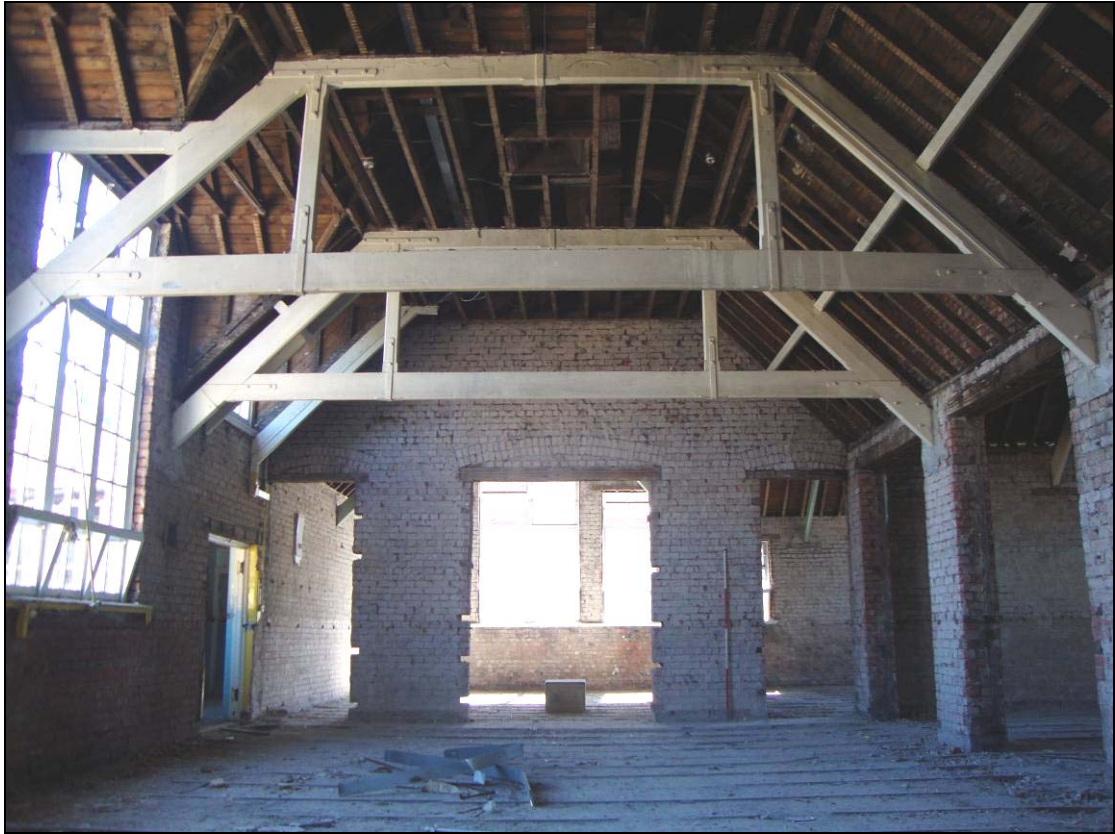
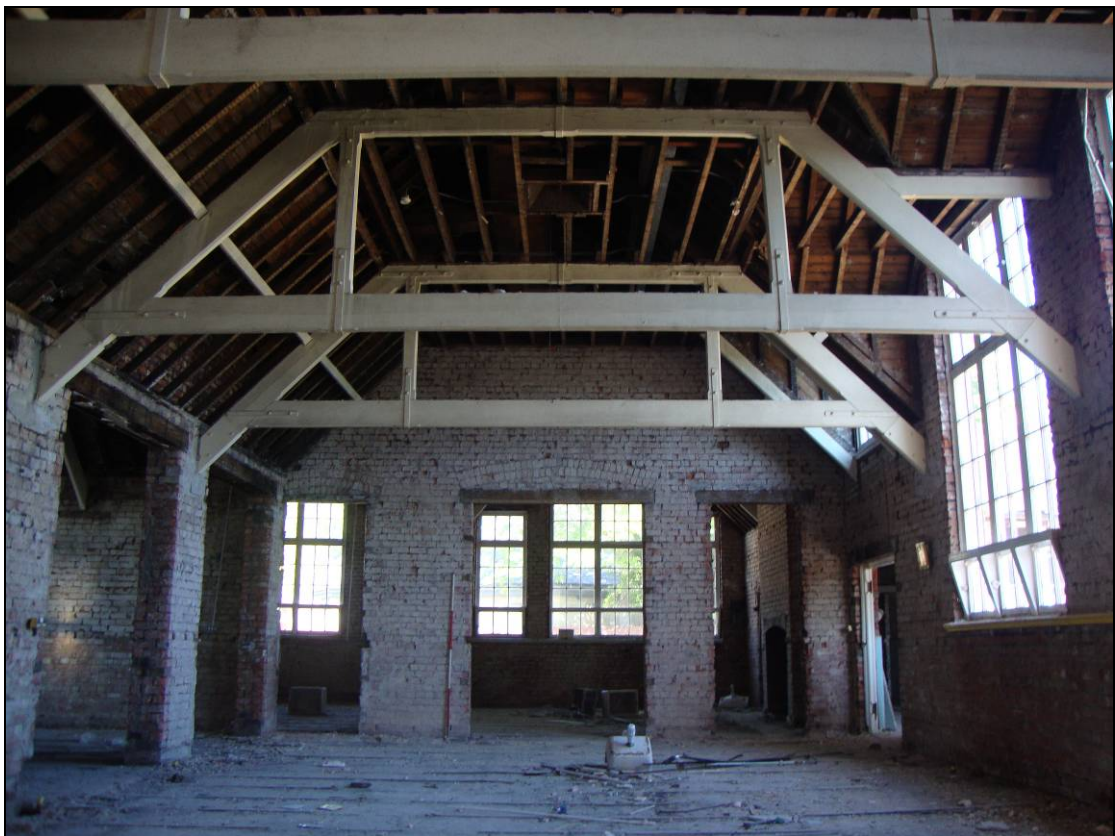
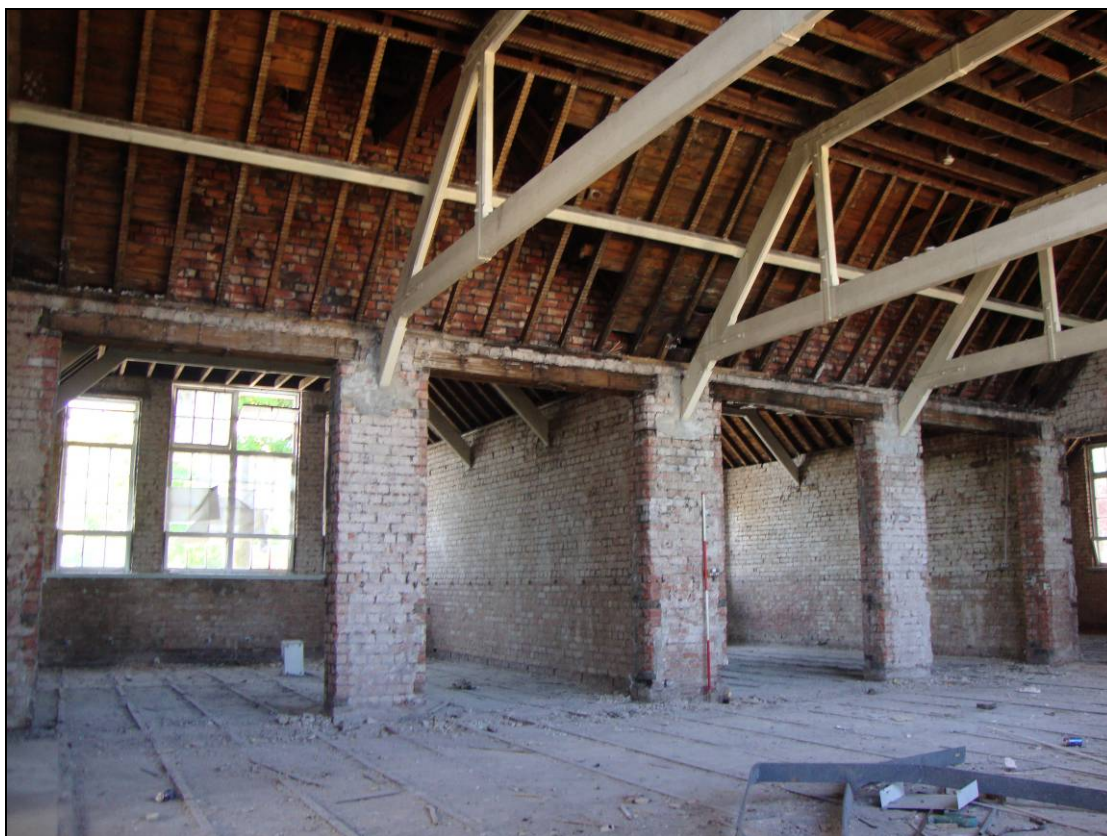
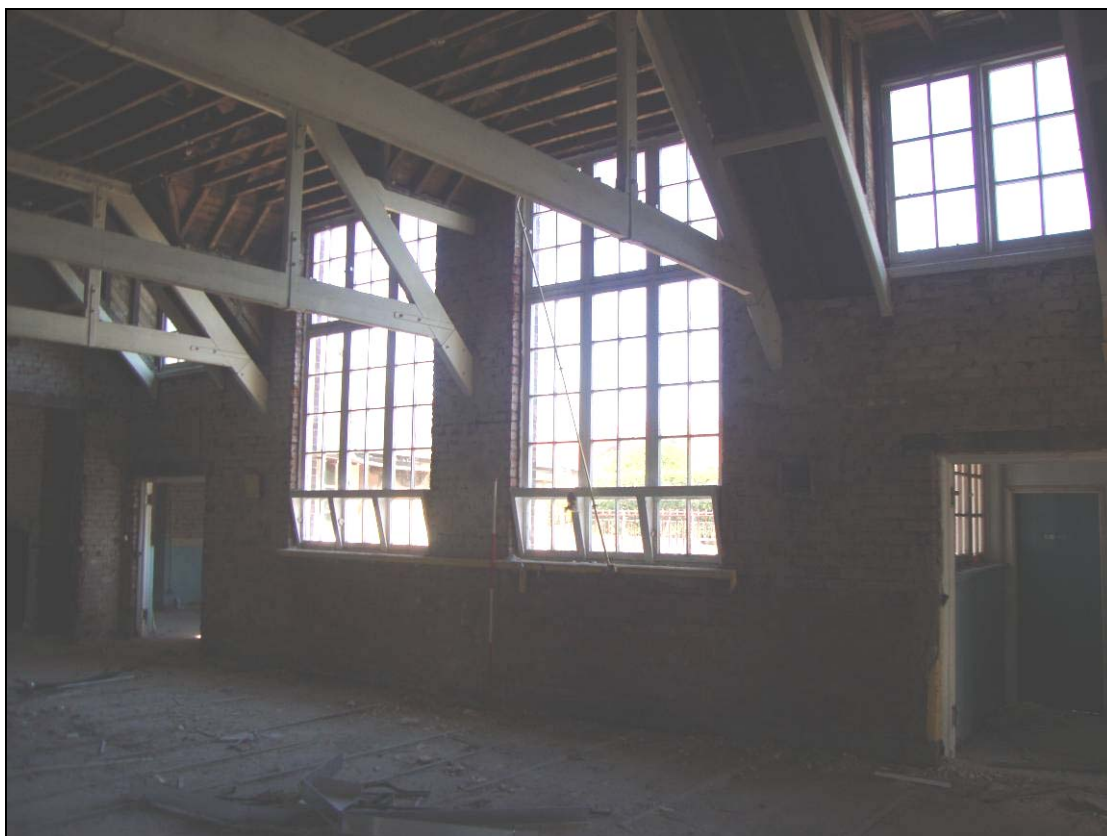
Room 4 comprises a large room in the centre of the school building that would have originally been intended as the assembly hall. The room consists of walls to the north, east, south and west and leads on to six classrooms; two classrooms to the west, two to the south and two to the east. The room also leads to Room 1 in the north west corner and Room 11 in the north east corner. The north elevation has two large windows side-by-side in the centre and a smaller window above each of the doors leading to Rooms 1 and 11. Although they have now been removed, the room would have had folding partitions in the walls, as well as doors, leading to Rooms 5, 7, 8 and 10. These partitions could have been opened to make the space larger. The openings on the east elevation each have relieving arches above them, as do two of the openings on the west elevation. The room is open to the ceiling with queen truss beams.

Figure 39: East elevation of Room 4, looking east. Scale = 2m

Figure 40: West elevation of Room 4, looking west. Scale = 2m

Figure 41: South elevation of Room 4, looking south west. Scale = 2m

Figure 42: North elevation of Room 4, looking north west. Scale = 2m

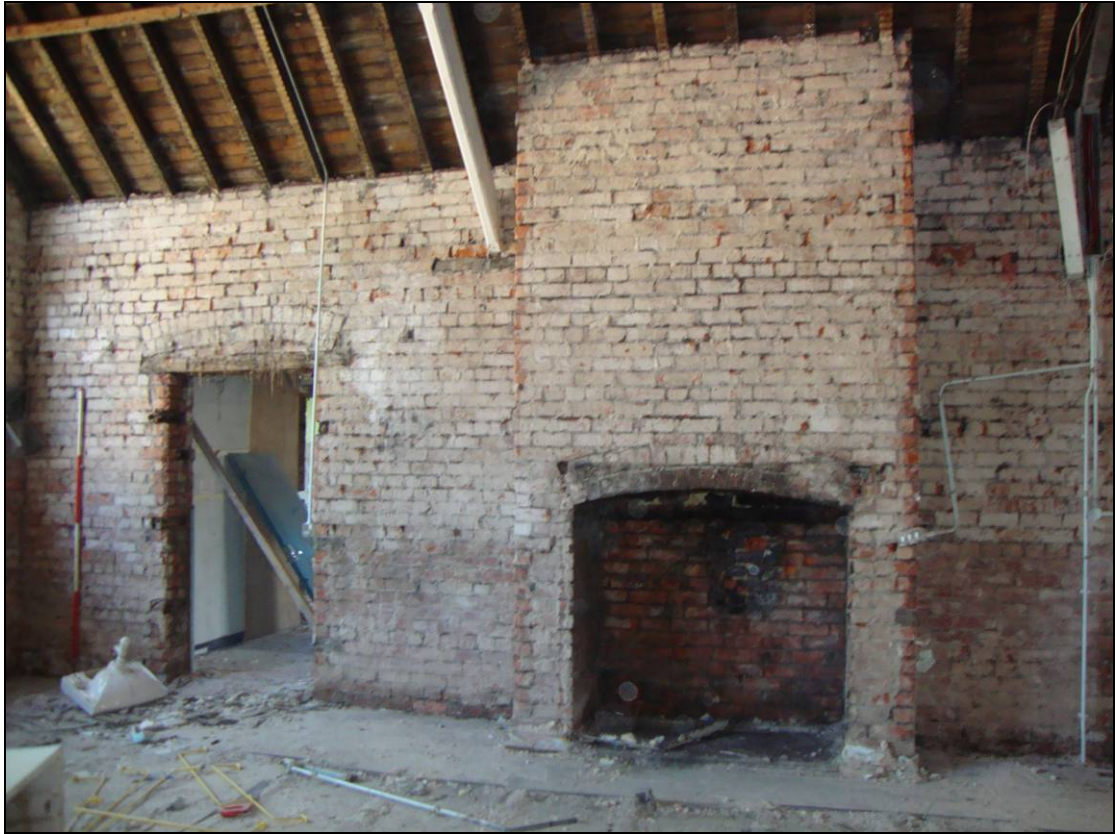
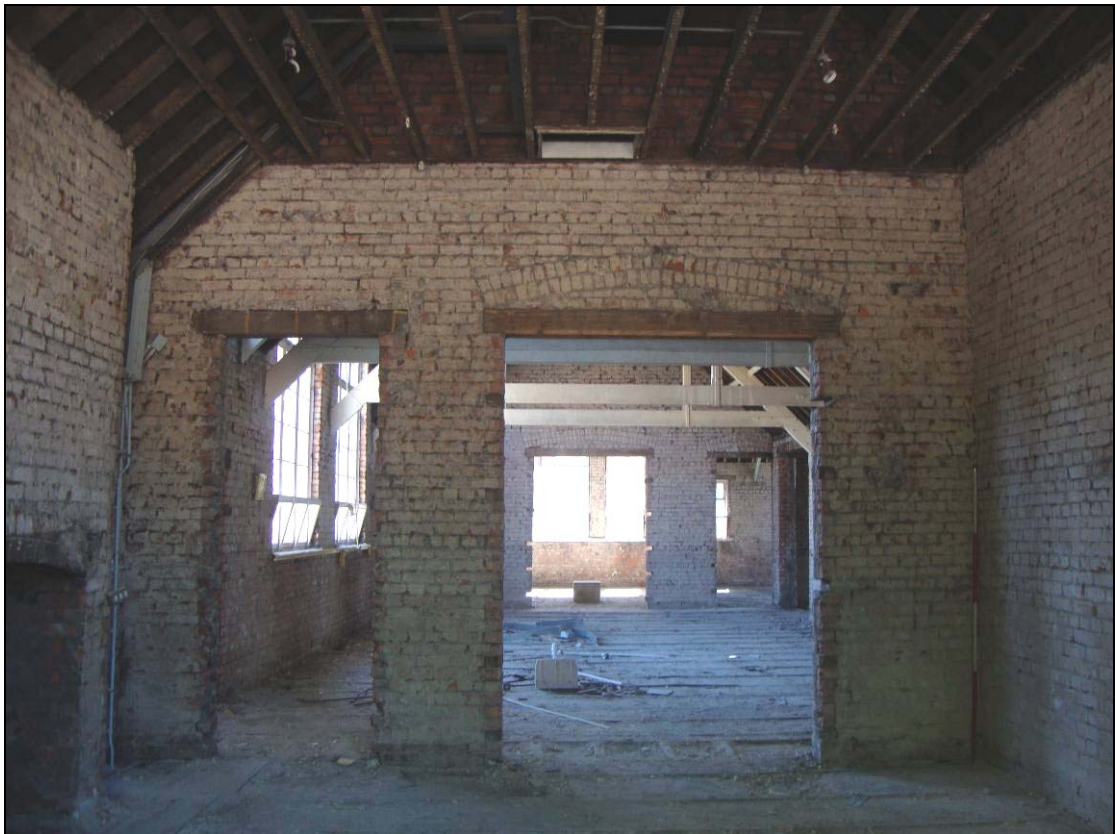
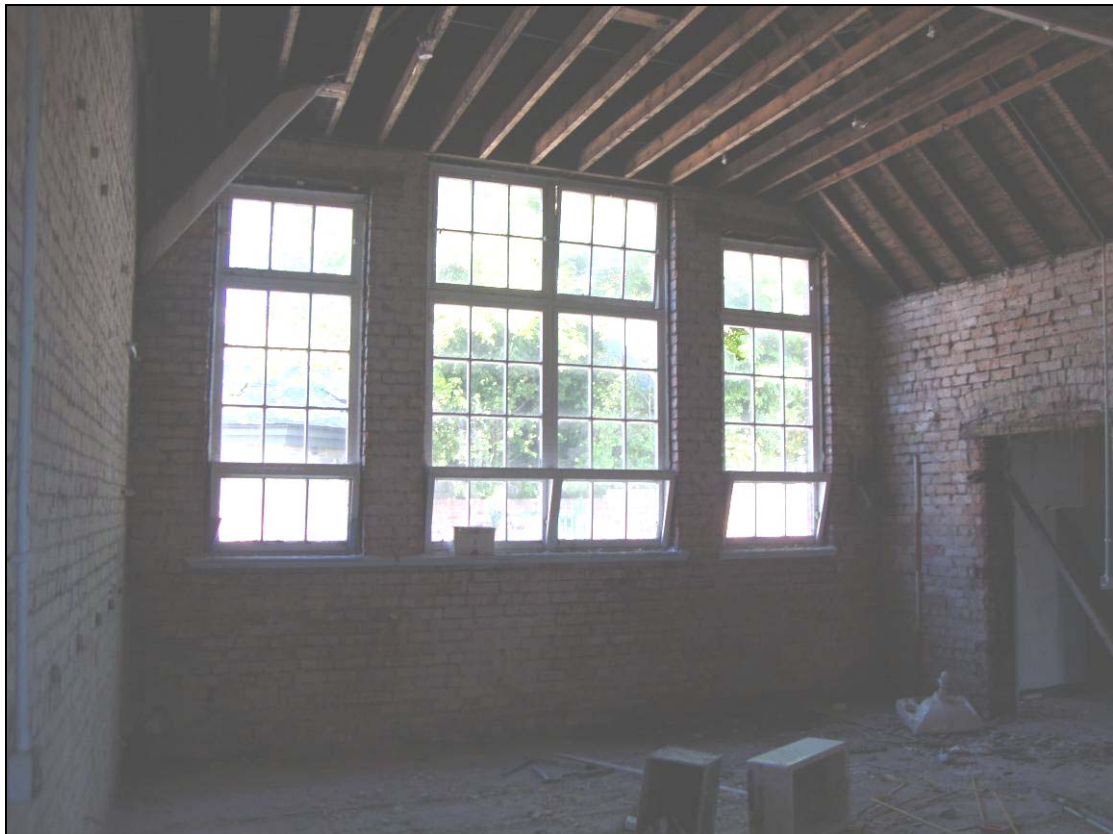
Room 5 is the northernmost classroom leading from the west elevation of Room 4. There are walls to the north, east, south and west. Only the west wall is external. The north elevation wall is also the south elevation wall of Room 1. There is a vent and three windows to the west elevation, the centre one being larger than the outer two. The north elevation wall has one door with a relieving arch, and a chimney breast with a large fireplace. The east elevation has one large opening and one small opening. The south elevation wall does not have any features. The fact that this room has a fireplace and a door leading directly to what would have been the girls' cloakroom indicates that this room would have been the Mistress' classroom.

Figure 44: North elevation of Room 5, looking north. Scale = 2m

Figure 45: East elevation of Room 5, looking east. Scale = 2m

Figure 46: West elevation of Room 5, looking west. Scale = 2m
