ST/1366/12/FUL

**An Archaeological Building Recording
at Cleadon Infant's School, Cleadon, South
Shields.**

Archaeological Research Services Ltd
Report No. 2012/39
June 2012

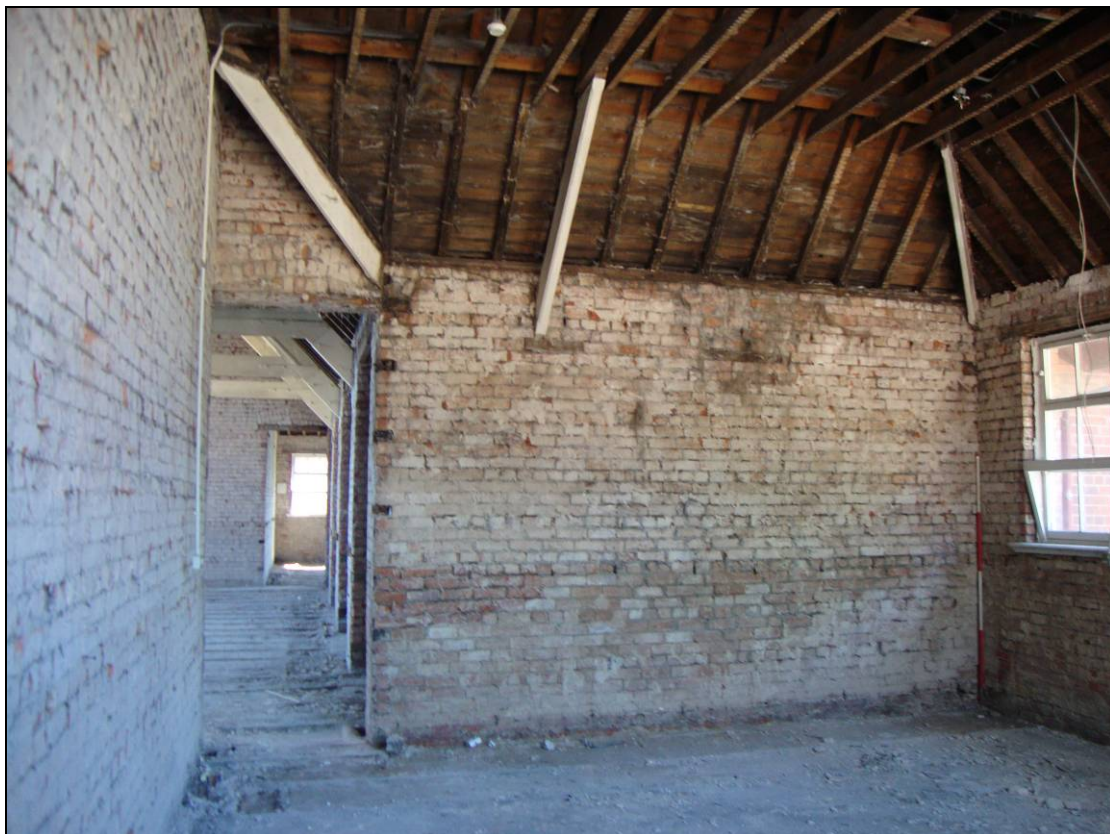
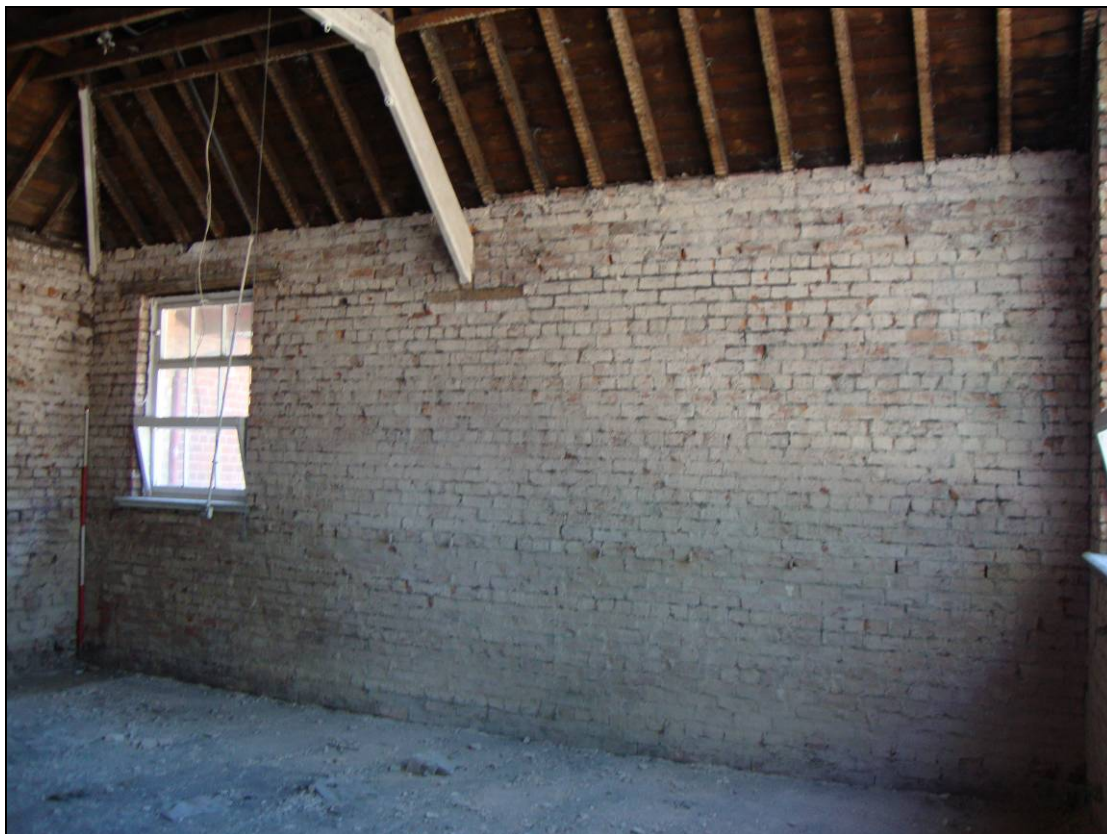
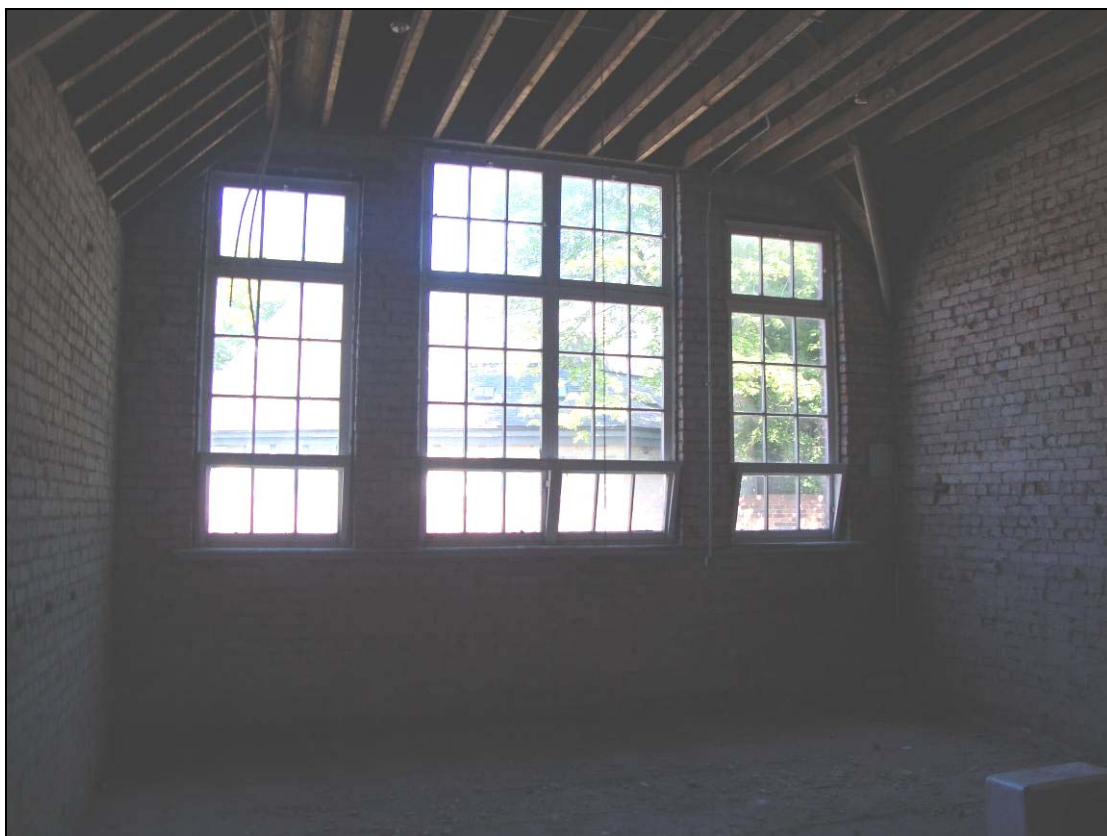
Room 6 comprises a rectangular room with walls to the north, east, south and west. This room was the southernmost classroom on the western side of the building. The west and south walls are external. The north elevation is also the south elevation of Room 5 and the east elevation is also the west elevation of Room 7. There is a vent and three windows to the west elevation; one large window in the centre and a smaller one flanking it on each side. There is also a small window at the eastern extent of the south elevation. The north elevation is featureless, and the east elevation has one door, leading from Room 4, at the northern extent.

Figure 47: East elevation of Room 6, looking east. Scale = 2m

Figure 49: South elevation of Room 6, looking south. Scale = 2m

Figure 50: West elevation of Room 6, looking west. Scale = 2m

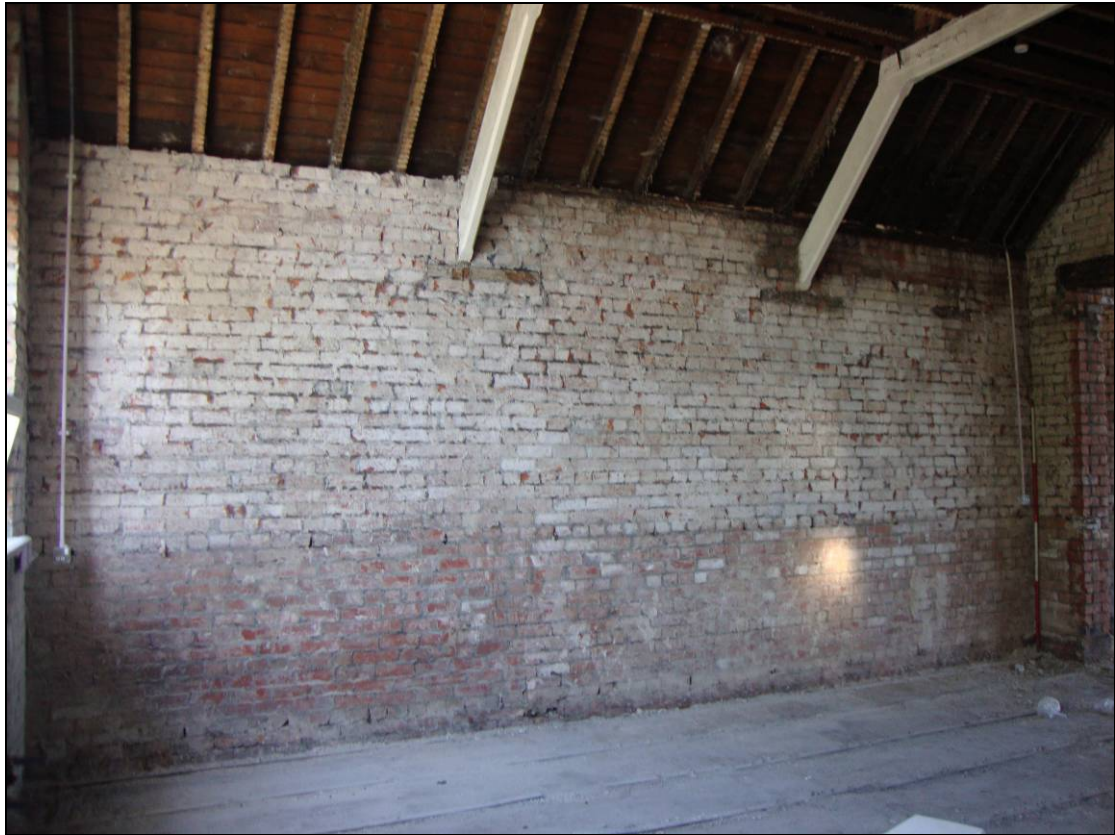
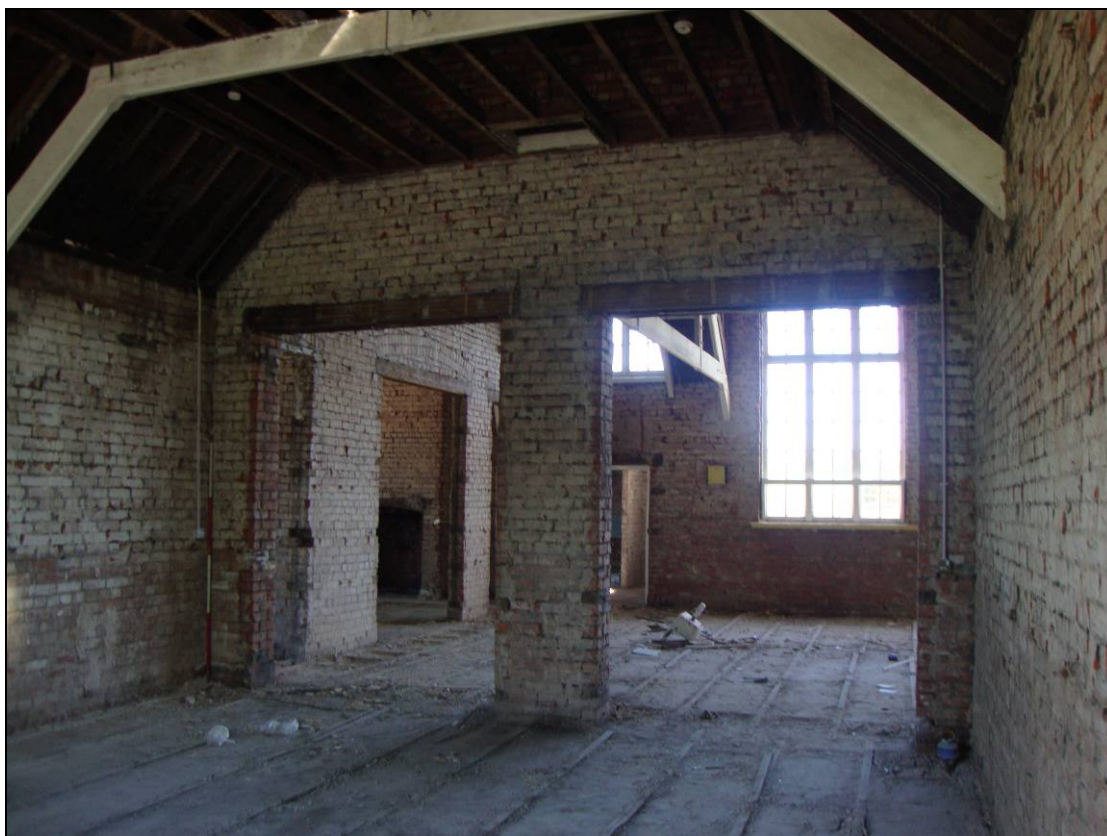
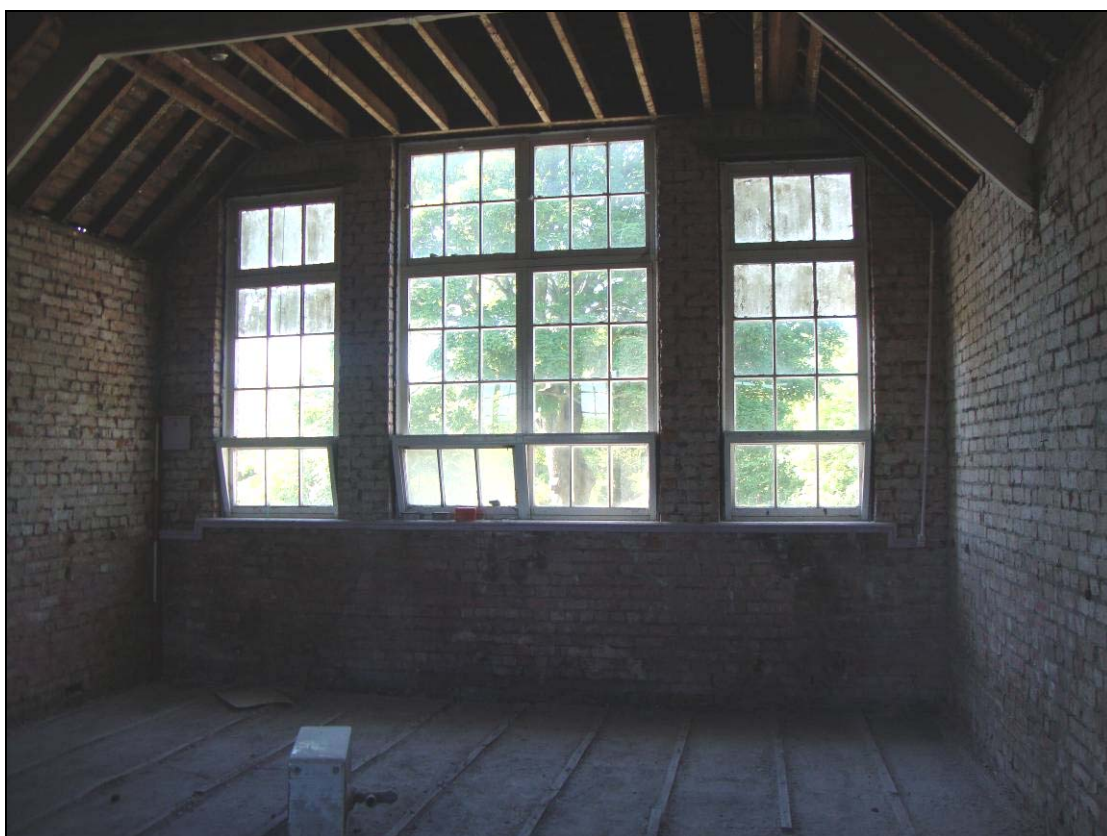
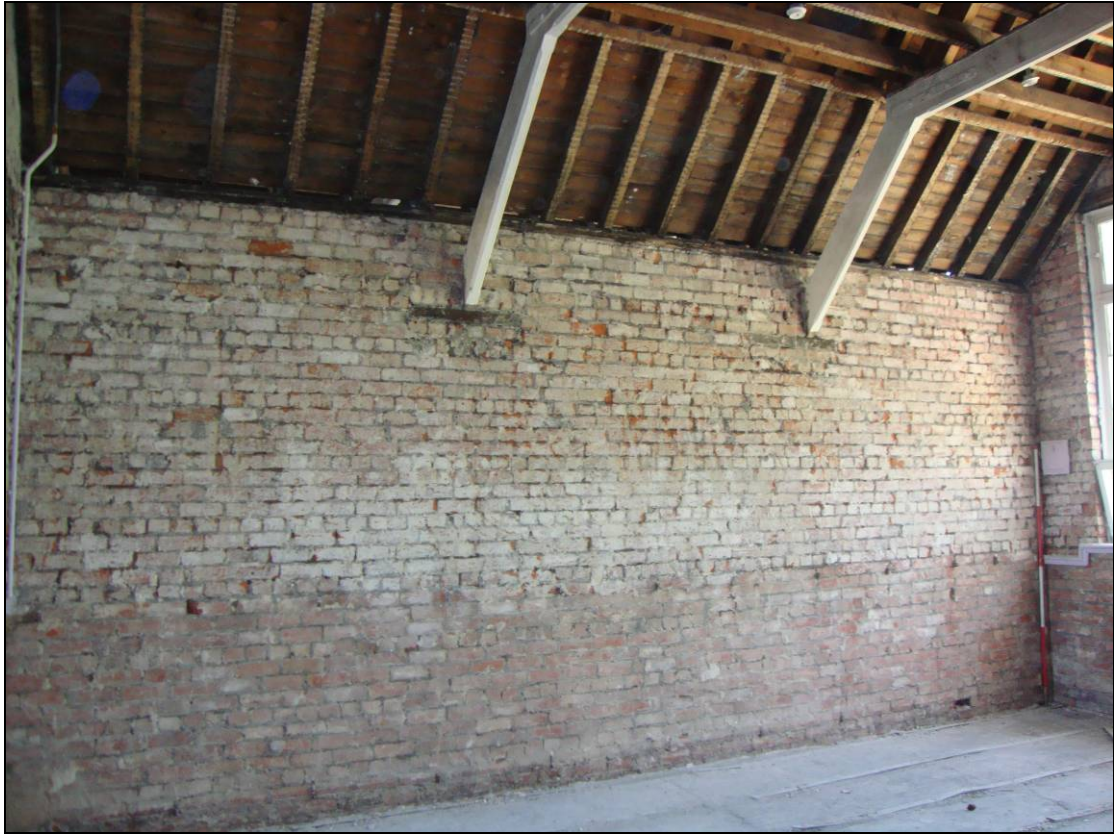
This room would have originally been a classroom and comprises a rectangular room with walls to the north, east, south and west. The west elevation is also the east elevation of Room 6 while the east elevation is also the west elevation of Room 8. The south elevation is an external wall and has a vent as well as three windows; one large one in the centre with a smaller one to each side. Both the east and west elevations are featureless. The north elevation wall also forms part of the south elevation of Room 4. This elevation has two openings leading from Room 4, one of which would have contained a sliding partition and the other of which would have contained a door. Neither of these features were present at the time of the survey, however.

Figure 51: West elevation of Room 7, looking west. Scale = 2m

Figure 52: North elevation of Room 7, looking north. Scale = 2m

Figure 53: South elevation of Room 7, looking south. Scale = 2m

Figure 54: East elevation of Room 7, looking east. Scale = 2m

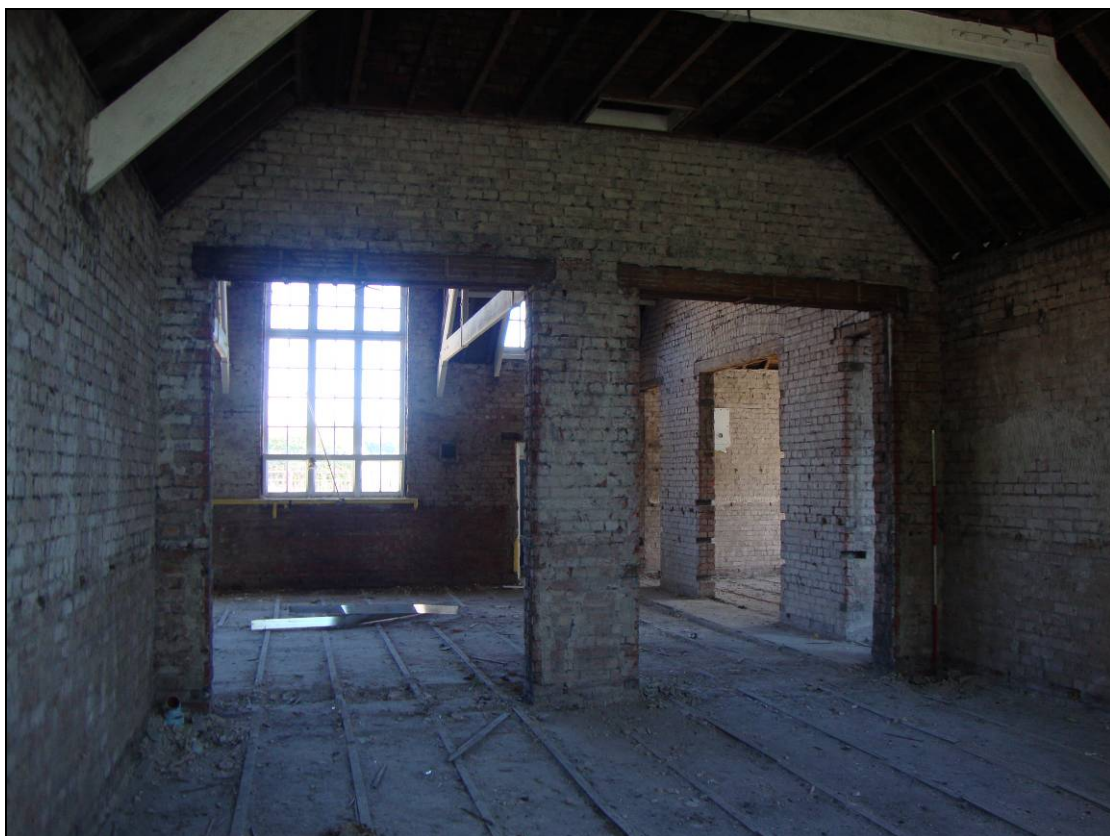
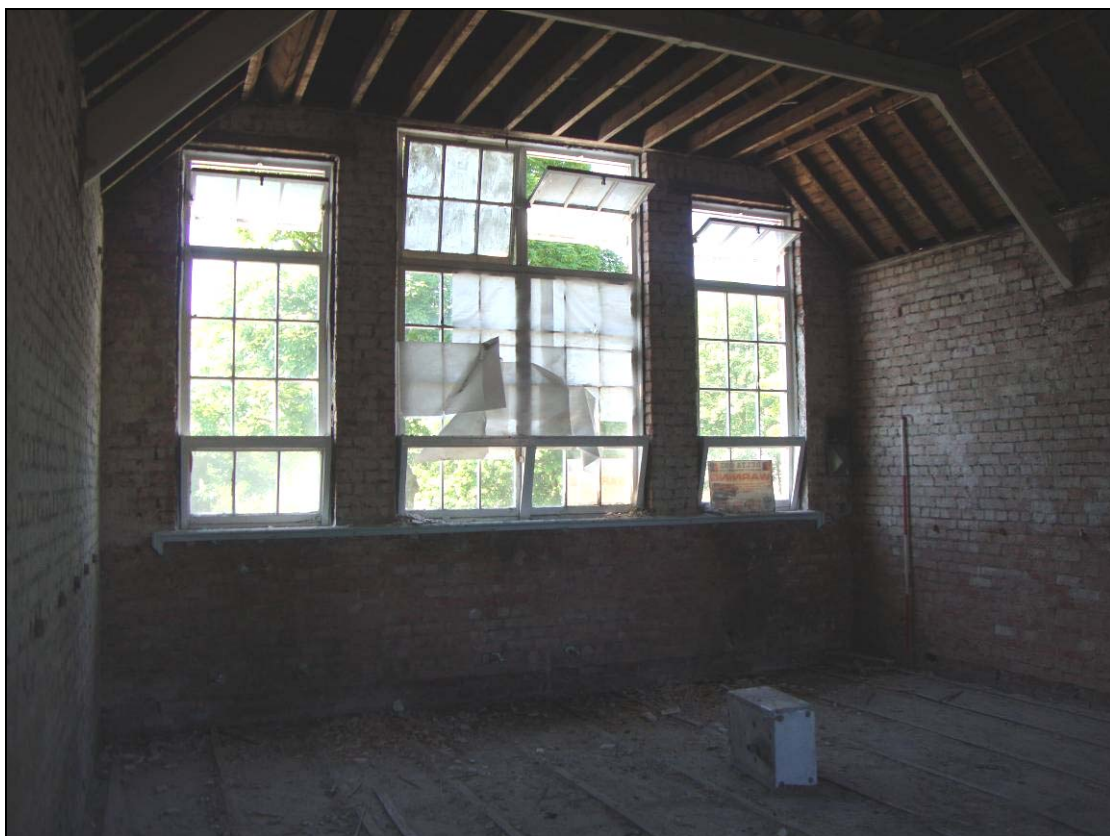
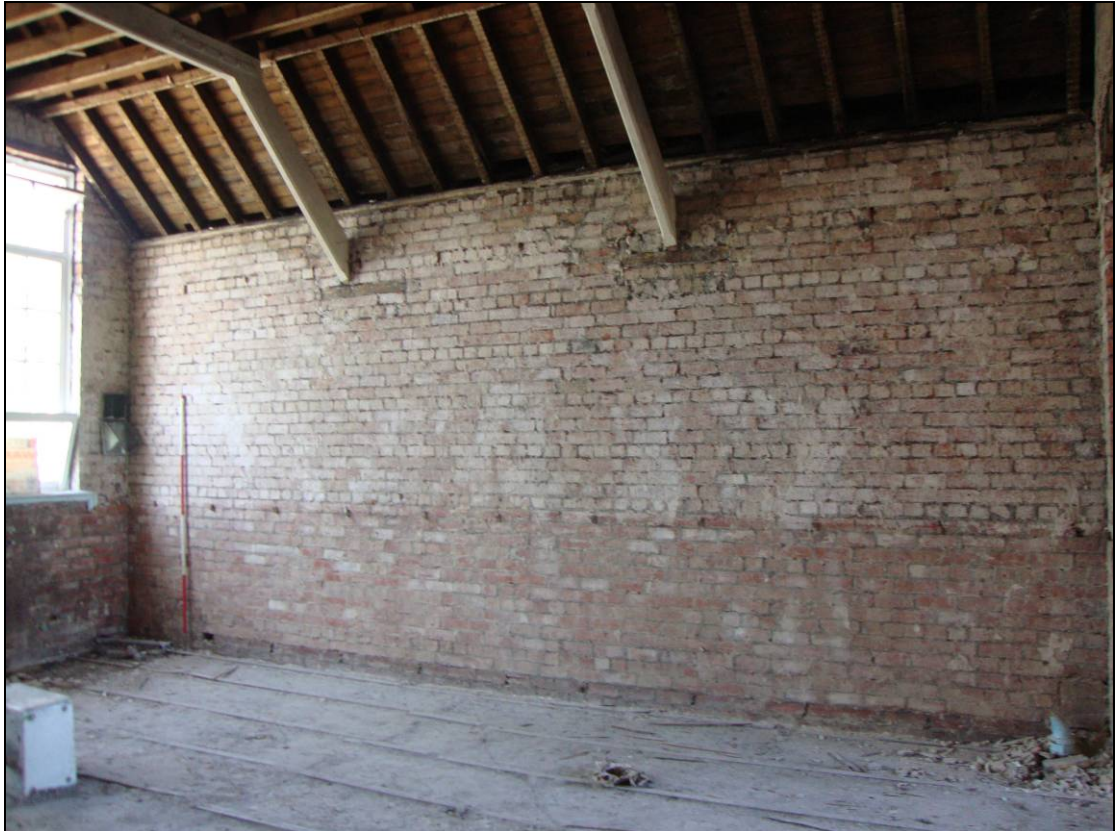
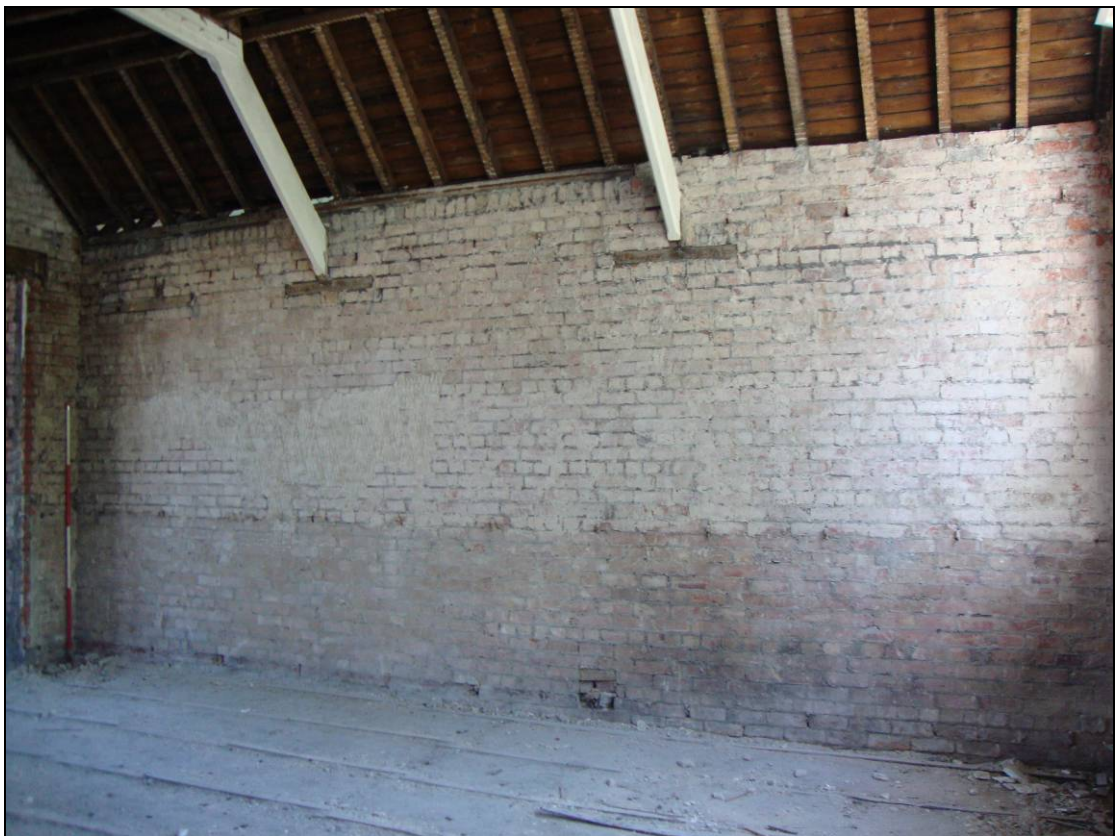
Room 8 would have originally been a classroom and comprises a small rectangular room with walls to the north, east, south and west. The south elevation wall is external, as is part of the east elevation wall. The other part of the east elevation is also the west elevation of Room 9 and the north elevation is also part of the south elevation of Room 4. There is a vent and three windows to the south elevation; there is one large window in the centre and a smaller one to each side. The east and west elevation walls are both featureless. The north elevation wall has two openings in it leading to Room 4. One of these would have originally contained a folding partition while the other would have contained a door. Neither of these features were present at the time of the survey, however.

Figure 55: North elevation of Room 8, looking north. Scale = 2m

Figure 56: South elevation of Room 8, looking south. Scale = 2m

Figure 57: West elevation of Room 8, looking west. Scale = 2m

Figure 58: East elevation of Room 8, looking east. Scale = 2m

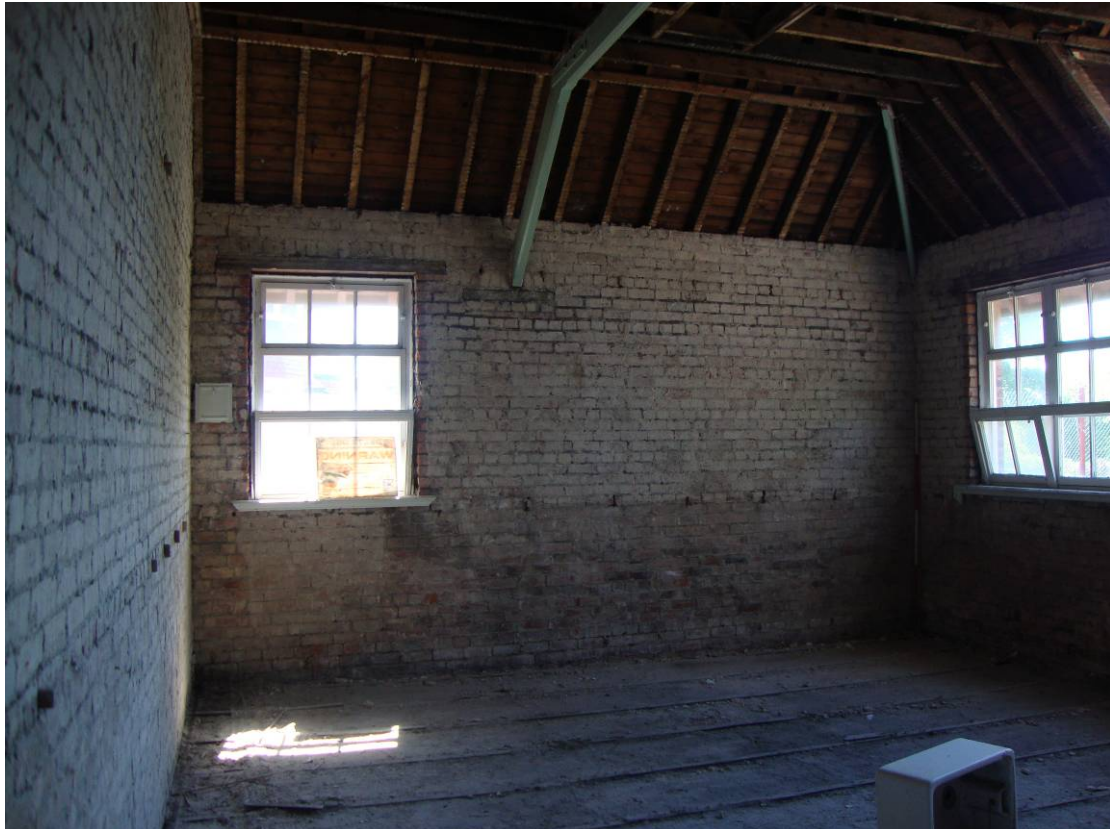
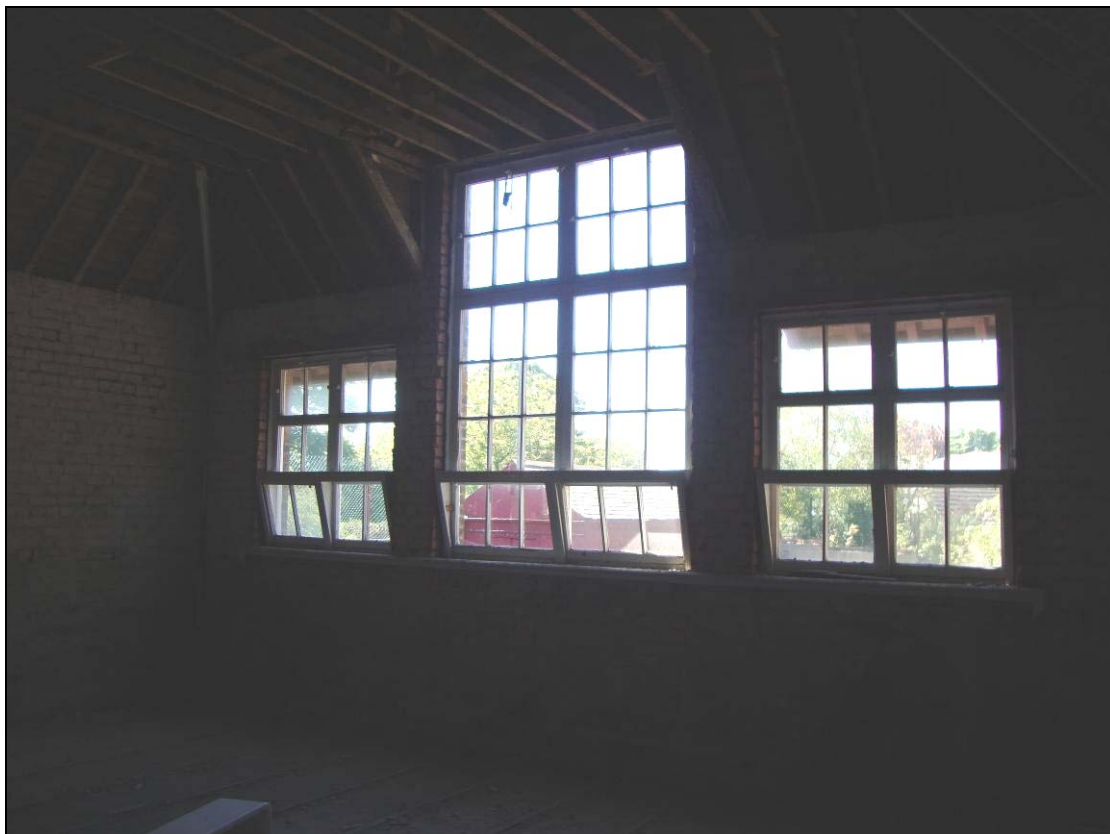
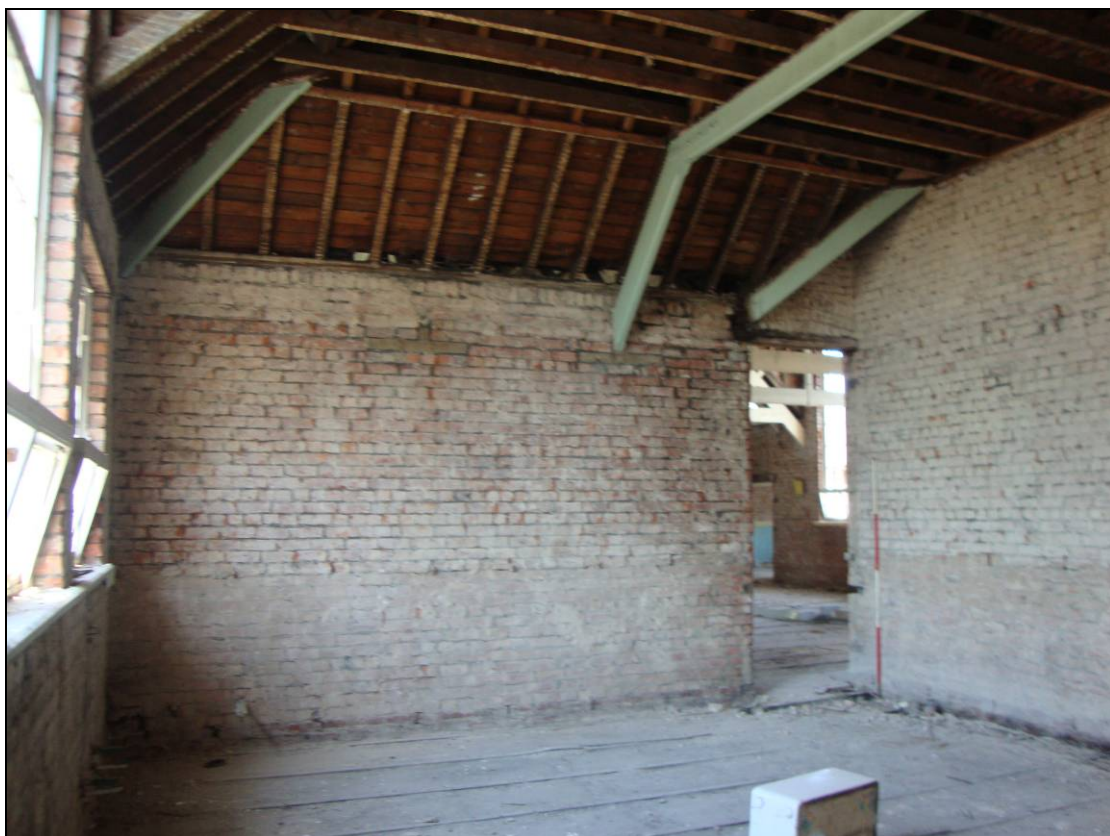
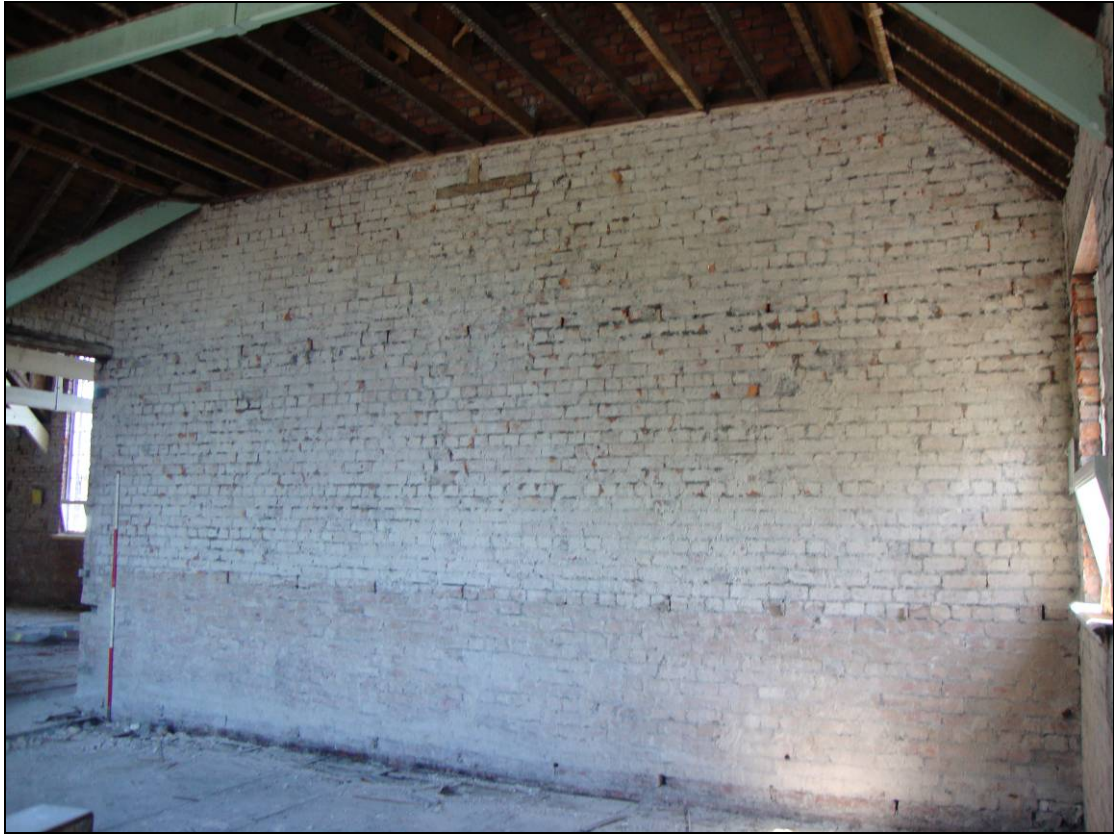
This room is the southernmost classroom on the eastern side of the building. It comprises a small rectangular room with walls to the north, east, south and west. The south and east elevation walls are external. The north elevation is also the south elevation of Room 10 while the west elevation is also the east elevation of Room 8. There is a single window to the east elevation, as well as a vent, and three windows to the south elevation. The north elevation is featureless and there is a single doorway into the room from Room 4 on the west elevation.

Figure 59: East elevation of Room 9, looking east. Scale = 2m

Figure 60: South elevation of Room 9, looking south. Scale = 2m

Figure 61: West elevation of Room 9, looking west. Scale = 2m

Figure 62: North elevation of Room 9, looking north. Scale = 2m

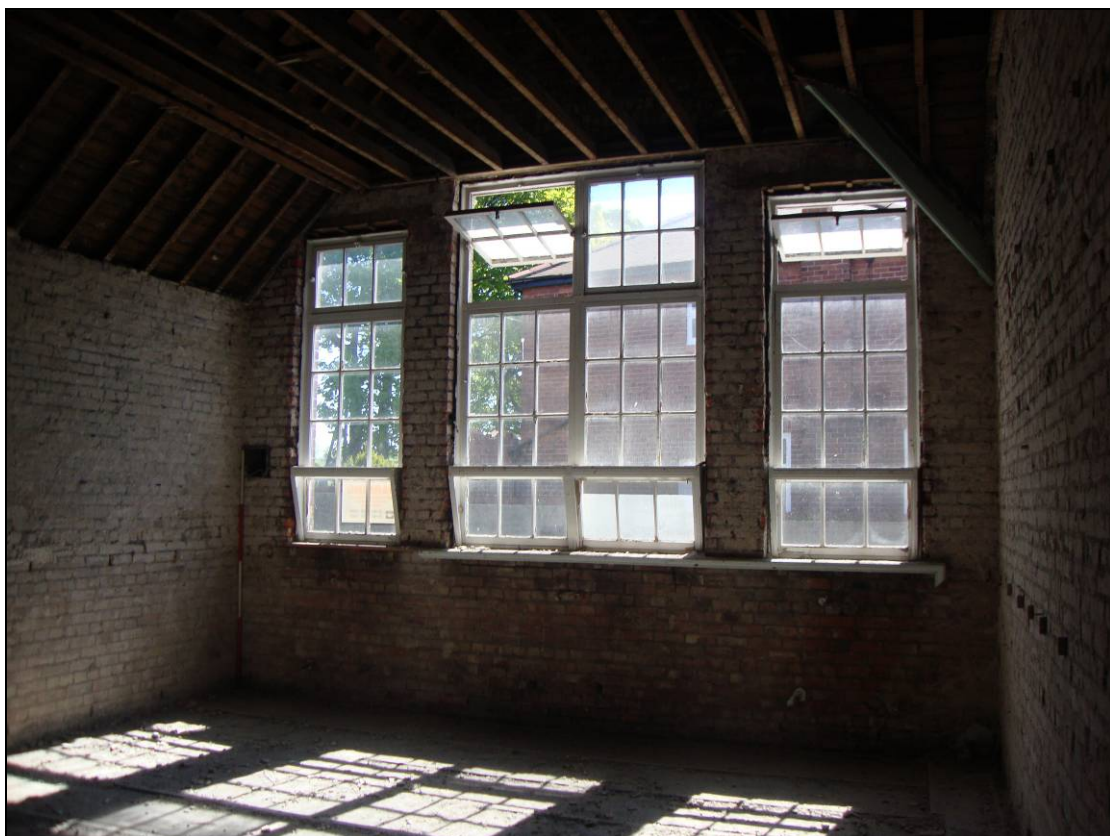
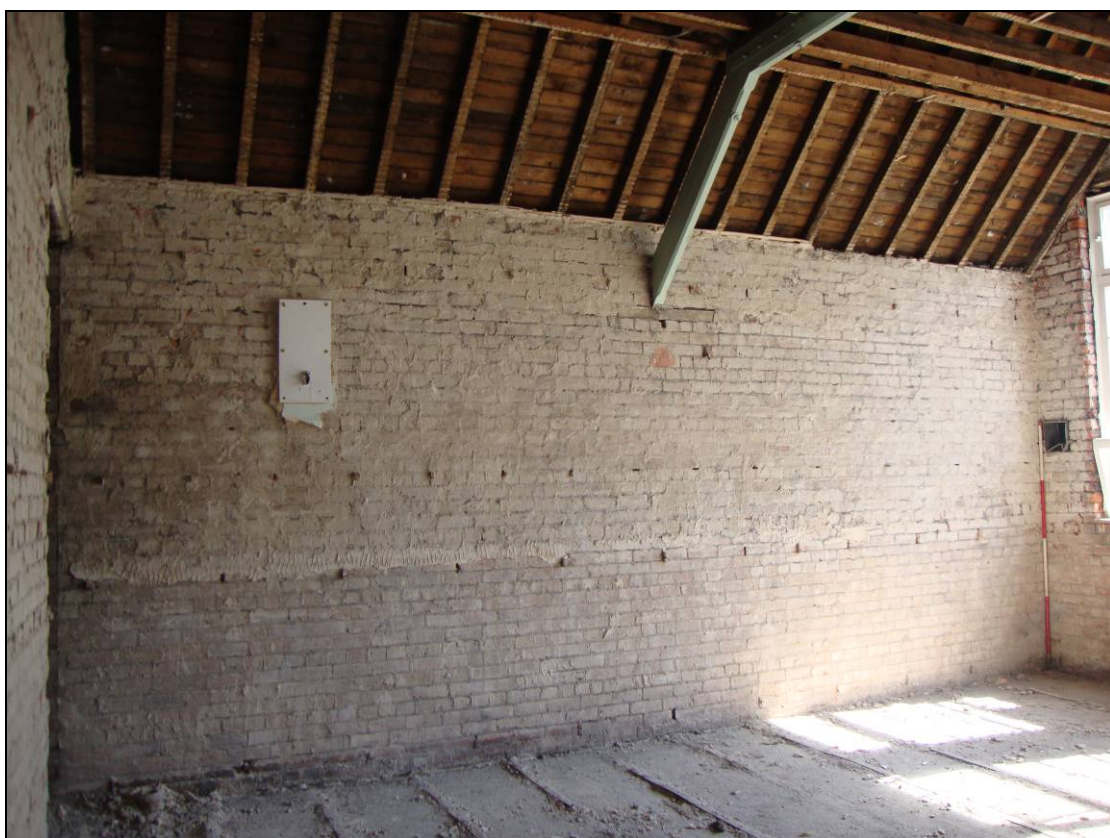
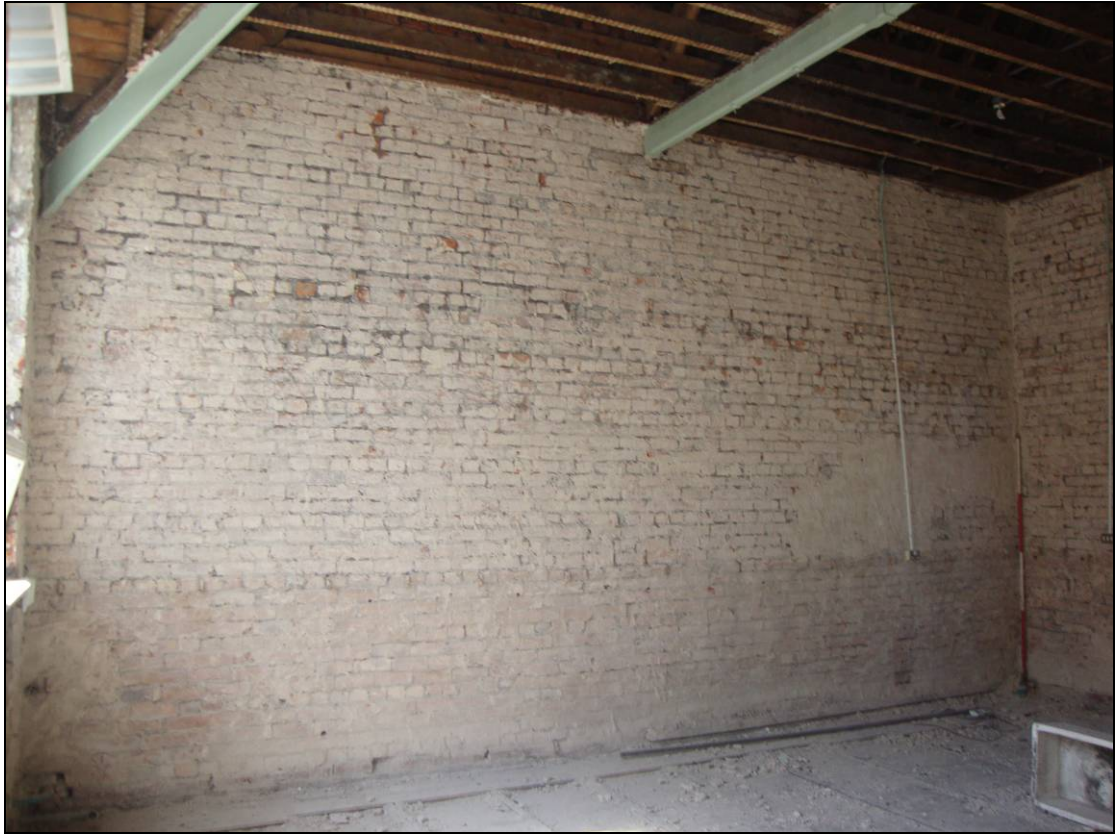
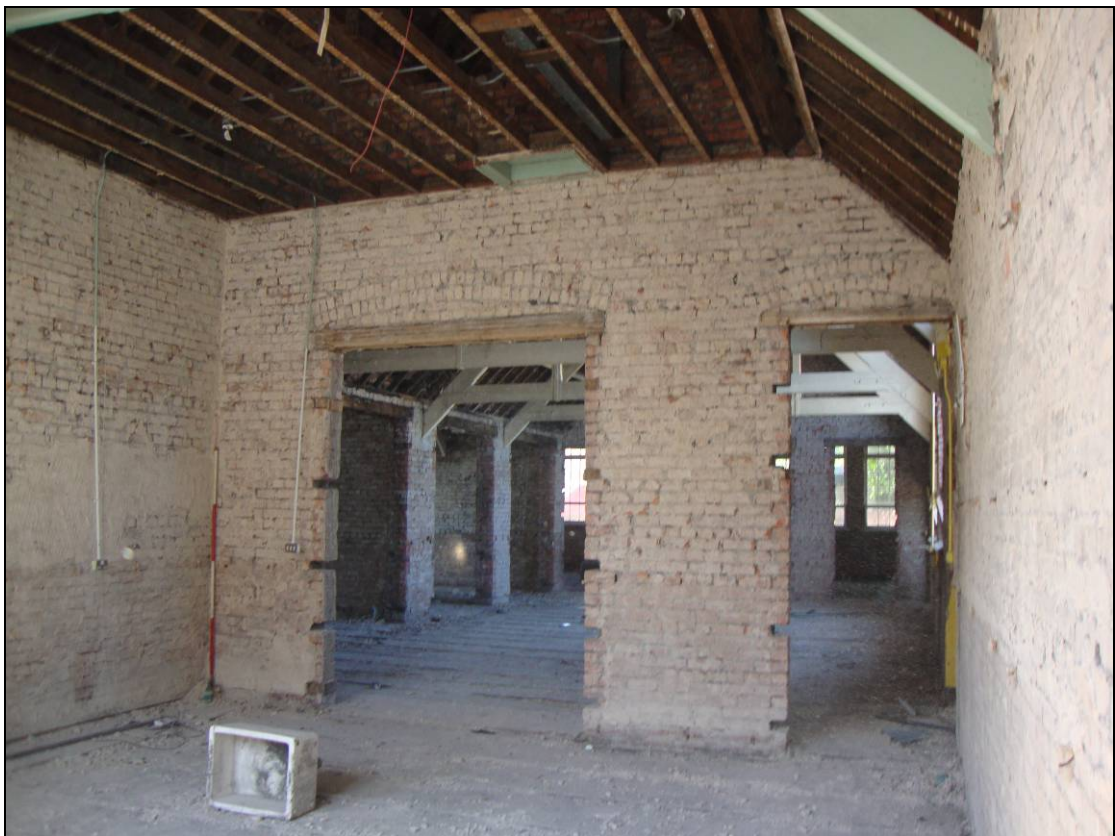
Room 10 is the northernmost classroom on the eastern side of the building. It comprises a small rectangular room with walls to the north, east, south and west. The east elevation wall is external while the other three are all internal. The north elevation of this room is also the south elevation of Room 11 and the south elevation wall is also the north elevation of Room 9. The west elevation wall is also the east elevation of Room 4. The east elevation has a vent and three windows; there is a large central window with a smaller window flanking it on each side. The north and south elevations are featureless while there are two openings leading from Room 4 on the west elevation. Originally one of these openings would have contained a sliding partition and the other would have contained a door.

Figure 63: East elevation of Room 10, looking east. Scale = 2m

Figure 64: North elevation of Room 10, looking north. Scale = 2m

Figure 65: South elevation of Room 10, looking south. Scale = 2m

Figure 66: West elevation of Room 10, looking west. Scale = 2m

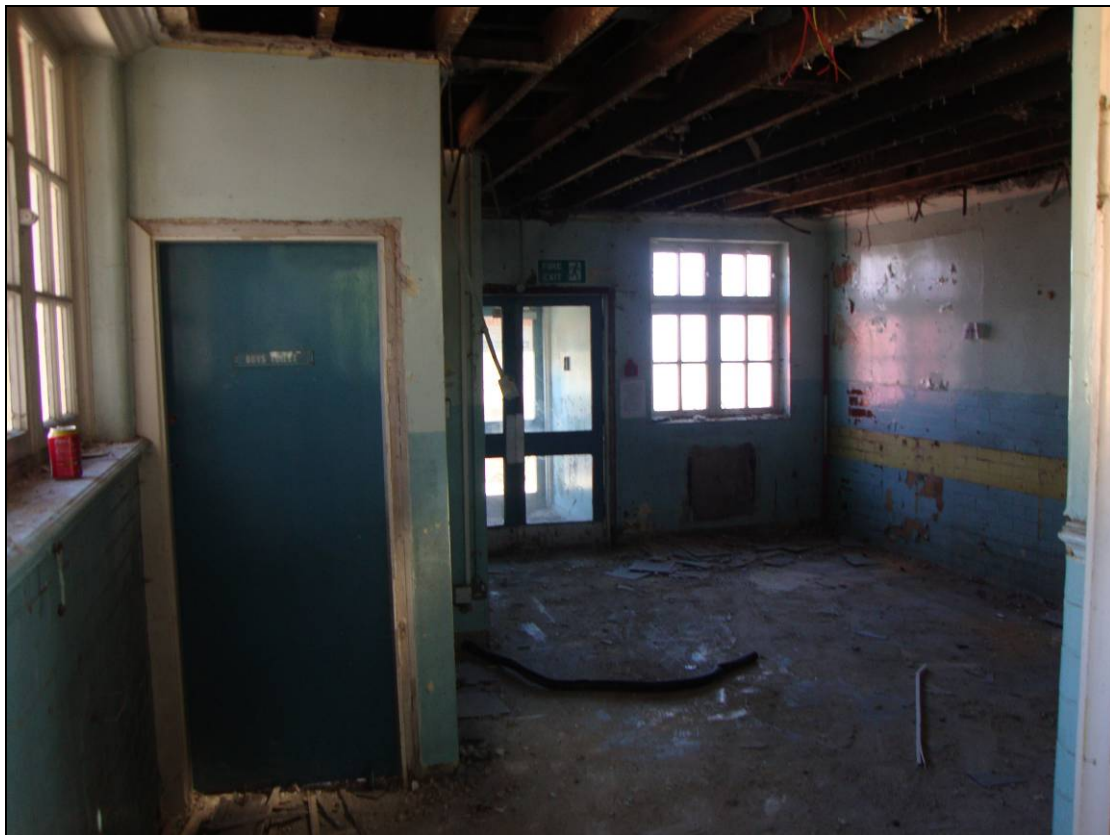
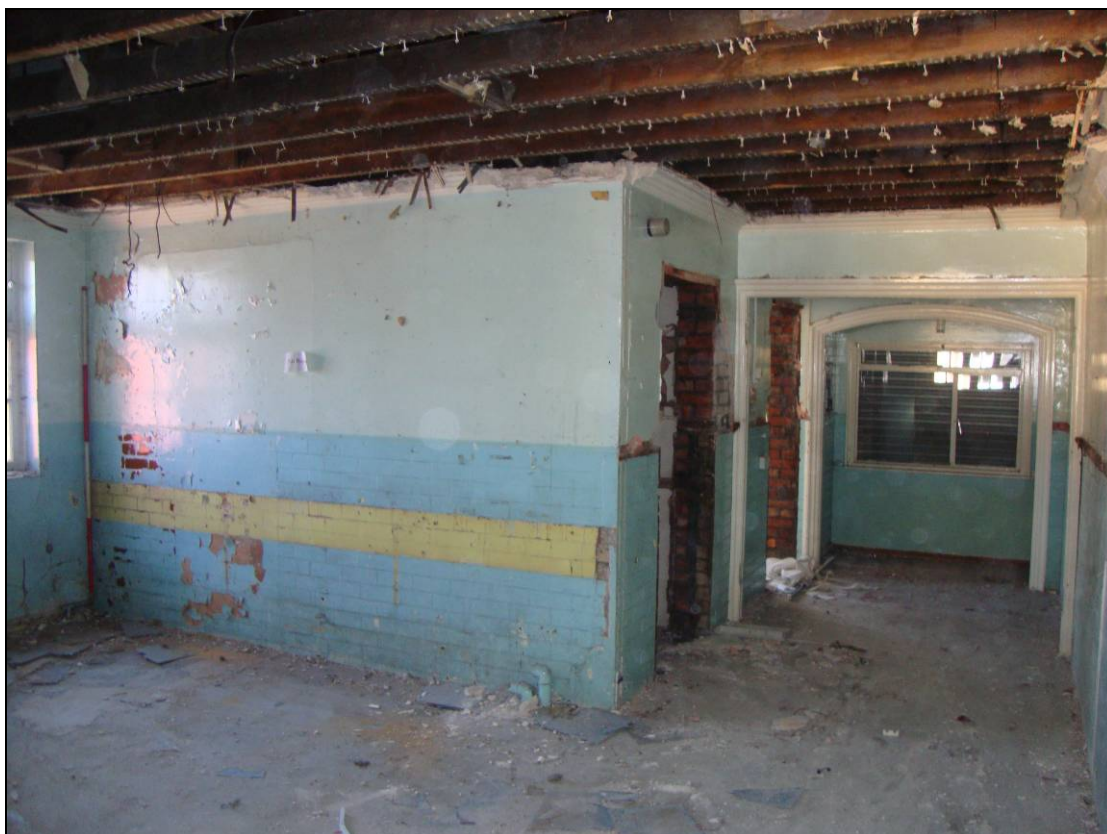
Room 11 consists of an 'L' shaped room in the north eastern corner of the building. The room is orientated north to south and then west to east and is a mirror image of Room 1. This room would have originally served as the entranceway and cloakroom for the boys. There is a door towards the western end of the south elevation that leads from Room 4. The west elevation comprises a later inserted partition brick-built wall that was constructed in order to create a corridor leading to the later toilet block extension. The north elevation wall has double doors leading to a small porch. The 'L' shape of the room is created by Rooms 12, 13 and 14 in the north east corner. The southern extent of the east elevation of the room displays evidence of a blocked doorway. This would have been the original boys' entrance into the school. The walls are constructed of brown glazed bricks from floor to dado rail height.

Figure 67: North elevation of Room 11, looking north. Scale = 2m

Figure 68: East elevation of Room 11. Scale = 2m

Figure 69: South elevation of Room 11, looking south west. Scale = 2m
