ST/1366/12/FUL

**An Archaeological Building Recording
at Cleadon Infant's School, Cleadon, South
Shields.**

Archaeological Research Services Ltd
Report No. 2012/39
June 2012

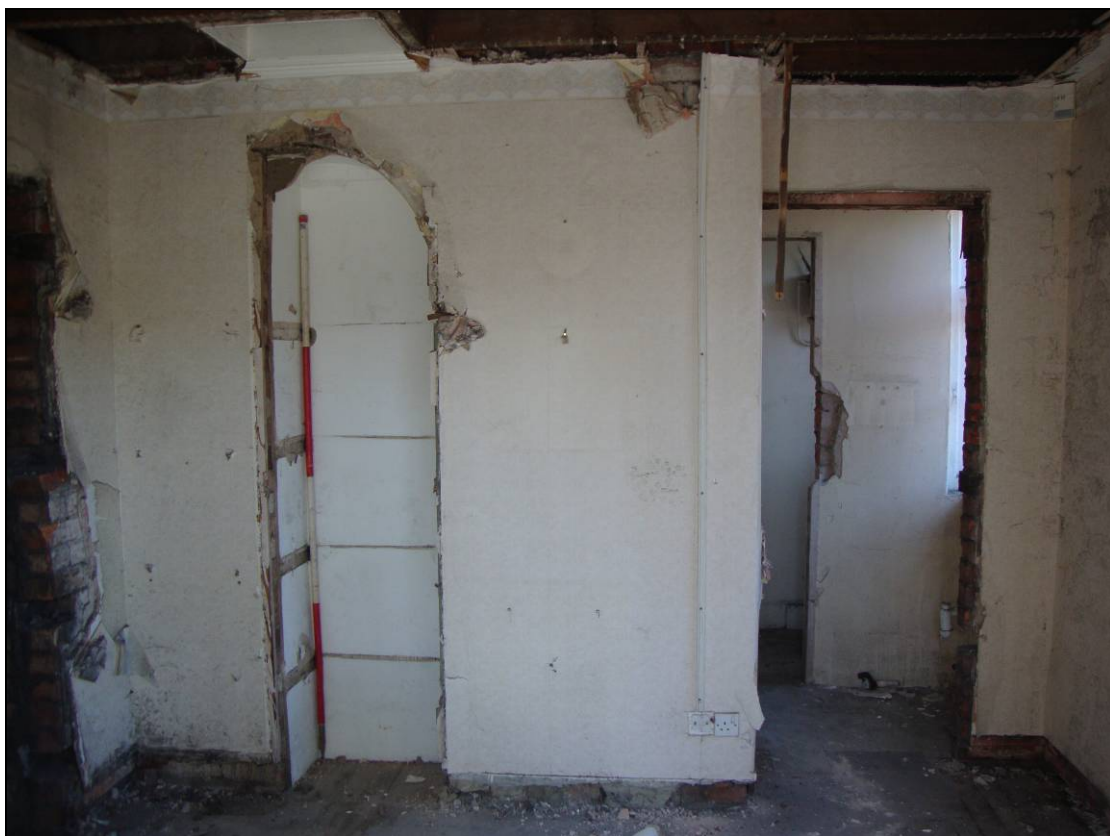
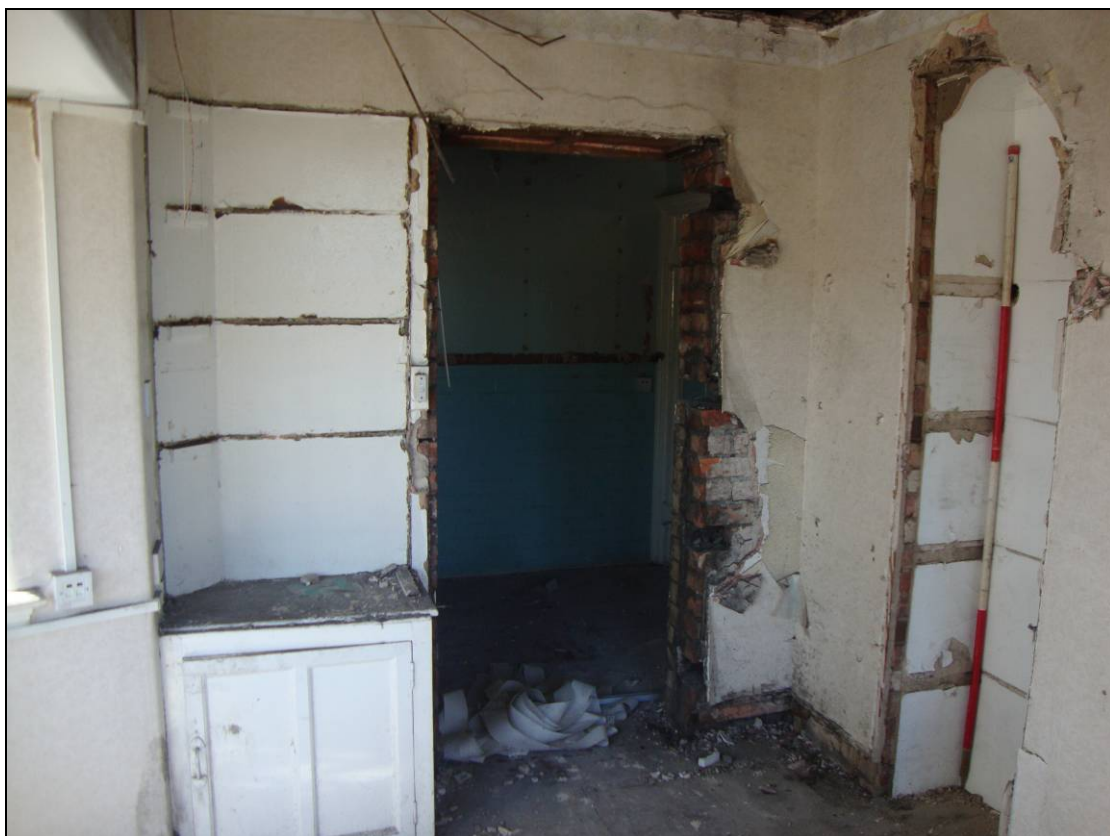
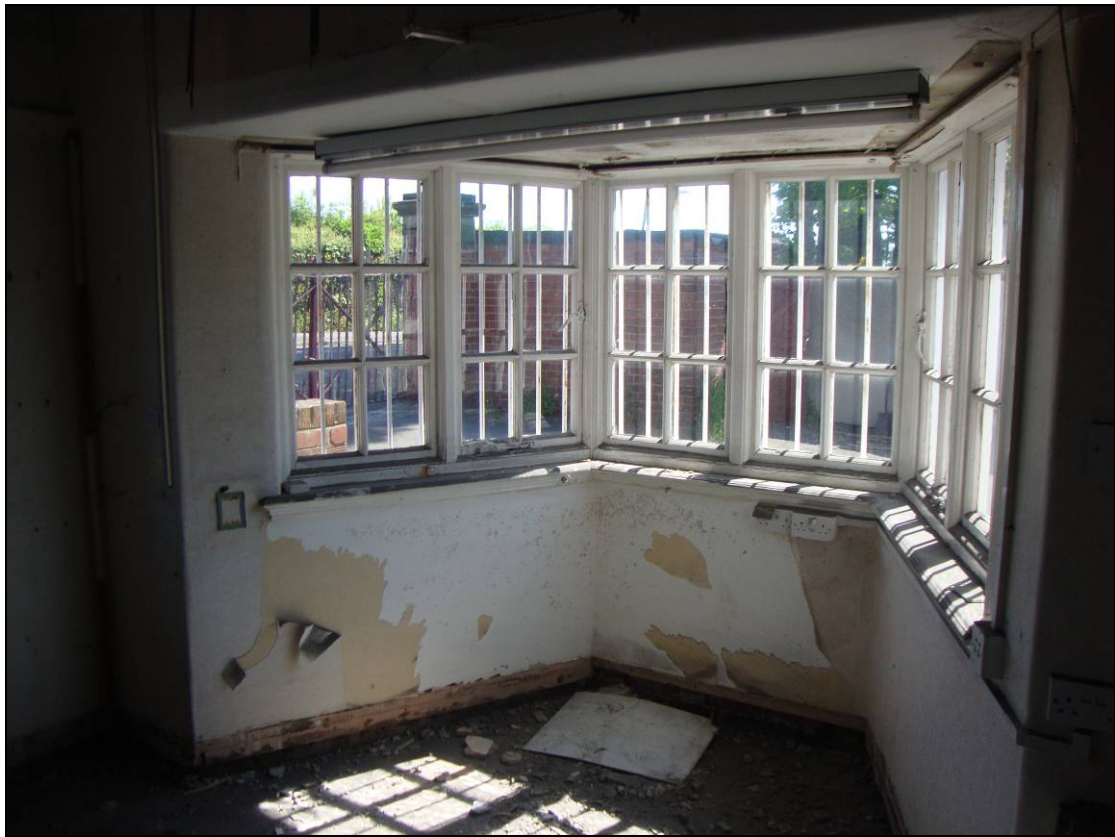
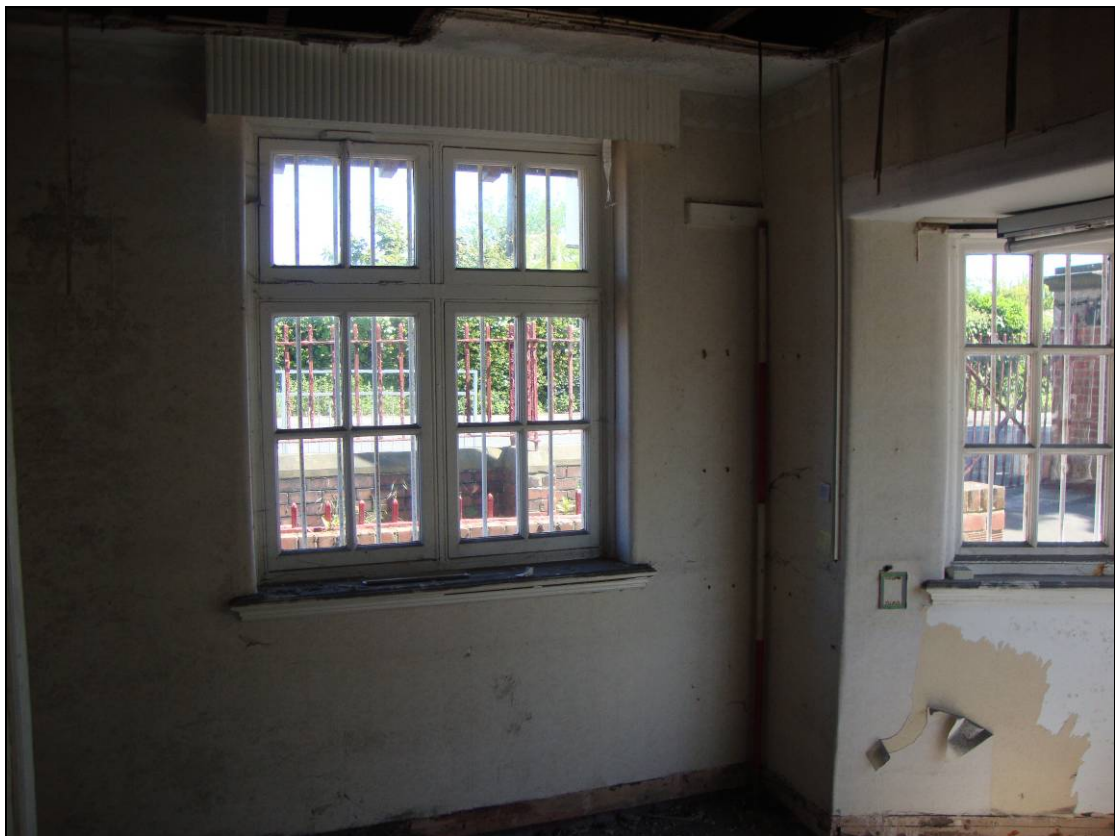
Room 13 comprises a small room in the north east corner of the building. This would have originally served as the Masters' Room due to its close proximity to the boys' entrance. The room has a doorway leading from Room 11 on the south elevation and a single window on the north elevation. There is a canted bay window to the east elevation, presumably so that the Masters were able to oversee the school boys while they were in the playground. There is a partially infilled niche in the wall of the west elevation as well as a blocked fireplace.

Figure 72: West elevation of Room 13, looking west. Scale = 2m

Figure 73: South elevation of Room 13, looking south. Scale = 2m

Figure 74: East elevation of Room 13, showing detail of bay window, looking east. Scale = 2m

Figure 75: North elevation of Room 13 with window, looking north. Scale = 2m
