REPORT NO: D7716/1

GEOENVIRONMENTAL APPRAISAL FOR LAND AT

PORLOCK, JARROW

SOUTH TYNESIDE HOMES.

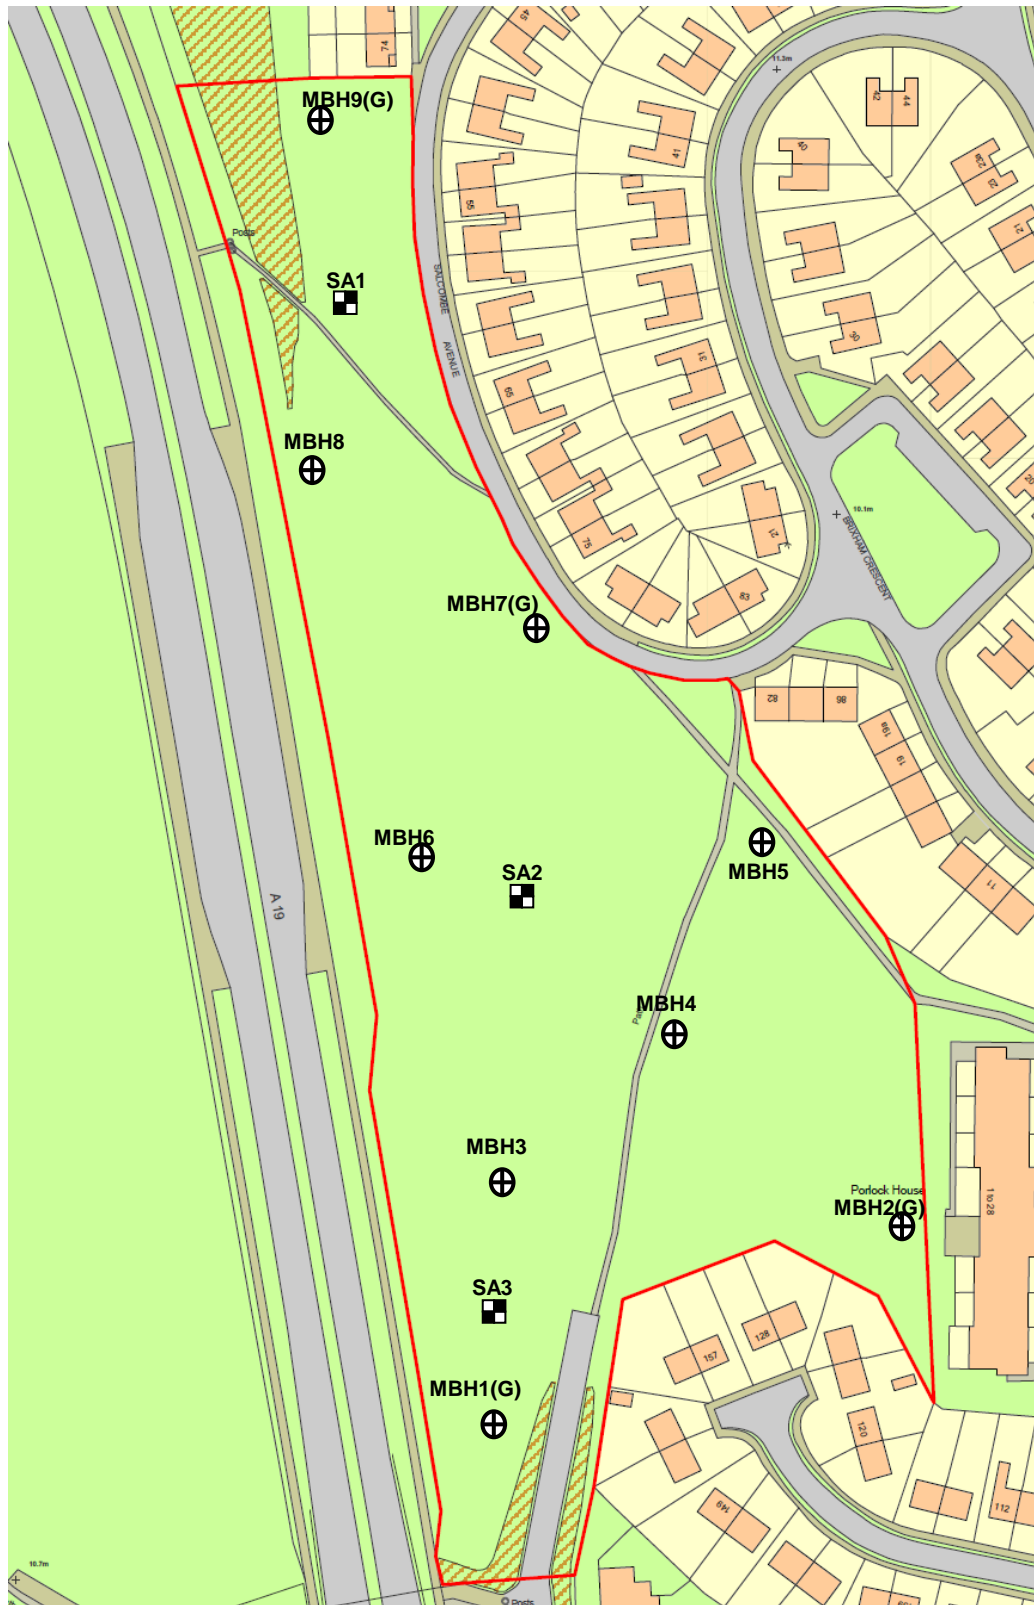
Contract: Porlock, Jarrow		Contract No: D7716	
	Client: South Tyneside Homes			
TEL: 0191 378 3151 FAX: 0191 378 3157		Drawing Title: Exploratory Hole location Plan		
Drawing No: D7716/02	Date: April 2013	Scale: NTS	Status: Final	Drawn by: GD

The exploratory holes listed below were advanced during December 2016. Records for each of the exploratory holes noted are included in Appendix B and the locations are shown on Drawing Number D7716/02 in Appendix A.

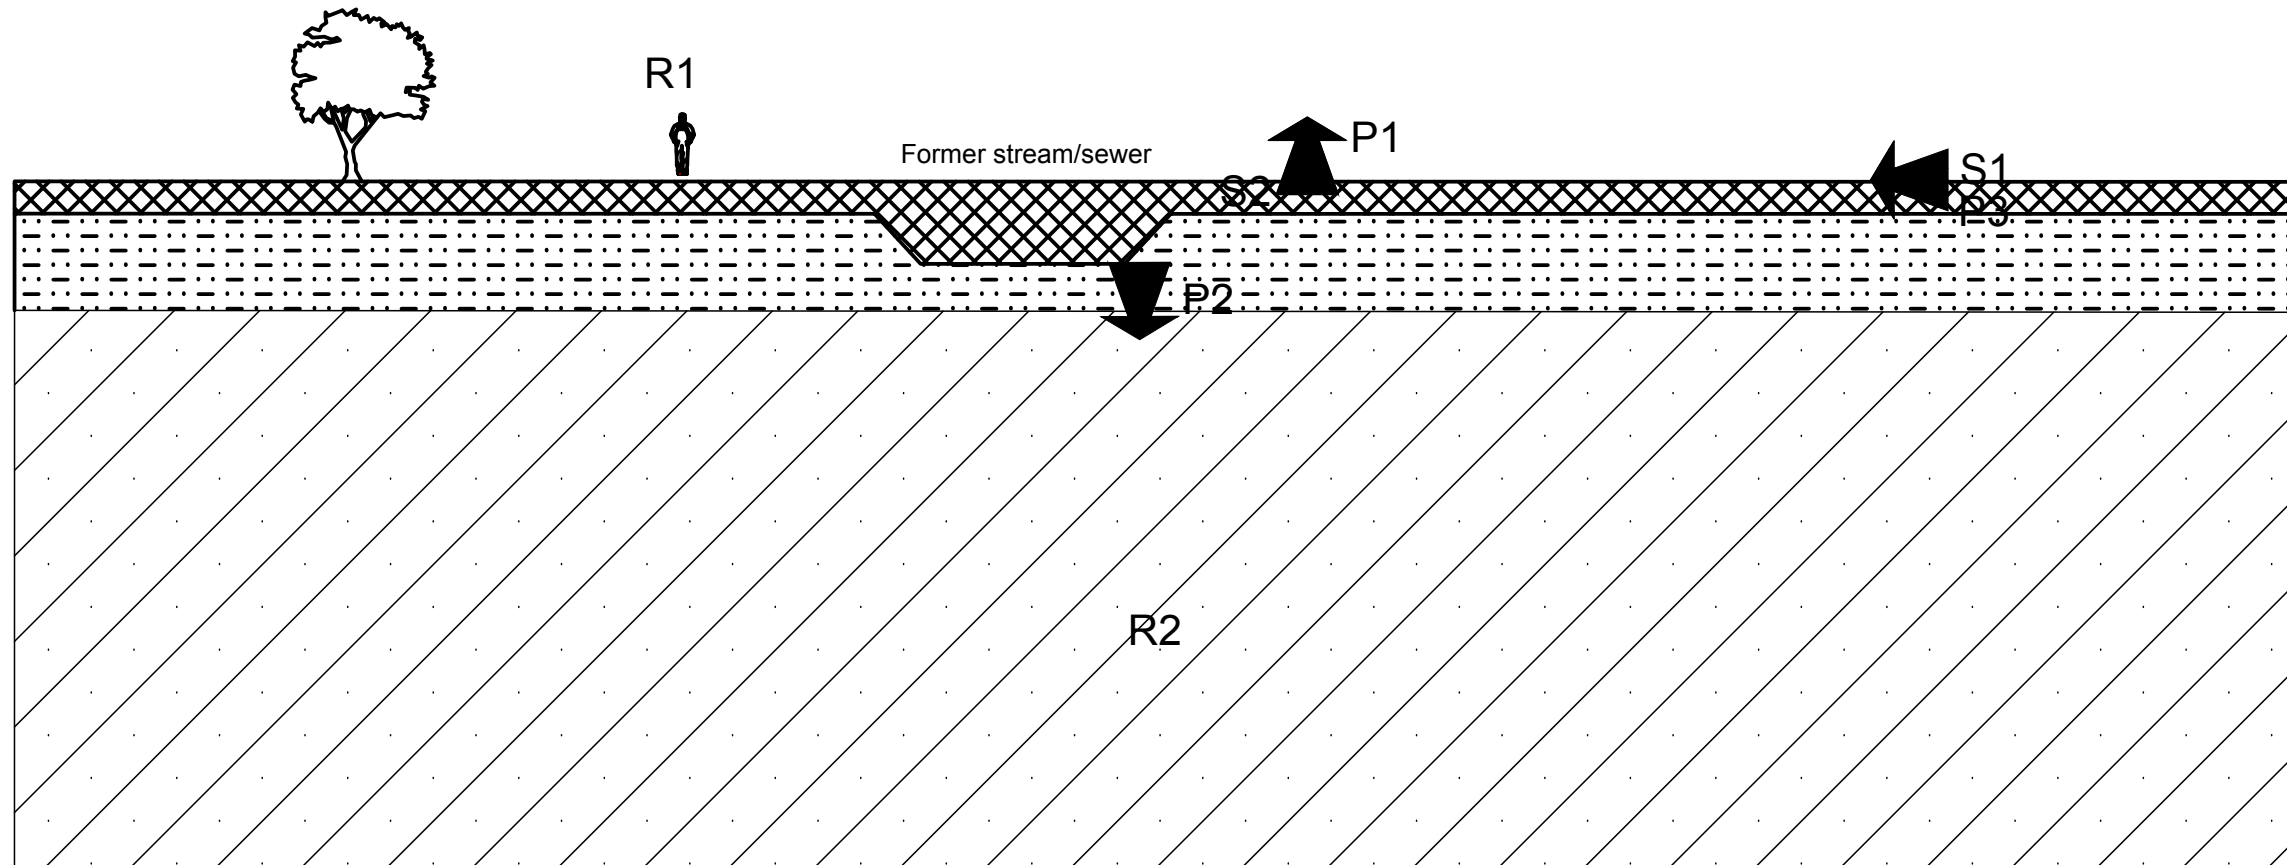
Ground Conditions Summary

The results of the 'Hazard Identification' process for significant sources of contamination in accordance with CLR11 are summarised above. The following section describes the results of the 'Hazard Assessment' process in which unacceptable risks are identified. Pathways and receptors are considered below. Contamination sources and pollutant linkages are shown in the revised Conceptual Site Model presented as Drawing No. D7716/03 in Appendix A.

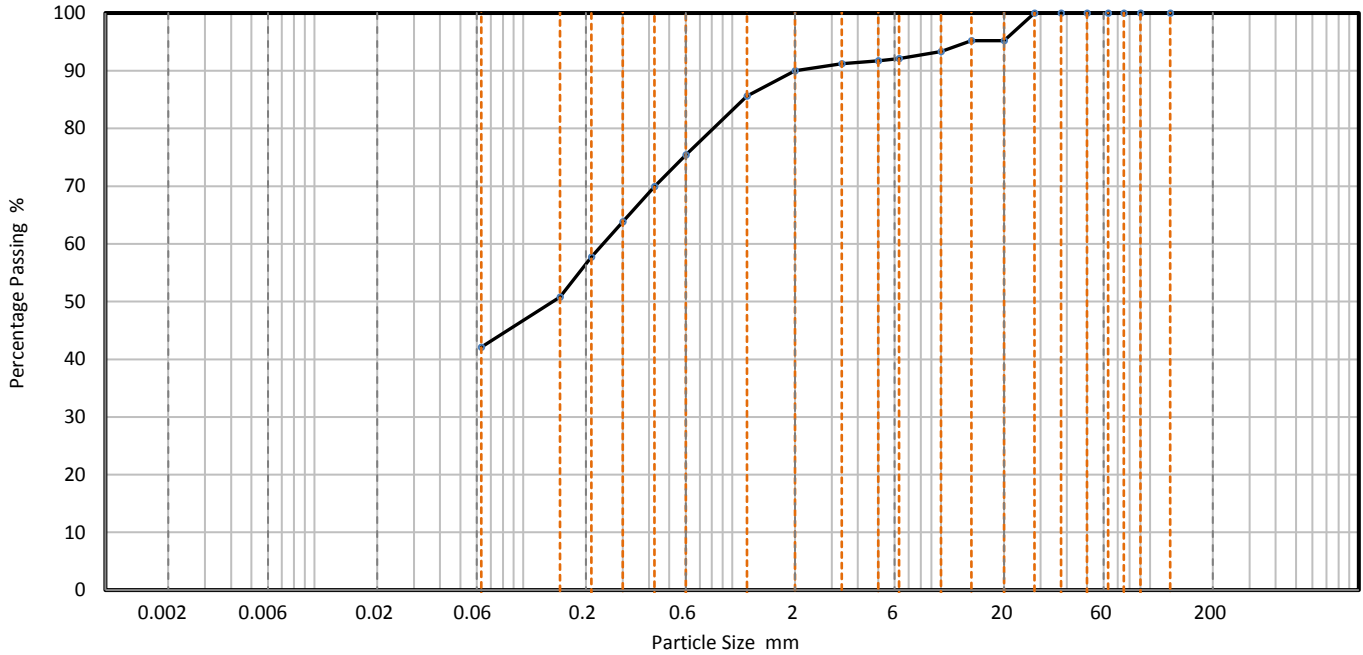
Hole	MBH3	Lab sample ID	SLMK2016121028
Depth (Top)	m 0.30	Test Method	BS 1377 - 2 : 1990 Clause 9.2
Depth (Base)	m	Soil Description	brown, slightly gravelly, clayey SAND
Sample type	B

Sieving		Sedimentation	
Particle Size mm	% Passing	Particle Size mm	% Passing
125	100		
90	100		
75	100		
63	100		
50	100		
37.5	100		
28	100		
20	95		
14	95		
10	93		
6.3	92		
5	92		
3.35	91		
2	90		
1.18	86		
0.6	75	Particle density (assumed) 2.65 Mg/m3	
0.425	70		
0.3	64		
0.212	58		
0.15	51		
0.063	42

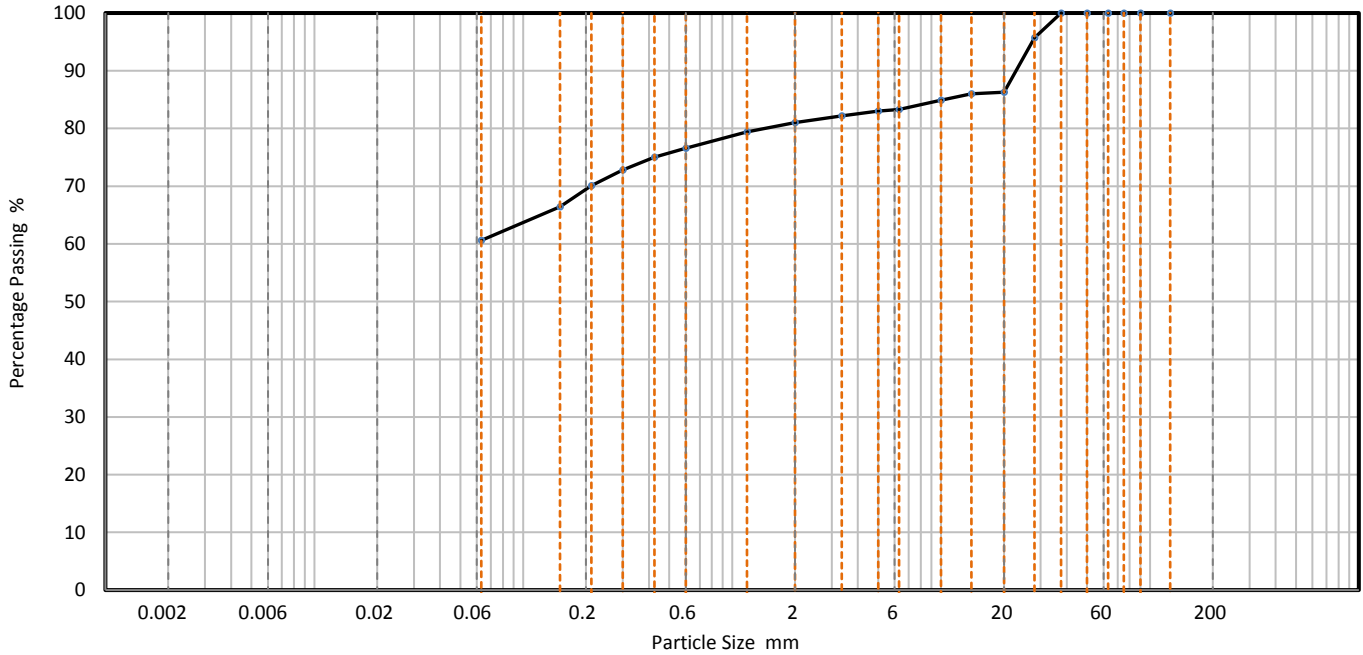
Hole	MBH5	Lab sample ID	SLMK2016121029
Depth (Top)	m 1.20	Test Method	BS 1377 - 2 : 1990 Clause 9.2
Depth (Base)	m	Soil Description	brown, slightly gravelly CLAY
Sample type	L

Sieving		Sedimentation	
Particle Size mm	% Passing	Particle Size mm	% Passing
125	100		
90	100		
75	100		
63	100		
50	100		
37.5	100		
28	96		
20	86		
14	86		
10	85		
6.3	83		
5	83		
3.35	82		
2	81		
1.18	79		
0.6	77	Particle density (assumed) 2.65 Mg/m3	
0.425	75		
0.3	73		
0.212	70		
0.15	66		
0.063	61

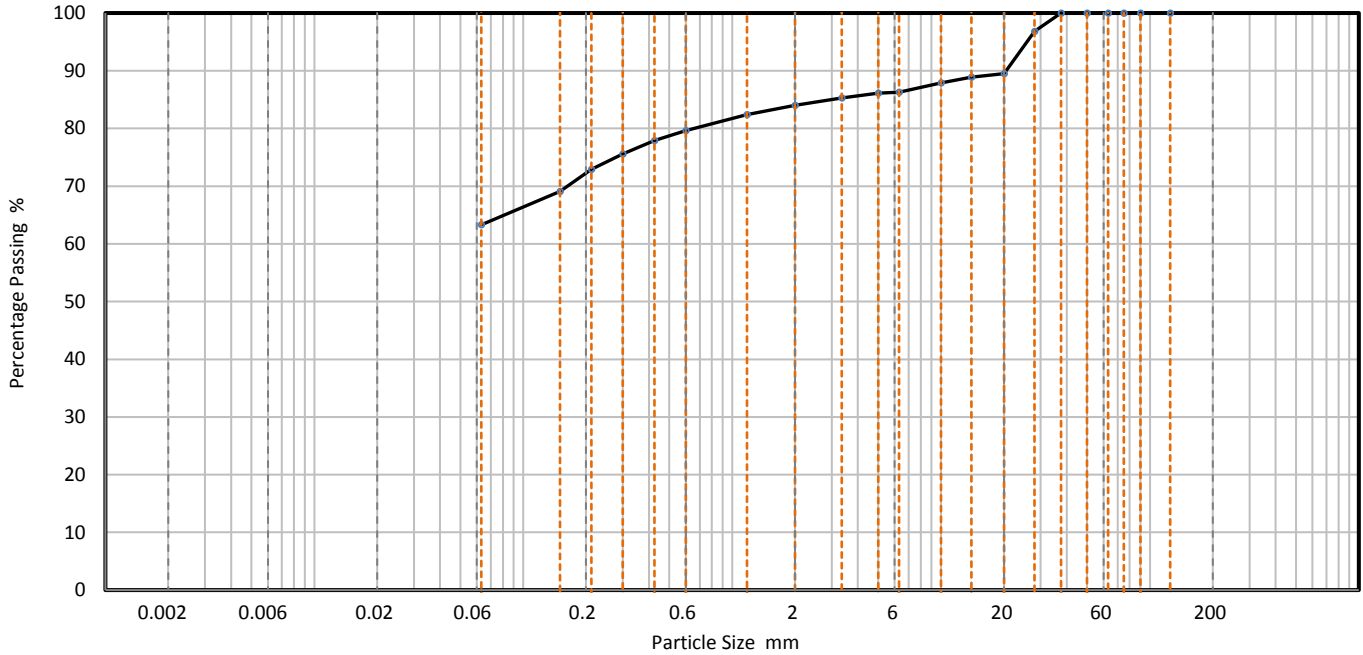
Hole	MBH9	Lab sample ID	SLMK2016121031
Depth (Top)	m 0.50	Test Method	BS 1377 - 2 : 1990 Clause 9.2
Depth (Base)	m	Soil Description	brown, slightly gravelly, sandy CLAY
Sample type	B

Sieving		Sedimentation	
Particle Size mm	% Passing	Particle Size mm	% Passing
125	100		
90	100		
75	100		
63	100		
50	100		
37.5	100		
28	97		
20	90		
14	89		
10	88		
6.3	86		
5	86		
3.35	85		
2	84		
1.18	82		
0.6	80	Particle density (assumed) 2.65 Mg/m3	
0.425	78		
0.3	76		
0.212	73		
0.15	69		
0.063	63

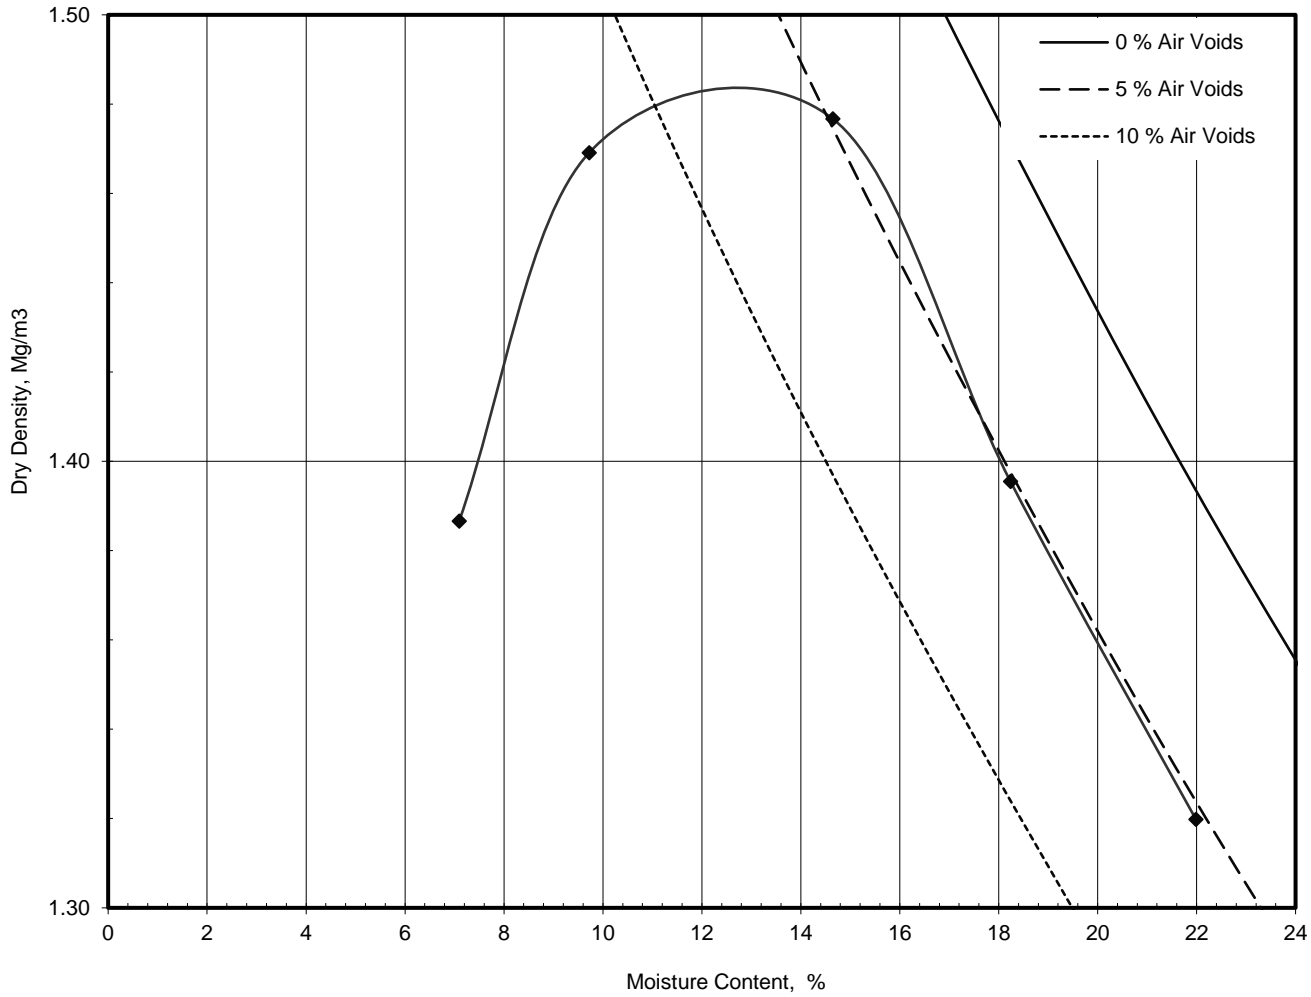
Maximum Dry Density	Mg/m ³	1.48
----------------------------	-------------------	-------------

Optimum Moisture Content	%	13
---------------------------------	---	-----------

Dry density/moisture content relationship indicates the maximum dry density ranges from 1.48Mg/m³ to 1.64Mg/m³ with the optimum moisture ranging from 13% to 16%. The received moisture content for the

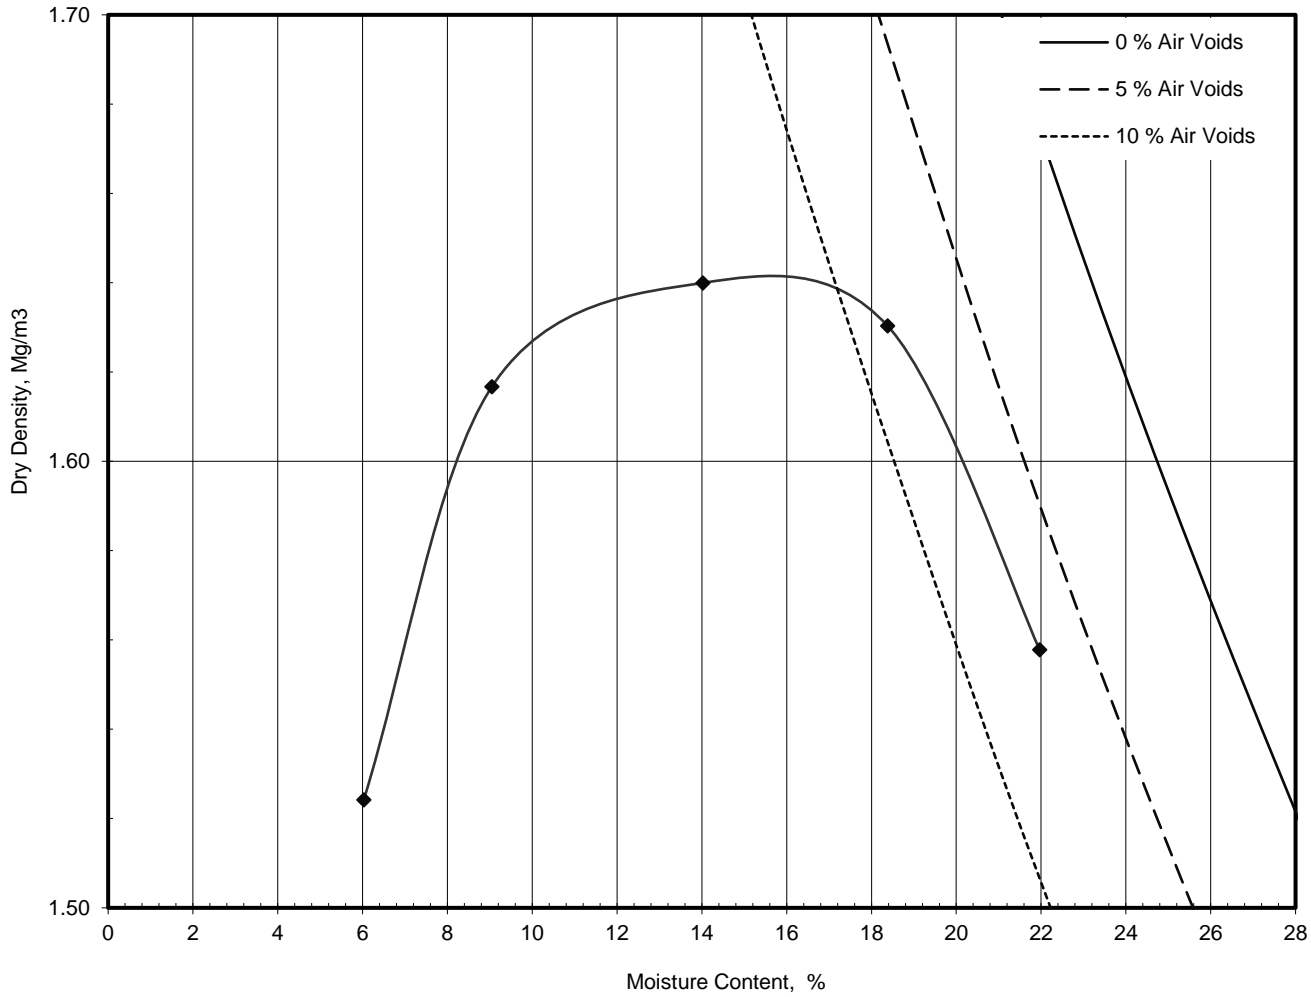
Maximum Dry Density	Mg/m³	1.64
----------------------------	-------	-------------

Optimum Moisture Content	%	16
---------------------------------	---	-----------

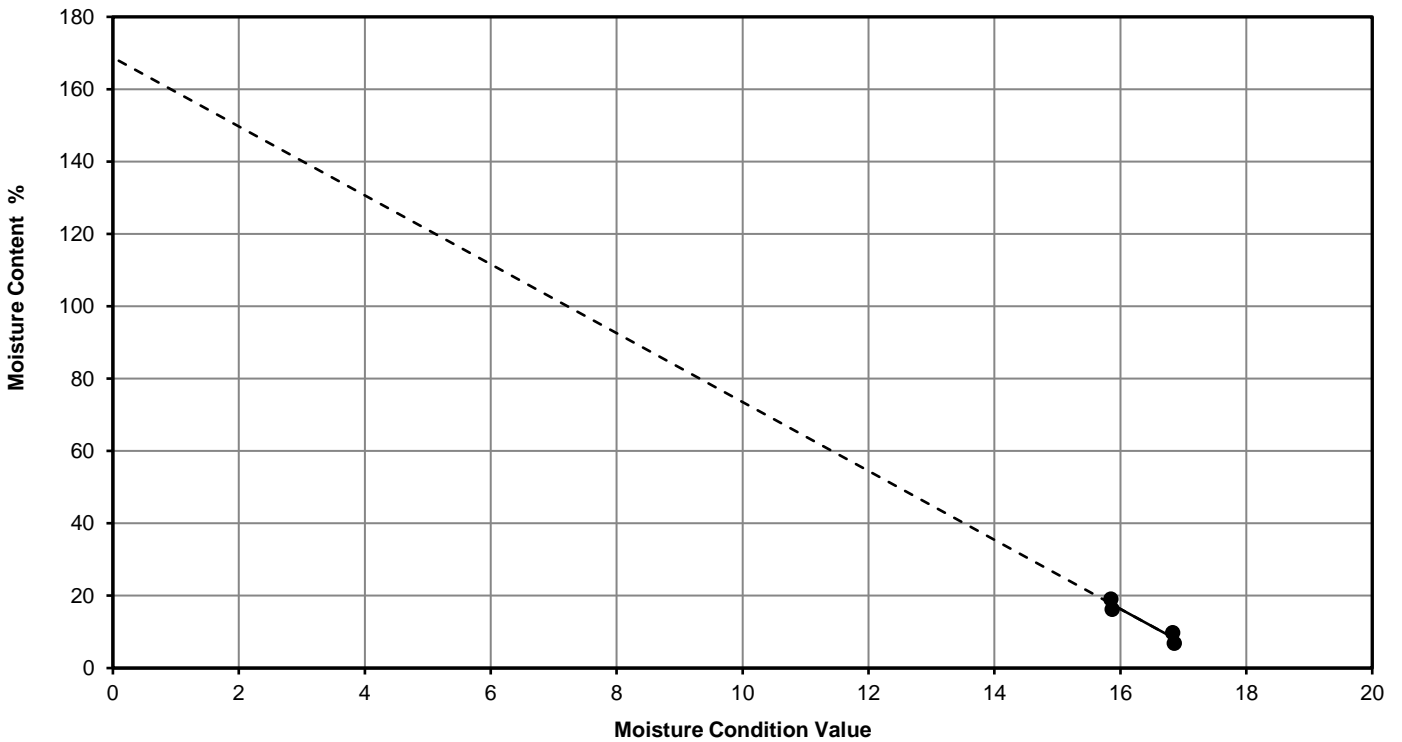
MCV Test Number	1	2	3	4	
Moisture Content, %	6.9	9.8	16.2	19.1	
Moisture Condition Value	16.9	16.8	15.9	15.8	
MCV report	16.9	16.8	15.9	15.8	
Effective / Valid data point	YES	YES	YES	YES	
Specimen remarks

Laboratory testing has indicated that the cohesive material would be classified as Class 2A (wet cohesive material), however, the classification of the clay may vary at different times of the year. The moisture content generally falls within the range PL-4 to 1.2PL, however, some areas of clay may require drying. Once the moisture is at acceptable limits (11.7-26.3%, with the maximum moisture content value being based on the average results of 1.2 times the plastic limit, and 0.5 times the liquid limit; the minimum moisture content value being based on the dry density/moisture content value tests). The re-use will be dependent upon the moisture content, onsite assessment/validation and weather conditions. At times of inclement weather, materials are likely to deteriorate quickly and achieving a lower moisture content may be difficult without the use of cement or lime stabilisation. Based on the acceptable moisture limits of 11.7-26.3% and the Moisture Condition Value (MCV) test results, it is recommended that MCVs between 12 and 21 are achieved for the re-used clay.

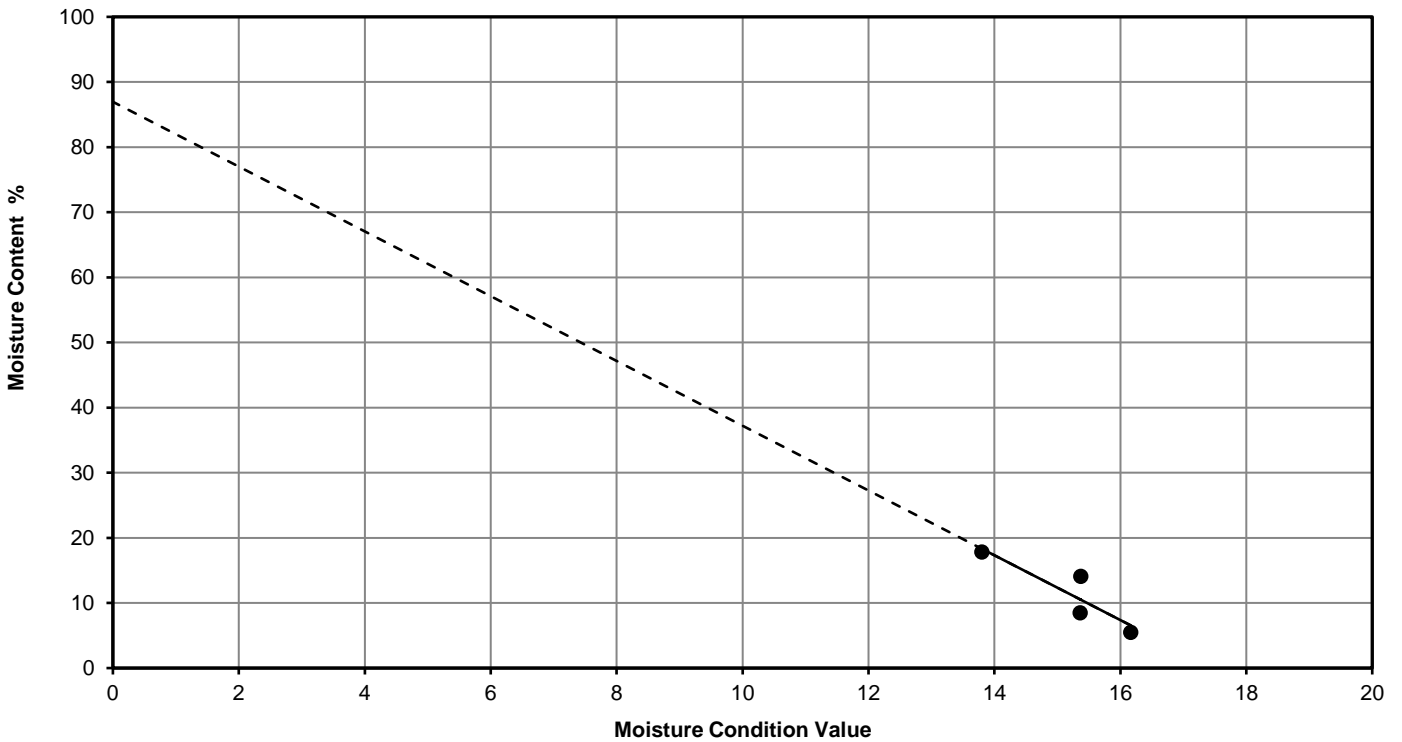
MCV Test Number	1	2	3	4	
Moisture Content, %	5.5	8.5	14.1	17.8	
Moisture Condition Value	16.2	15.4	15.4	13.8	
MCV report	16.2	15.4	15.4	13.8	
Effective / Valid data point	YES	YES	YES	YES	
Specimen remarks

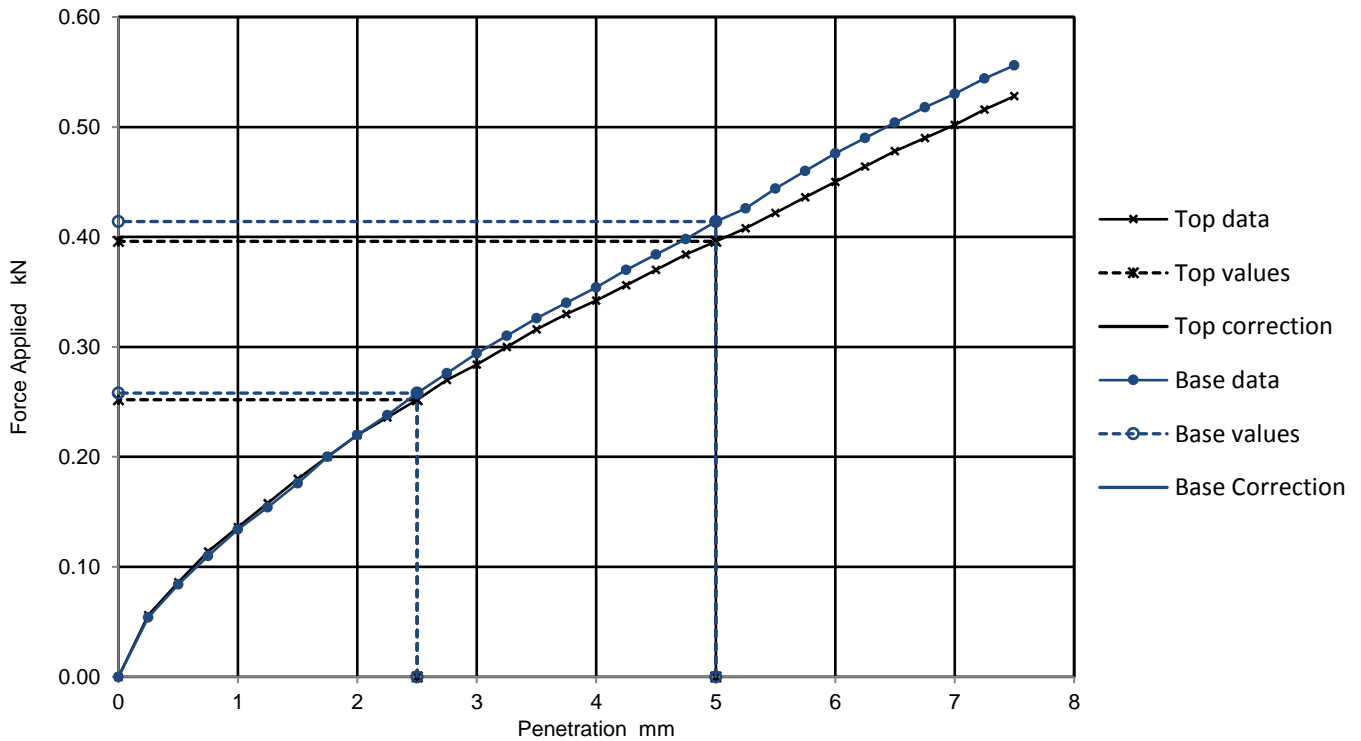
Curve correction applied	CBR Values, %				Moisture Content %
		2.5mm	5mm	Highest	Average	
TOP		1.9	2.0	2.0	2.0	35.6
BASE		2.0	2.1	2.1		34.9

Highways	A CBR of at least 2% should be achievable within natural clay.
Remediation and Preparatory Works	A remediation strategy will be required.
Recommendations for Further SI Works	Possible further testing around MBH9, to confirm that contaminated topsoil is an isolated hotspot.

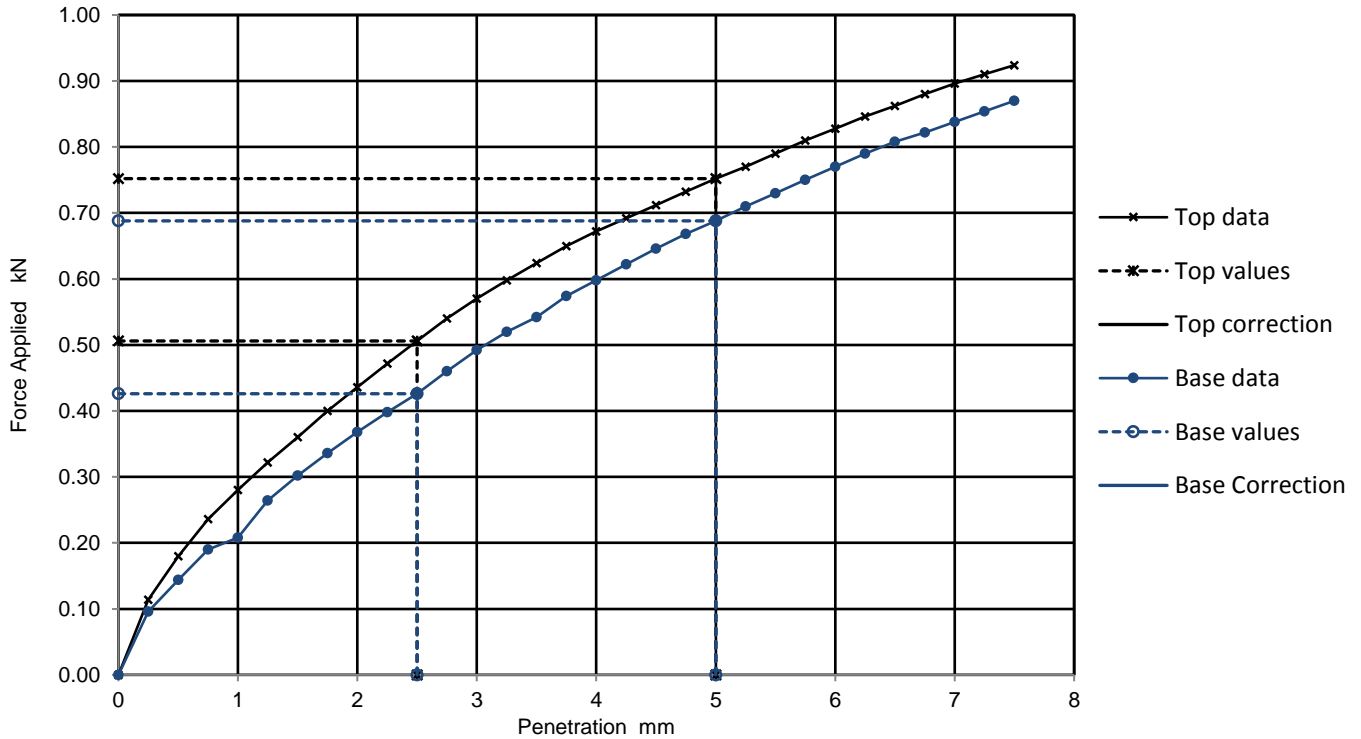
Force v Penetration Plots

Curve correction applied	CBR Values, %				Moisture Content %
	2.5mm	5mm	Highest	Average	
TOP	3.8	3.8	3.8	3.6	24.5
BASE	3.2	3.4	3.4		25.6
