PHASE 2: GROUND INVESTIGATION REPORT

GUS ROBINSON DEVELOPMENTS LTD

PROPOSED RESIDENTIAL DEVELOPMENT

GORDON HOUSE

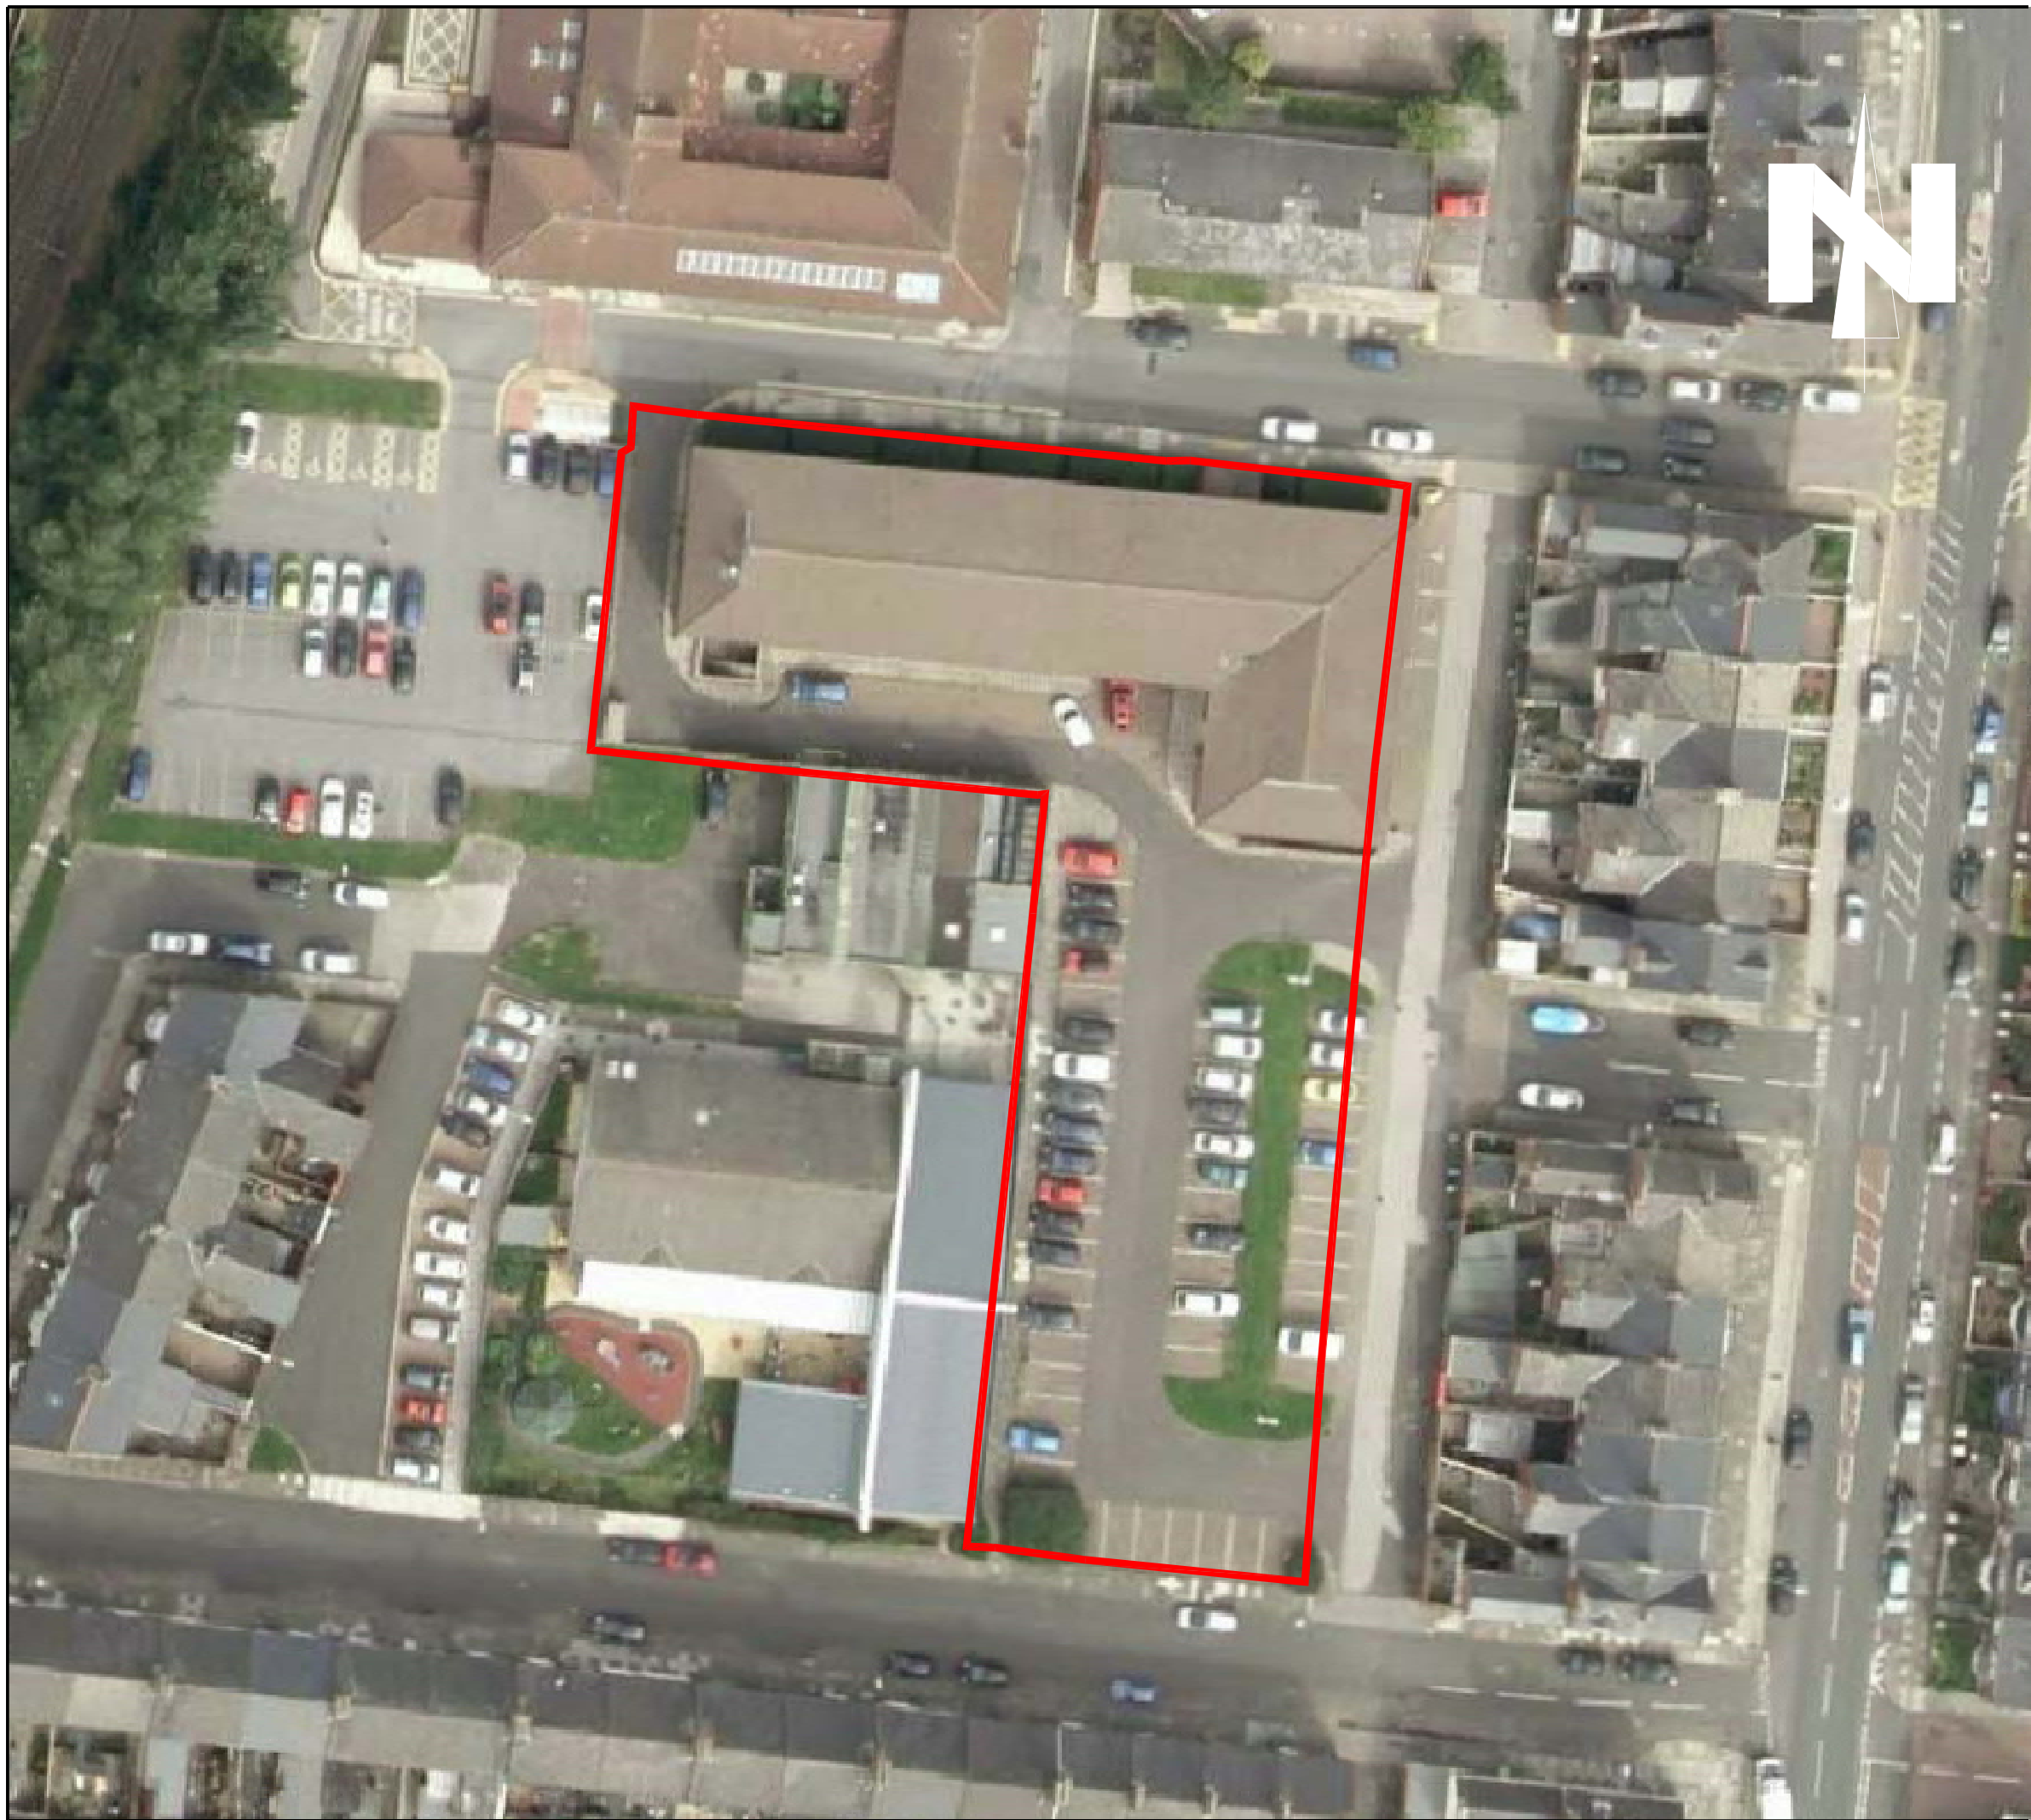
The intrusive investigation works comprised the sinking of 2 no. rotary open boreholes (labelled RBH's 1 - 2) and the sinking of 8 no. windowless sampling boreholes (labelled BH's 1 - 8) accompanied by the installation of 3 no. combined ground gas and groundwater monitoring wells, installed at the location of BH's 1, 3 & 5. The positions of the investigation locations can be seen on the Borehole Location Plan, a copy of which can be seen in Appendix II. It should be noted that this plan is for orientating purposes only, as the positions shown are approximate and the plan is not to a standard scale.
