## Arboricultural Impact Assessment

For Trees At  
Temple Park,  
South Shields

Tolent Living Ltd

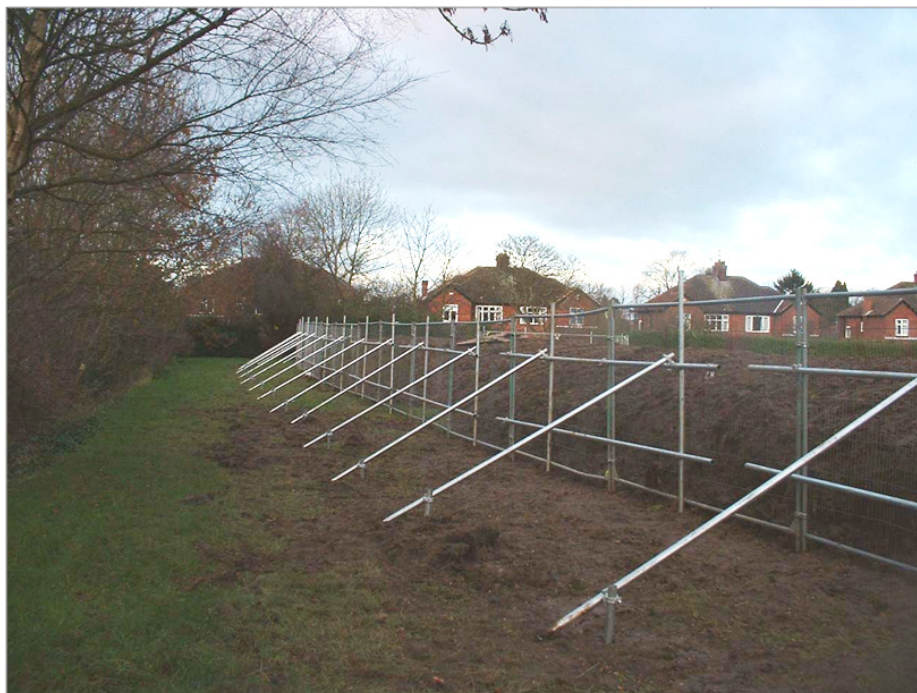
Figure 3 - Example of a barrier erected on a site

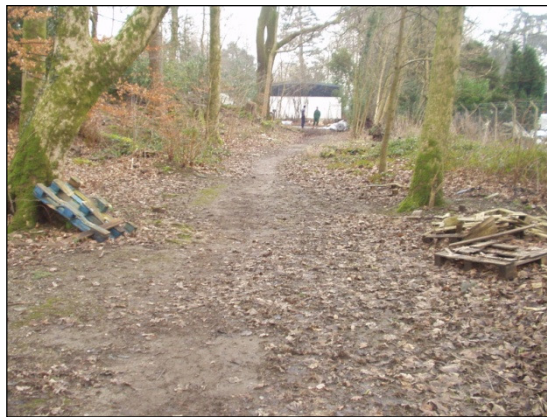
*Photo 1- line of new road prior to the commencement of works*

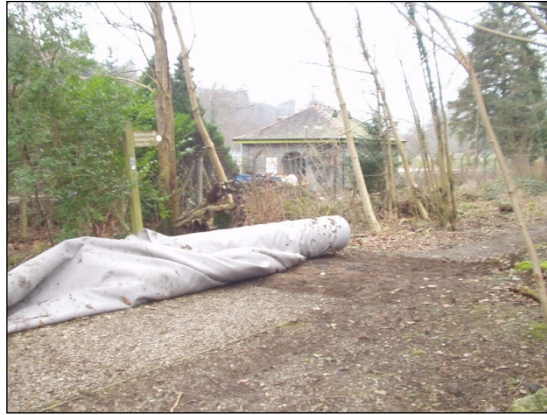
*Photo 2- laying of Fibretex material onto existing subgrade*

- 1) Lay a Treetex T300 geotextile material directly on the existing subgrade. Overlap dry joints by 300mm

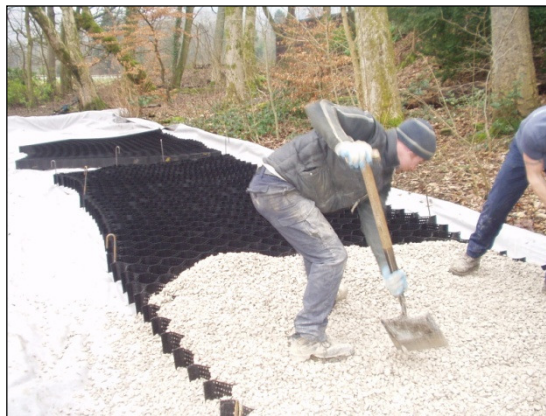
*Photo 3- expanding and filling the Cellweb system*

- 2) Lay and expand the cellular confinement system, Cellweb by Geosynthetics Ltd, and anchor open during infilling. As a general indication only, a depth of at least 100mm is required for domestic traffic up to approximately 3 tons. A 200 mm depth should accommodate vehicles up to approximately 8 tons. Footpaths and cycle ways generally require a depth of 75mm. Geosynthetics Ltd provide a free consultation, design and advisory service to help specify the exact depth and construction of the Cellweb system.

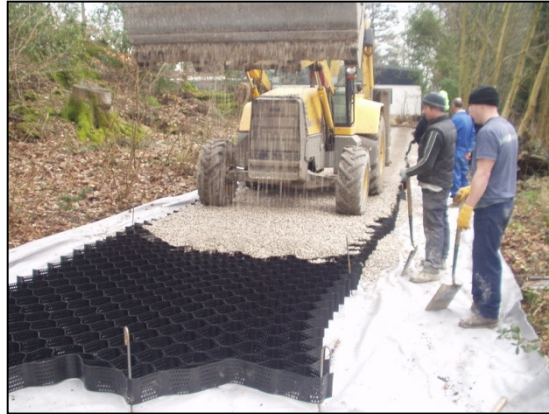
Photo 4- once filled the system can support plant to carry aggregate to the fill area

- 4) Fill the cellular confinement system with aggregate (the amount is dependent on the depth of the Cellweb employed). The aggregate should not contain any fines and be of an inert type material such as whinstone chips rather than any lime based product. The angular particle dimensions should be 20-40mm. As most urban soils are already alkaline in nature, the use of dolomite, limestone or crushed concrete is not suitable for this application as it can react with rain water with the potential to change the soil pH and form impenetrable layers which impede water movement and gaseous exchange
