# AllAboutTrees

## Arboricultural Method Statement

For Trees At  
Temple Park,  
South Shields

Tolent Living Ltd

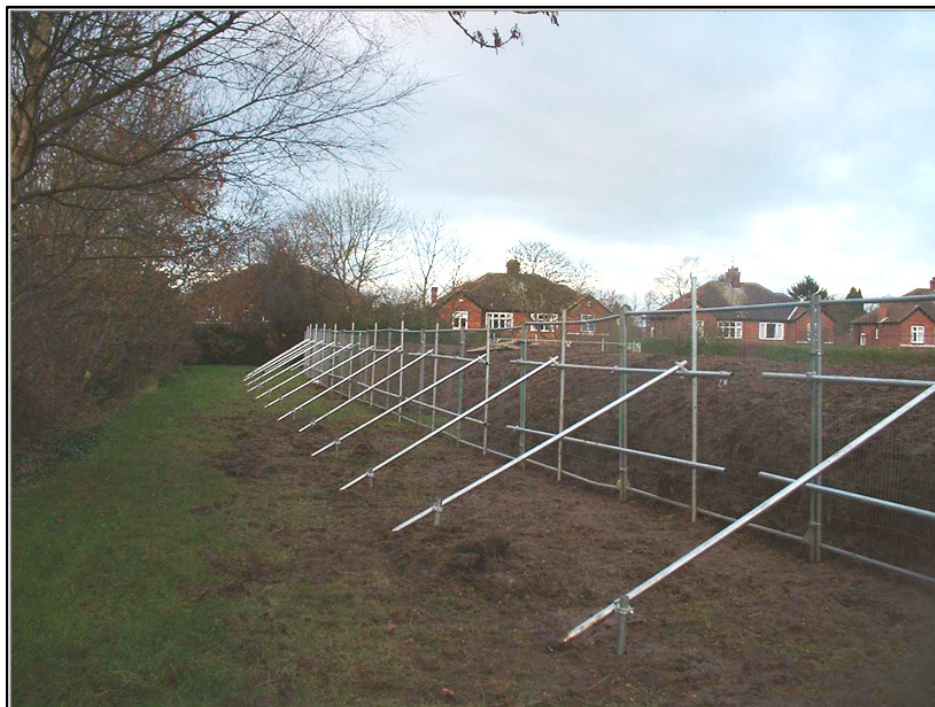
Figure 2- Example of a barrier erected on a site

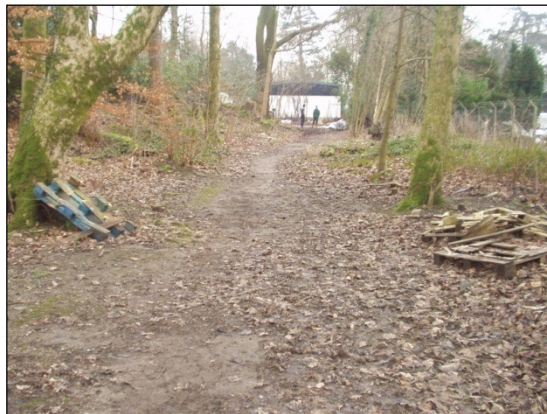
*Photo 1- line of new road prior to the commencement of works*

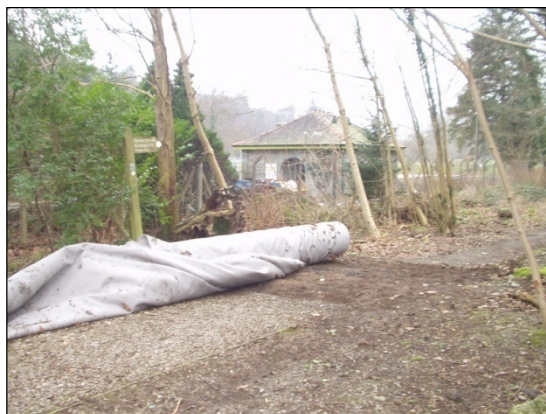
- 1) Lay a Treetex T300 geotextile material directly on the existing subgrade. Overlap dry joints by 300mm

*Photo 2- laying of Fibretex material onto existing subgrade*

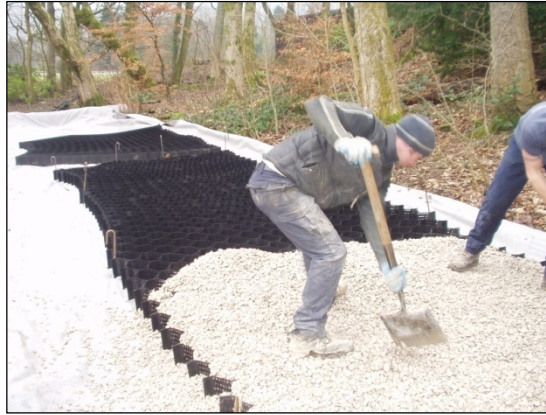
*Photo 3- expanding and filling the Cellweb system*

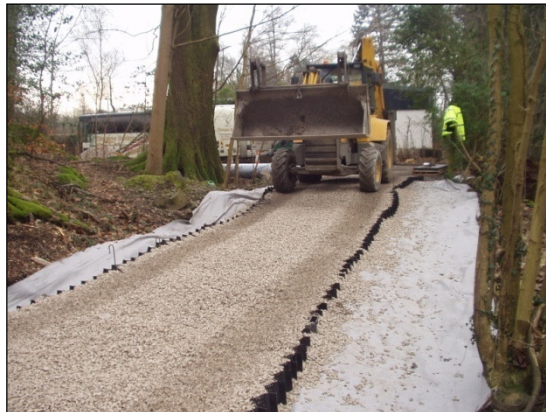
*Photo 4- once filled the system can support plant to carry aggregate to the fill area*
