PHASE 2: GROUND INVESTIGATION REPORT

PROPOSED RESIDENTIAL DEVELOPMENT

FORMER SITE OF ST. AIDAN'S CHURCH

Project No: 08-494

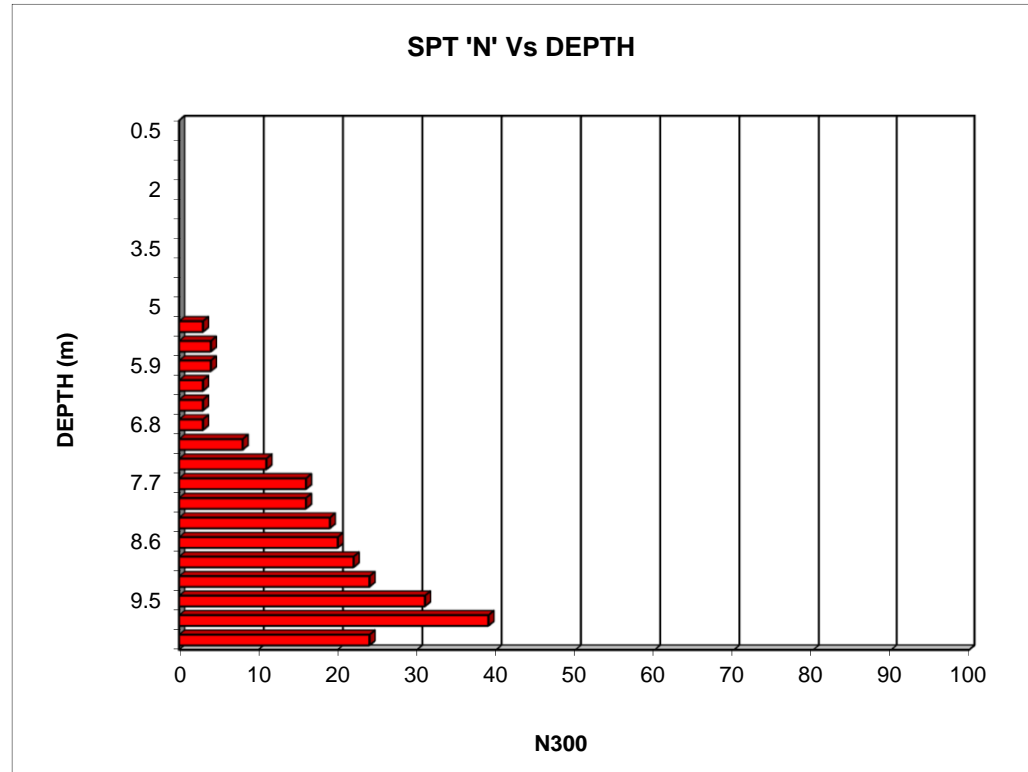
TORQUE
(N.m)

As can be seen from the results and subsequent relative density profiles the deeper drift deposits become competent between depths of c.7.00m and c.8.00m with equivalent SPT 'N' values ranging from 6 up to 16. Below these depths the underlying ground conditions become even more competent up to the terminal depth of the dynamic probes (i.e. c.10.00m bctl's) with the equivalent SPT 'N' values ranging from 19 up to 49.

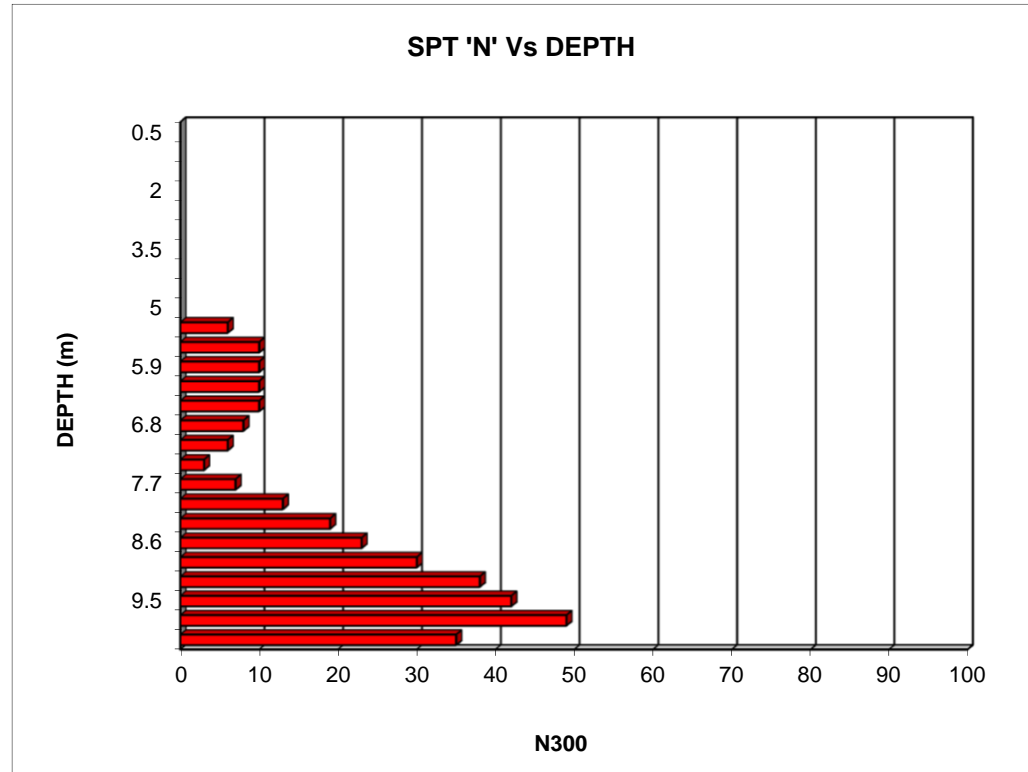
TORQUE
(N.m)

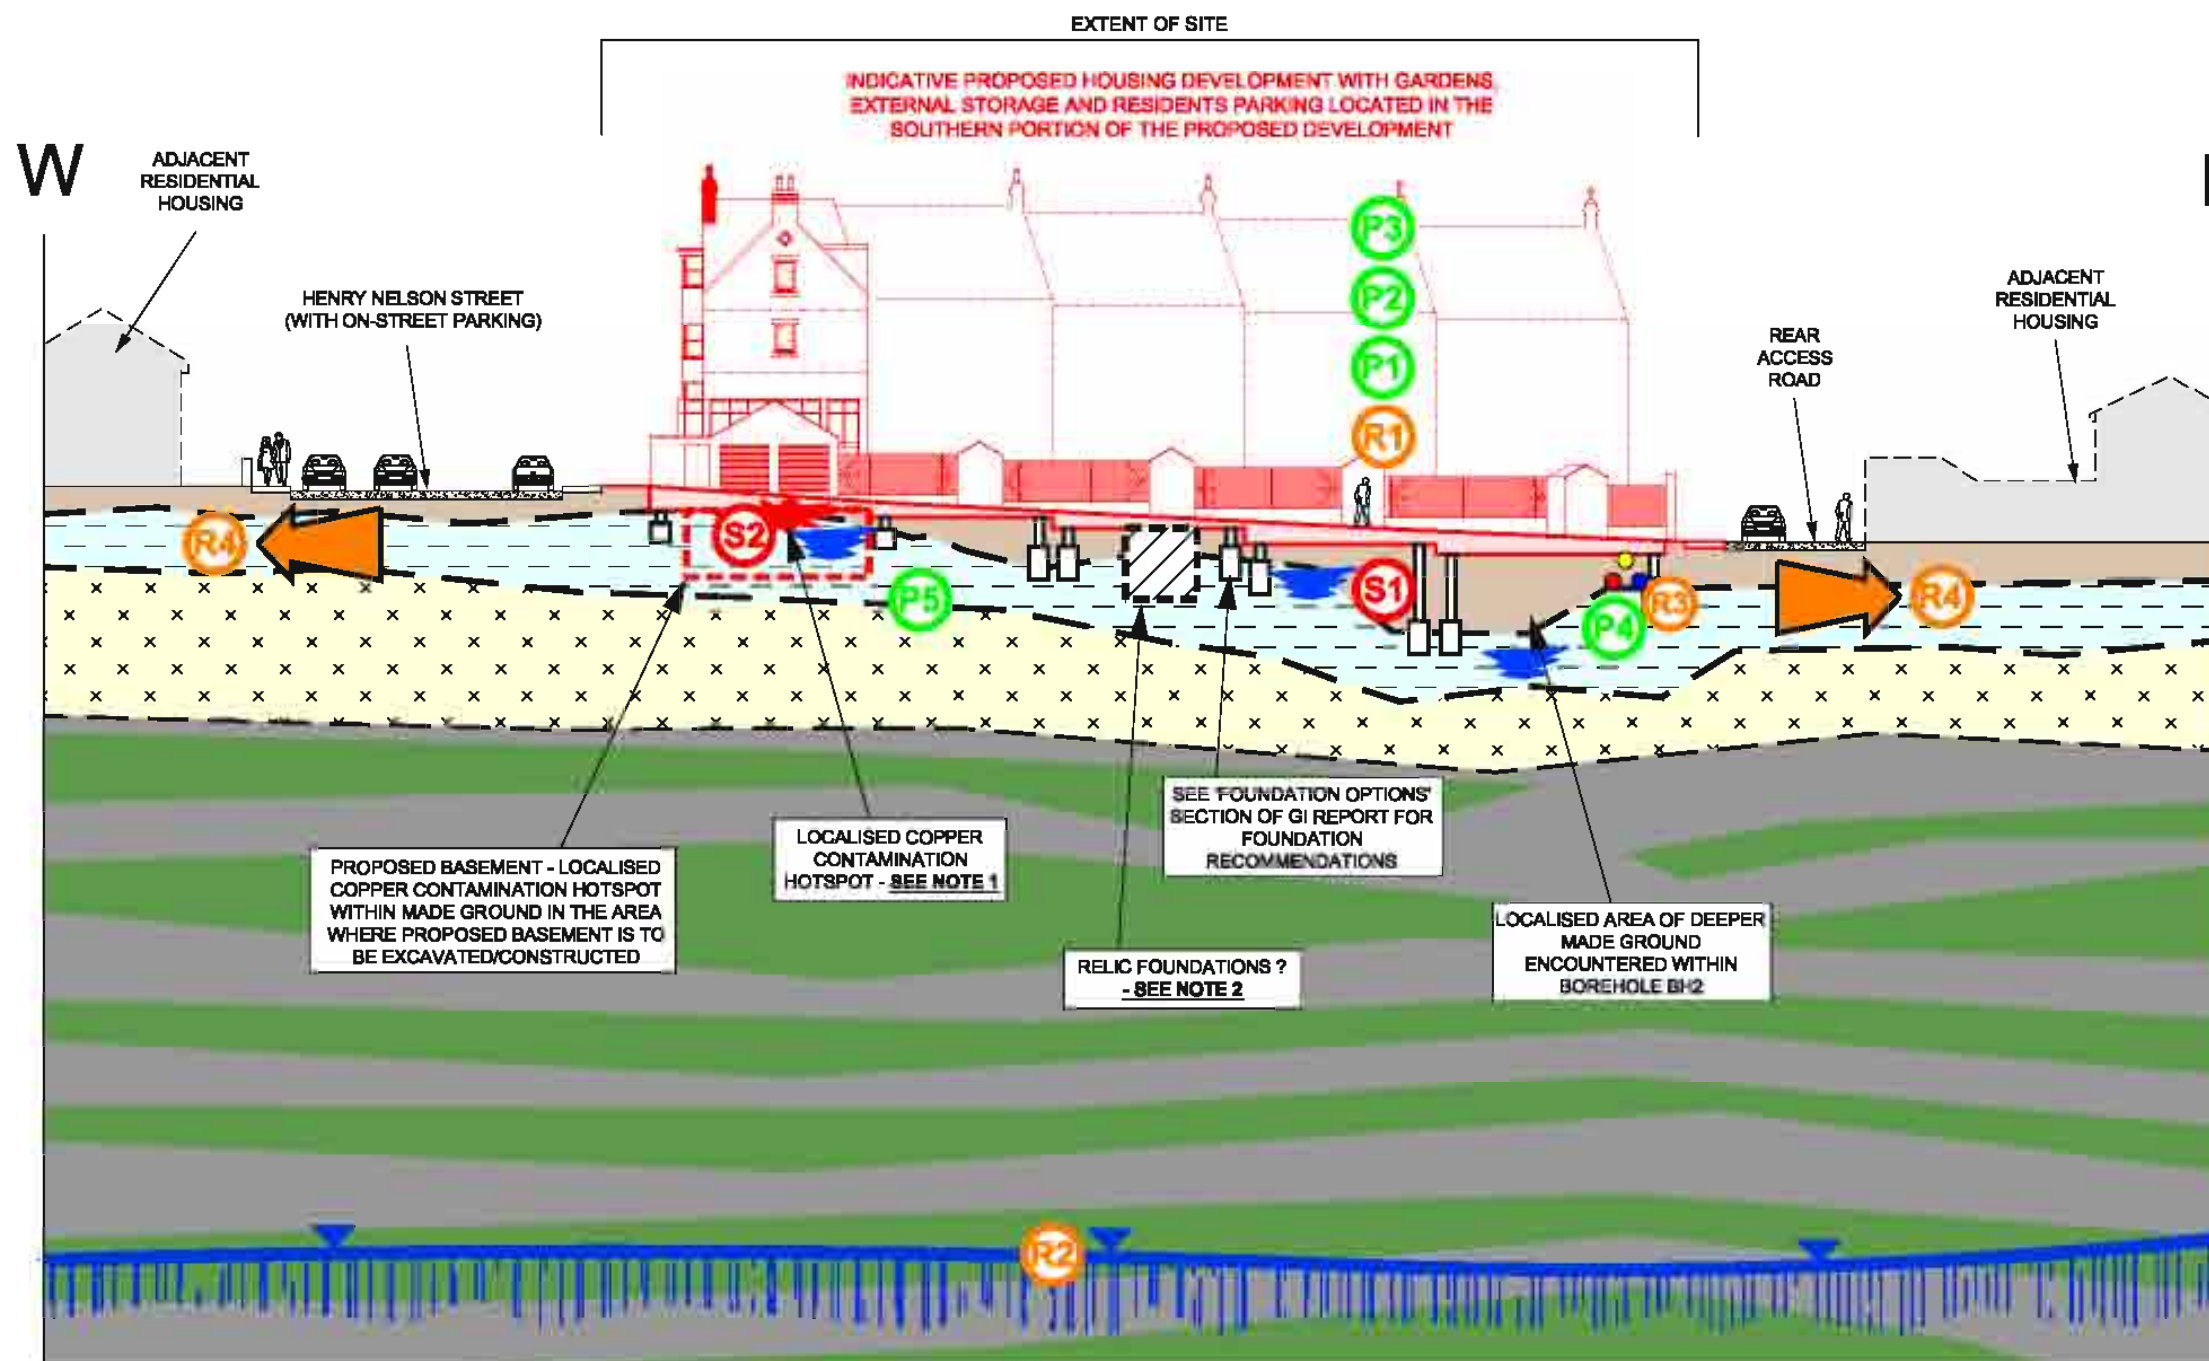
- SOURCES:**
 S1 - MADE GROUND - SEE NOTE 1
 S2 - LOCALISED COPPER CONTAMINATION HOTSPOT - SEE NOTE 1
- PATHWAYS:**
 P1 - INGESTION
 P2 - INHALATION OF INDOOR/OUTDOOR AIR
 P3 - DERMAL CONTACT
 P4 - MIGRATION THROUGH SERVICES
 P5 - POTENTIAL LEACHING OF CONTAMINANTS - SEE NOTE 1
- RECEPTORS:**
 R1 - HUMAN HEALTH (END USERS)
 R2 - GROUNDWATER (MINOR AQUIFER)
 R3 - PROPOSED BUILDING MATERIALS - FLOOR SLABS, FOUNDATIONS AND BURIED SERVICES
 R4 - ADJACENT SITES

- MADE GROUND
- GRAVELLY SANDY CLAY
- SILTY SAND/GRAVELLY SILTY SAND
- CARBONIFEROUS MIDDLE COAL MEASURES (MCM) (MUDROCKS RECORDED AT ROCKHEAD)

- GROUNDWATER (MINOR AQUIFER) - ANTICIPATED TO BE PRESENT AT DEPTH WITHIN THE SOLID GEOLOGY
- POCKETS OF TRAPPED/PERCHED SURFACE WATER
- LOCALISED COPPER CONTAMINATION 'HOT-SPOT'

PROPOSED BASEMENT - LOCALISED COPPER CONTAMINATION HOTSPOT WITHIN MADE GROUND IN THE AREA WHERE PROPOSED BASEMENT IS TO BE EXCAVATED/CONSTRUCTED

LOCALISED COPPER CONTAMINATION HOTSPOT - SEE NOTE 1

RELIC FOUNDATIONS ? - SEE NOTE 2

Following the completion of the contamination screening a representative schematic cross section indicating the ground profile used for the Conceptual Site Model (CSM) can be found in Appendix IV. This model summarises the Conceptual Exposure Model (CEM) for this particular site post construction, assuming no remediation, additional protection or removal of the source contamination takes place.
