## Arboricultural Method Statement

19 West Meadows Road,

Cleadow

Mrs A Mulholland

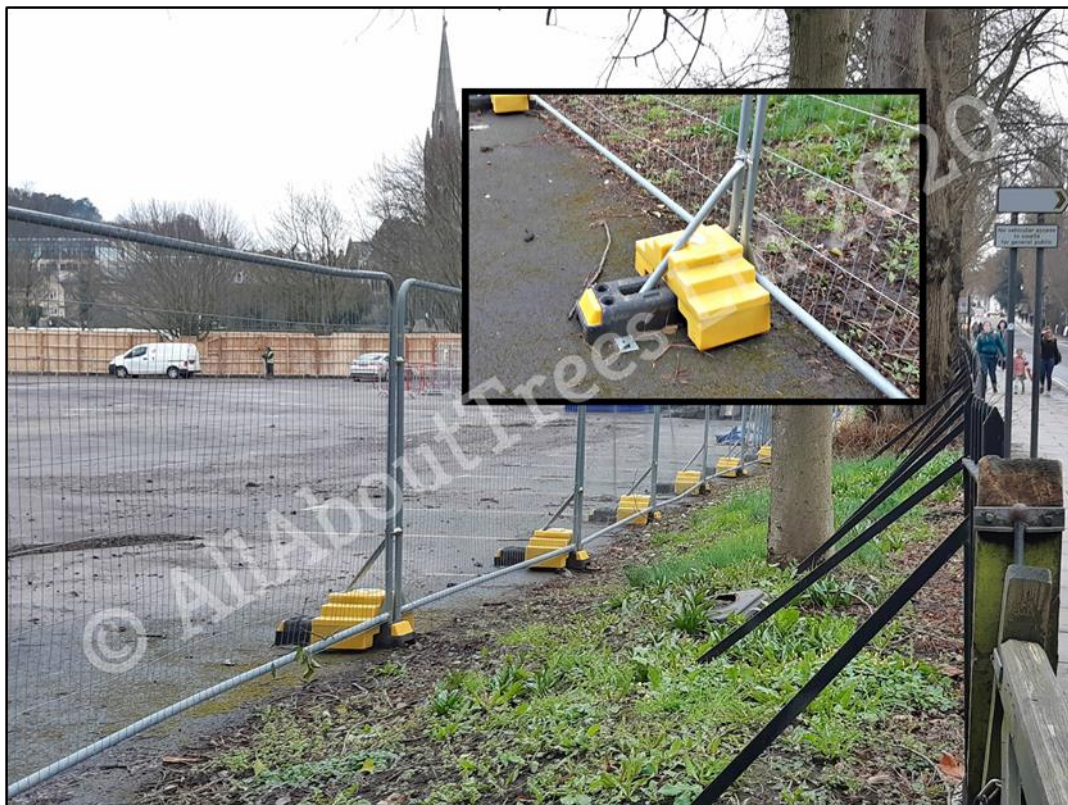
Figure 2 – An example of a barrier erected on a site

3.3.4 The barrier should consist of proprietary 2m tall welded mesh panels mounted on rubber or concrete feet. The panels must be joined together with a minimum of two anti-tamper couplings situated at least 1m vertically apart and installed uniformly throughout the barrier so that they can only be removed from inside the barrier. The panels must be supported by stabilising struts mounted on a block tray.

3.3.6 All types of barriers must be firmly attached to prevent movement by site personnel or vehicles and all-weather signs with the wording "Construction exclusion zone- keep out" should be attached.
