**BAT SURVEY & RISK ASSESSMENT
FOR 19 WEST MEADOWS ROAD
CLEADON**

Veronica Howard, BSc (Hons), PhD, MCIEEM
February 2022

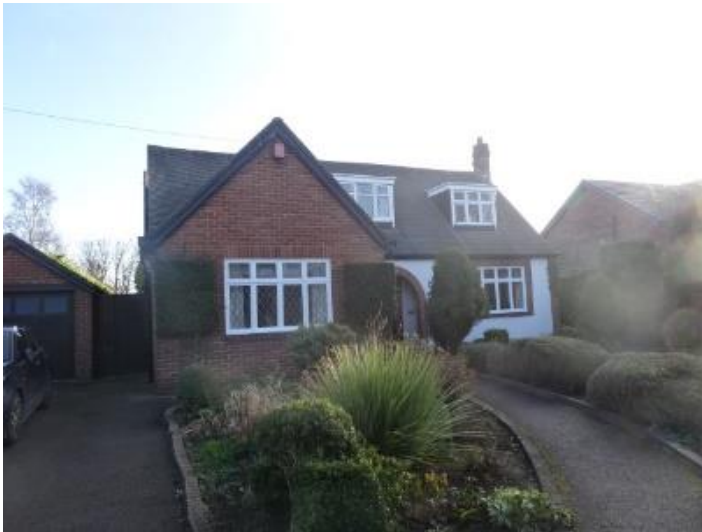
- 1.3 The property is a brick-built dormer bungalow with a pitched tile roof. Part of the front elevation has rendered walls. There is a detached garage to one side of the property and a conservatory abutting onto the rear elevation.
- 1.4 The bungalow, garage and conservatory are in a very good state of repair as regards their potential to support a bat roost. No cracks or crevices were found in the walls or at the wall tops nor beneath the roofing tiles or barge boards. The windows and doors are modern and well fitted with no gaps around the frames.

Front elevation

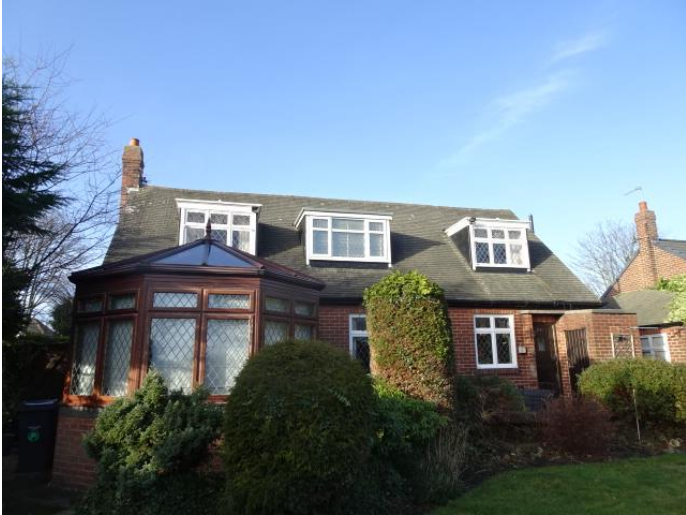
Rear elevation

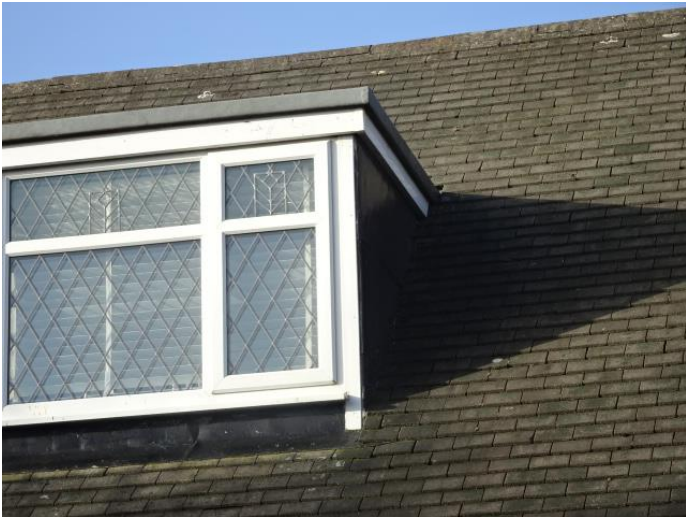
Roof and dormer window

2.3.2 No potential roost sites were found as there are no cracks or crevices in the exterior walls or at the wall tops or behind the barge boards. No gaps could be seen under the roof tiles or at the roof edges.

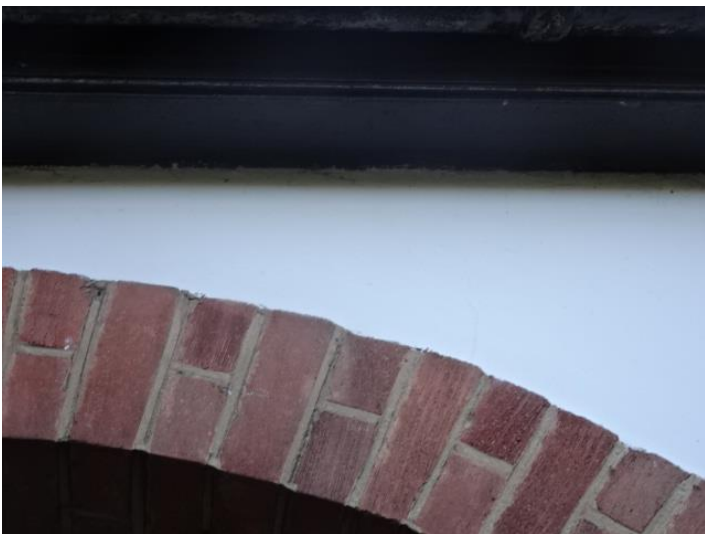
Wall top - sealed

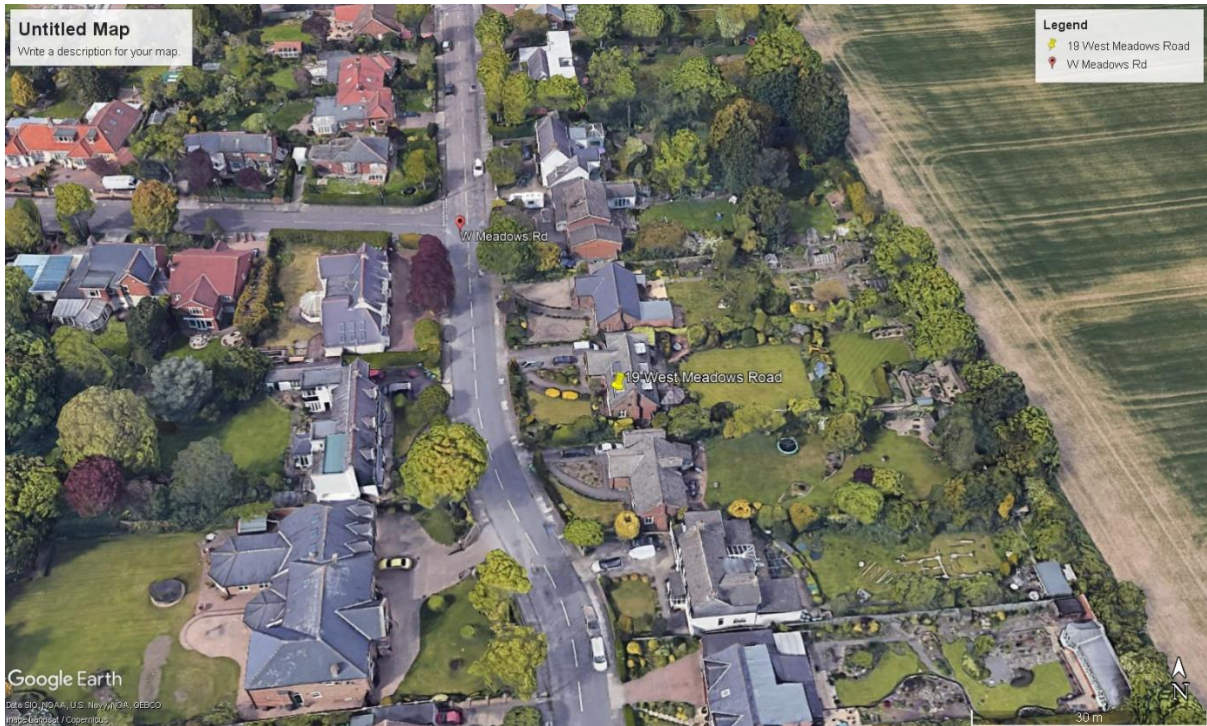
Surrounding Habitat (See aerial photo above)

- 1.5 There are gardens to the front and rear of the bungalow, mainly laid to lawn with a number of trees on the east boundary and further trees in the grounds of other properties and on the roadsides. There is arable land to the east of the property, a local road to the west and further houses to the north and south.
