**Bat Risk Assessment Survey of:**

44 Kirskstone Ave  
Jarrow  
NE32 4ER

**Report Ref:** McKenzie\_KirkstoneAvenue\_Bat1.1

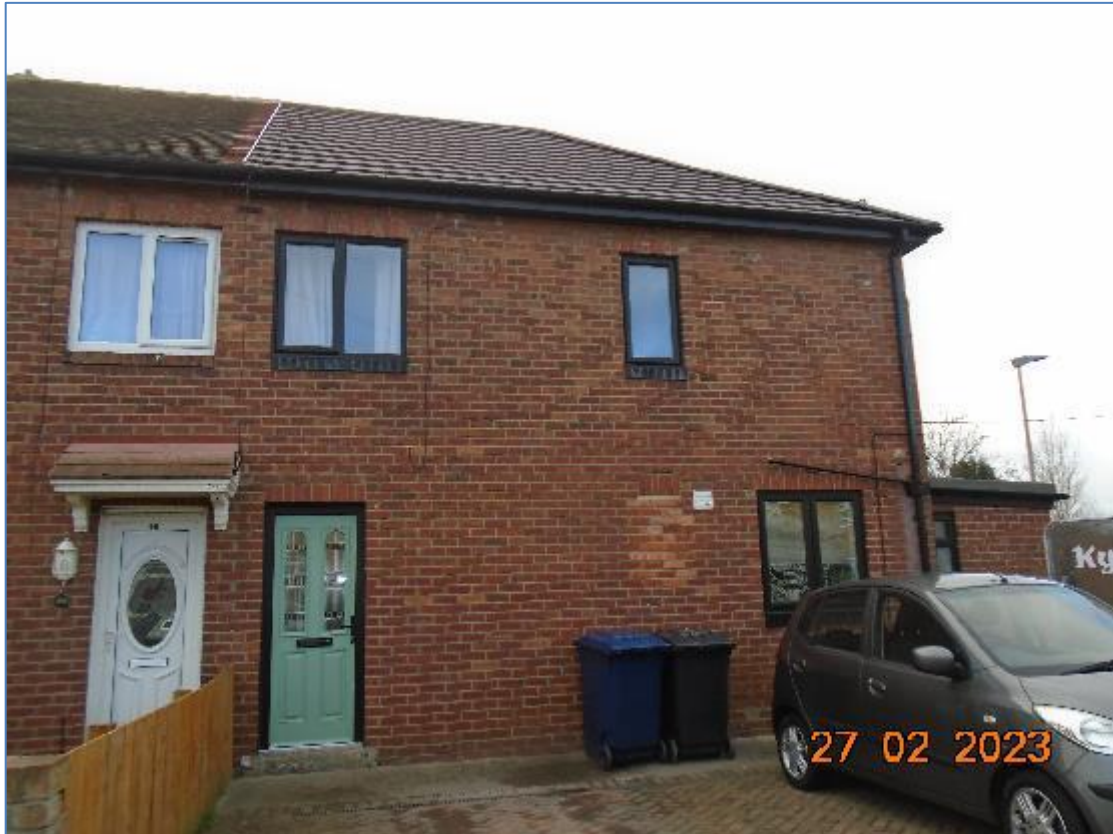
**Photograph 1 – Front (north-east) elevation of the property.**

3.4.1 The property is a semi-detached two storey brick-built dwelling, with a hipped tiled roof. (Photographs 1 - 3). Two velux windows are present within the main roof. A single storey extension with a shallow pitched felt roof is present on the side (north-west) elevation (Photograph 4). The client confirmed that the property has very recently been re-roofed, to include new tiles, lining, verges, soffits and fascias. The tiles and verges of the main roof were intact, with no

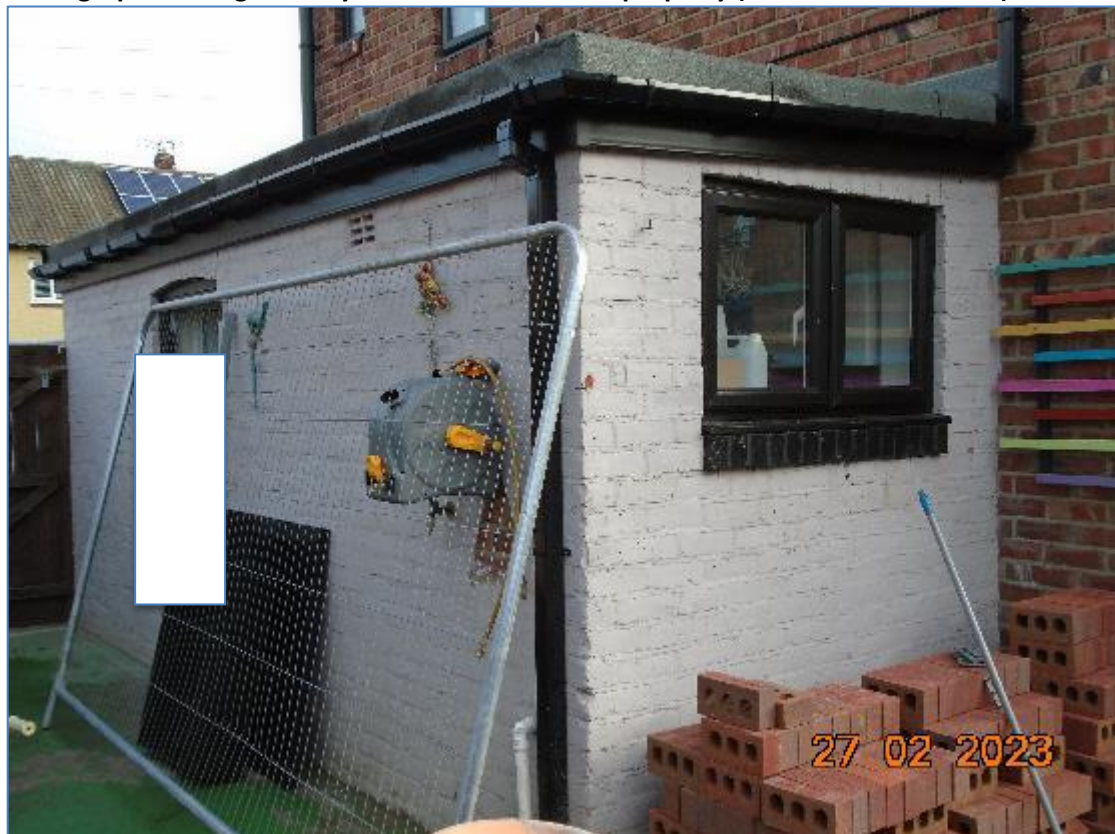
**Photograph 4 – Single storey side extension to the property (north-west elevation).**

gaps noted. The uPVC soffits and fascias of the both the main dwelling and side extension site sits flush with the supporting walls (Photograph 5). The felt roof of the single storey side extension was intact with no ripped, missing or raised sections noted. The brickwork of the property is in generally good condition with no significant mortar gaps noted. The windows and doors are all uPVC framed and are sealed well to the supporting walls.

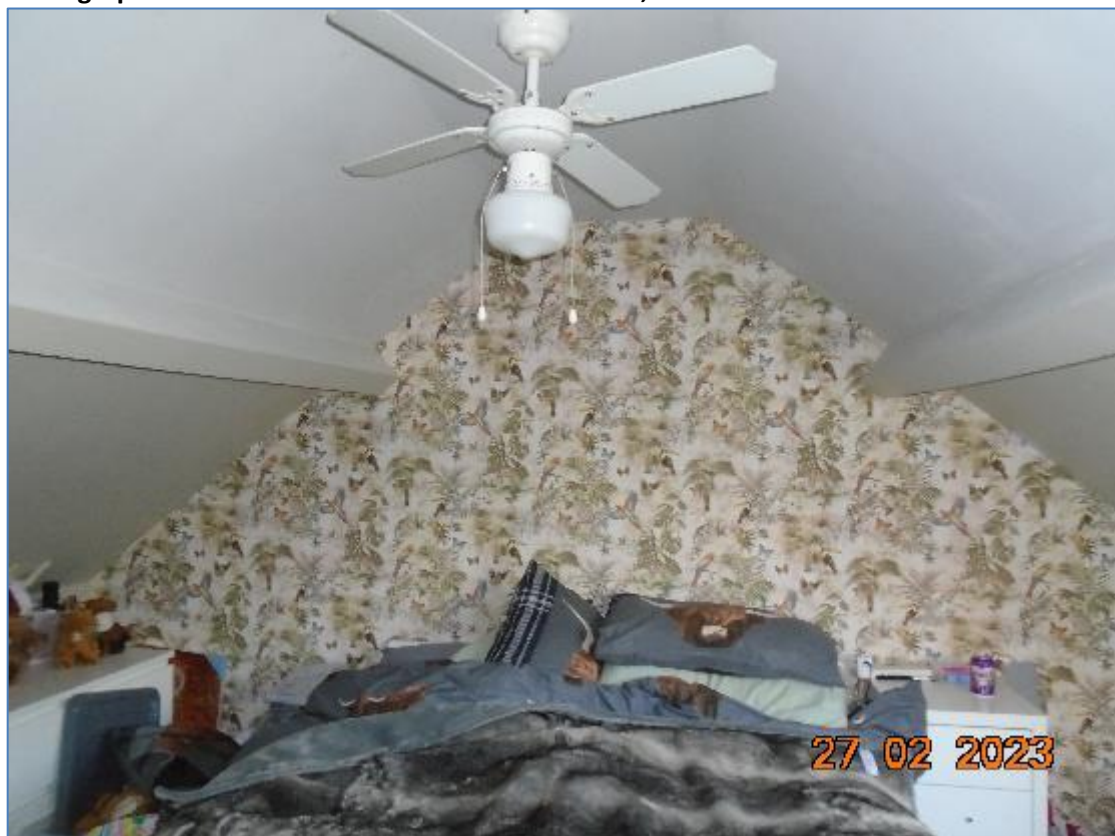
**Photograph 6 – Interior view of the former roof void, now converted for habitable use.**

3.4.2 Internally the entire roof void has been converted to create habitable space (Photograph 6).
