## THE BARNES INSTITUTE SR6 7BY PHASE 1 WINDOW REPLACEMENT

### Barnes Institute

G. F. bay sliding sash centre and end frame elevations

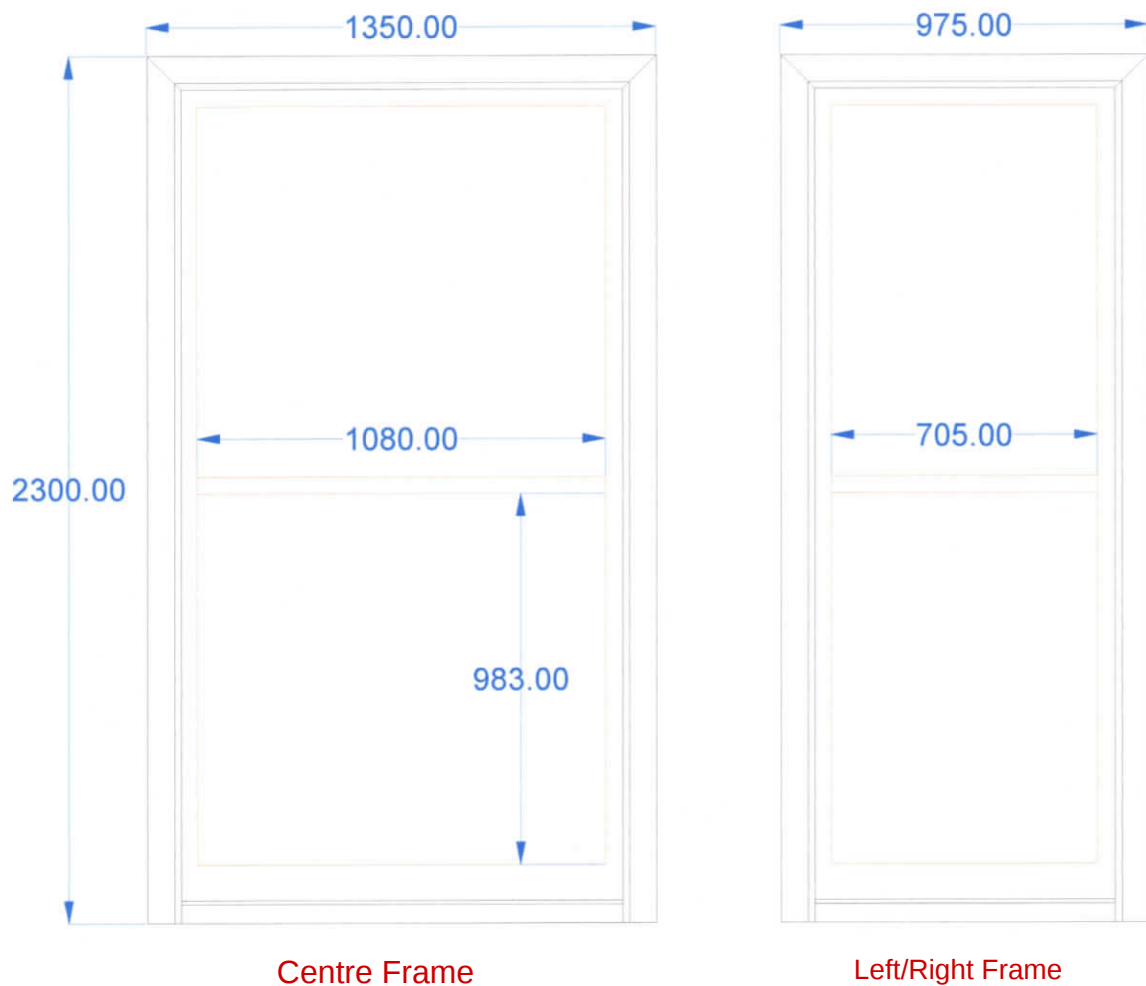
# 2a

Detail in black showing existing box sash lining.

Detail in brown showing new sliding sashes and glass sizes.

- 2a. An integrated two-storey 3-frame bay window on the ground floor;  
1 centre frame and 2 side frames, 1 left and 1 right;
