## THE BARNES INSTITUTE SR6 7BY PHASE 1 WINDOW REPLACEMENT

### Barnes Institute

F. F. Front sliding sash office and store elevations.

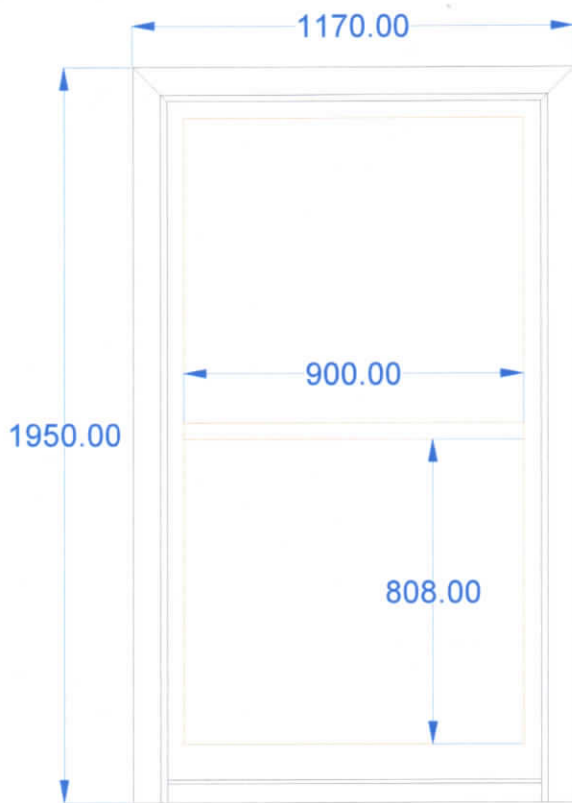
Office

Detail in black showing existing box sash lining.

Detail in brown showing new sliding sashes and glass sizes.
