## THE BARNES INSTITUTE SR6 7BY PHASE 2 WINDOW REPLACEMENT

### Barnes Institute

G. F. Side sliding sash elevations.

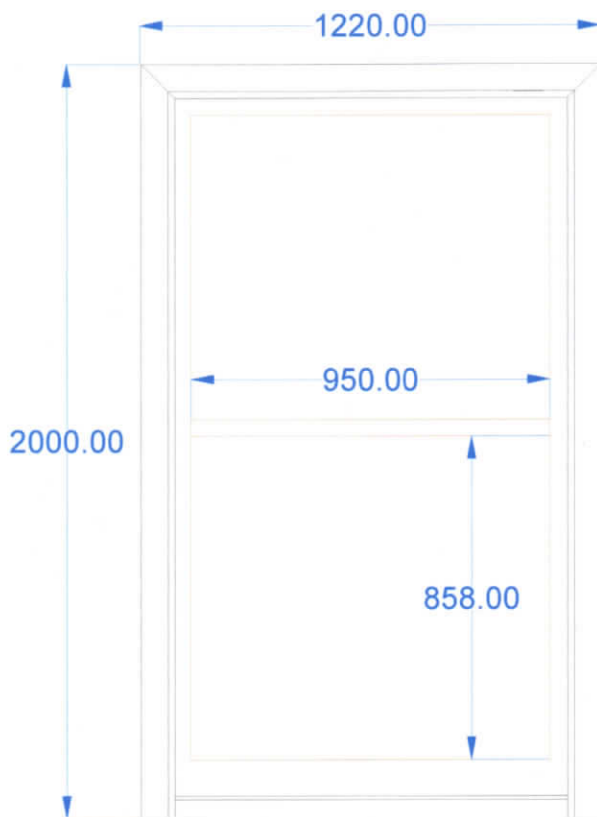
3 large (5a)

Detail in black showing existing box sash lining.

Detail in brown showing new sliding sashes and glass sizes.

5. Seven blocked-up ground floor windows to be replaced on the south face of the building, 3 large (5a), 5 small (5b).
