## South Tyneside College

### S278 Road Safety Audit Designers Response

| Reference | S278 Road Safety Audit Designers Response<br>24185 - TA |

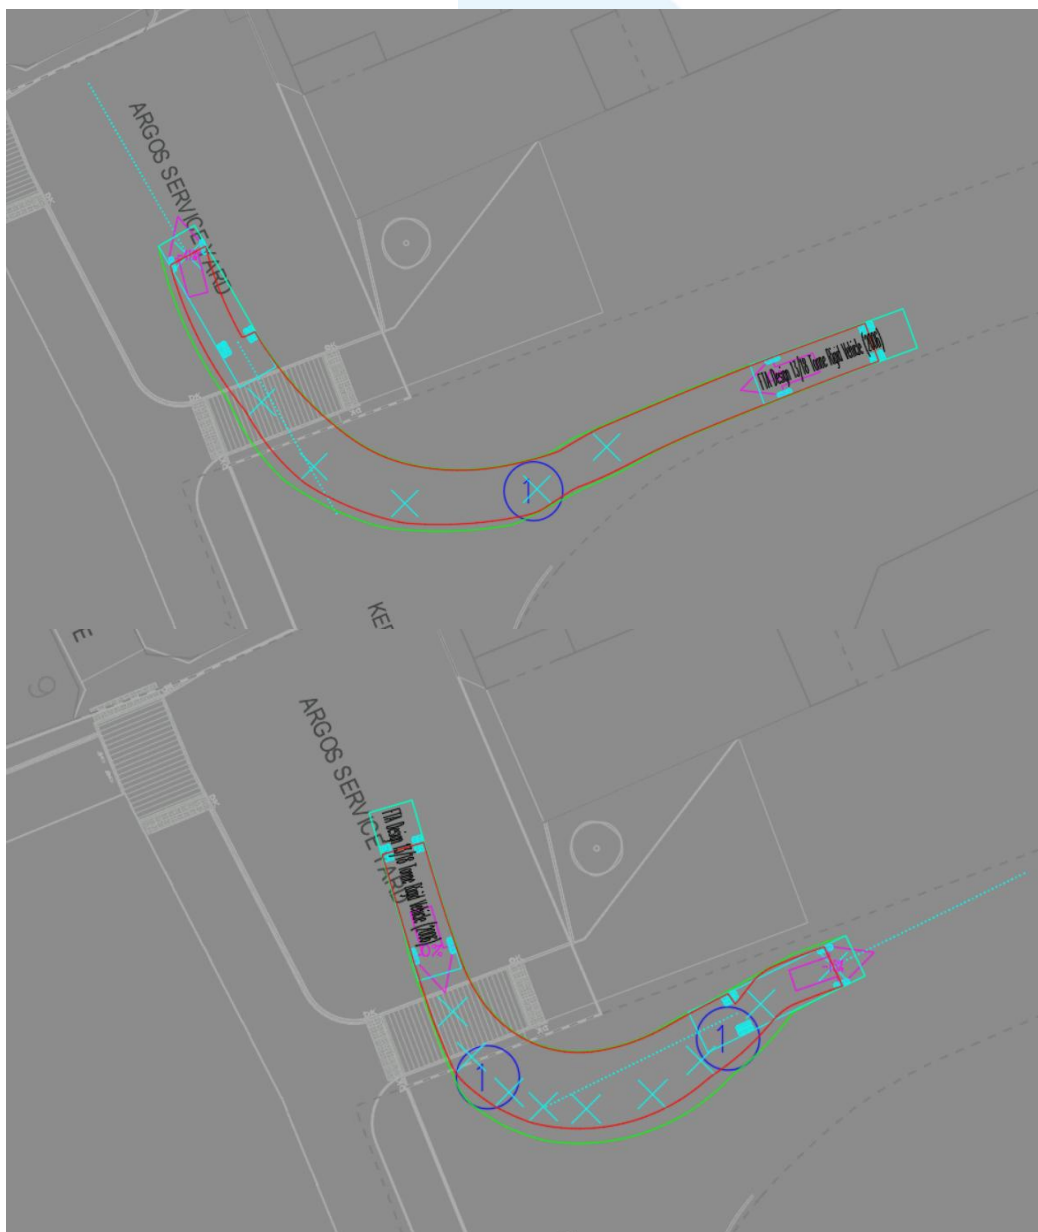
Figure 1 – Argos Service Yard Swept Path Analysis

FTA Design 13/18 Tonne Rigid Vehicle (2006)  
Overall Length 10.000m  
Overall Width 2.550m  
Overall Body Height 3.645m  
Min Body Ground Clearance 0.440m  
Track Width 2.470m  
Lock to lock time 3.00s  
Kerb to Kerb Turning Radius 11.000m

Figure 1 shows a 18 tonne vehicles movements into and from the service yard. The paths shows that a radii on the junction is not required in this instance.

### 2.1 ZONE 1 ARGOS SERVICE YARD SWEEP PATH

Problems 2.1.1, 2.1.2

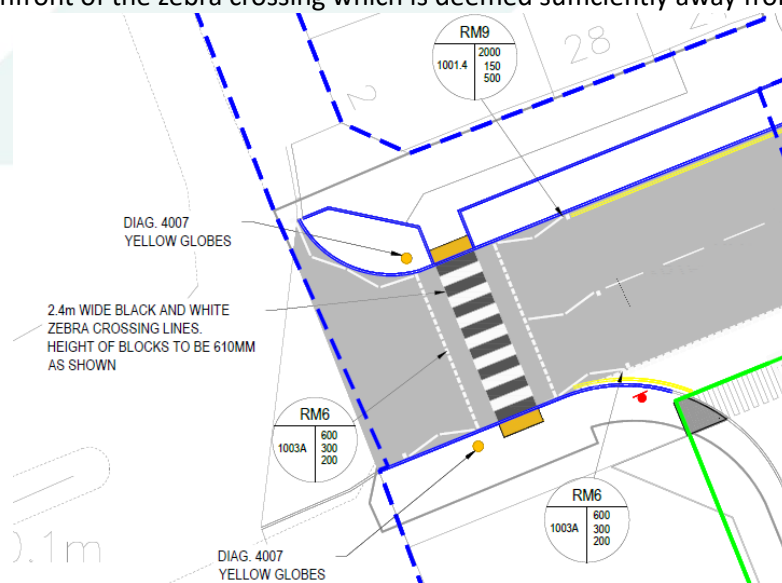
Figure 2 – Zebra Crossing

Following the Stage 1 & 2 recommendations, LTN1/95 Appendix C Option Assessment, and Traffic Signs Regulations and General Directions Chapter 6 14. Option assessment have been reviewed and a Zebra Crossing has been implemented on the junction within Chapter Row. The blister paving is in accordance with the Department of Transport, 'Guidance on the Use of Tactile Paving Surfaces' with 800mm present in front of the zebra crossing which is deemed sufficiently away from the junction.
