# **PHASE I PRELIMINARY CONTAMINATION RISK ASSESSMENT**

**LAND AT GARWOOD STREET, SOUTH SHIELDS,  
SOUTH TYNESIDE, NE33 5AG**

**PREPARED FOR SOUTH TYNE BUILDING SUPPLIES LIMITED**

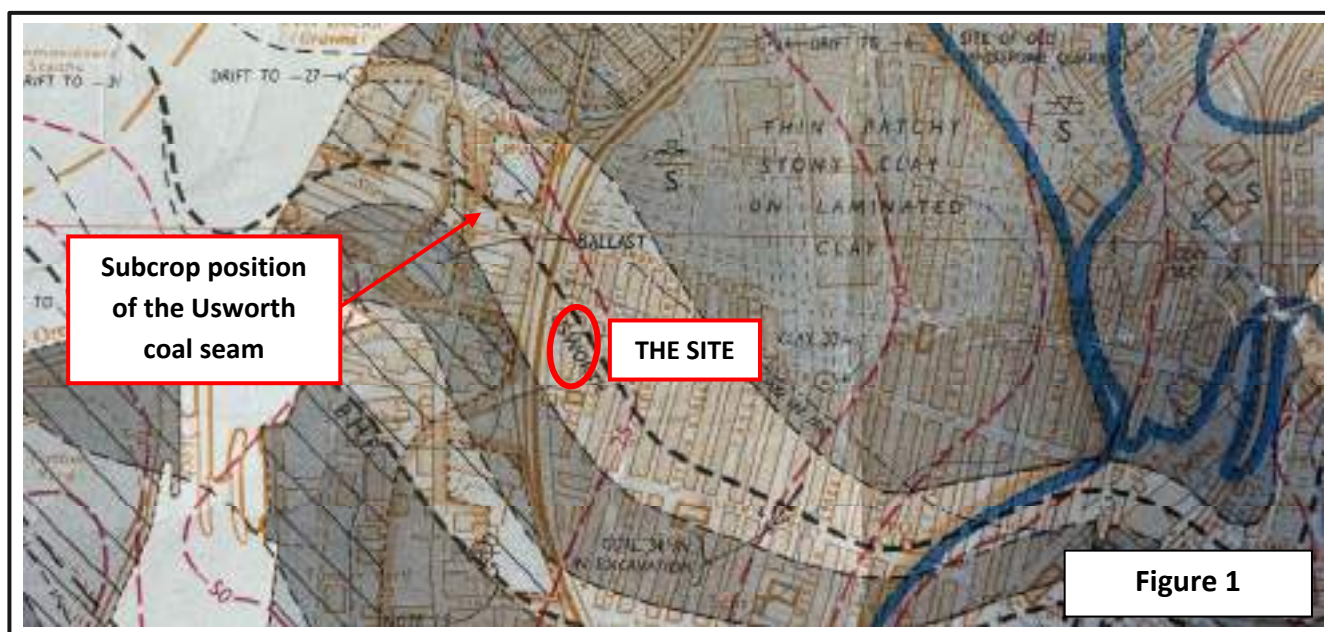
For illustration purposes, an extract of BGS Sheet NZ36NE, 1:10,560 scale can be seen in Figure 1 below.

Based on the expected site geology, there are 5 no. coal seams above the shallowest recoded workings, with the Usworth coal seam being the shallowest and subcropping beneath the site with a seam thickness of 0.55m. Based on the Generalised Vertical Section, the second shallowest seam beneath the site (Top Ryhope Five-Quarter) would be anticipated to be c.122m below the Usworth coal. An archive BGS borehole records a 0.50m thick coal seam at c.15.50m below ground level that remained intact. Data obtained directly from the Coal Authority, along with BGS mapping and historical borehole logs, indicate that if there are unrecorded workings present within the Usworth coal seam, which subcrops beneath the site at an estimated depth of between 15m and 20m below site levels, the 10t criterion would not be met for the site. The overall risk is considered to be MEDIUM, therefore, to fully assess the extent of the risk posed by the Usworth coal seam beneath the site, confirmatory deep rotary boreholes will be required.

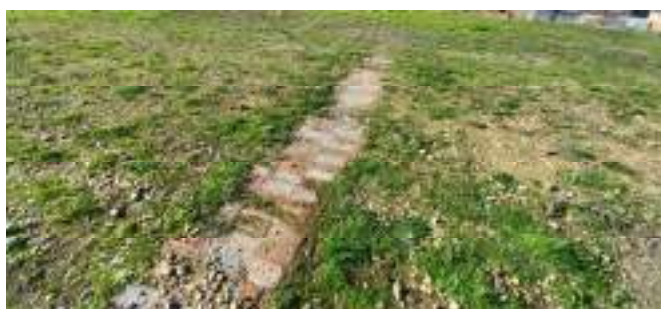
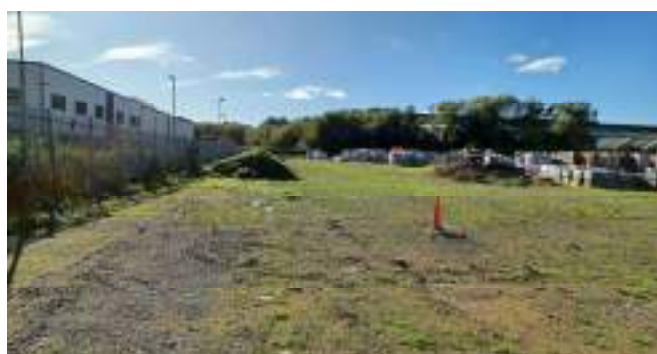
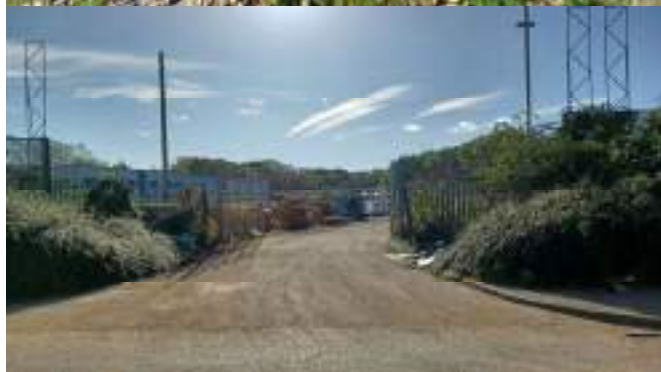
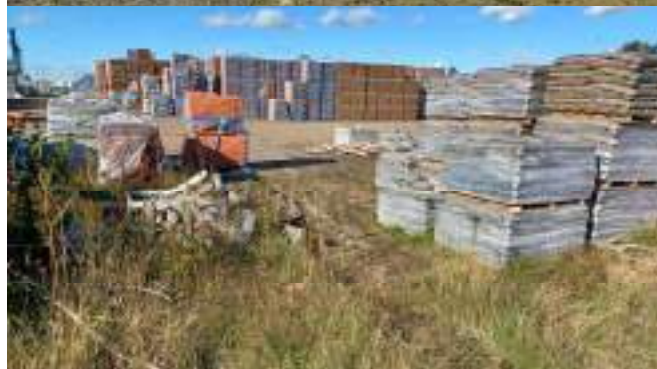
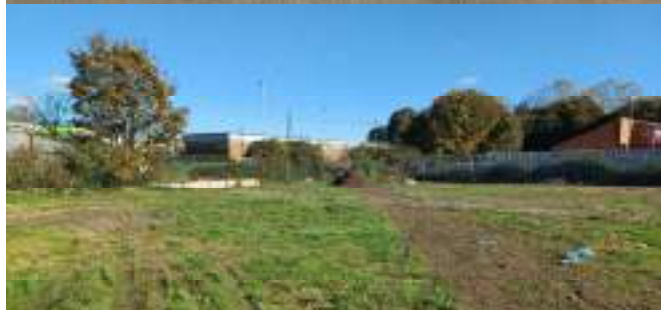
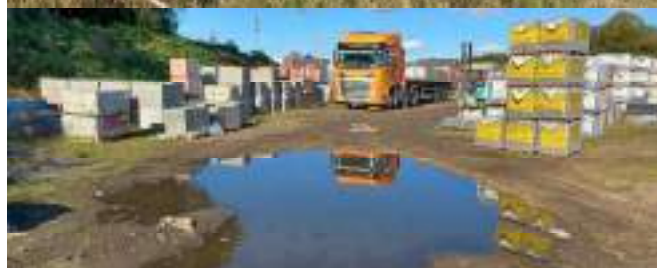
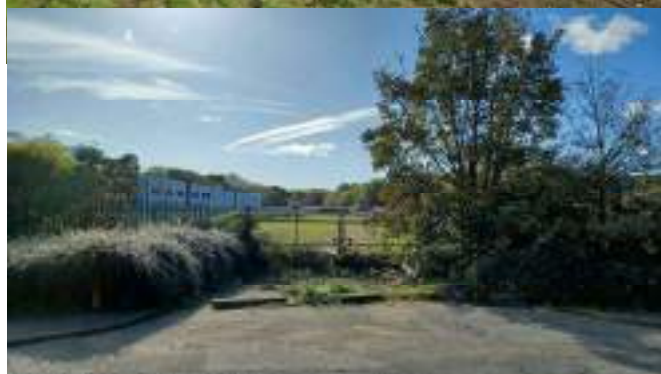
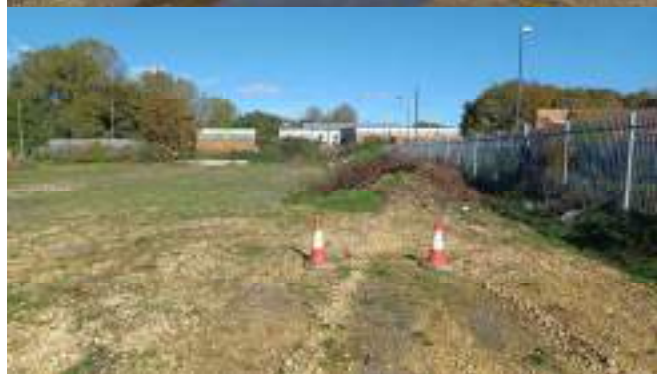
#### SITE PHOTOGRAPHS

The reconnaissance survey identified that the foundations of the now-demolished residential buildings remain on the site and are visibly present.

During the reconnaissance (walkover) survey standing water was noted at the area where vehicles perform turning manoeuvres.

| Issue or hazard | Level of potential risk | Comments |
|---|---|---|
| Sub-surface structures | MEDIUM risk | Any relic sub-structures (walls and foundations) encountered during the site works should be grubbed up and removed off site |
