# AllAboutTrees

## Arboricultural Impact Assessment & Method Statement For Trees On Land Adjacent To 39 Sunderland Rd, East Boldon

For  
Phil Hartley

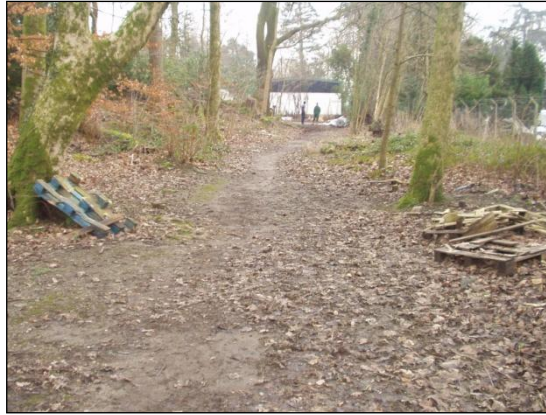
*Photo 1- line of new road prior to the commencement of works*

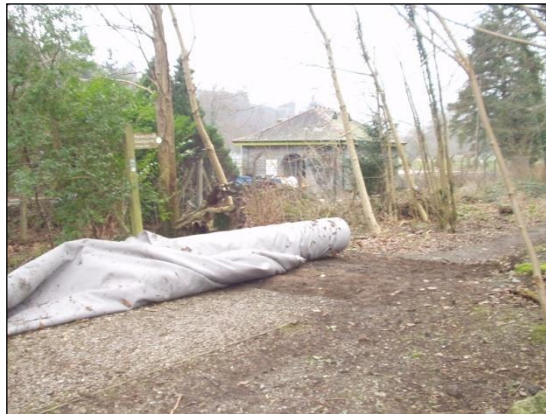
- 1) Lay a Treetex T300 geotextile material directly on the existing subgrade. Overlap dry joints by 300mm

*Photo 2- laying of Fibretext material onto existing subgrade*

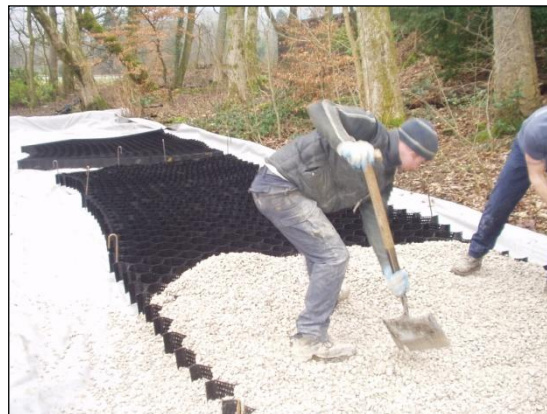
*Photo 3- expanding and filling the Cellweb system*

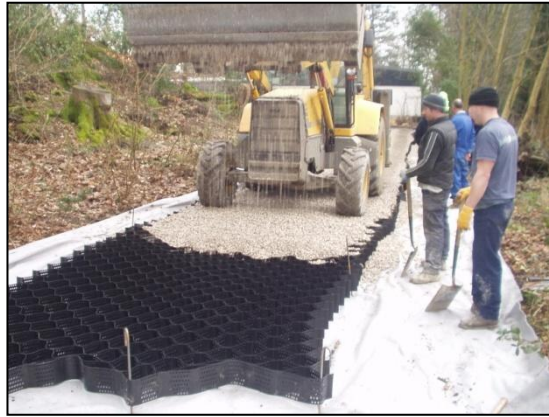
*Photo 4- once filled the system can support plant to carry aggregate to the fill area*

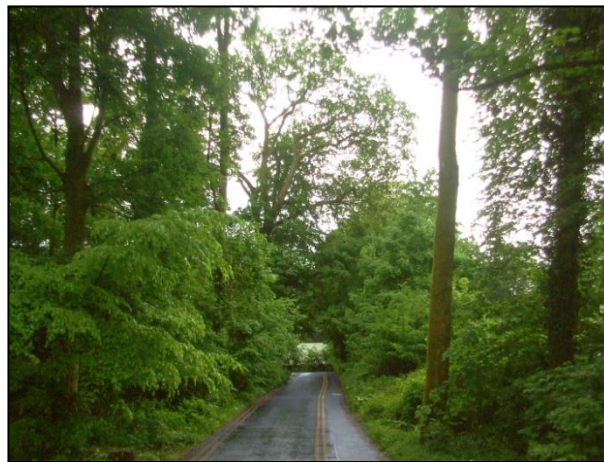
Photo 5- completed road using porous tarmac surfacing
