## **19 Frederick Street, South Shields**

Noise impact assessment

13285.1001-A

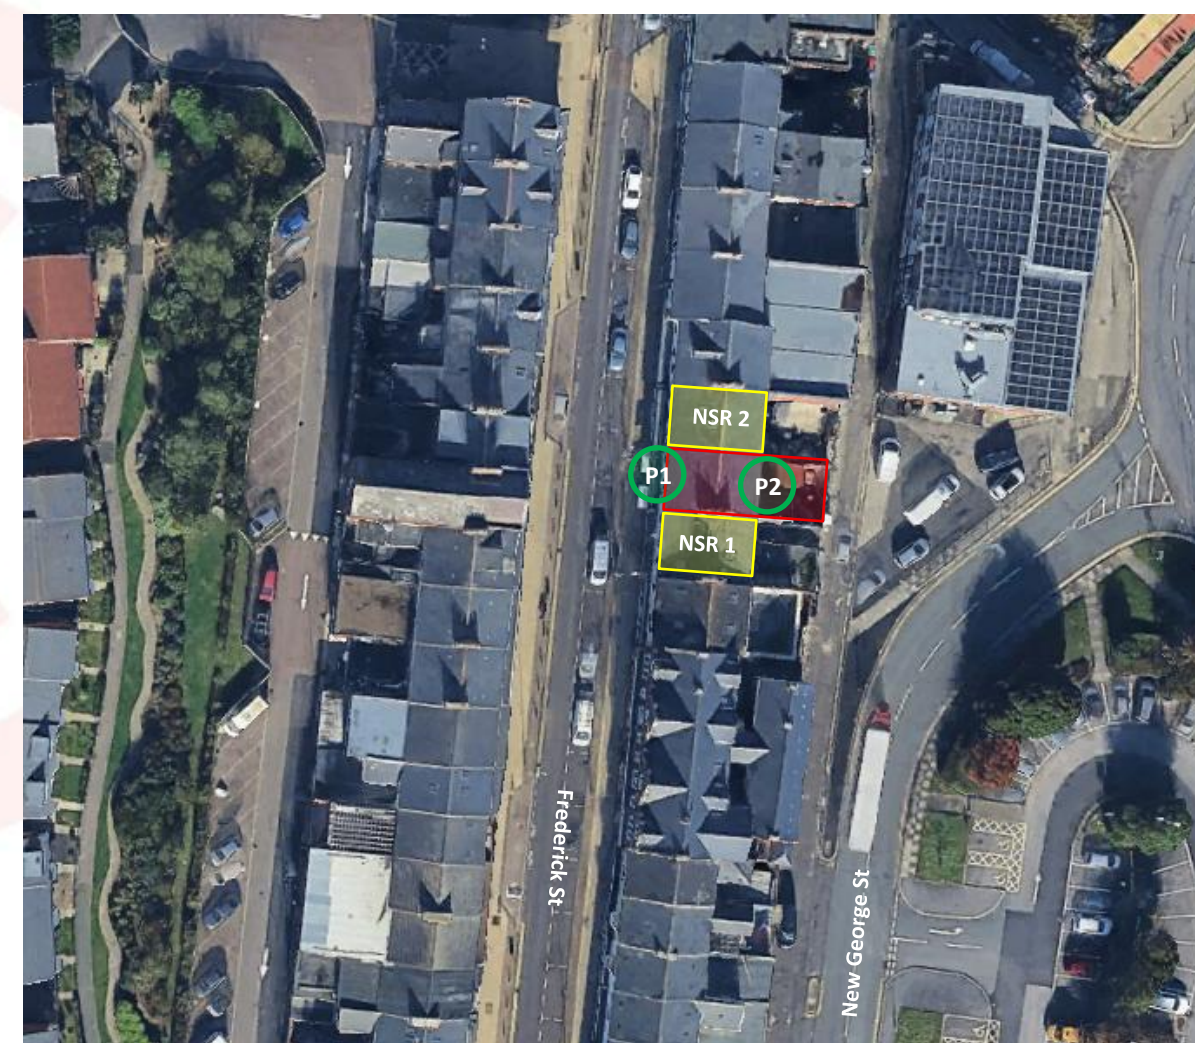
Figure 1: Proposed site (red), measurement positions (green) and identified NSRs (yellow)

- 2.1 A change of use is proposed at 19 Frederick Street, South Shields, to convert the attic level of the existing building from office accommodation to a Pilates and Yoga fitness studio. The proposed studio would comprise a single open-plan exercise space at attic level, accessed via the existing internal staircase. Figure 1 shows the location of the site and the nearest identified residential receptors.

- 4.7 Unattended measurements were undertaken at Position 1 (P1) and Position 2 (P2), as shown in Figure 1.
- 4.8 The sound level meter at P1 was installed at approximately first-floor window height on the front (west-facing) façade of the building.

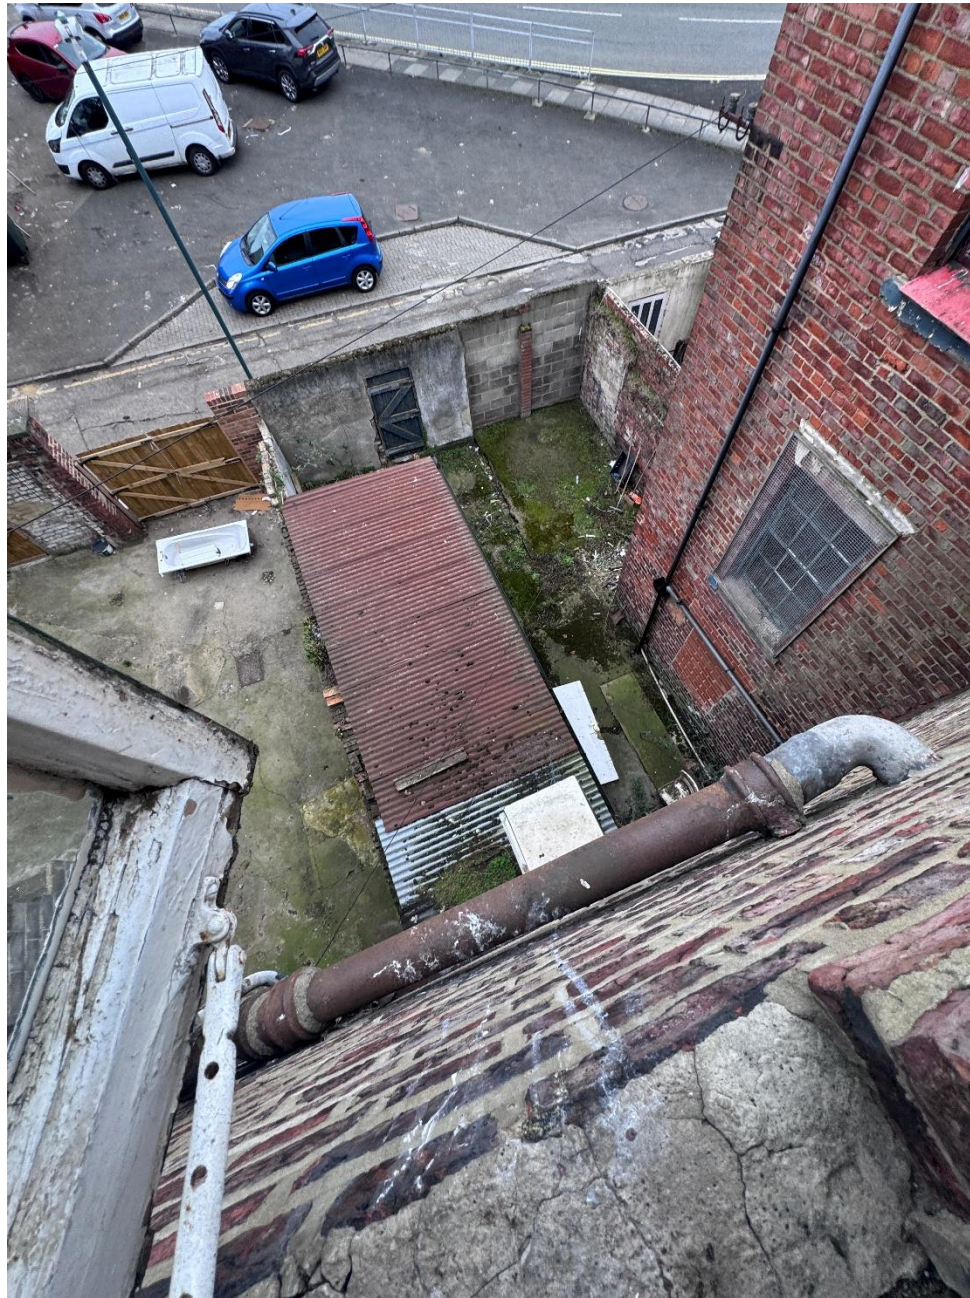
Figure 2: View of the rear elevation of the building and surrounding yard area.

- 3.1 The external walls of the building appear to comprise solid brick masonry construction. The attic level occupies the uppermost part of the structure beneath a pitched roof. The external façade and surrounding context are shown in Figure 2

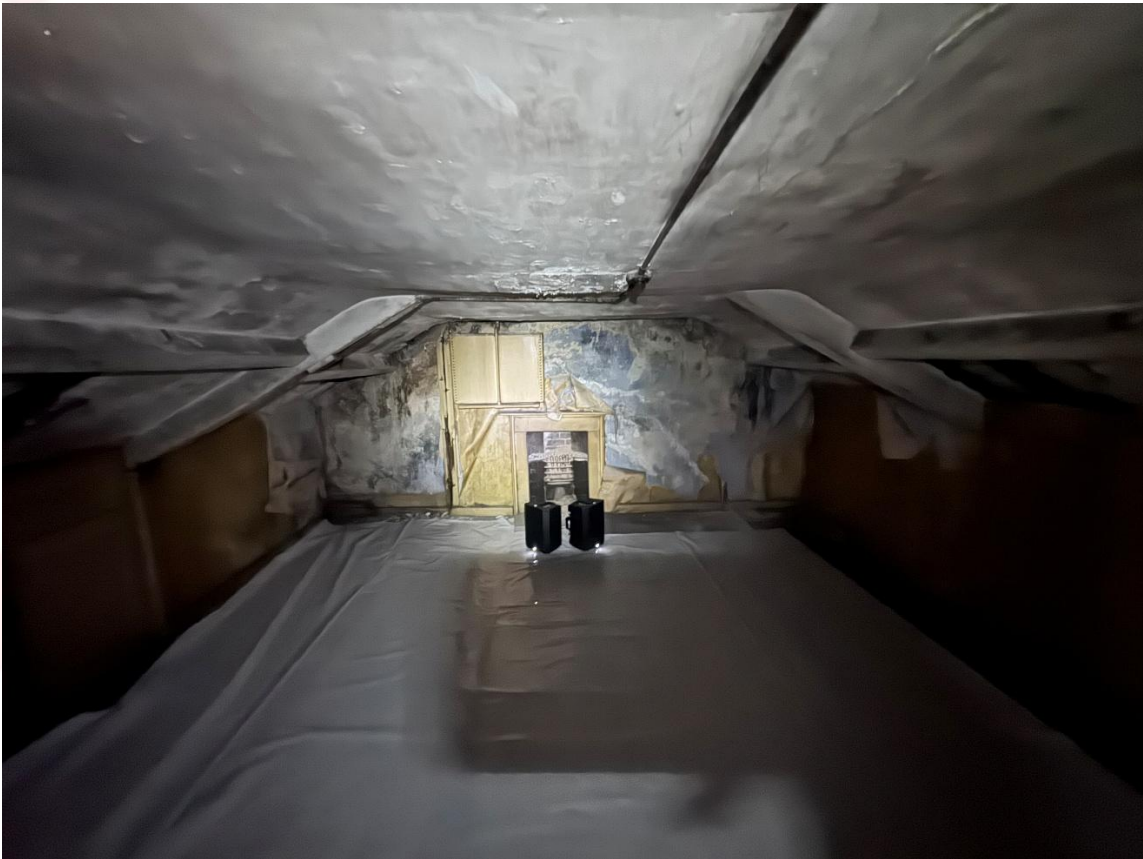
Figure 3: Noise break-out measurements in progress
