## **Geo-Environmental Assessment**

Lizard Lane  
Whitburn,  
Sunderland,  
SR6 7HG

**For Story Contracting**

Report ref. 25/4660.A.1

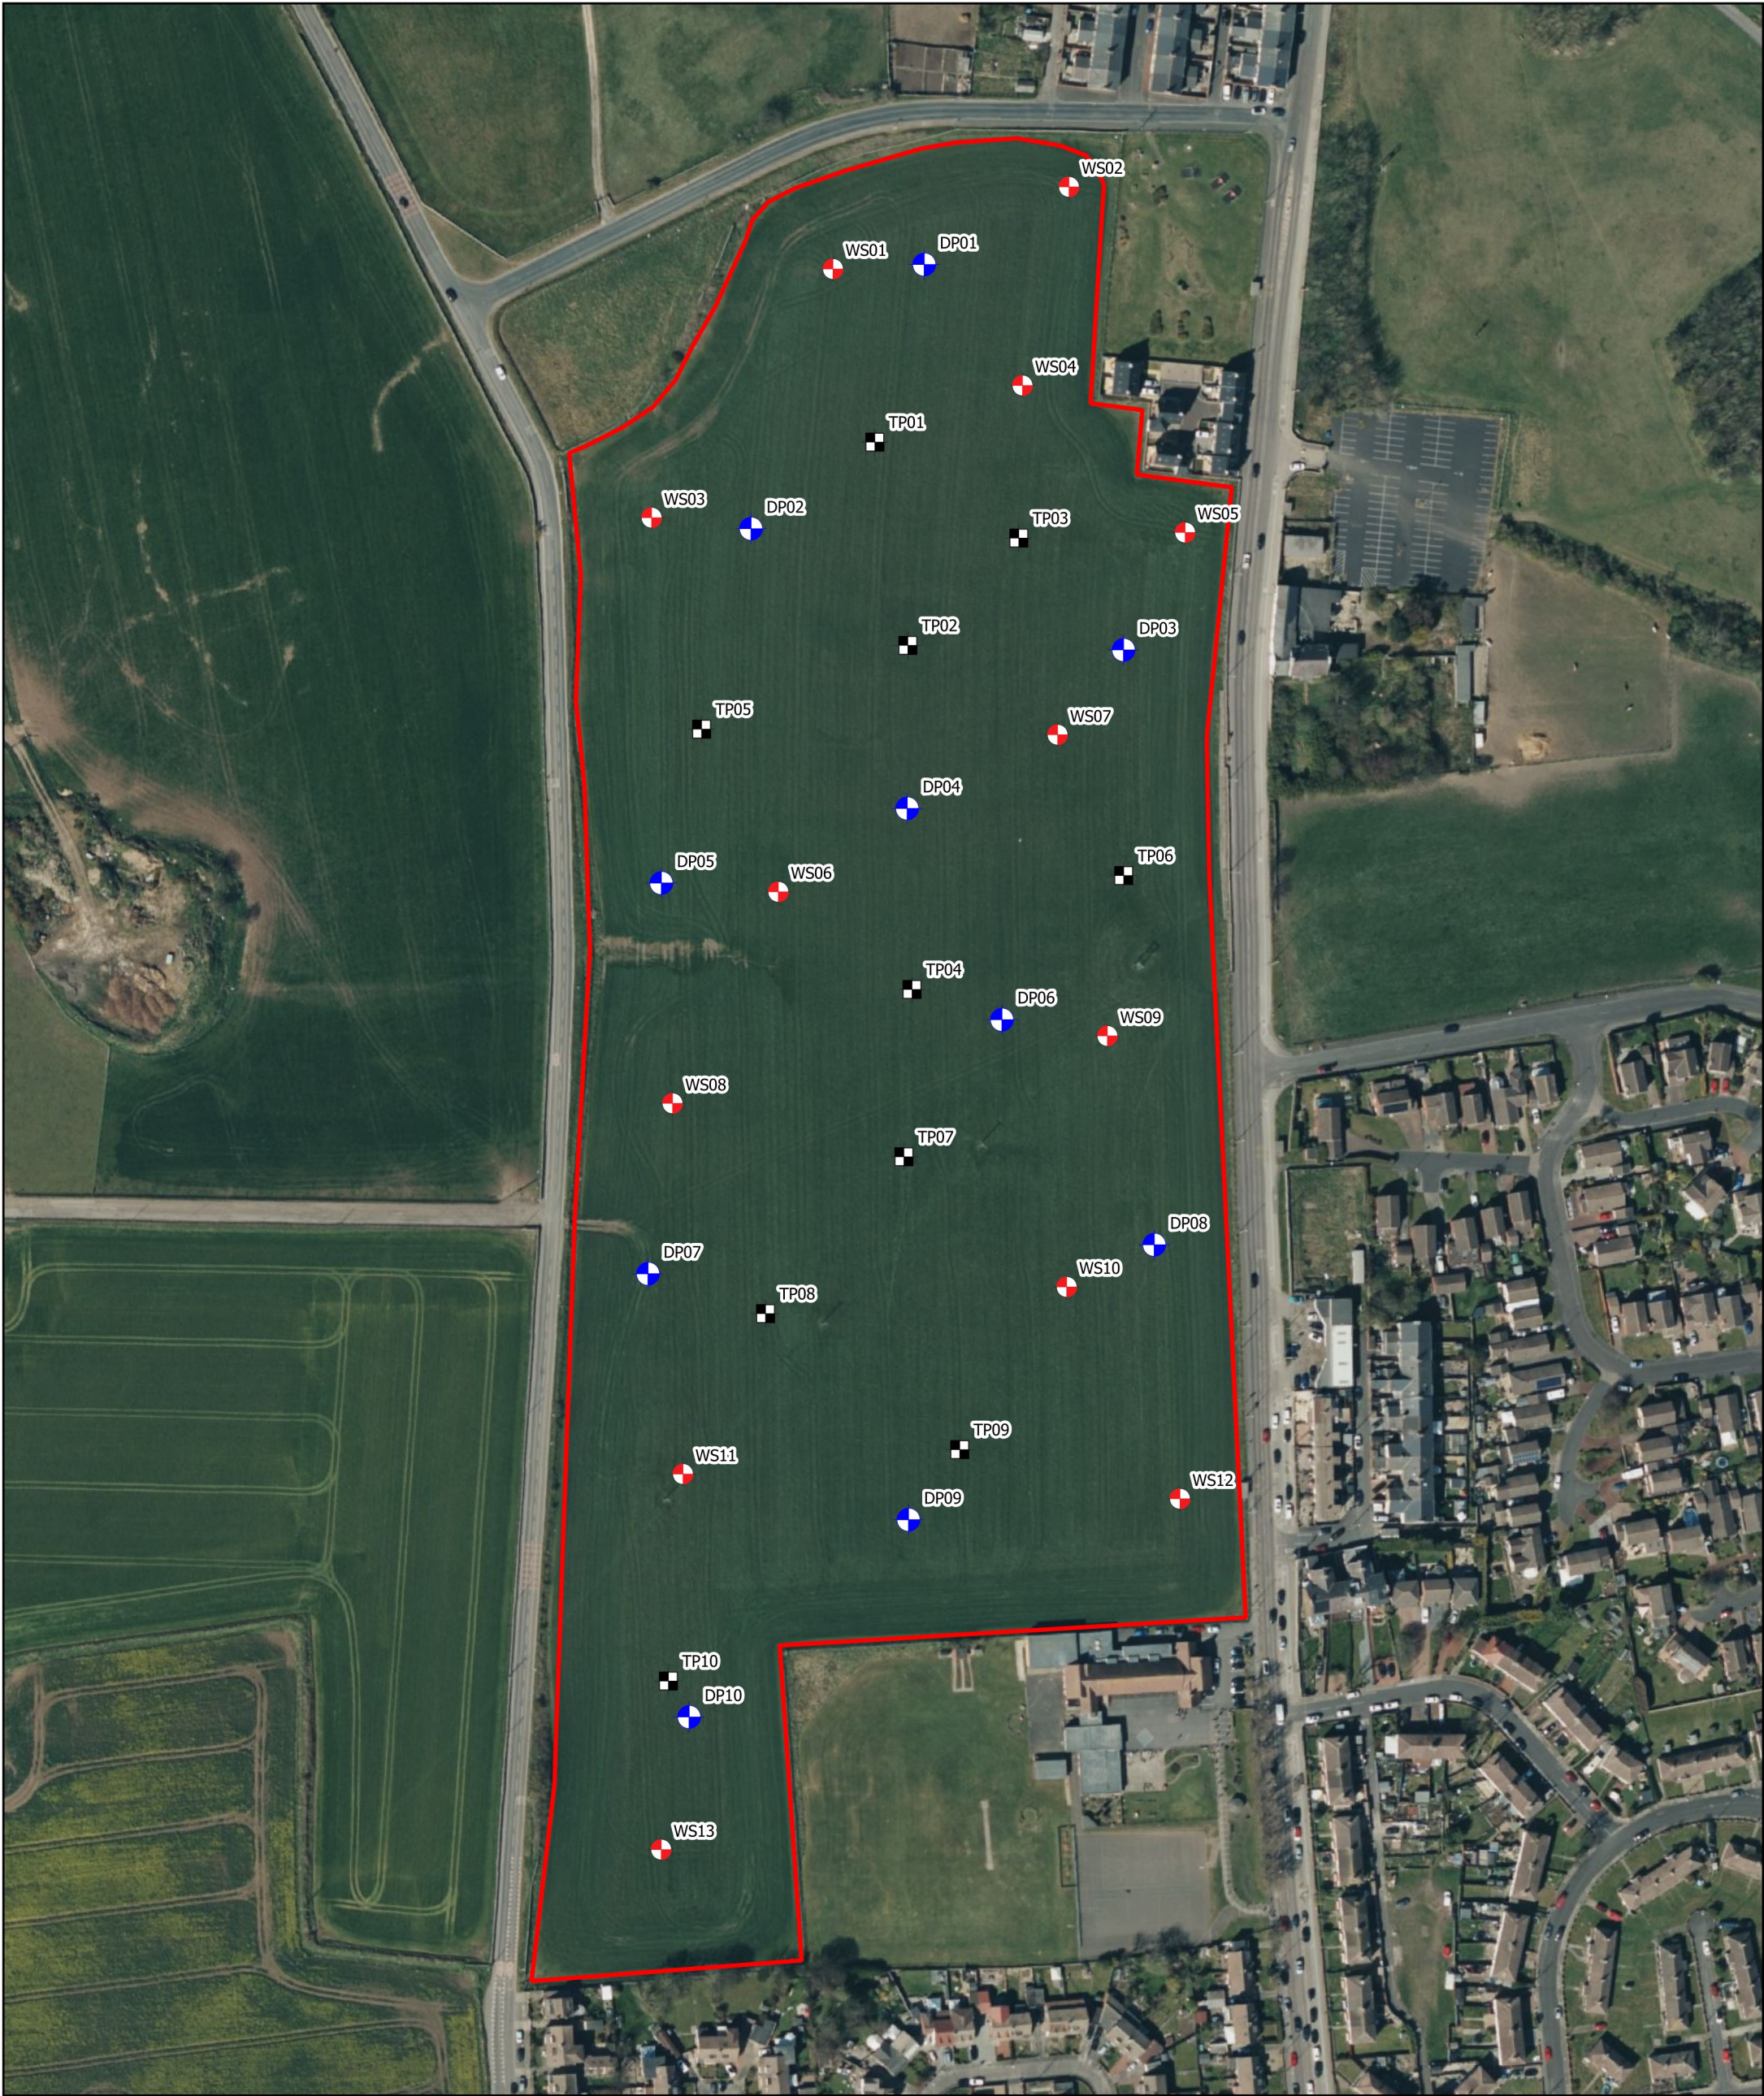
## **Appendix A – Drawings and Figures**

- Exploratory Holes
- Dynamic Sample Location
  - Trial Pit Location
  - Dynamic Probe Test Location
  - Site Boundary

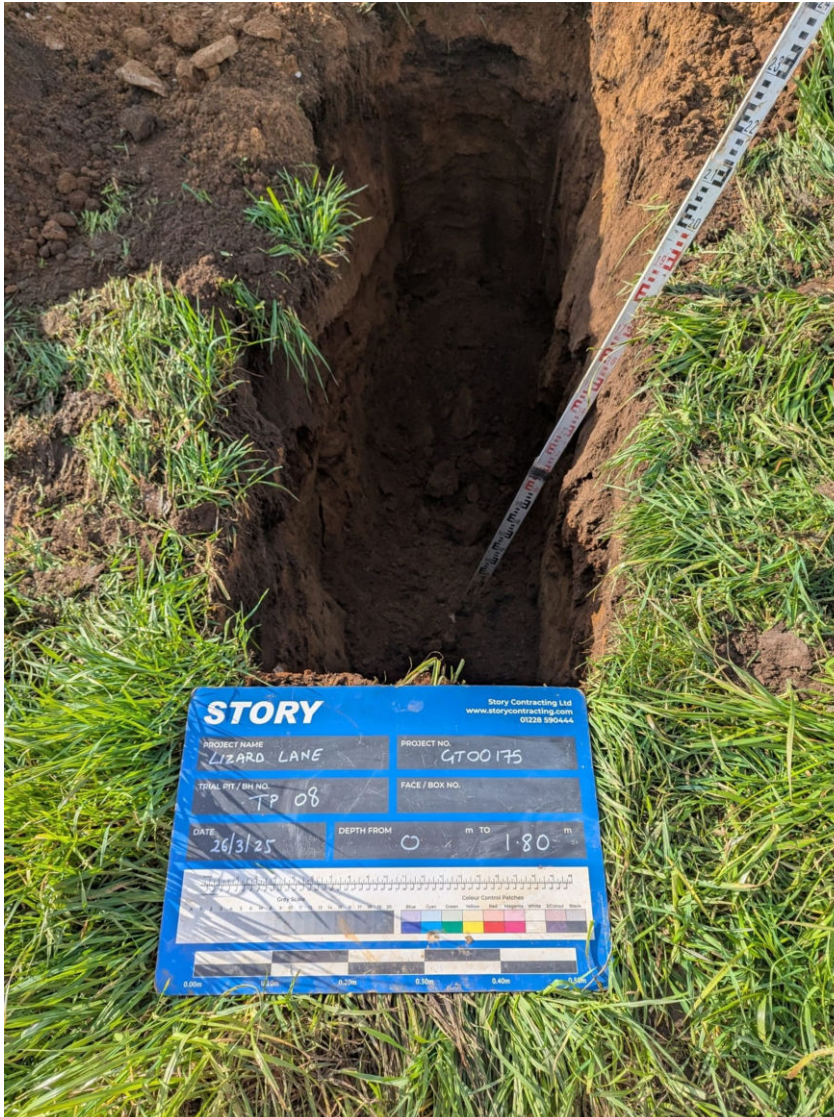
TP08

1. Machine dug trial pit from 0.00m to 1.80m.
2. No groundwater encountered during digging.
3. Backfilled with arisings upon completion.

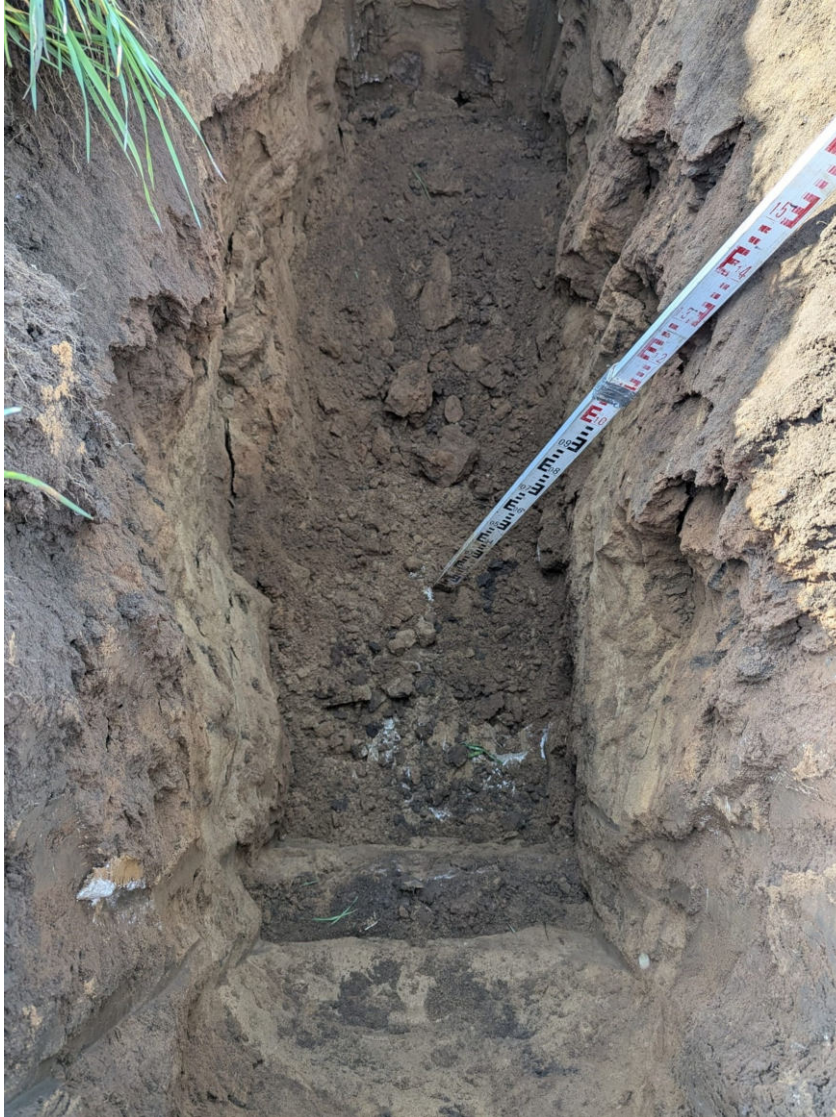
TP08

1. Machine dug trial pit from 0.00m to 1.80m.
2. No groundwater encountered during digging.
3. Backfilled with arisings upon completion.

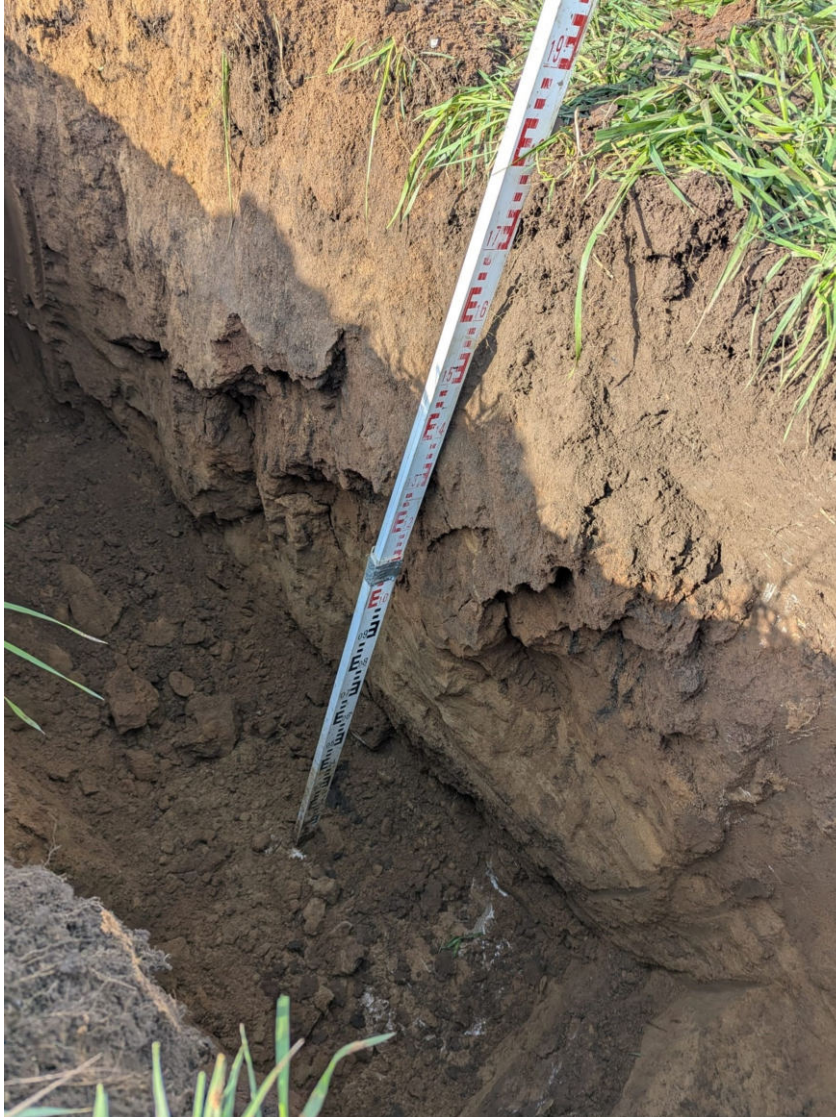
FACE B

1. Machine dug trial pit from 0.00m to 1.80m.
2. No groundwater encountered during digging.
3. Backfilled with arisings upon completion.

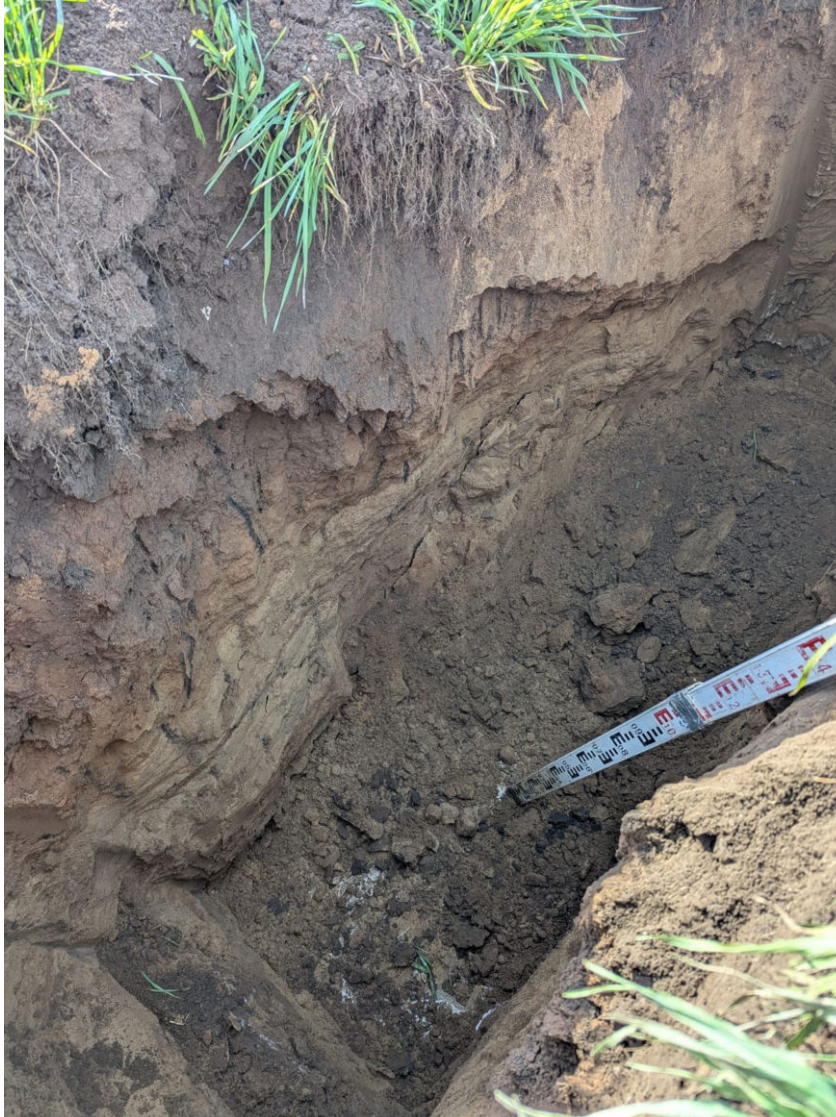
FACE D

1. Machine dug trial pit from 0.00m to 1.80m.
2. No groundwater encountered during digging.
3. Backfilled with arisings upon completion.

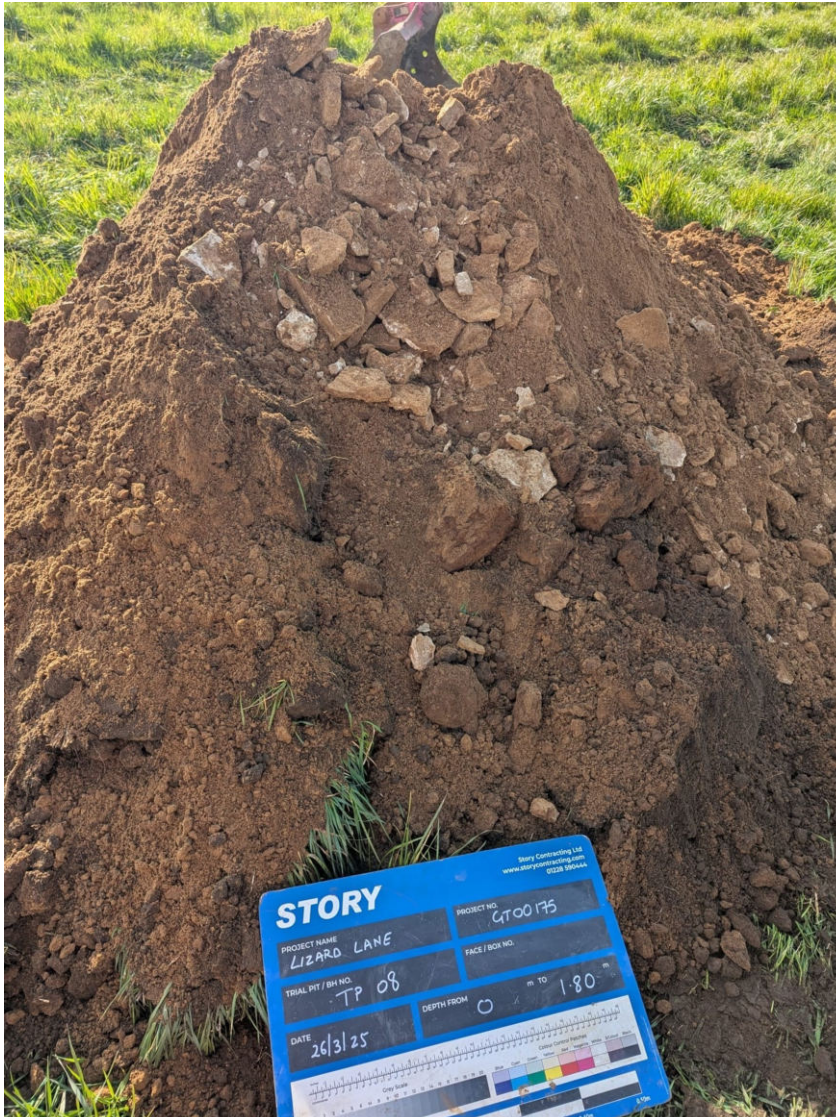
TP ARISINGS

1. Machine dug trial pit from 0.00m to 1.80m.
2. No groundwater encountered during digging.
3. Backfilled with arisings upon completion.

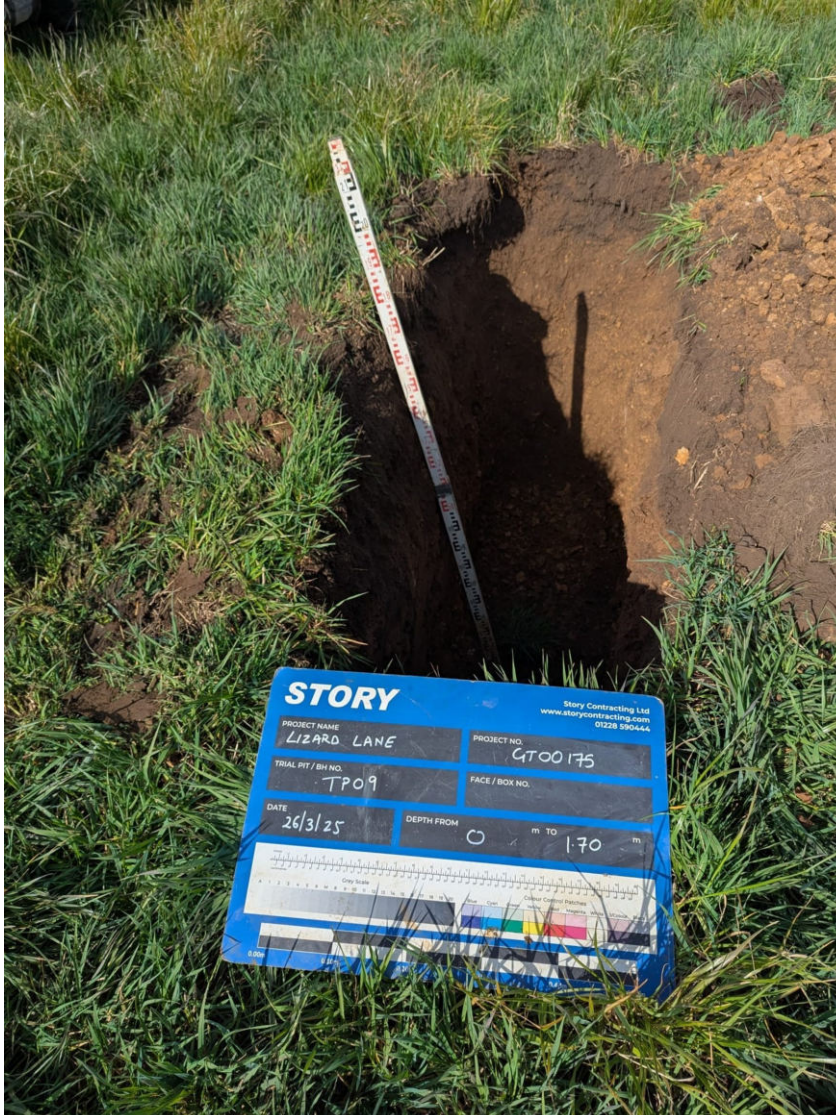
TP09

1. Machine dug trial pit from 0.00m to 1.70m.
2. No groundwater encountered during digging.
3. Backfilled with arisings upon completion.

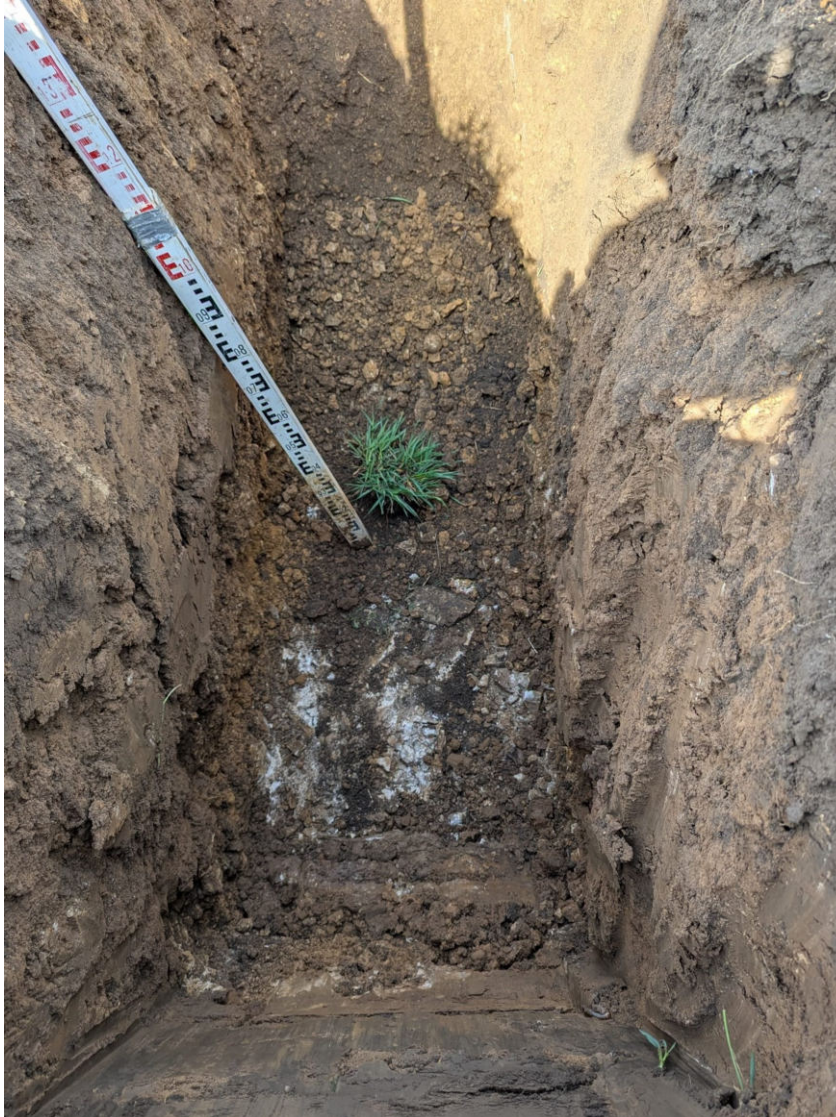
TP09

1. Machine dug trial pit from 0.00m to 1.70m.
2. No groundwater encountered during digging.
3. Backfilled with arisings upon completion.

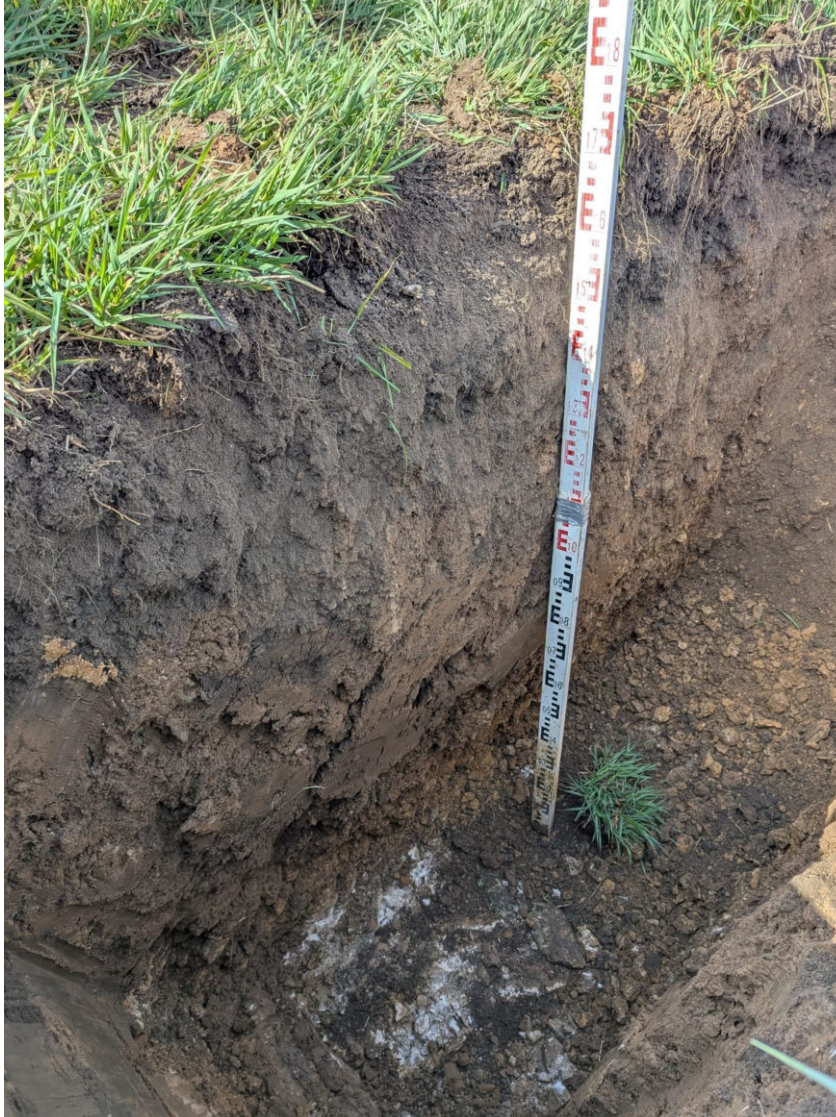
FACE D

1. Machine dug trial pit from 0.00m to 1.70m.
2. No groundwater encountered during digging.
3. Backfilled with arisings upon completion.

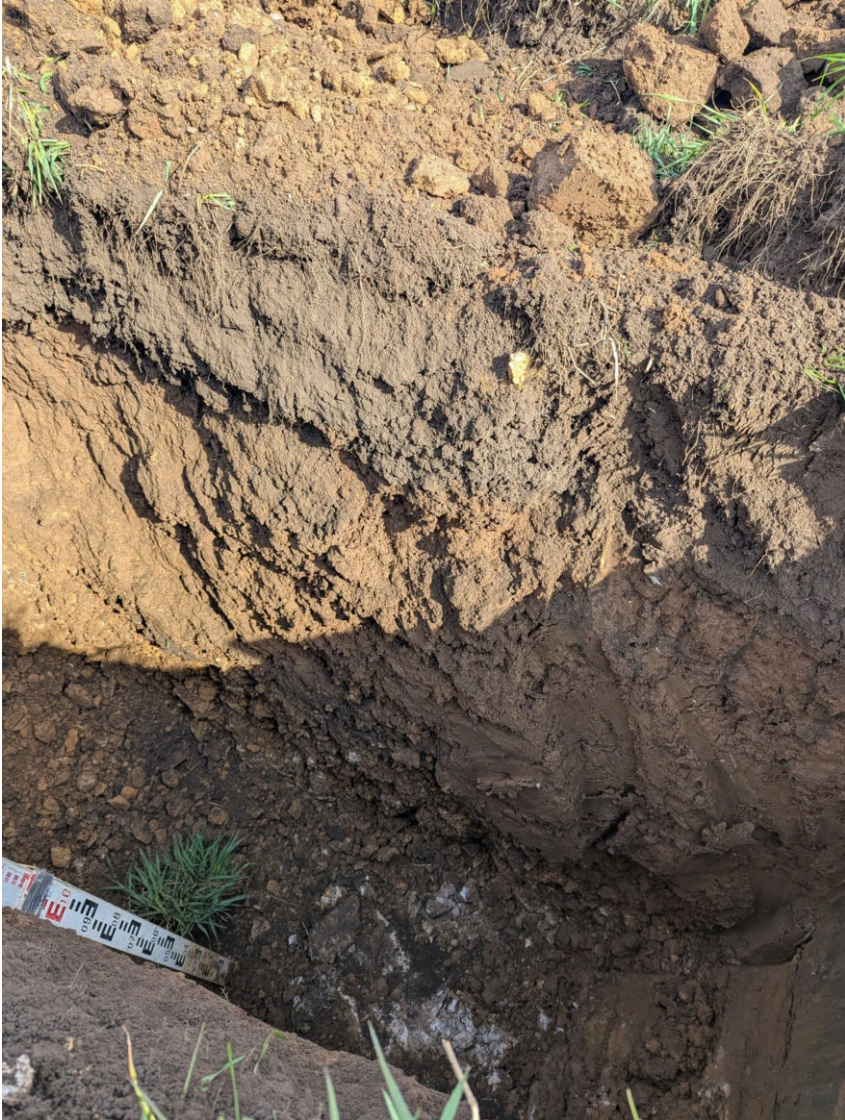
FACE B

**General Remarks:**  
1. Machine dug trial pit from 0.00m to 1.70m.  
2. No groundwater encountered during digging.  
3. Backfilled with arisings upon completion.

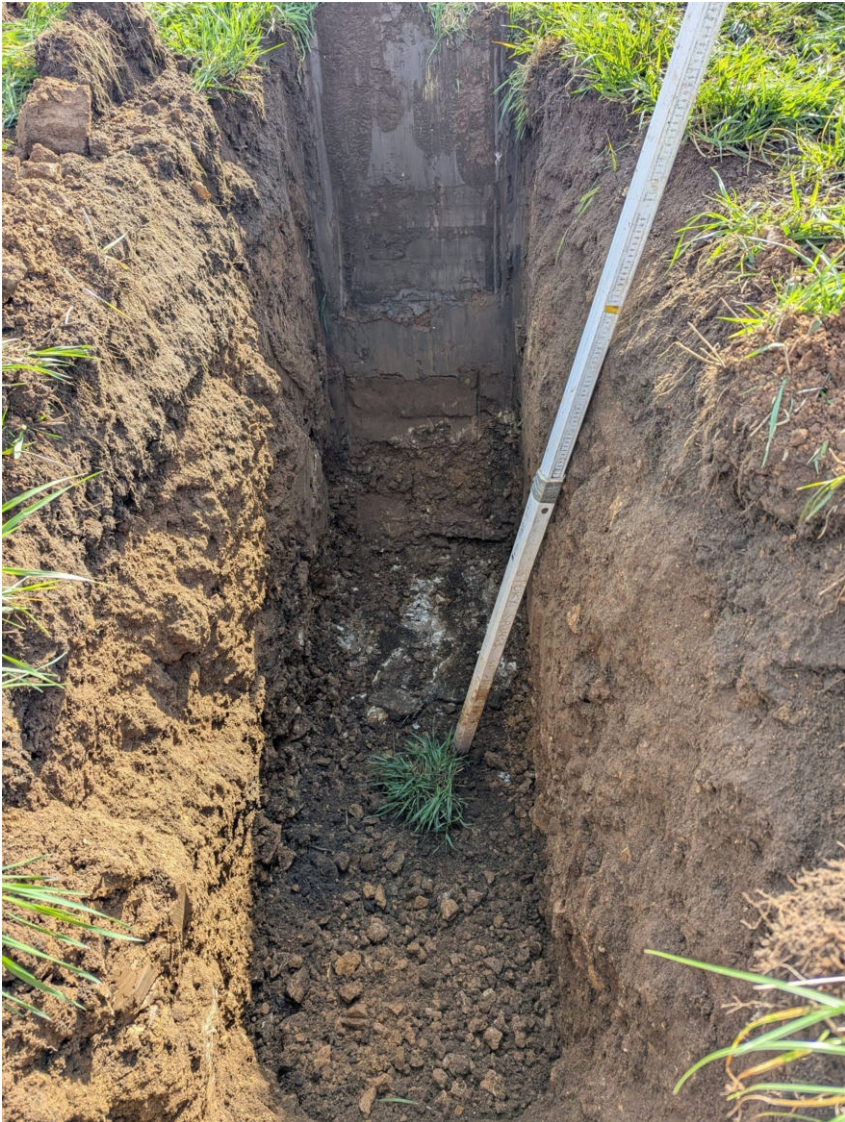
FACE C

**General Remarks:**  
1. Machine dug trial pit from 0.00m to 1.70m.  
2. No groundwater encountered during digging.  
3. Backfilled with arisings upon completion.

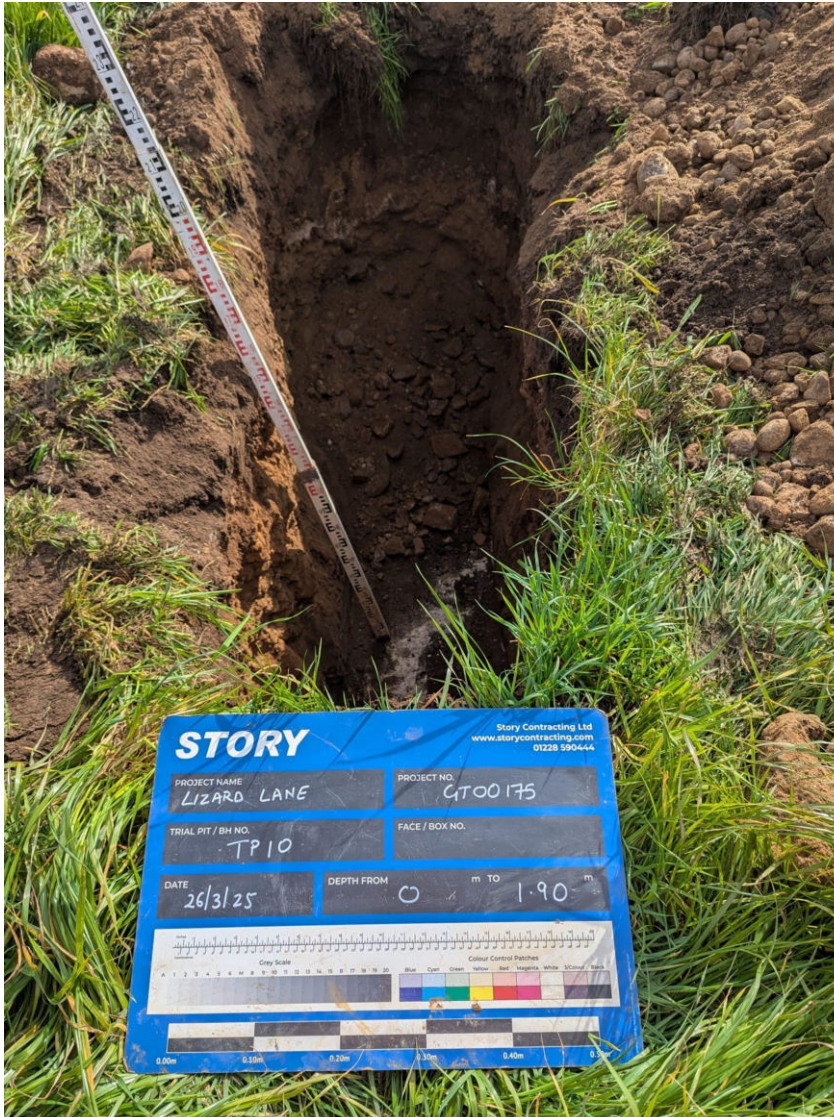
TP10

1. Machine dug trial pit from 0.00m to 1.90m.
2. No groundwater encountered during digging.
3. Backfilled with arisings upon completion.

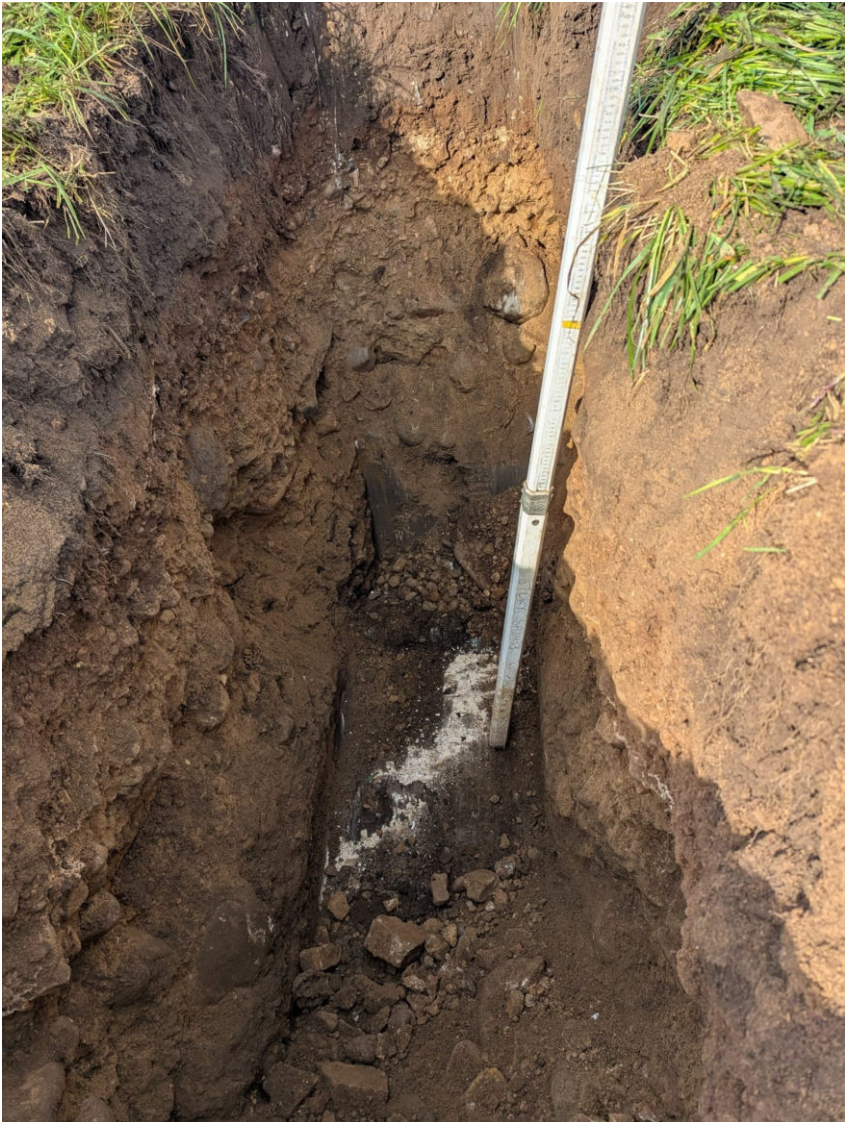
FACE A

- 1. Machine dug trial pit from 0.00m to 1.90m.
- 2. No groundwater encountered during digging.
- 3. Backfilled with arisings upon completion.

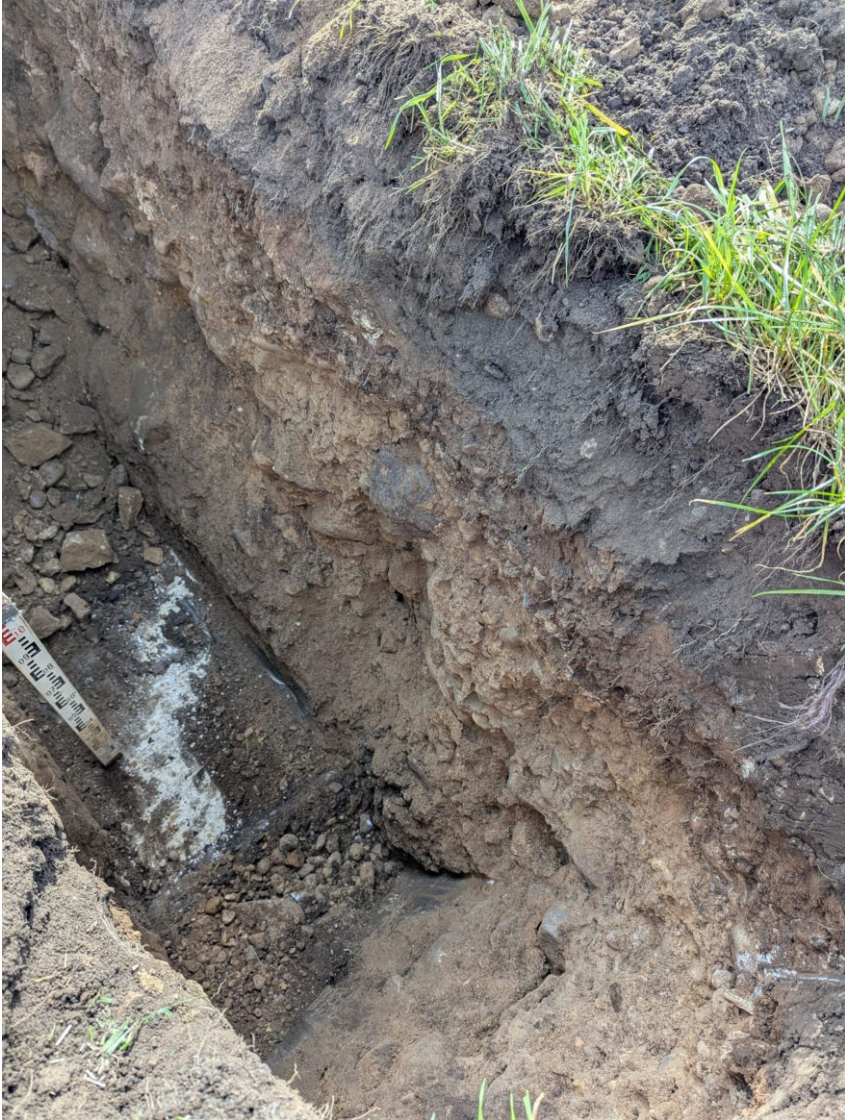
FACE B

**General Remarks:**  
1. Machine dug trial pit from 0.00m to 1.90m.  
2. No groundwater encountered during digging.  
3. Backfilled with arisings upon completion.

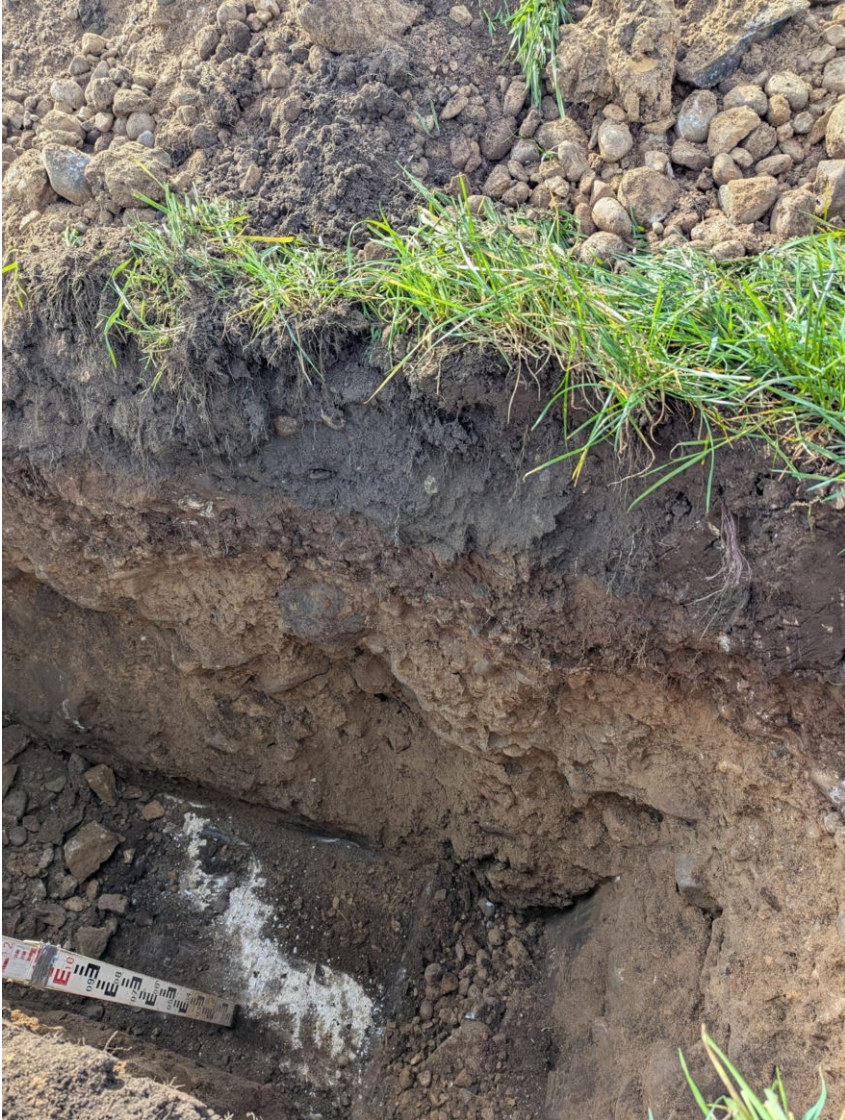
FACE B

**General Remarks:**  
1. Machine dug trial pit from 0.00m to 1.90m.  
2. No groundwater encountered during digging.  
3. Backfilled with arisings upon completion.

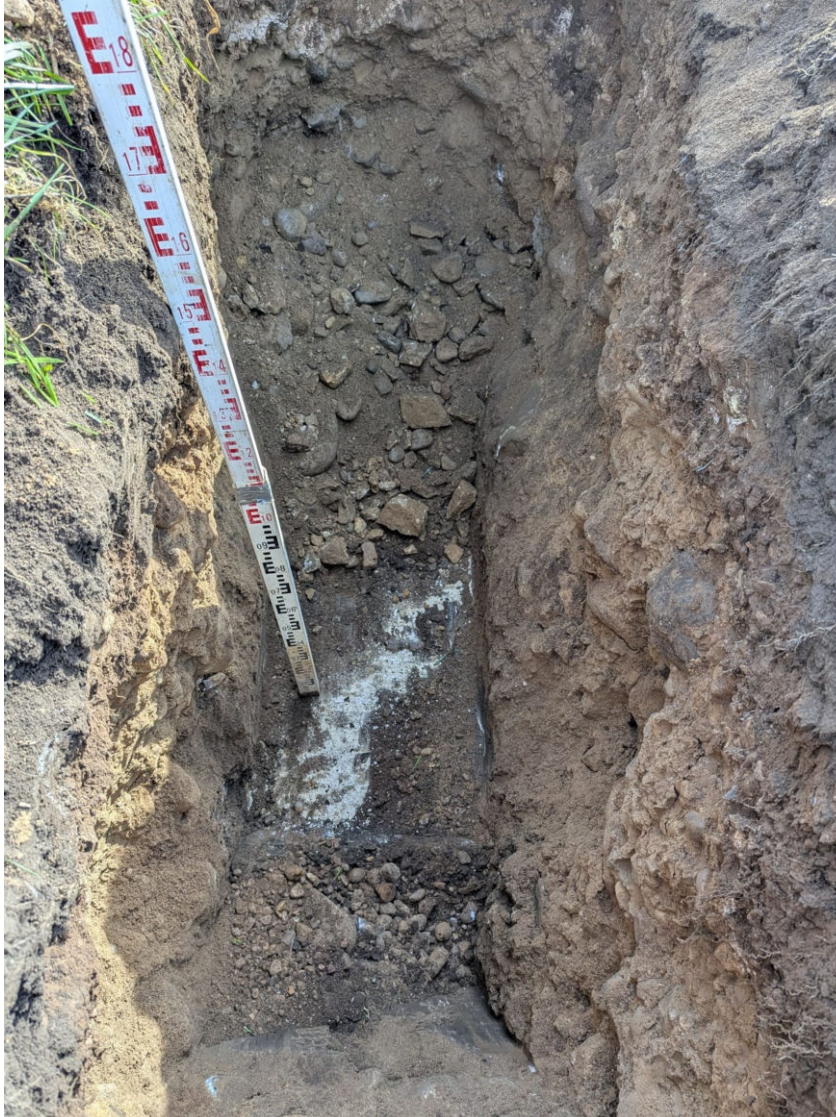
TP10

1. Machine dug trial pit from 0.00m to 1.90m.
2. No groundwater encountered during digging.
3. Backfilled with arisings upon completion.
