# All About Trees

Arboricultural Impact Assessment  
& Method Statement For Trees At  
St. Simons Community Centre,  
Wenlock Road, South Shields - Revision A

Ball Rolling (Methley) Ltd

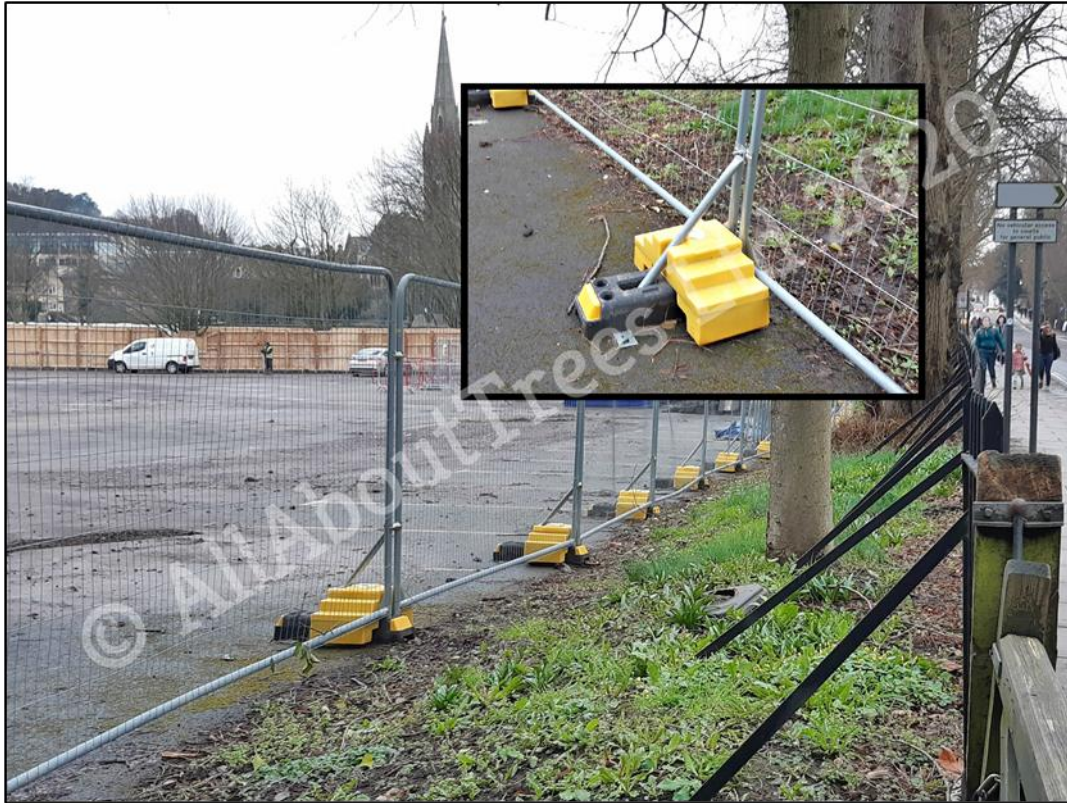
*Figure 3 – An example of a barrier erected on a site*

5.5.10 All types of barriers must be firmly attached to prevent movement by site personnel or vehicles and all-weather signs with the wording "Construction exclusion zone- keep out" should be attached.
