# **TRANSPORT ASSESSMENT PROPOSED RESIDENTIAL DEVELOPMENT**

**Holborn Riverside, South Shields**

**February 2021**

**Cussins & Keepmoat Homes**

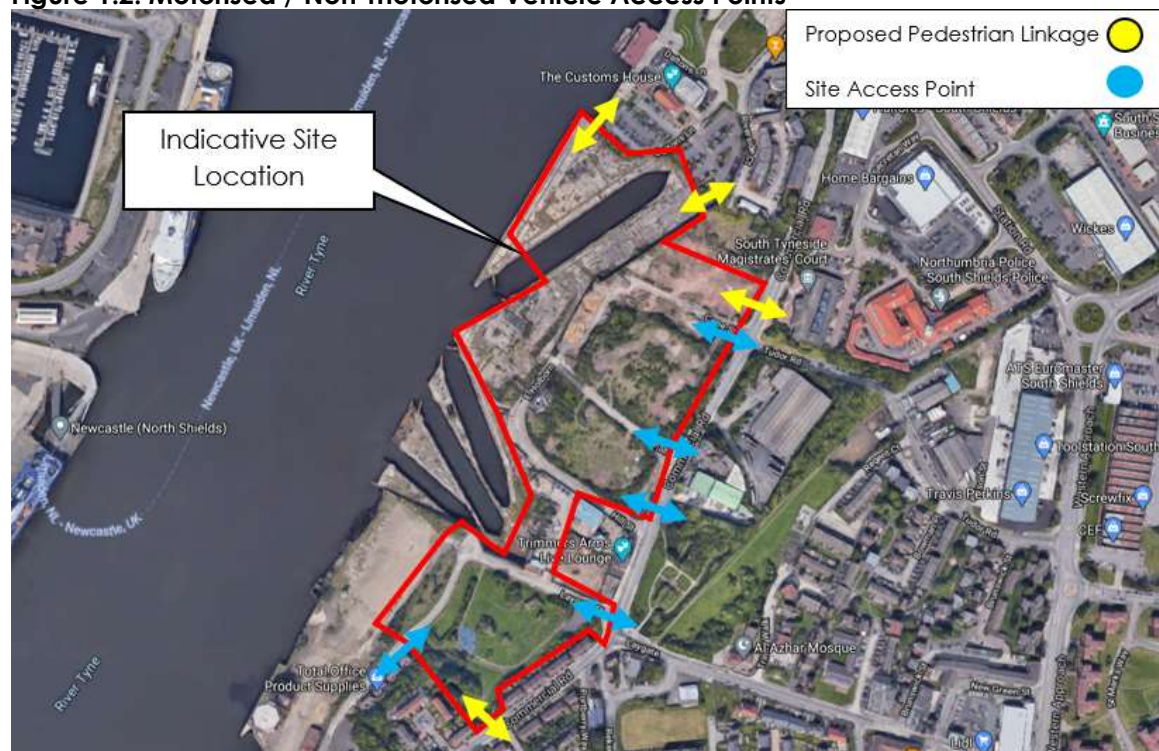
**Figure 1.2: Motorised / Non-motorised Vehicle Access Points**

pedestrian permeability from the existing footway network, external to the site. **Figure 1.2** shows the various access points for motorised / non-motorised users.

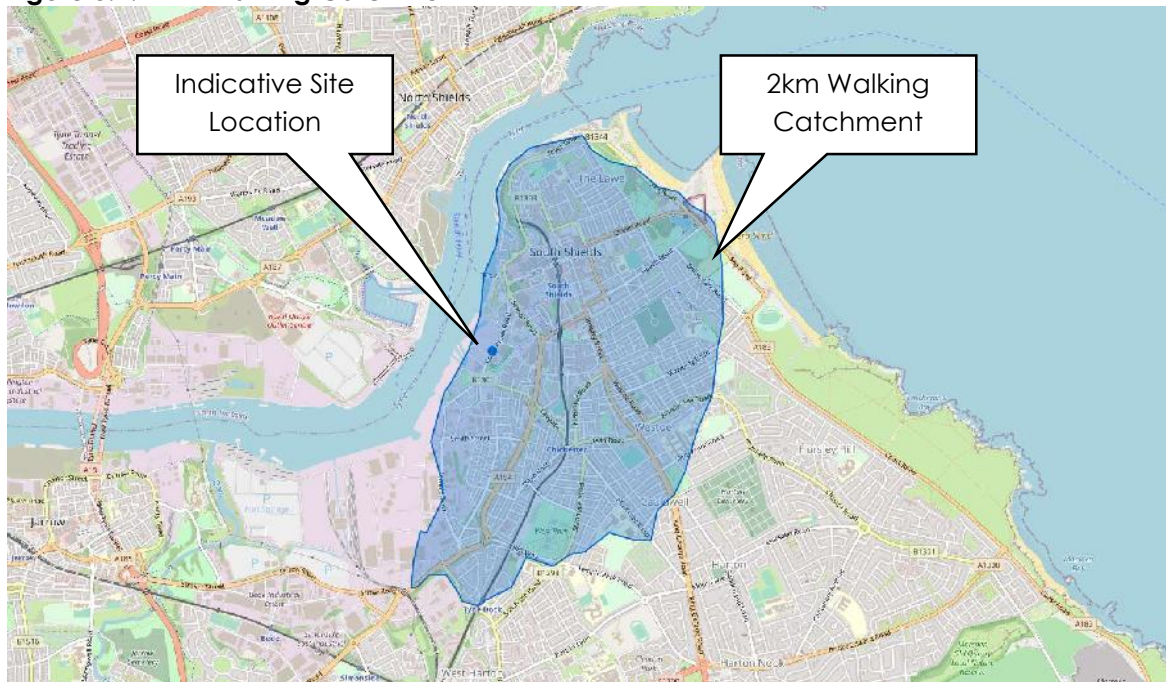
**Figure 3.1: 2km Walking Catchment**

- 3.3 As can be seen in **Table 3.1**, the preferred maximum walking distance for 'walking / commuting' is 2km. A 2km walking catchment from the site would, therefore, include the entirety of South Shields as well as, Westoe and Cauldwell. **Figure 3.1** illustrates a 2km walking catchment from the site.

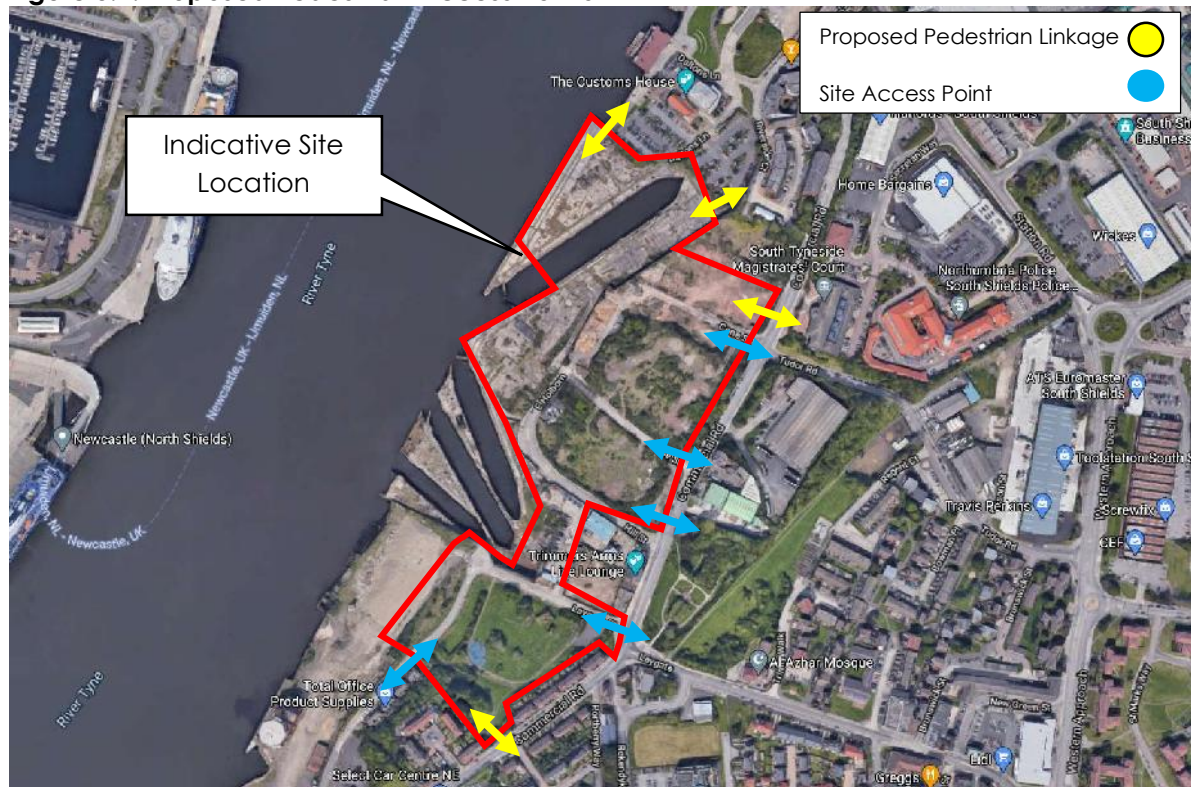
**Figure 3.2: Proposed Pedestrian Access Points**

- 3.4 As can be seen on the proposed site masterplan, provided at **Appendix A**, pedestrian access to the site will be taken from a number of points on the northern, eastern, and southern boundaries of the site. As discussed previously, there are vehicle access points onto Commercial Street and West Holborn on the eastern and southern site boundaries, which will offer pedestrian access also.
- 3.5 On the northern boundary, 2no. pedestrian links are proposed, which will connect to the existing quayside and onto Riverside Court, on the eastern boundary a pedestrian link will be provided to the north of Cone Street, whilst another pedestrian access is proposed onto Commercial Road, close to the south-eastern corner of the site. The locations of the access points for pedestrians are illustrated in **Figure 3.2**.

- 6.5 The locations of the proposed vehicle and pedestrian access points have been previously illustrated in **Section 3** of this Transport Assessment and can be found at **Figure 3.2**.

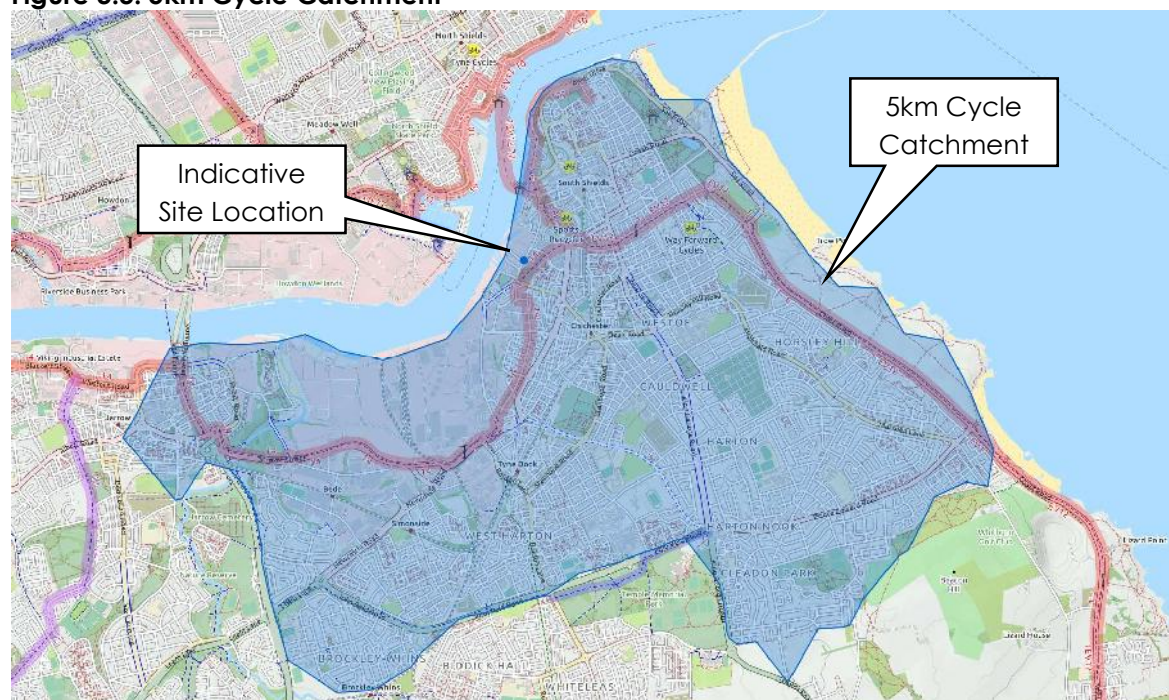
**Figure 3.3: 5km Cycle Catchment**

- 3.10 In addition to the wide range of amenities found within the town centre which are readily accessible on foot, the site is well located for access to the wider area by bike. It is generally accepted that destinations within a distance of 5km can be considered accessible by bike; likely destinations within 5km are detailed later in this section. A 5km cycle catchment of the site includes the entirety of South Shields, alongside Westoe, Cauldwell, Horsley Hill, Harton, Cleadon Park and West Harton; this catchment is illustrated in **Figure 3.3** below.

- 3.11 As can be seen in **Figure 3.3**, there are a number of cycle routes in the vicinity of the site which could be utilised by future residents and visitors. **Figure 3.4** illustrates the cycle routes in the vicinity of the site.

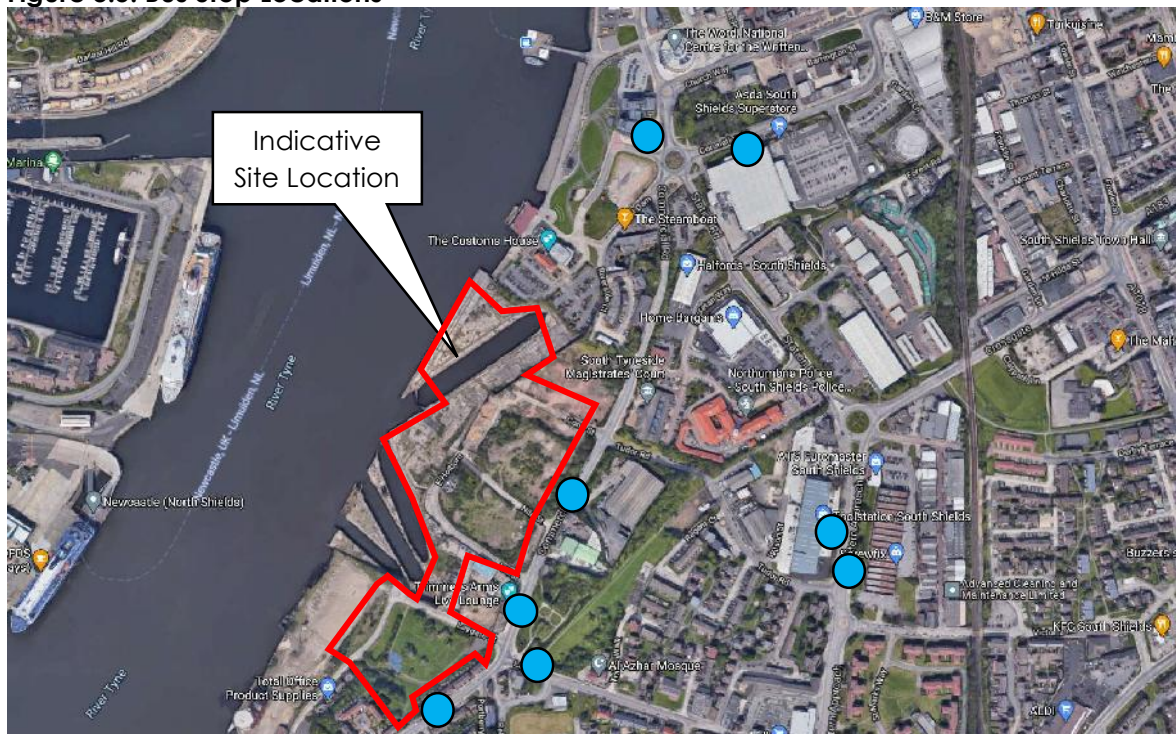
**Figure 3.5: Bus Stop Locations**

- 3.19 **Figure 3.5** illustrates the locations of bus stops on Commercial Road, the B1344, Coronation Street and on Western Approach. A summary of the services available from these stops is provided in **Table 3.3**.

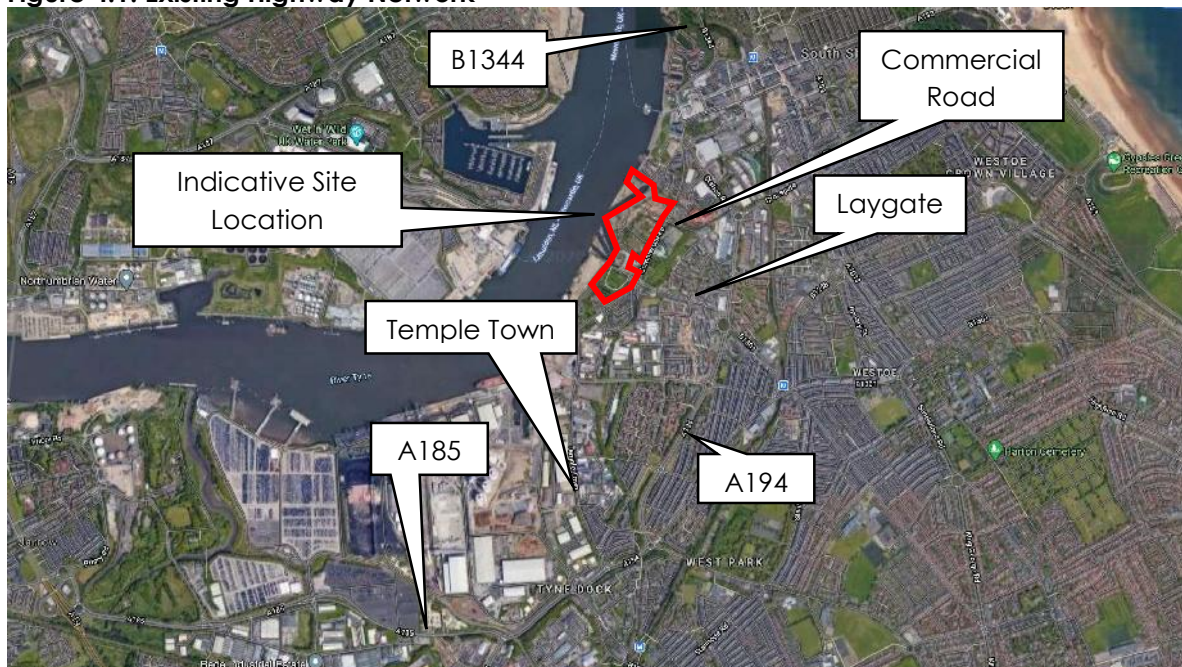
**Figure 4.1: Existing Highway Network**

- 4.2 A description is provided below of the key routes in the vicinity of the site; for ease, it is also shown in **Figure 4.1**.

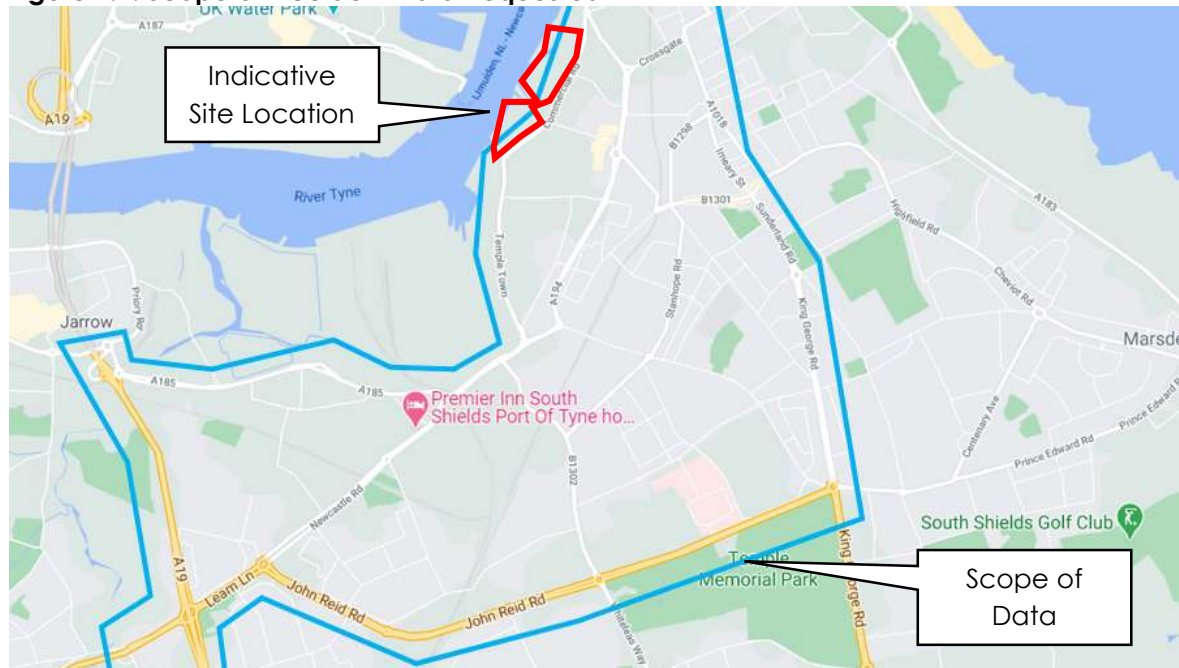
**Figure 4.2: Scope of Accident Data Requested**

- 4.11 Accident data for the most recent 5-year period (2015 - 2020) has been obtained from the Traffic Accident Data Unit (TADU), which provides accident data for the Tyne and Wear district. The extent of the scope of accident data requested from TADU is illustrated in **Figure 4.2** overleaf, however, this scope was selected to include the following routes / junctions located in the vicinity of the site, including:
- Commercial Road / Corstophine Town / Temple Town;
  - Laygate / Western Approach / B1301 / A194 / New George Street roundabout;
  - A194 and Lindisfarne Roundabout; and
  - A185.

- 4.12 As can be seen in **Figure 4.2**, the scope of the accident data requested is extensive and covers a significant part of the local highway network in South Shields as well as major routes, including the A194, A185 and A19. Given the scale of the network identified, the assessment of accident analysis has focused on the primary routes and junctions in the vicinity of the site where development trips would likely travel (based on the gravity model discussed in **Section 5**). The full accident dataset is provided at **Appendix B**.

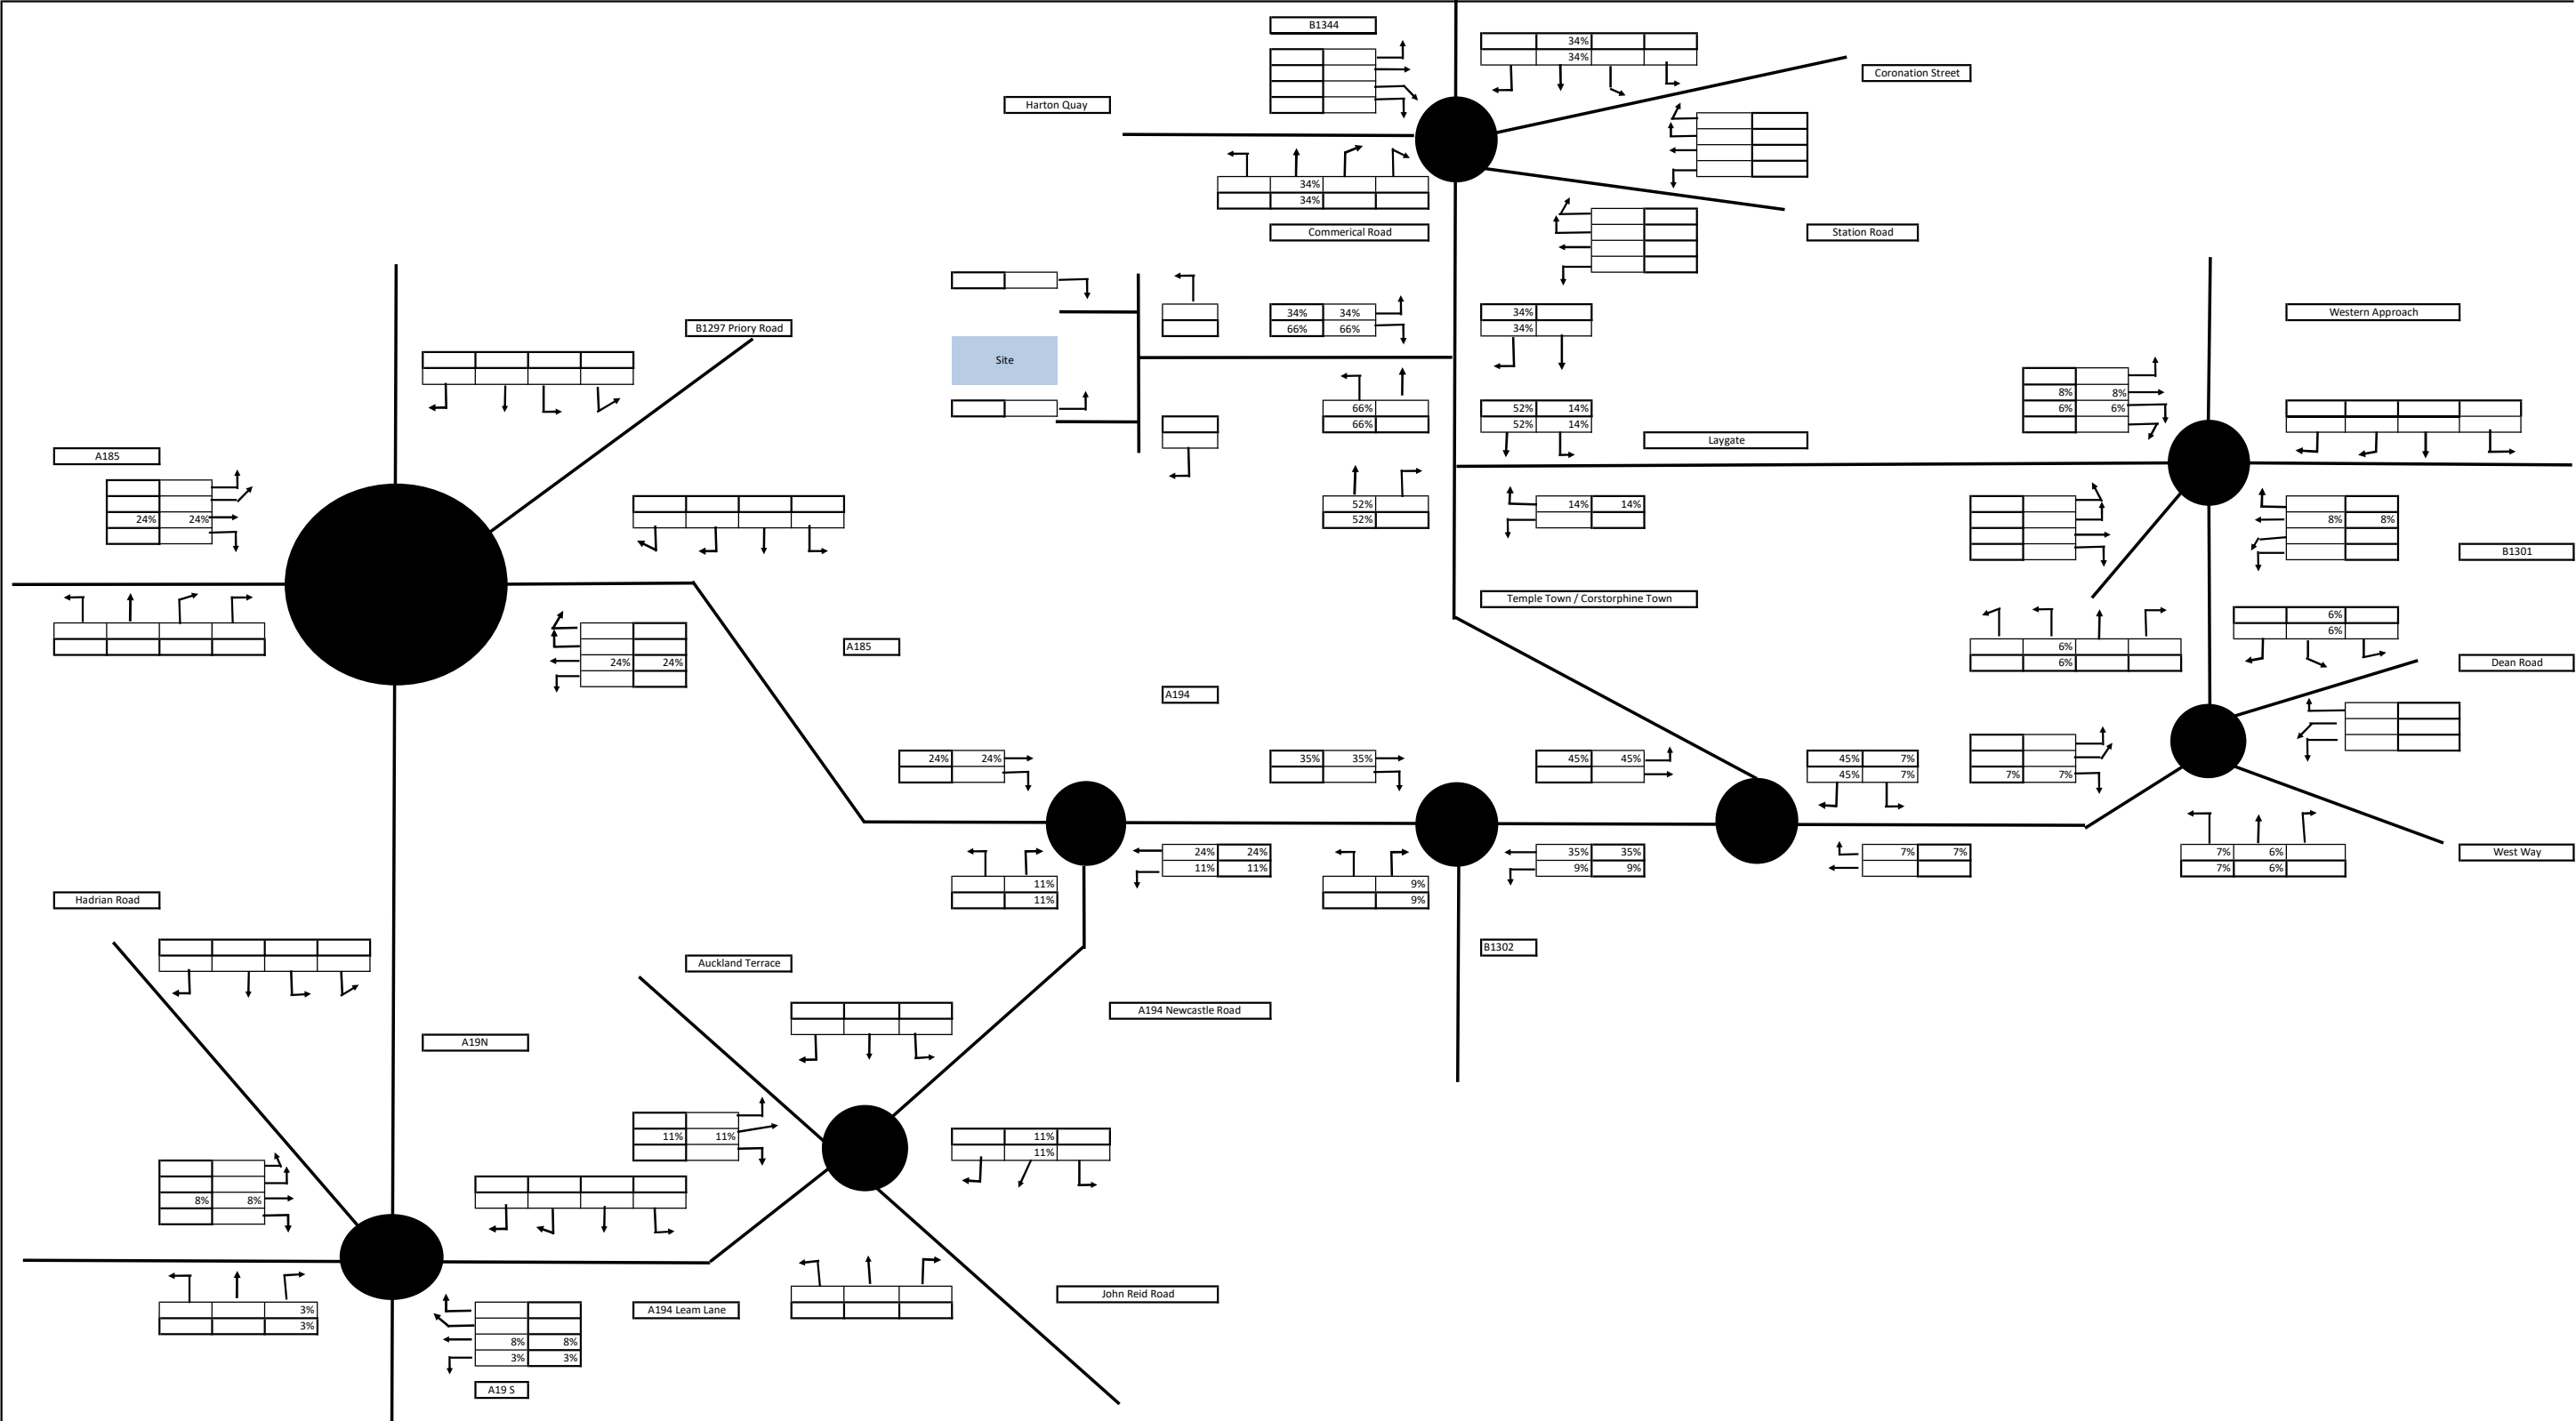
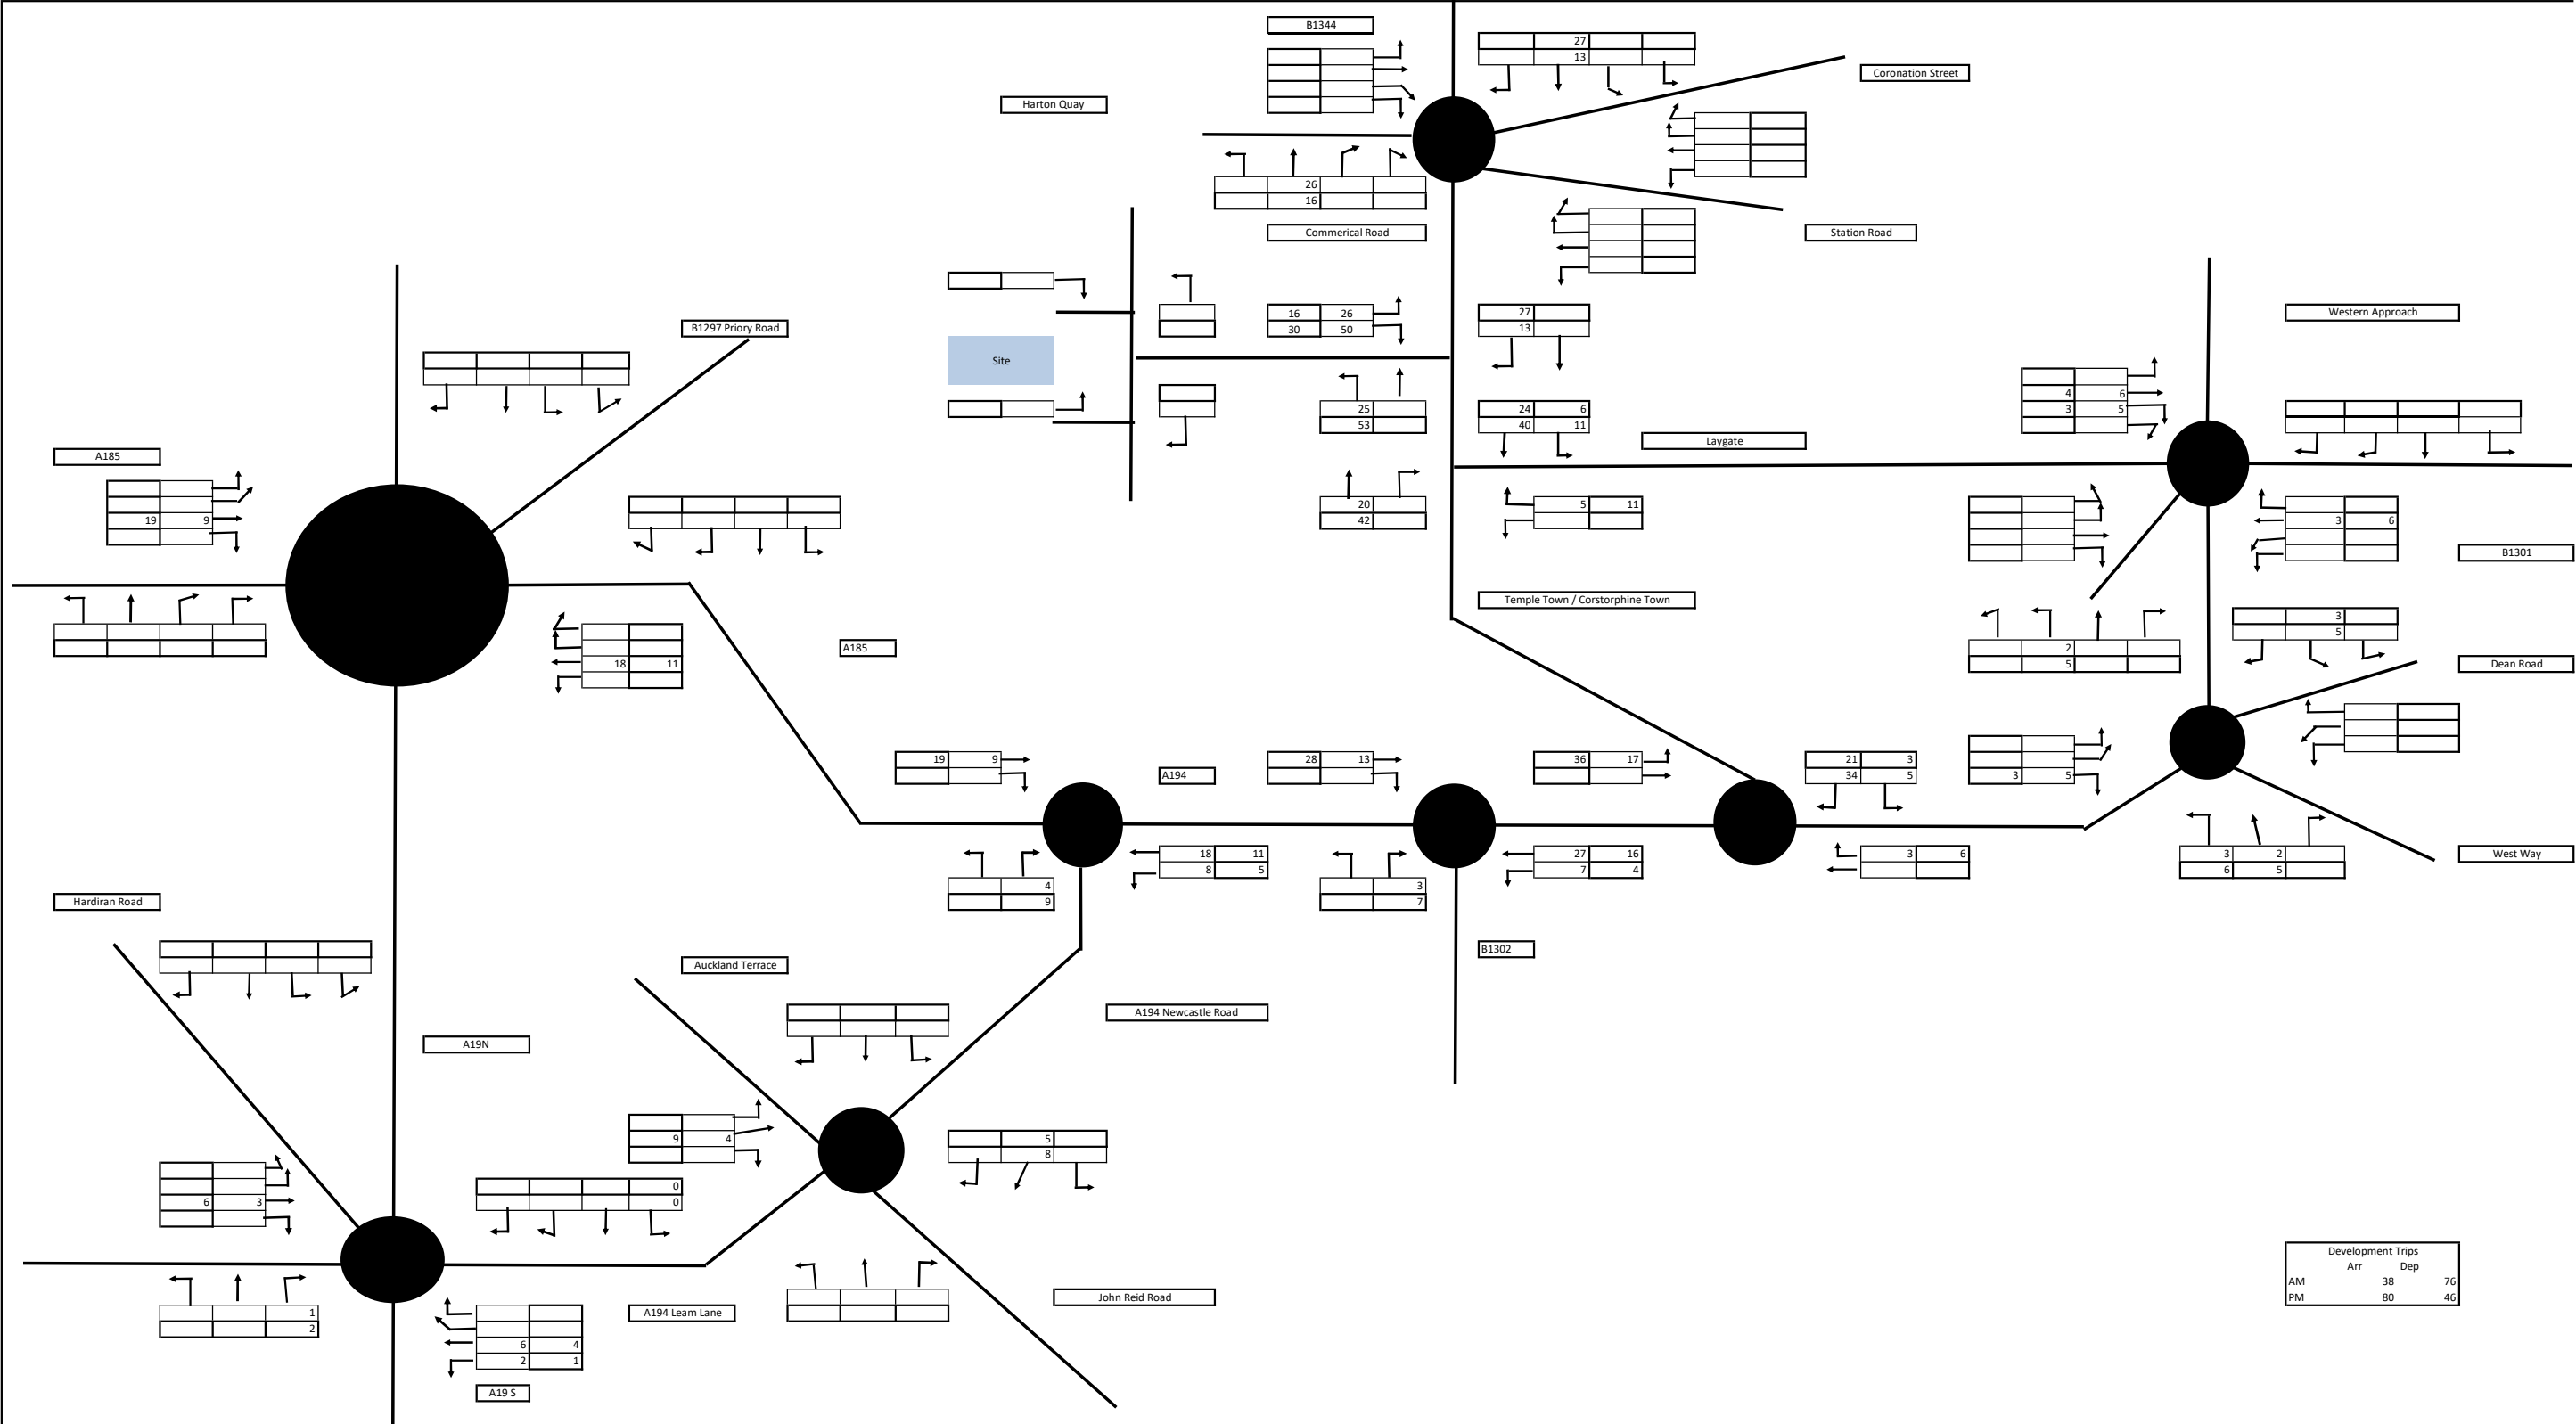
### Network Flow Diagrams

| Keepmoat Homes Ltd | Holborn Riverside | Gravity Model Distribution | | | | | Design | GH | Approved | GS |
