COAL MINING INVESTIGATION

25 MOORE AVENUE, SOUTH SHIELDS, SOUTH TYNESIDE, NE34 6AA
PREPARED FOR GARY CRAIG ARCHITECTURAL SERVICES LIMITED

Project No.	**GEOL20-9383**	**Client**	**Mr & Mrs Keith Thompson**
Report Type	**Coal Mining Investigation**		
Planning Ref.	**ST/0828/20/FUL**		
Design Team	**Gary Craig Architectural Services Limited**		
Project Type	**Proposed Residential Development**		
Site Address	**25 Moore Avenue, South Shields, South Tyneside, NE34 6AA**		
NGR	**437485, 564796**		
Date	**07/03/2021**

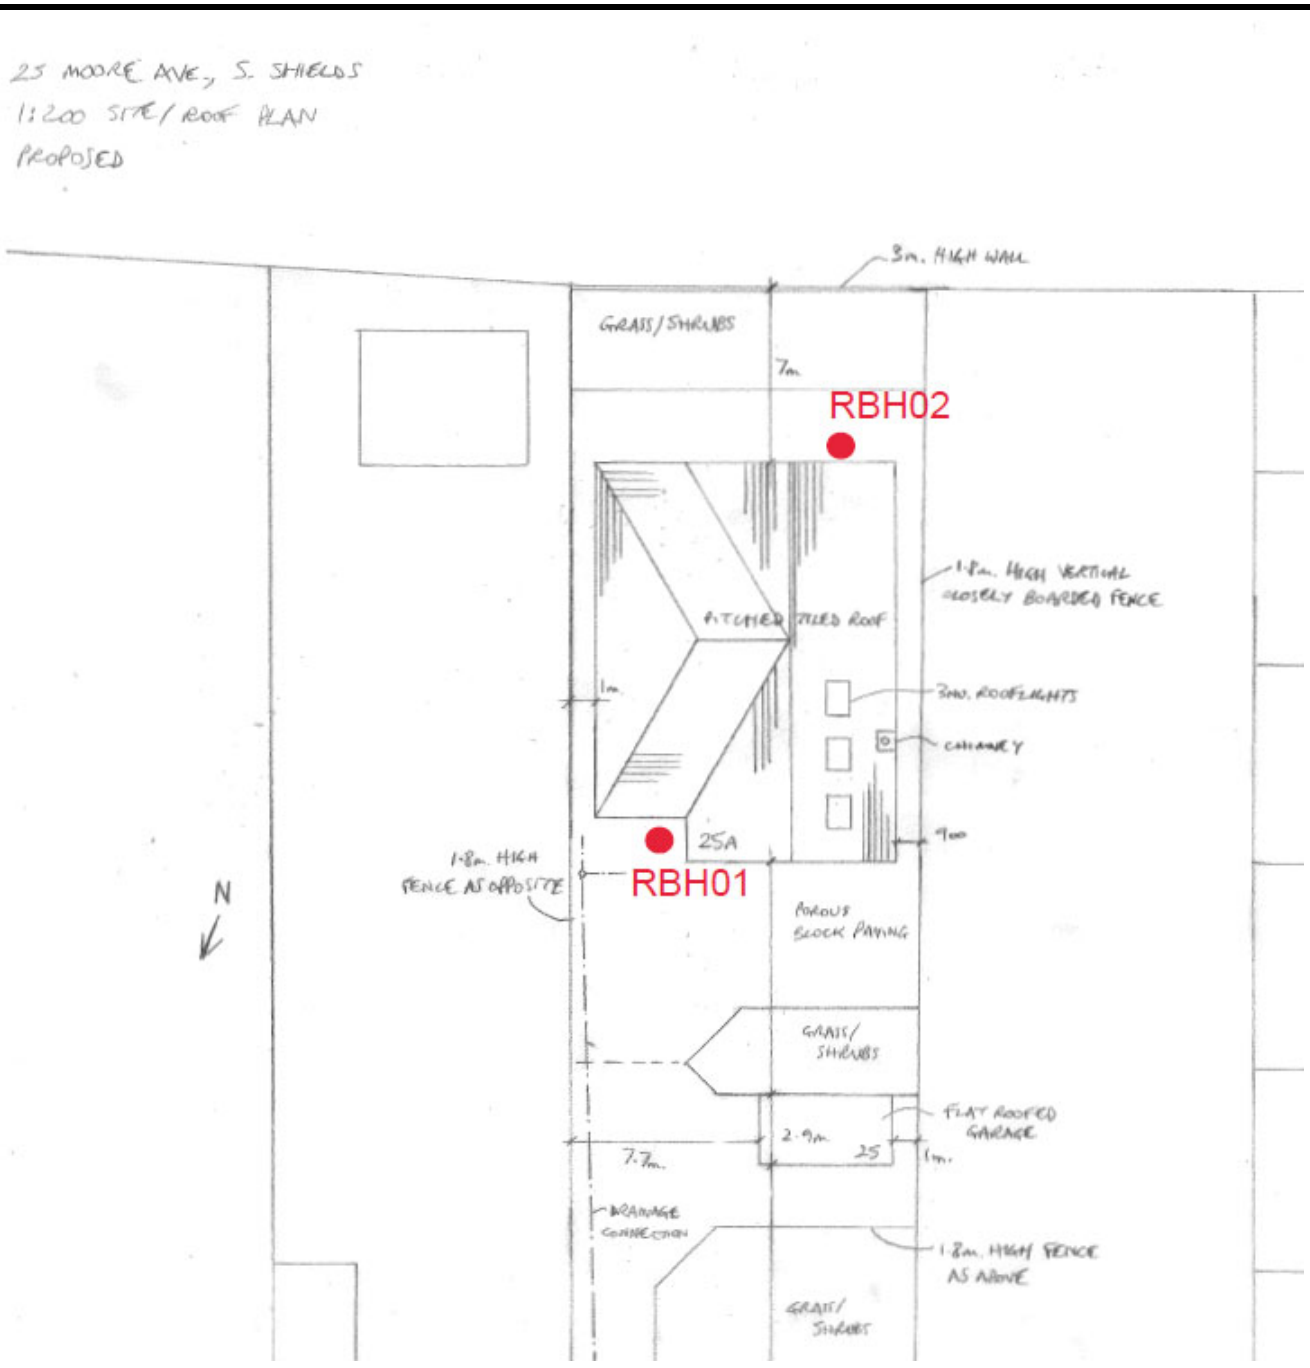
BOREHOLE LOCATION PLAN

At the borehole locations, natural limestone bedrock deposits were recorded at depths of between 3.65m (RBH01) and 3.80m (RBH02) and were proven to depths ranging between 9.15m (RBH01) and 9.25m (RBH02) before thin sandstone deposits were recorded (ranging between 0.50m to 1.35m in thickness).

No coal seams, or any evidence of coal workings (broken ground or voiding) or water ingress, were recorded at the borehole locations. Full (100%) water flush and steady drilling rates were maintained during the investigation period and there were no significant gas readings detected during and upon completion of the boreholes. The boreholes were backfilled with bentonite and made safe upon completion.

Based on the borehole investigation works completed, the site of the proposed residential building can be considered safe, stable, and suitable for development and thus no further assessment or intrusive investigation works are required with regards to historical shallow coal mining activities.
