TREE SURVEY

AT
SANDFIELD HOUSE
DOWNHILL LANE
WEST BOLDON

Document Title: TREE SURVEY

Date: 20th January 2015

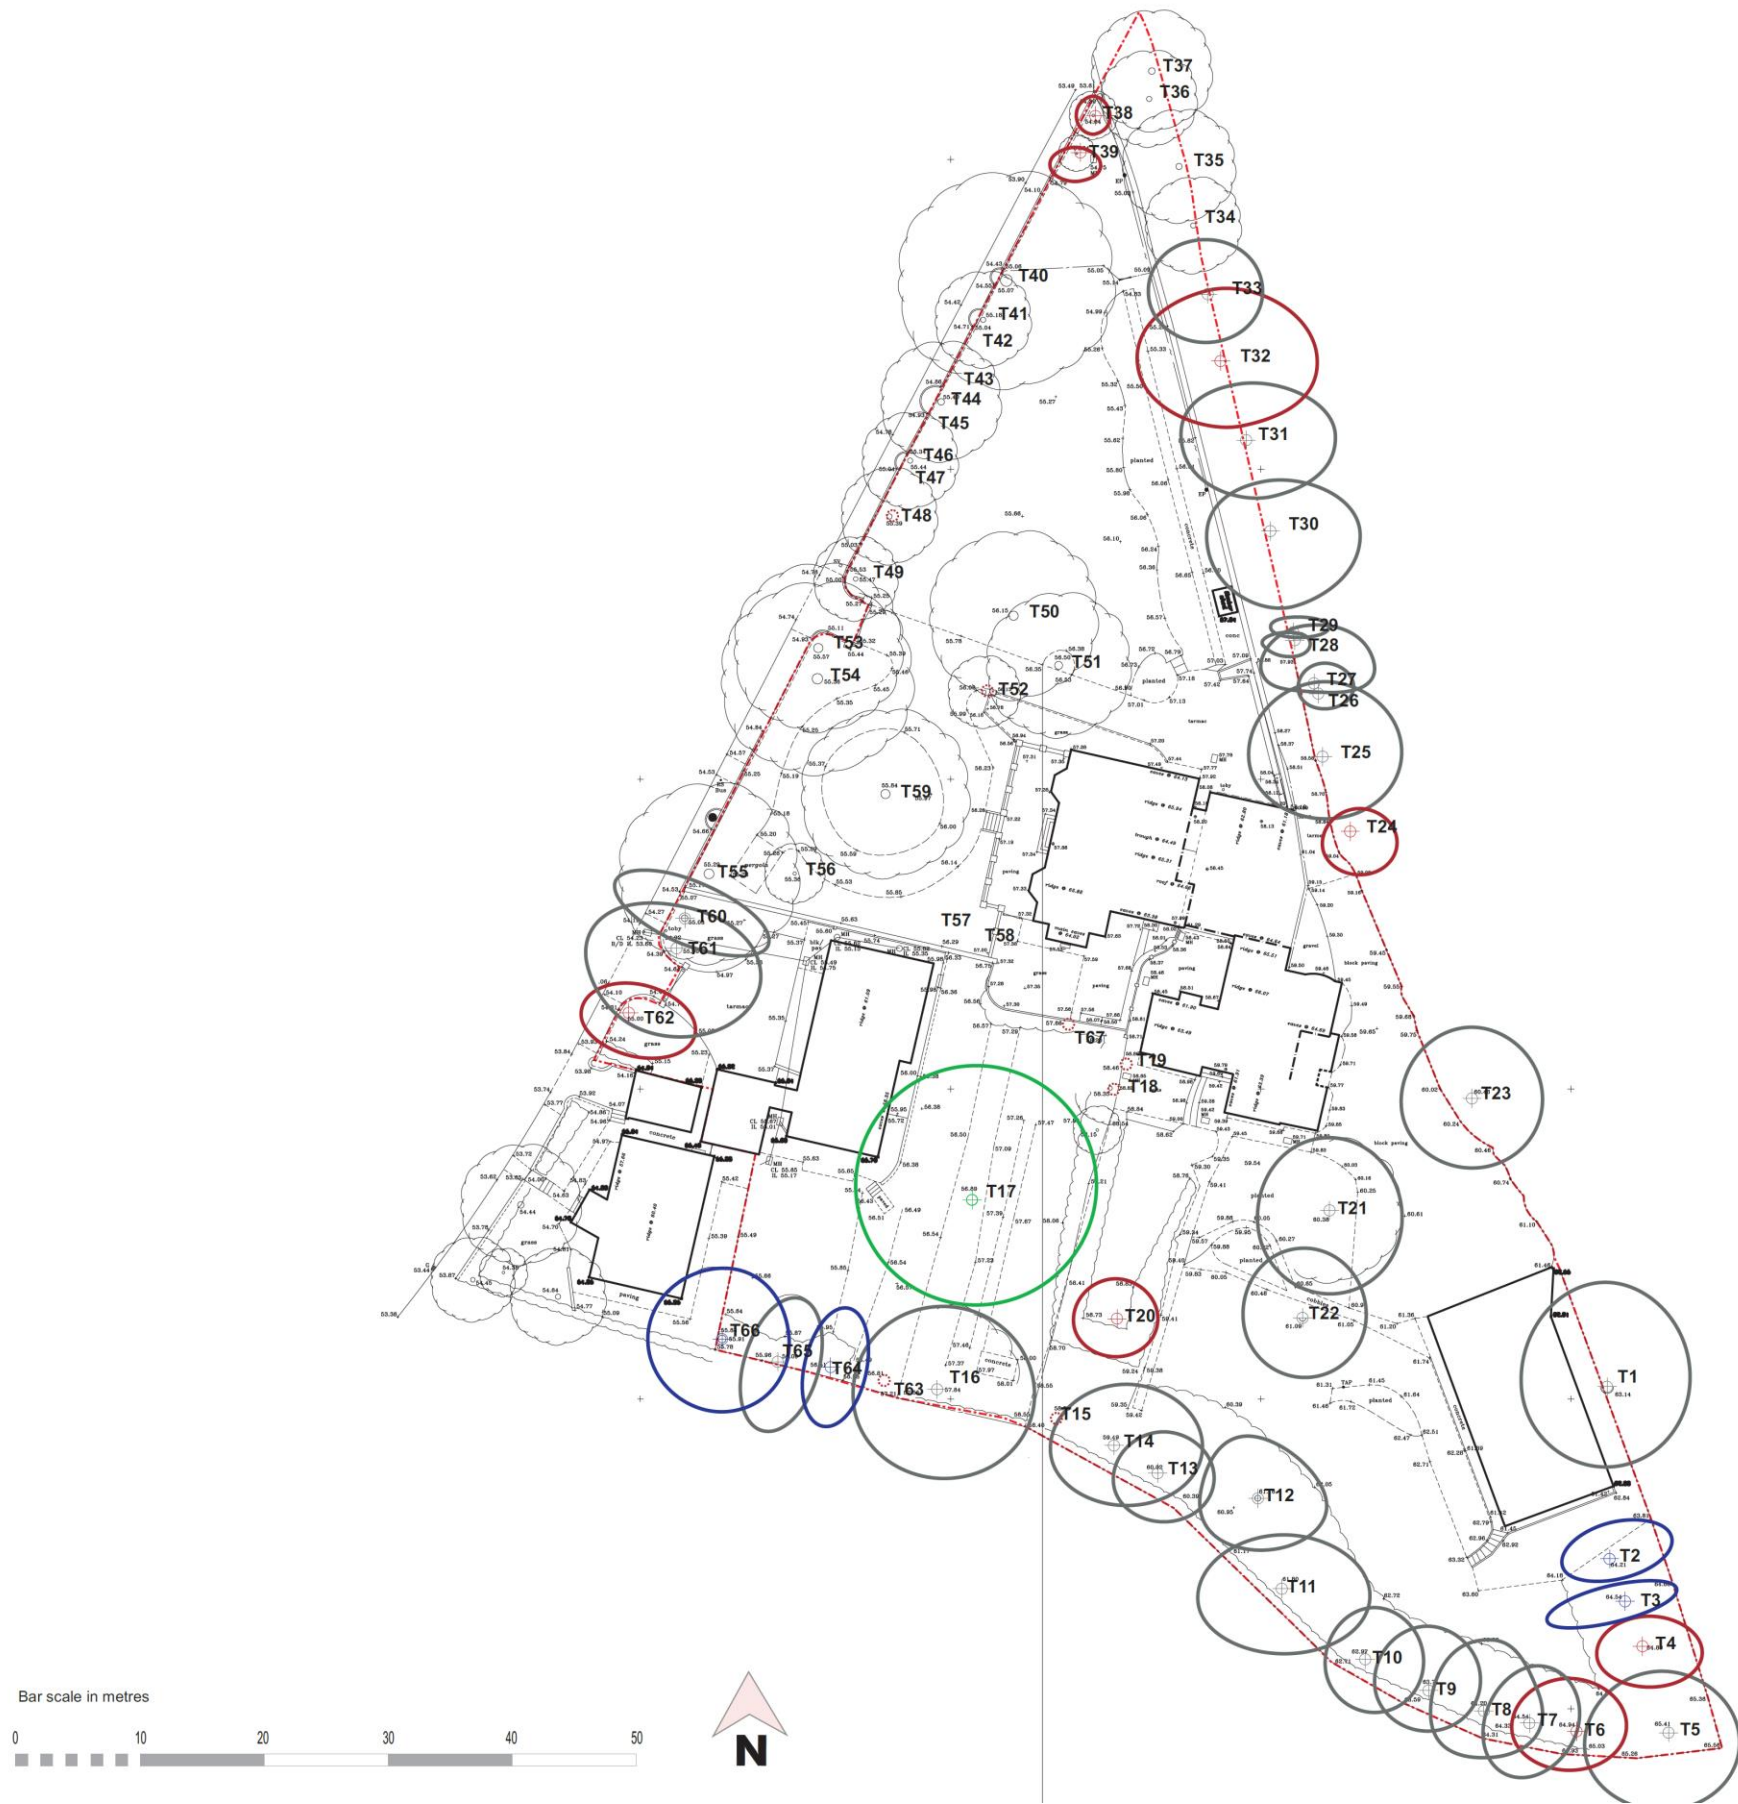
Figure 2: Tree Survey Plan

Based on this assessment, the trees were divided into four categories. All the surveyed trees with their categories, differentiated on plan by colour, are shown on drawing reference **ajt/ 735. Figure 2**. The tree reference numbers relate to the individual

2.3.4 A series of photograph plates are provided below, to illustrate the form, condition and location of the individual and groups of trees in context of the site and surrounding area. The location and survey reference of the trees is show on drawing reference **ajt/ 735. Figure 2**.

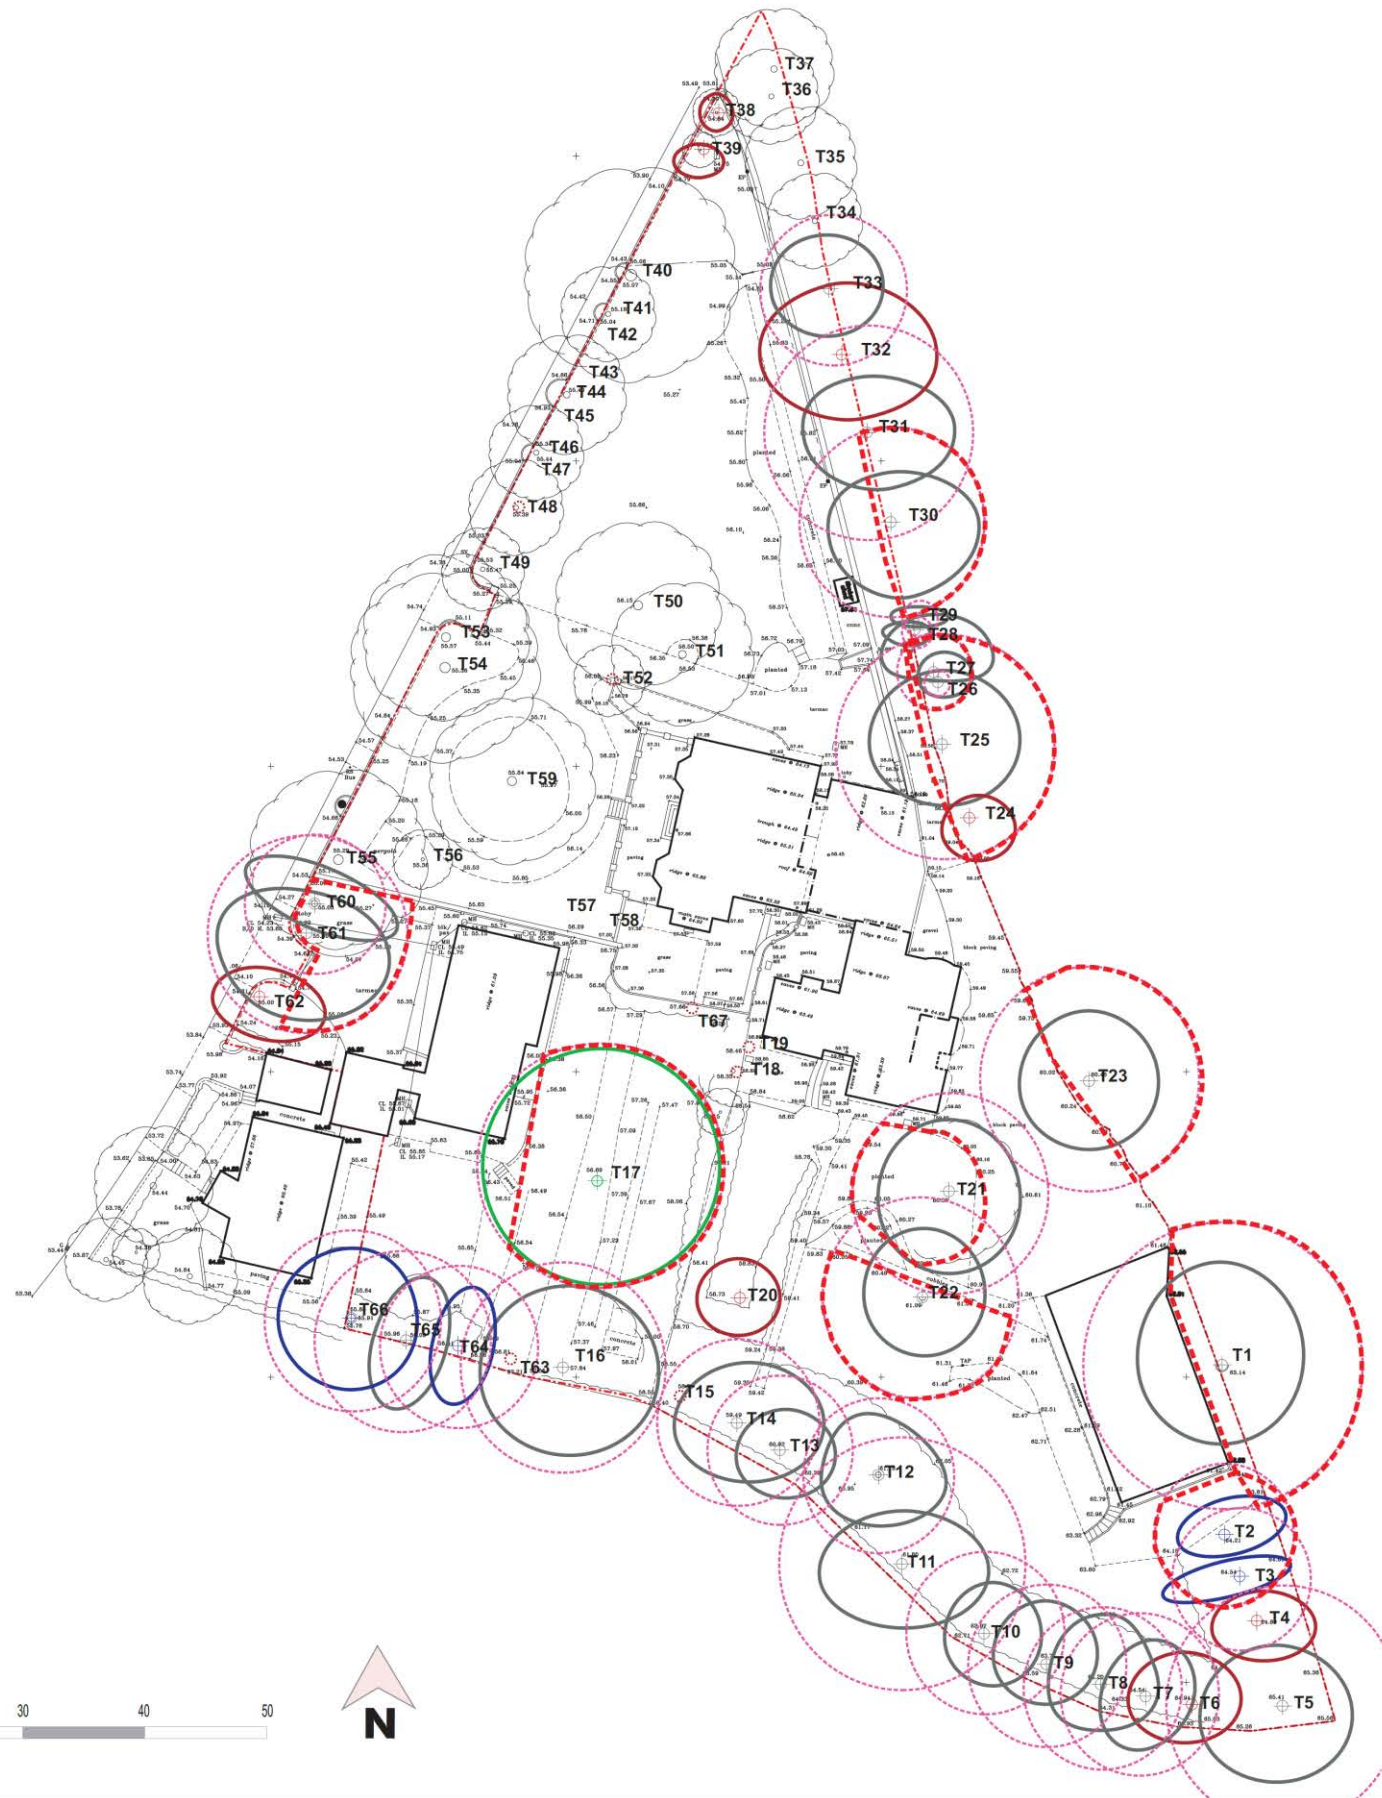
Figure 3: Tree Constraints Plan

The TCP is shown on the drawing reference **ajt/ 735. Figure 3.**

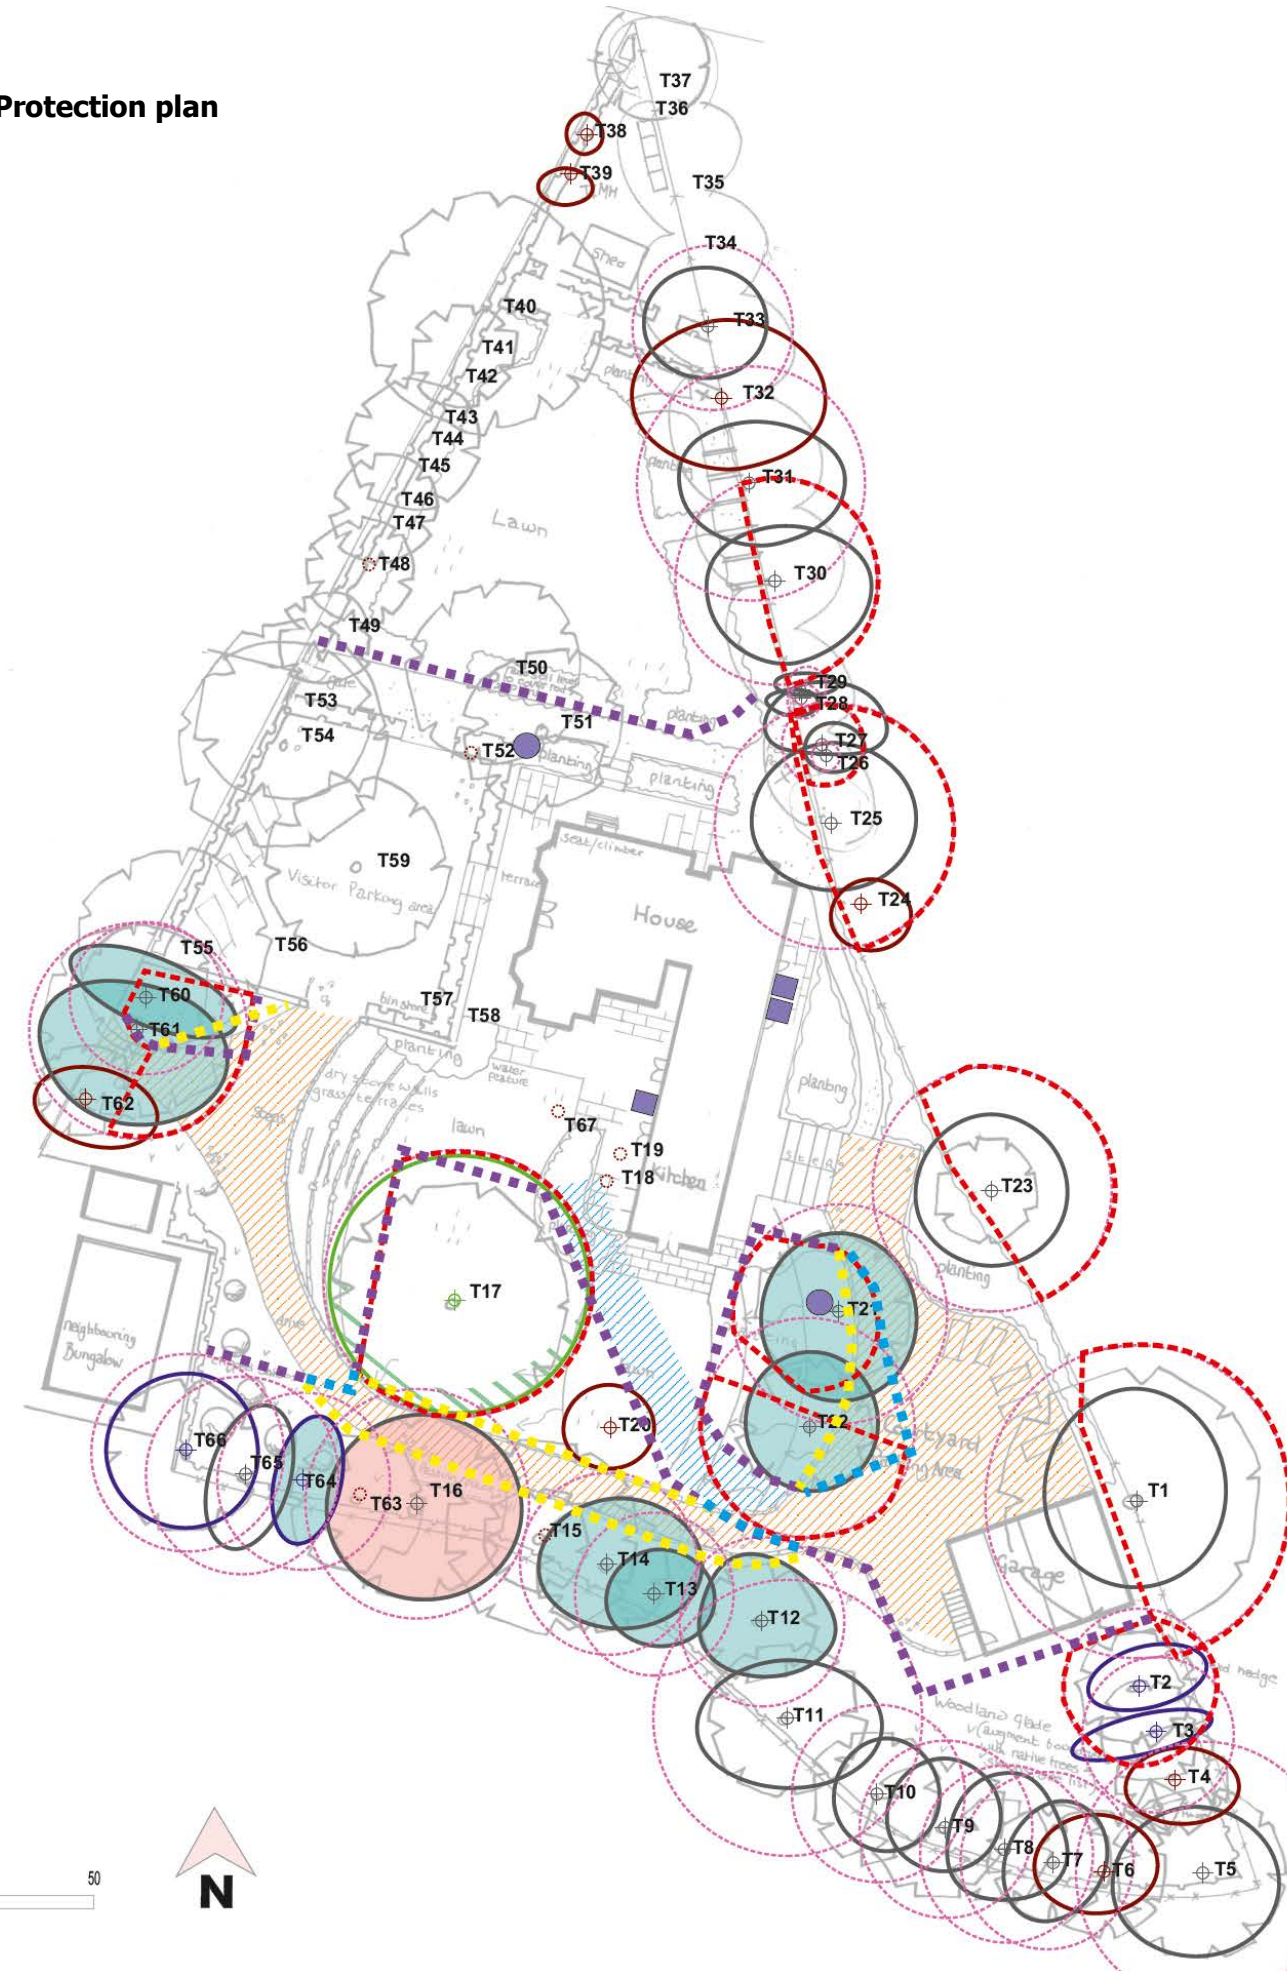
Figure 4: Arboricultural Impact Assessment and Tree Protection plan

- 3.3.5 The location of the proposed development, in conjunction with the surveyed trees and the tree protection to protect the Root Protection Area (RPA) during construction and marked as a construction exclusion zone, are shown on drawing reference **ajt/735.Figure 4**.

- 3.3.9 It is considered that the proposed development would not have a detrimental impact upon the trees to be retained, as long as the recommended mitigation works are undertaken to protect the trees from potential damage or harm during demolition and construction and safe guard their future survival. Planning and subsequent site management would aim to minimise disturbance of the existing trees to be retained and it is anticipated that the root protection area (RPA) as shown on **ajt / 735.Figure 4**, will protect the root systems to ensure the survival of the trees during the construction phase and for the longer term. The proposed protective barriers would be erected in the locations as required in accordance with BS5837: **2012, 'Trees In Relation to Design, Demolition and Construction - Recommendations'**.
