Mechanical Inspection Report

at
McNulty Yard
for
Port of Tyne

Prepared for: Port of Tyne
Prepared by: P McKay
Reviewed by: P Appleton
Date: February 2013

Project No: 5570

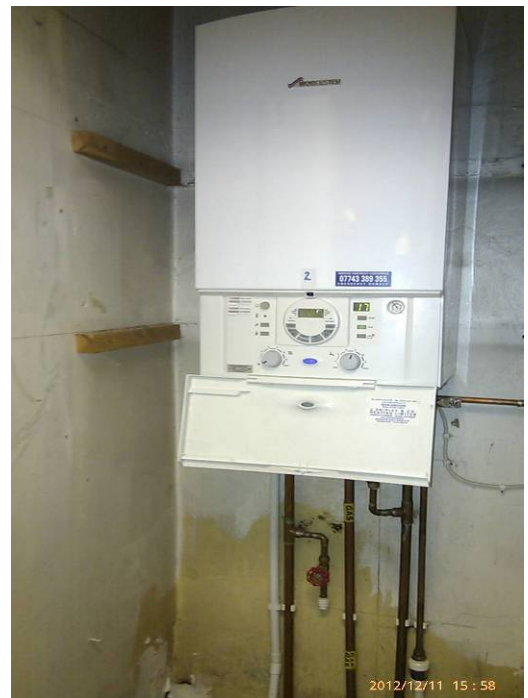
Combi Gas Boiler located in cupboard on stair landing

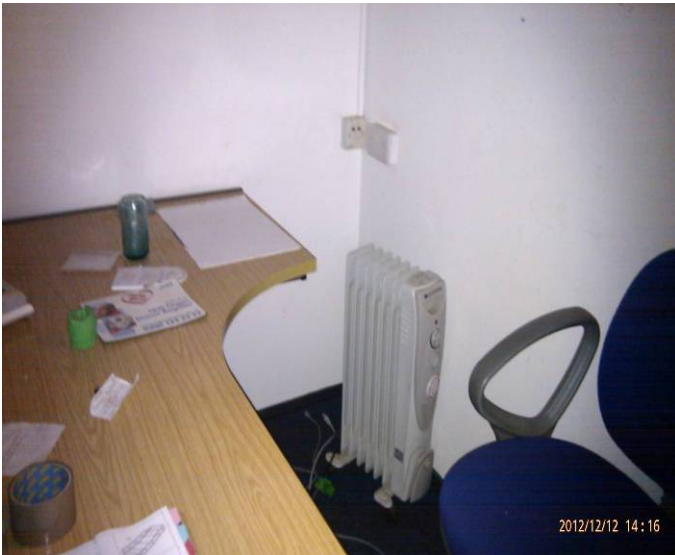
1st Floor Offices, Corridor Electric Heater

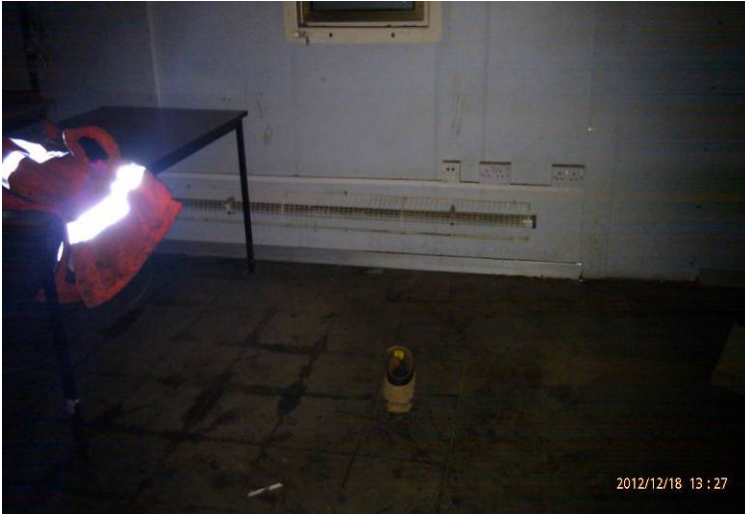
Electric Heaters Mess Area
