Structural Appraisal

St Hilda's Colliery South Shields

Tyne and Wear Building Preservation Trust

**October 2014
Project Reference: Q117**

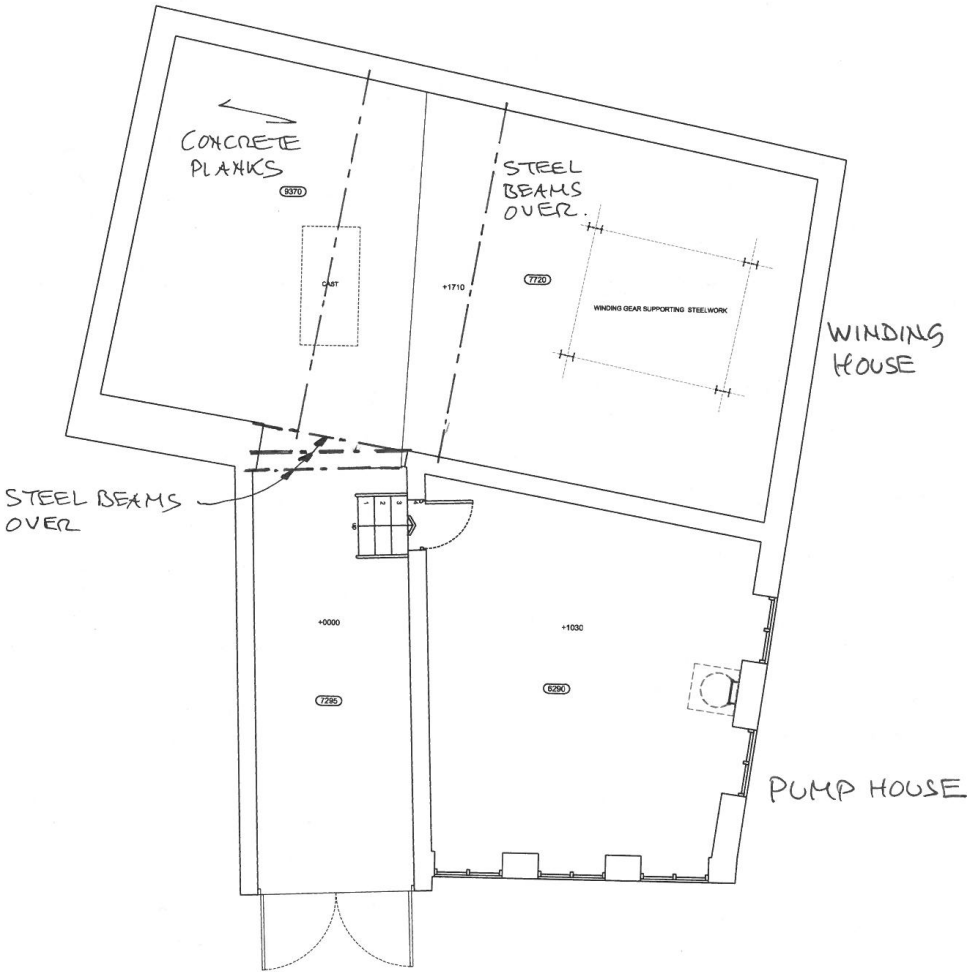
ST HILDA'S COLLIERY
STRUCTURAL ISSUES Q117/01
OCTOBER 2014

Of greatest concern however is the Winding House roof. The exposed steel beams are very corroded and large flakes of rust from the webs are lying on the flanges. The south end of one of the beams has corroded right through in places on its bottom flange.

There are also some heavily corroded beams over the entrance passageway through the Pump House. These are not of high significance structurally, but there is a risk of small pieces of rusting metal falling off.

The Winding House roof needs urgent replacement. It is not practicable to repair it in-situ because the steel beams need to be replaced and they must be located in the same place as the existing, because the concrete planks span from one to the next. The concrete condition is more difficult to assess from ground level, but if the beams are to be replaced the concrete will have to be renewed too.
