# Harton Quays, South Shields, Tyne and Wear.

## Historic Wall Survey

Curtins Ref: 076755-CUR-XX-XX-RP-S-00101

Client Name: Muse Developments Ltd

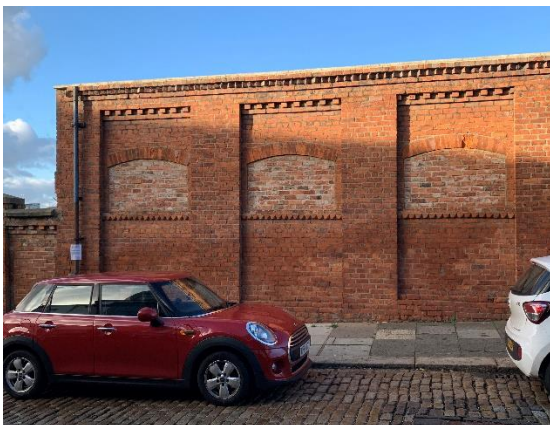
**Photograph 7:** *Wall Section 3*

- This section of the wall is the remaining façade of Staithes House and comprises of 950mm long x 500mm deep masonry piers at approximately 3m centres. Between these piers are masonry panels set back 100mm former the face of the pier. These masonry panels then have old window openings in filled with relatively new masonry. These window openings have flat arch above them instead of a lintel. This wall also has decorative dental work masonry to window sills and head of the wall. (Refer to Photograph 7 in Appendix A)

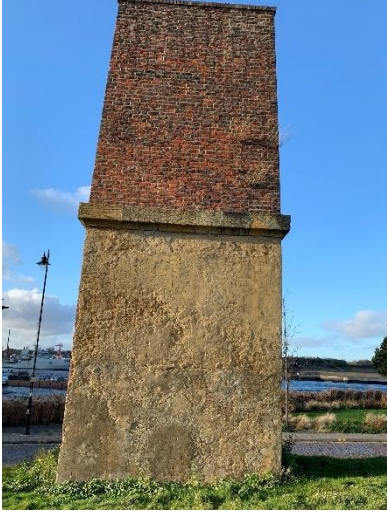
<p><b>Photograph 37:</b> <i>Chimney South Elevation</i></p>	<p><b>Photograph 38:</b> <i>Chimney South Elevation</i></p>

- The upper section of the west elevation appeared in reasonable condition for its age although it was heavily weathered with some mortar loss to joints. The lower section of wall has been rendered however most of this render had now been weathered and fallen off with 20% remaining on the wall. The render that remained was loose in several areas and could be dislodged with little effort. The brickwork now exposed by the loss of render appeared in reasonable condition given its age. (Refer to Photographs 33, 34, 35 & 36 for West Elevation in Appendix A)
- The south elevation had a horizontal crack in the render that appeared to emanate from the brickwork below. (Refer to Photograph 38 in Appendix A)
