## BUILDING SURVEY

**Property Address**The Former Coach House & Link  
Structure to Original Building  
Single Storey Offshoot:3 Beach Road  
South Shields  
Tyne & Wear  
NE33 2QA

The instructions are specific and restricted to inspection and assessment of structural condition of the Coach House and adjoining single storey structure built up between the Coach House and the gable wall of the original single storey offshoot structure built out to the rear of 3 Beach Road, South Shields, Tyne & Wear, NE33 2QA.

Tuesday 8 May 2018

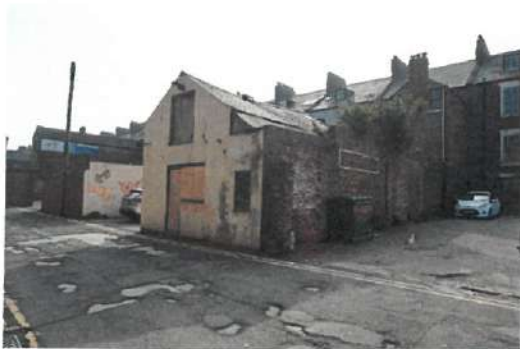
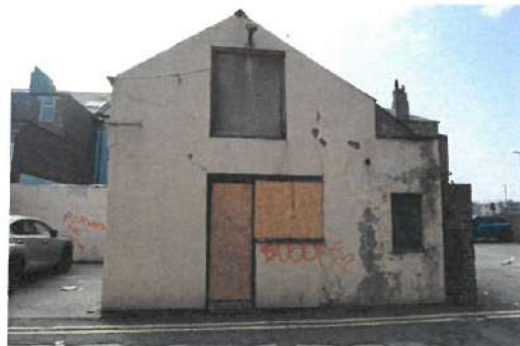
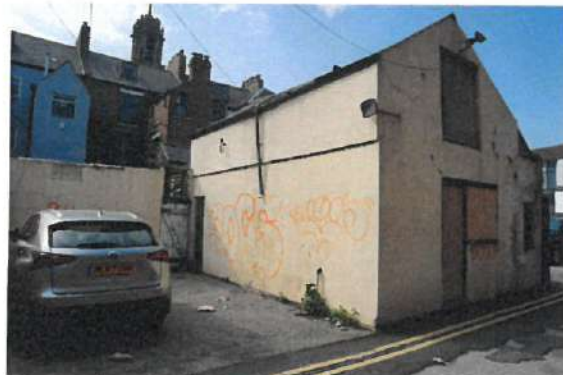
To the rear of the site of 3 Beach Road, NE33 2QA there is a former Coach House built up from the rear lane boundary, that structure having been abandoned, in disuse and subsequently now in derelict condition.

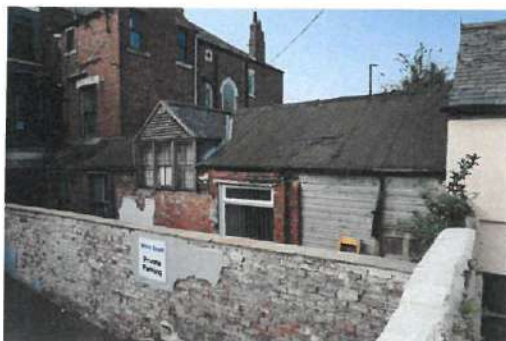
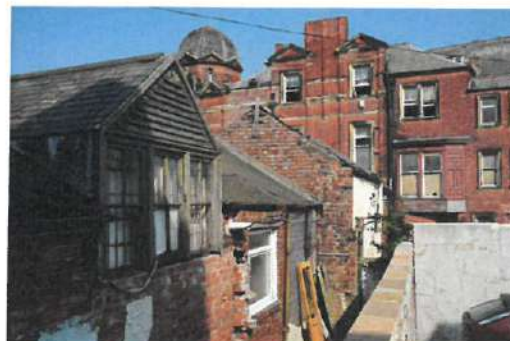
This structure has attachment to the original single storey built out extension structure to the rear of the original build two storey offshoot formed by enclosure of the open yard space that was formerly between the external wall faces of the single storey offshoot structure and the south gable wall of the Coach House with a pitched slate roof, the opening to the yard enclosed with a timber framed structure with horizontal set shiplap style timber cladding to the external face.

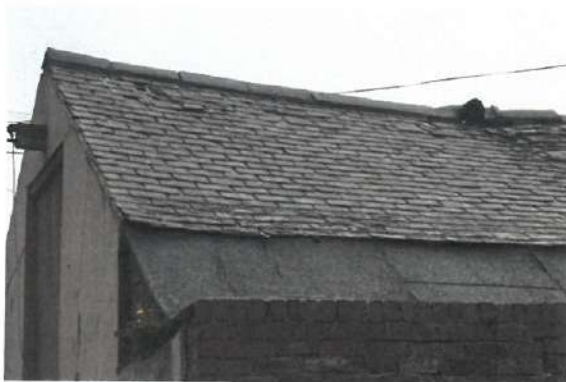
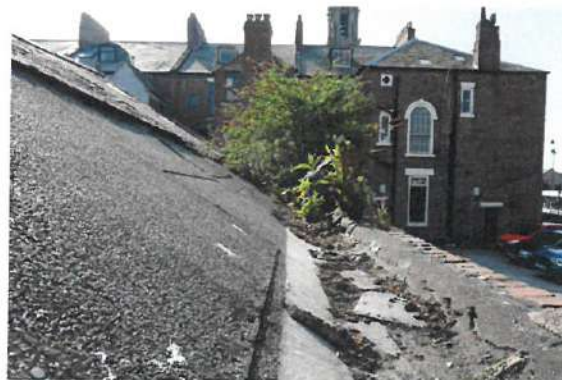
### **Base of Coach House West Roof Pitch Single Pitch Felt Roof Covering**

The mineralised felt roof covering applied to enclose the passageway that was positioned between the west wall face of the Coach House structure and the west of site boundary wall has a mineralised felt covering.

The mineralised felt roof covering is a basic grade oversurface application, as demonstrated by the securing to position of feltwork elements with zinc nails.

To the base of the single pitch felt roof there is a formed and lined gutter, that lining material defective and substantially blocked with mature growth vegetation.

The single pitch mineralised felt surfaced roof covering to the enclosed passage would require replacement, in full, to achieve an effective extent and longstanding repair.

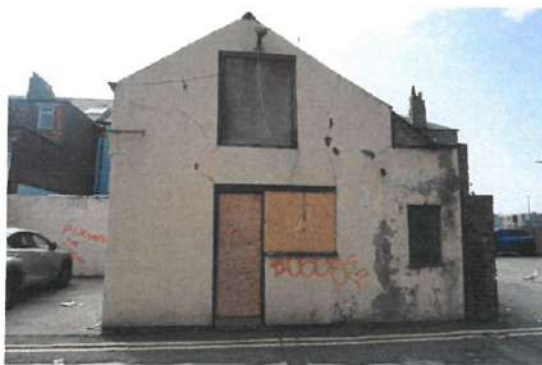
To the north gable wall, the believed to be original hay loft entry point appears to be retained, whatever wall opening was in place at ground floor level having been built up and modified to form a combination pedestrian door and window unit.

The rendering will have been applied, in part, to provide cosmetic disguise to the modifications carried out to the north gable wall.

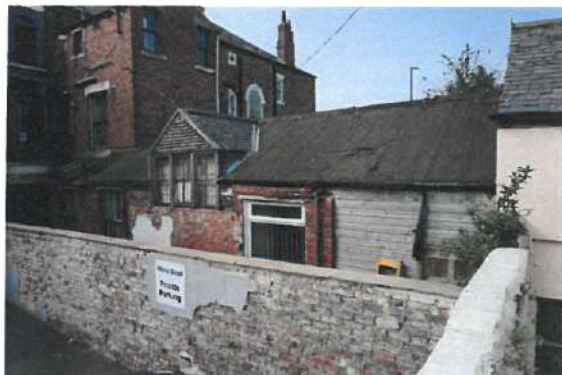
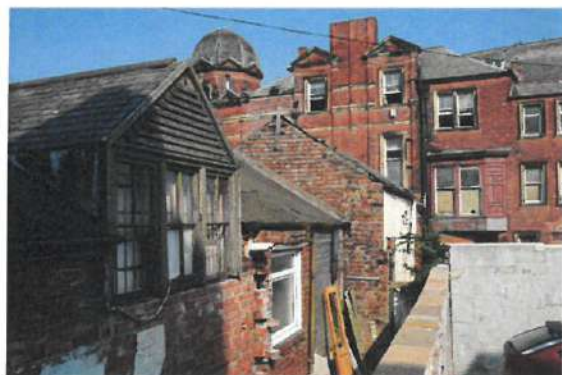
The east wall to the basic form link structure is timber framed with shiplap style timber cladding external wall face.

A pedestrian door is fitted.

The timber framed and externally shiplap board clad wall will need to be removed, in full, and replaced.

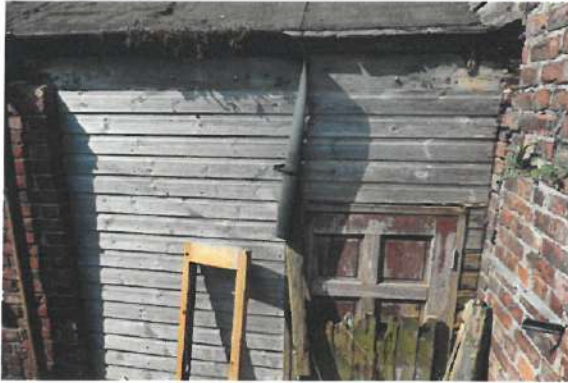
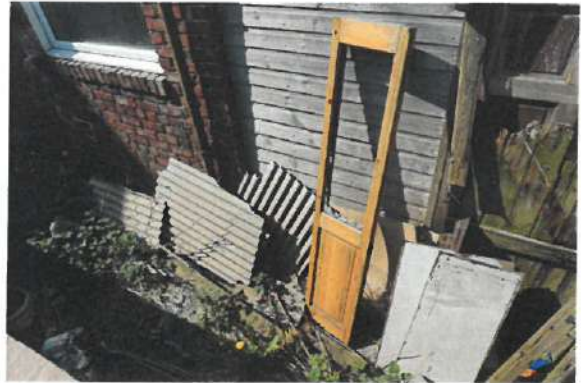
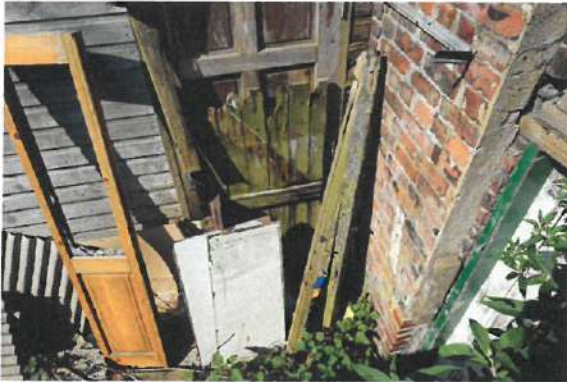
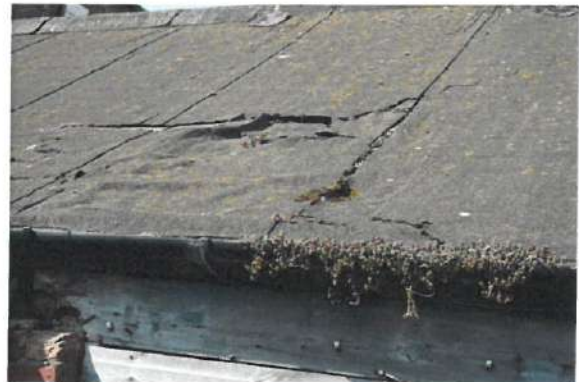
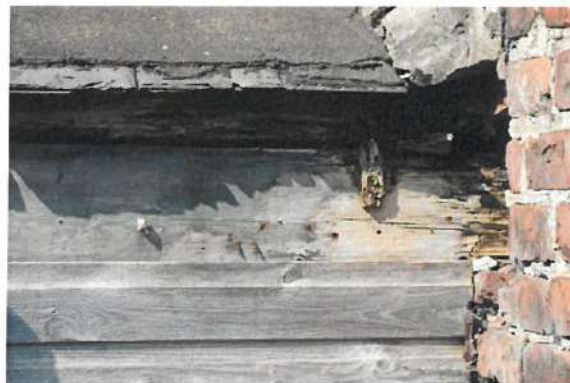
Timbers to the base of the timber clad external wall finish and to the base of the door could not be seen as materials and debris were placed against those base external wall areas.
