## Damp Survey

1 & 3 Beach Road, South Shields, NE33 2QA

Glen Griffiths

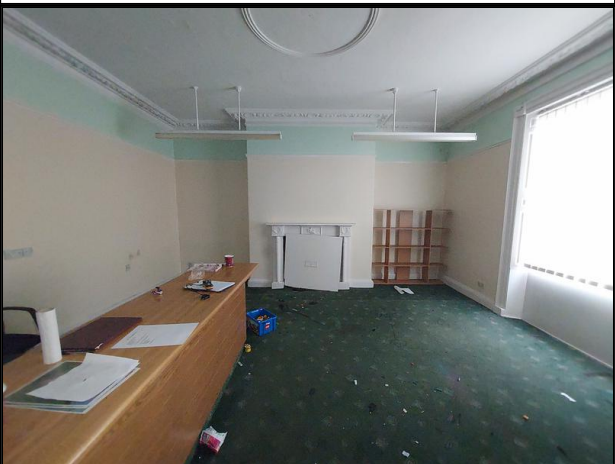
Figure 48 - Chimney Breast

A timber panel concealing the fire place was removed and unveiled a significant amount of soot and debris in the mouth of the opening, where the flue appears to have suffered from collapse.  
(See figures 48 - 50)

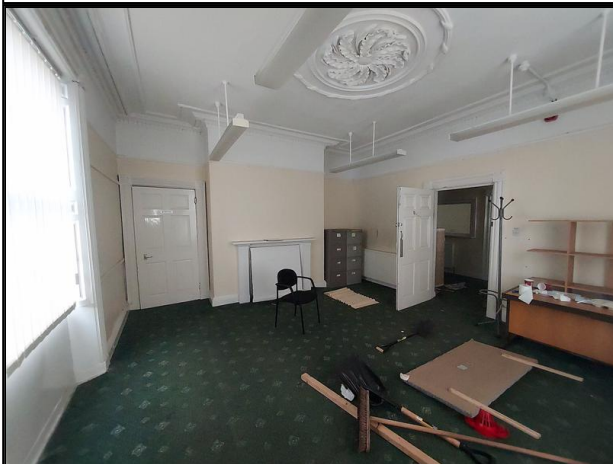
Figure 51 - Chimney Breast

(See figures 51 - 53)

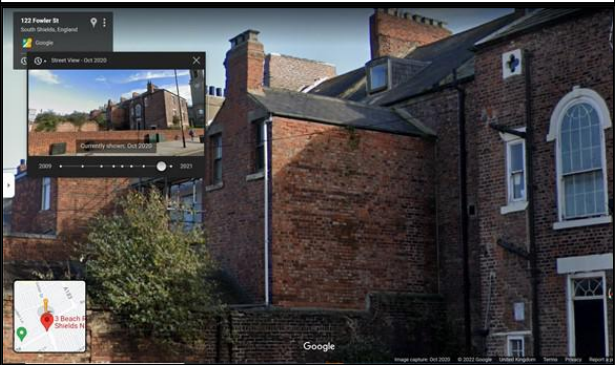
Figure 58 - External Wall

(See figure 58)

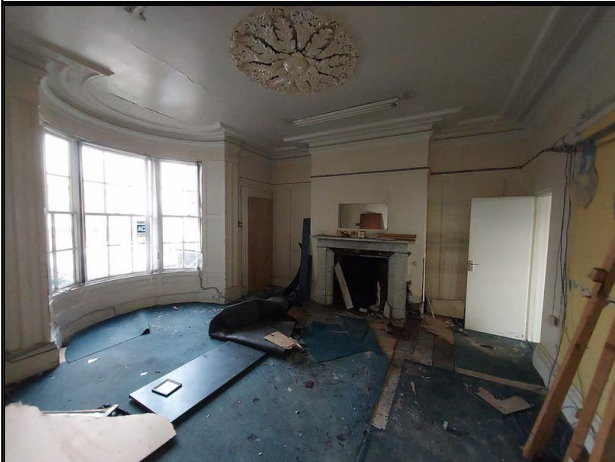
Figure 59 - Chimney Breast

appears to have been attributed to partial collapse of the flue lining.  
(See figures 59 - 62)
