| <b>Title:</b> | <b>BS:5837 Tree Survey, Arboricultural Impact Assessment (AIA), Arboricultural Method Statement (AMS) &amp; Tree Protection Plan (TPP)</b> |
| <b>Client:</b> | <b>Fokhrul Islam</b> |
| <b>Site:</b> | <b>Marsden Cottage, South Shields, NE34 7AD</b> |
| <b>Date:</b> | <b>23 September 2025</b> |

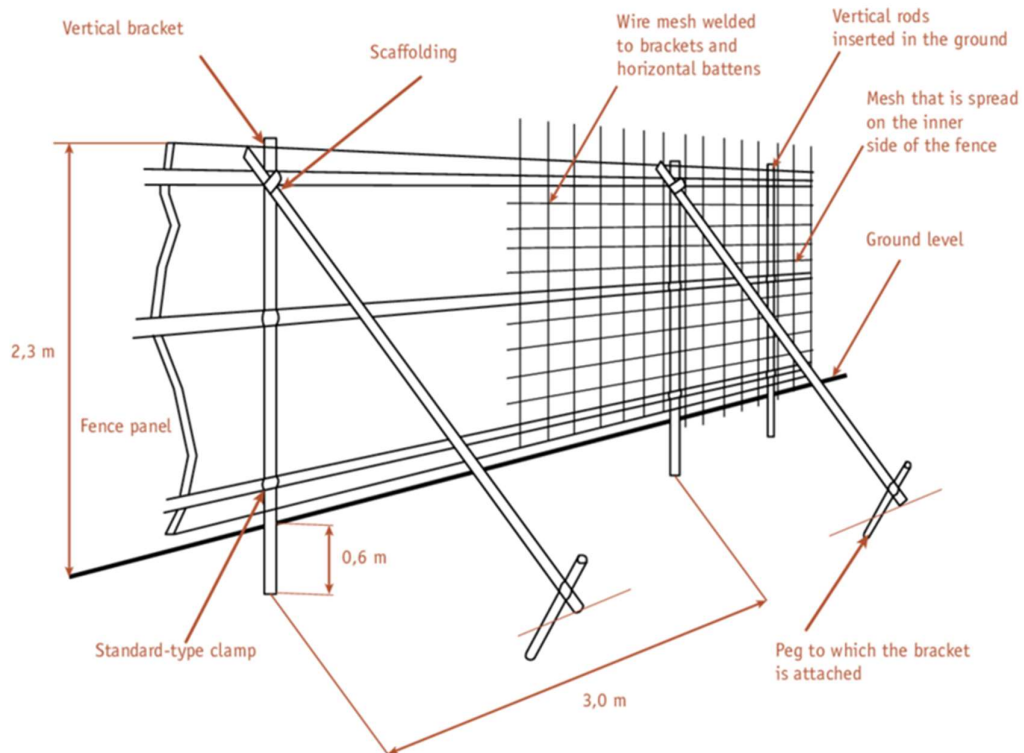
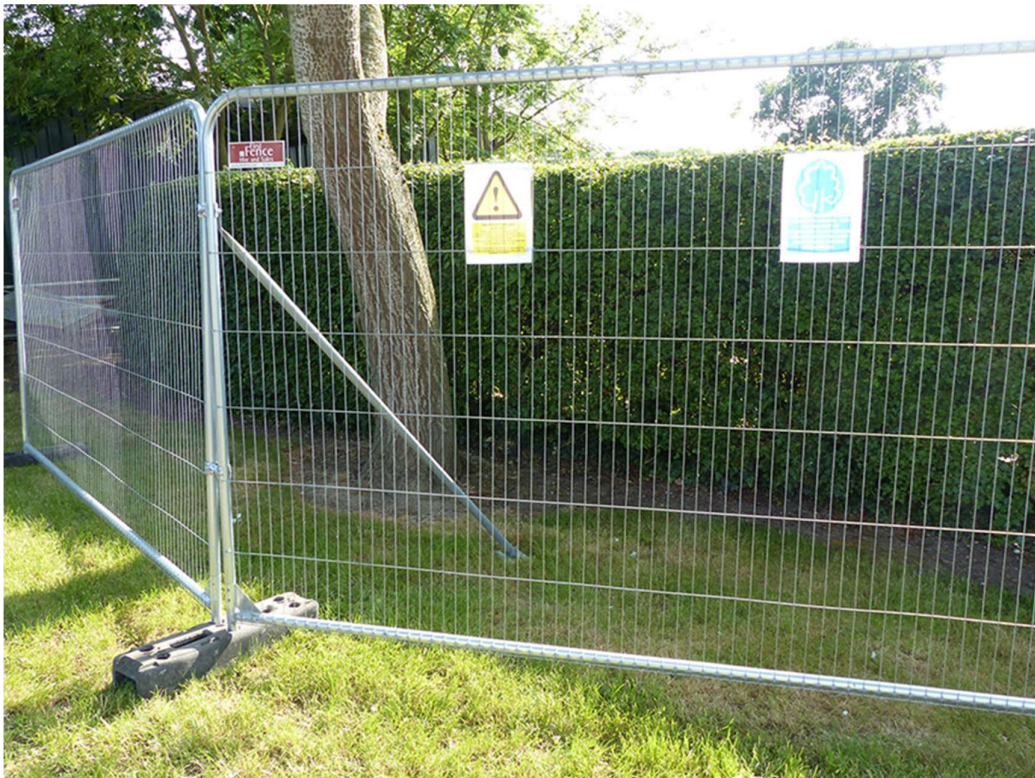
4.10 **Potential Impact:** Damage to the tree's rooting zones or tree roots during construction phase.

**Solution:** Install tree protection fencing in the location given in the Tree Protection Plan (appendix 7.5) to the following specification.
