**CASTLE**

**16 BARRINGTON STREET  
SOUTH SHIELDS  
TYNE AND WEAR  
NE33 1AN**

**SPECIFIC DEFECT SURVEY**

**FEBRUARY 2026**

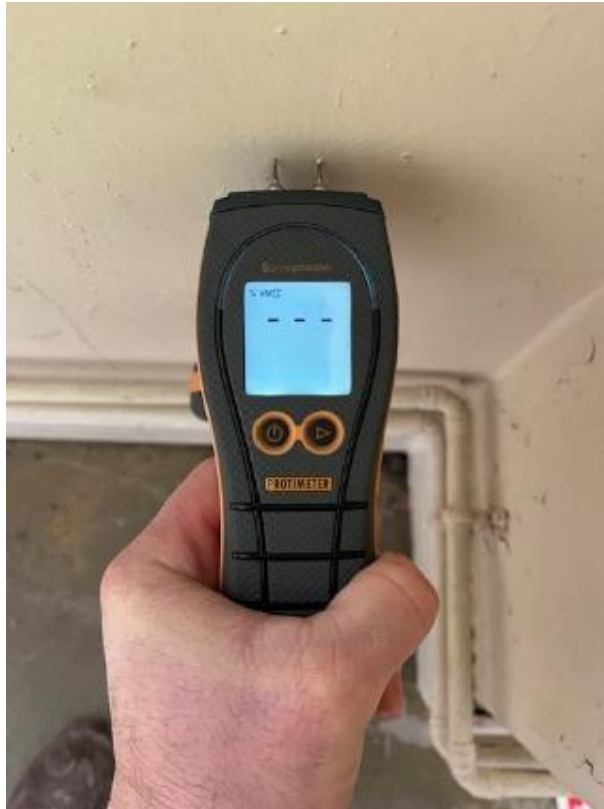
P6 – Store Room, no moisture content recorded

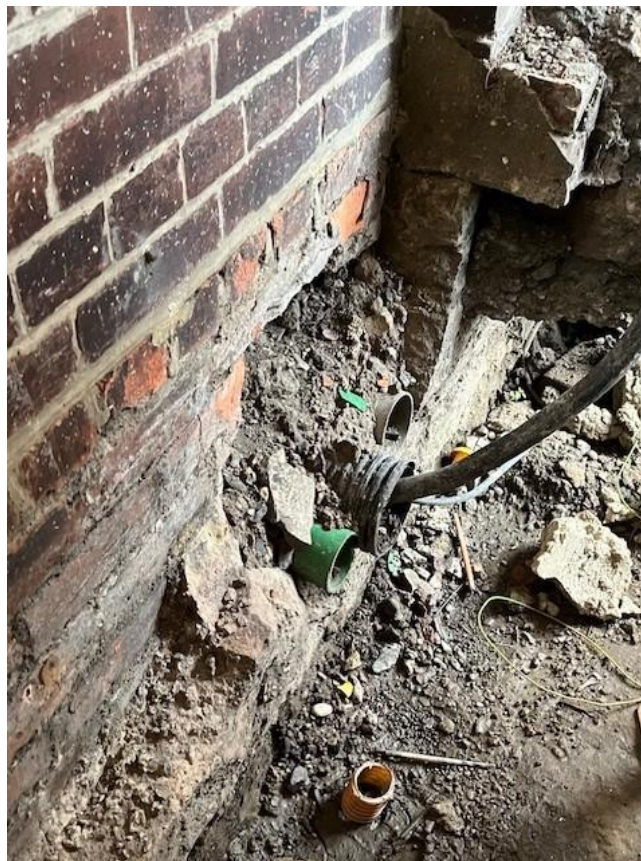
P9 – East Elevation services penetration below ground level  
Note ground level above finished floor level

- To prevent bridging and the transfer of moisture from the new path directly into the masonry walls it is recommended that a vertical damp proof course inserted as an isolating layer between the walls and the path; this is good practice and will eliminate the risk of any penetrating dampness. A sketch detail is enclosed in Appendix C and manufacturer's Product Details in Appendix E. It is also advised that a slight cross-fall is incorporated into the path to ensure surface water does not run towards the external wall
- Install vertical damp proof membrane collars around the below ground penetrating services

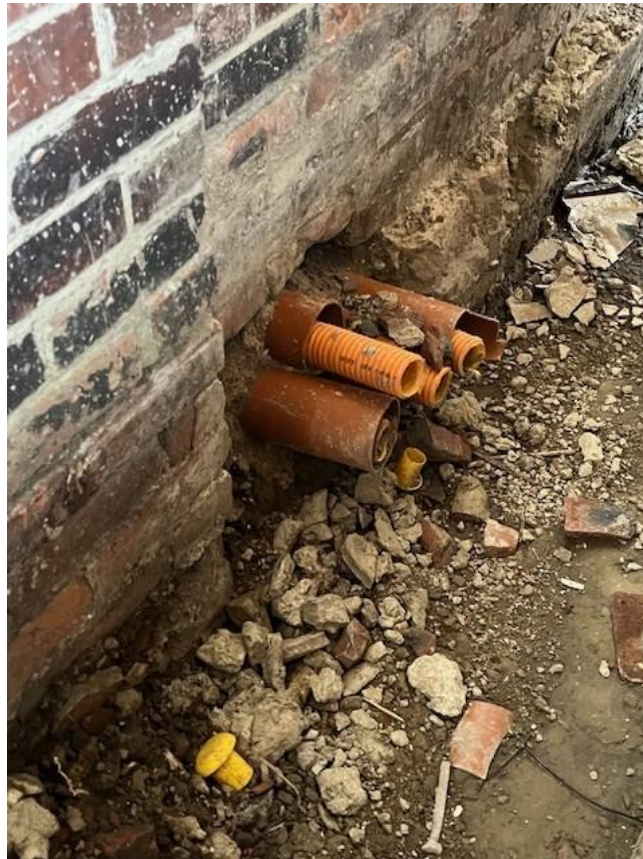
P14 – East Elevation services penetration

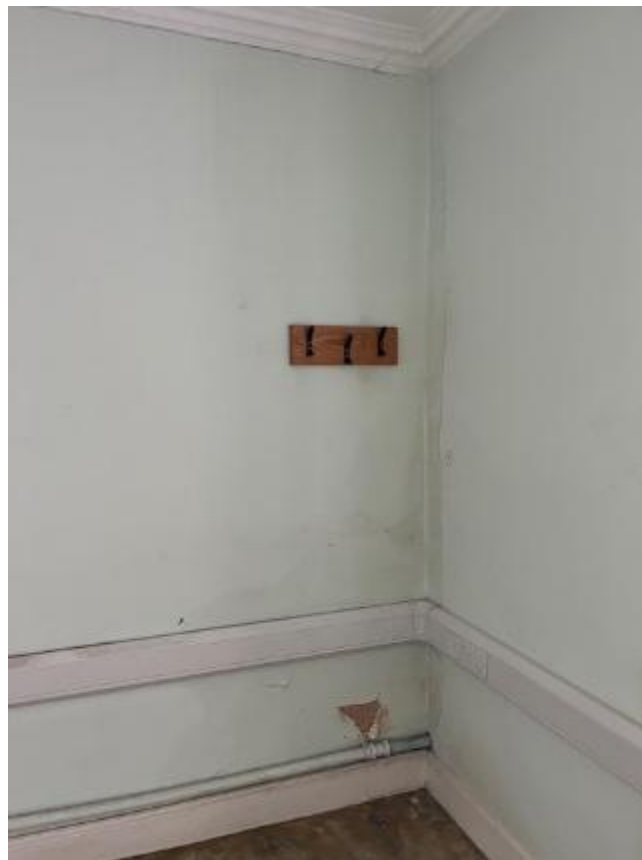
P38 – Visual evidence of penetrating dampness

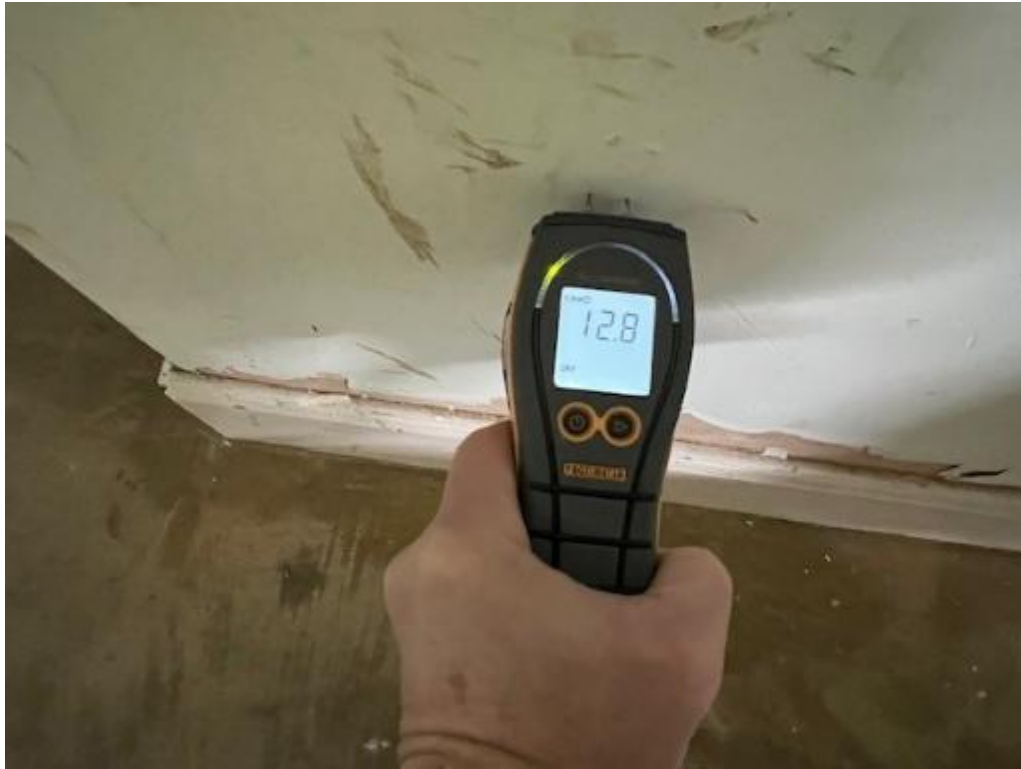
P64 – Wall 12.8% moisture content

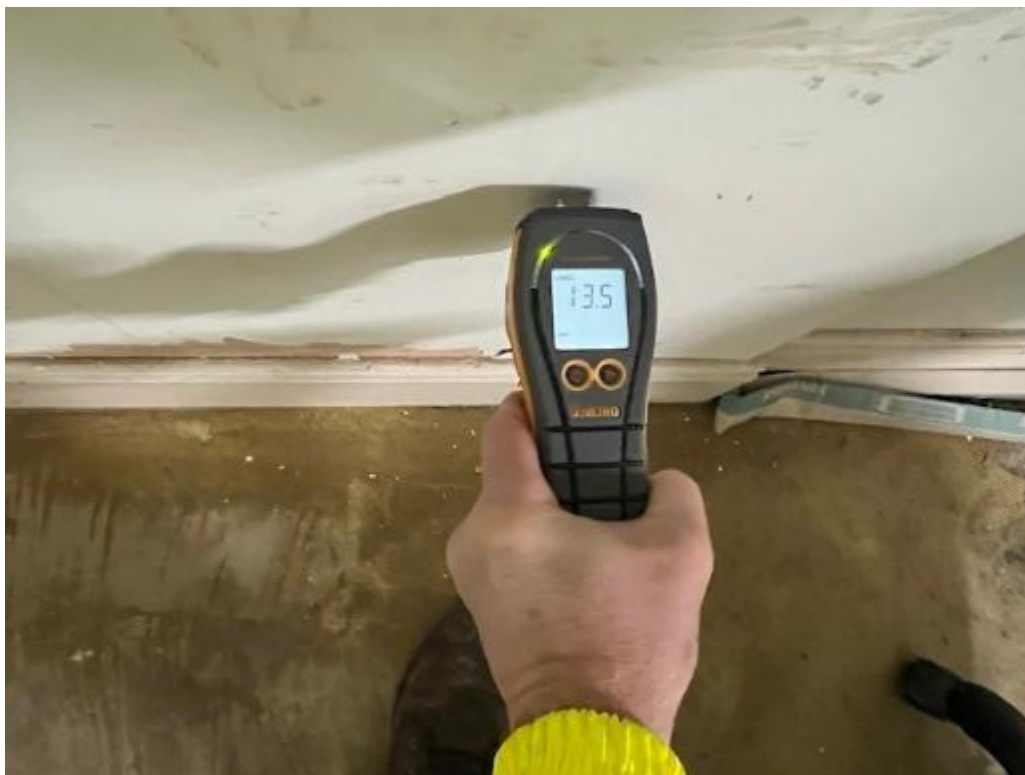
P65 – Wall 13.5% moisture content

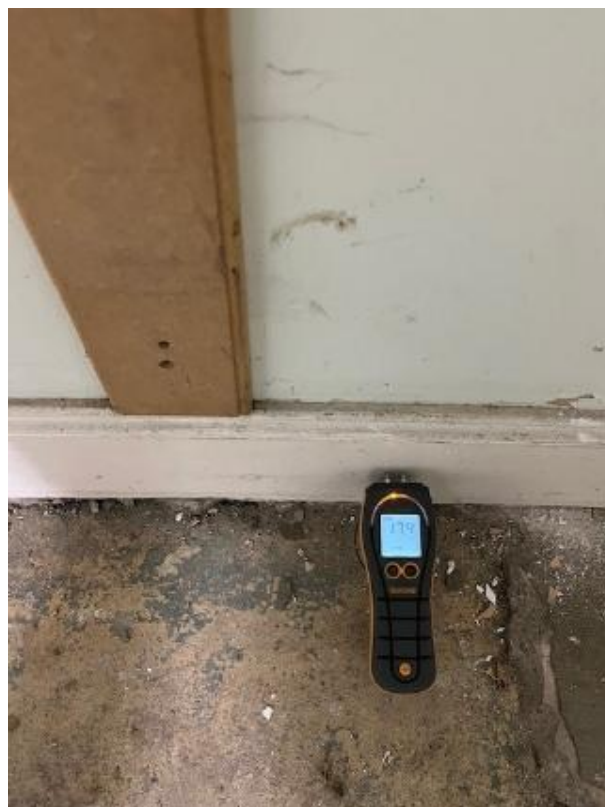
P67 – Circulation Area 02, Wall skirting 17.4%
