## Survey Report & Proposal

16 Barrington Street  
South Shields  
NE33 1BB

Date of Report: 12/02/2026

Our Reference: NE16318-UPDATED

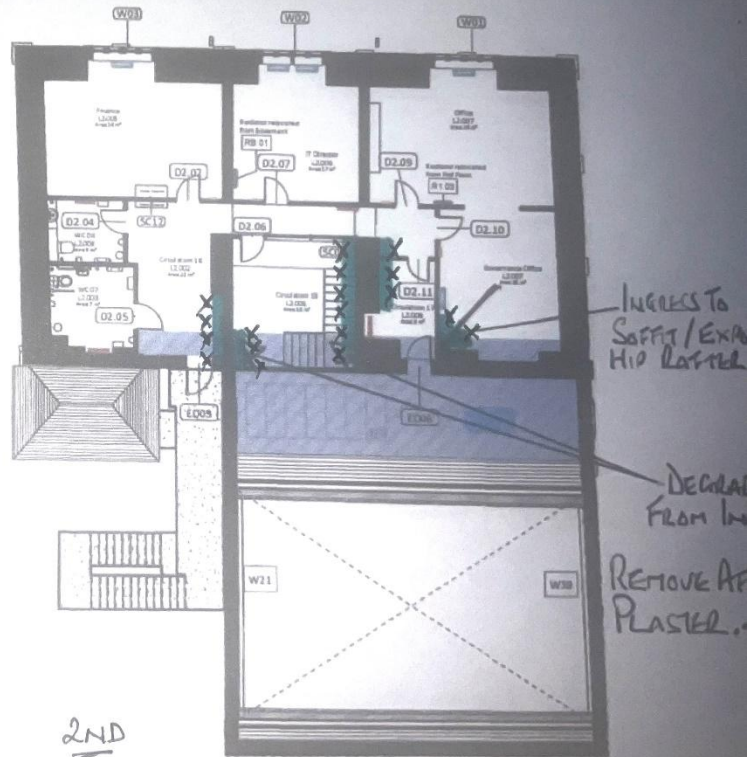
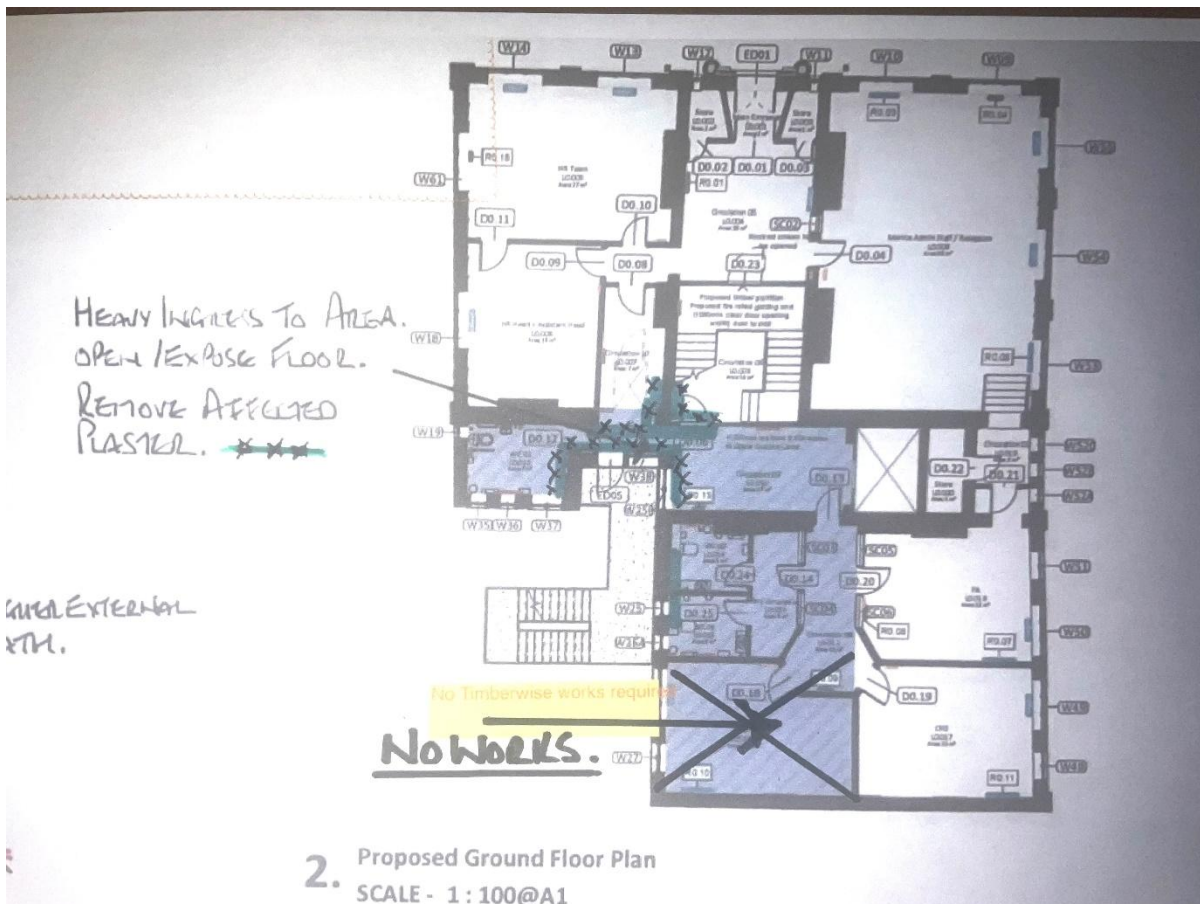
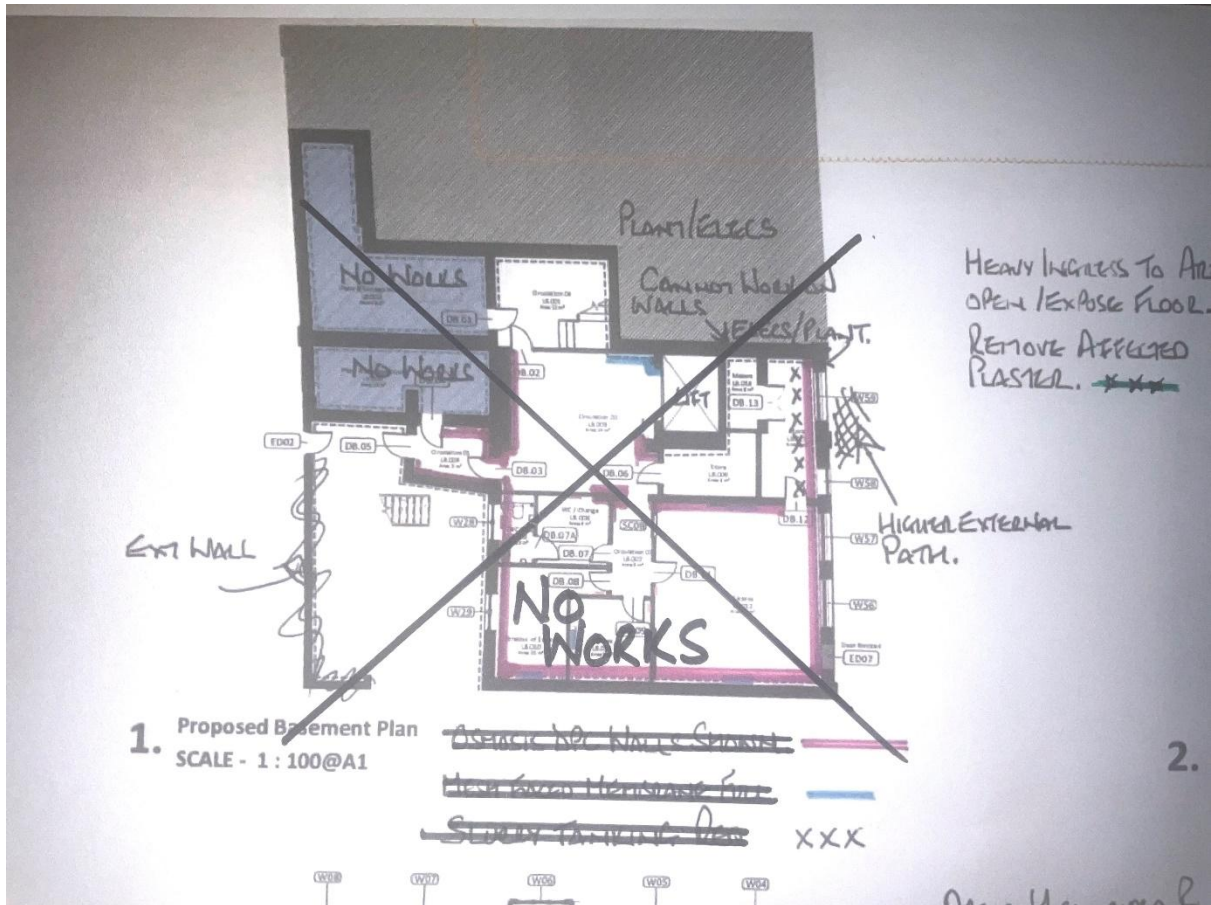
AREAS HIGHLIGHTED BLUE  
INDICATE AREAS OF GENERAL  
WATER INGRESS,  
WE HAVE MARKED ON THOSE  
AREAS SPECIFIC ISSUES.

ONCE WALLS ARE EXPOSED  
TO BE TREATED WITH MASONRY  
BIOCIDE ALONG WITH TIMBER  
TREATMENT TO LOCAL AREAS.
