ST/09 70/15/FUL
Site Investigation Report

**Proposed Housing Development
Waterside Park, Hebburn**

Report Number S60330/SI

May 2006

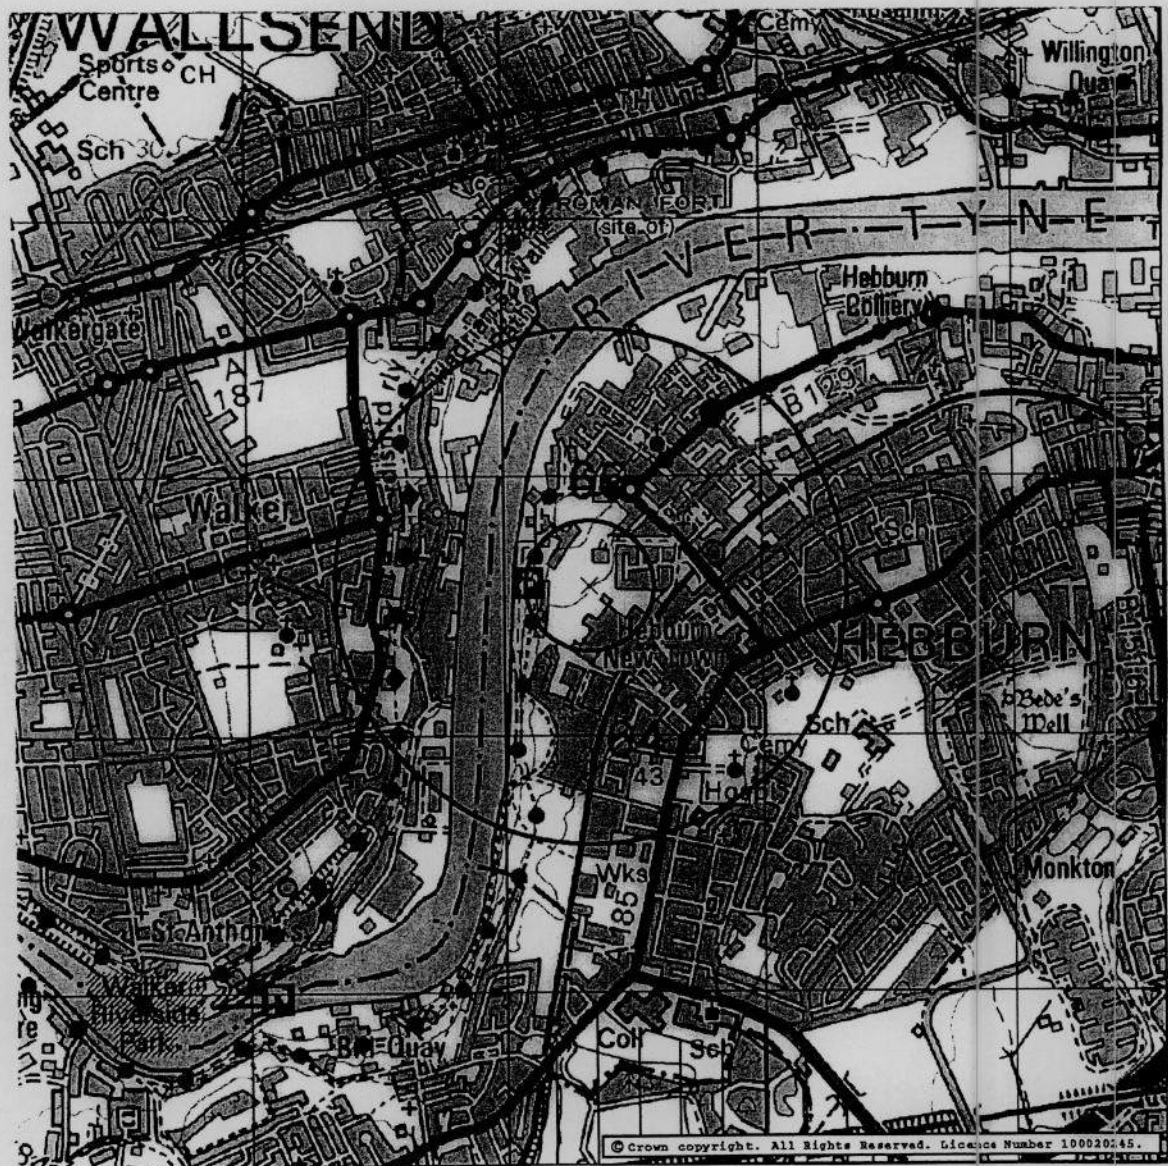
CLIENT : HEBBURN PROPERTIES LTD

PROJECT: WATERSIDE PARK, HEBBURN

DATE: MAY 2006

- 2.1 The preliminary site inspection, as recommended in BS5930 and BS10175, was undertaken on 29th March 2006. A site location map is presented in Figure 1, Appendix 1. The site is centred at Ordnance Survey Co-ordinates 430340E, 564570N.
