# CHURCH LANE WHITBURN

## ~ ARCHAEOLOGICAL EVALUATION and HISTORIC BUILDINGS RECORD ~

<i>Project code:</i> AP 15/55	<i>Stage:</i> Final	<i>Compiled by:</i> RJC	<i>Control:</i> MJ	<i>Completion date:</i> 19/11/15
----------------------------------	------------------------	----------------------------	-----------------------	-------------------------------------

REPORT ON AN ARCHAEOLOGICAL EVALUATION  
AND HISTORIC BUILDINGS RECORD

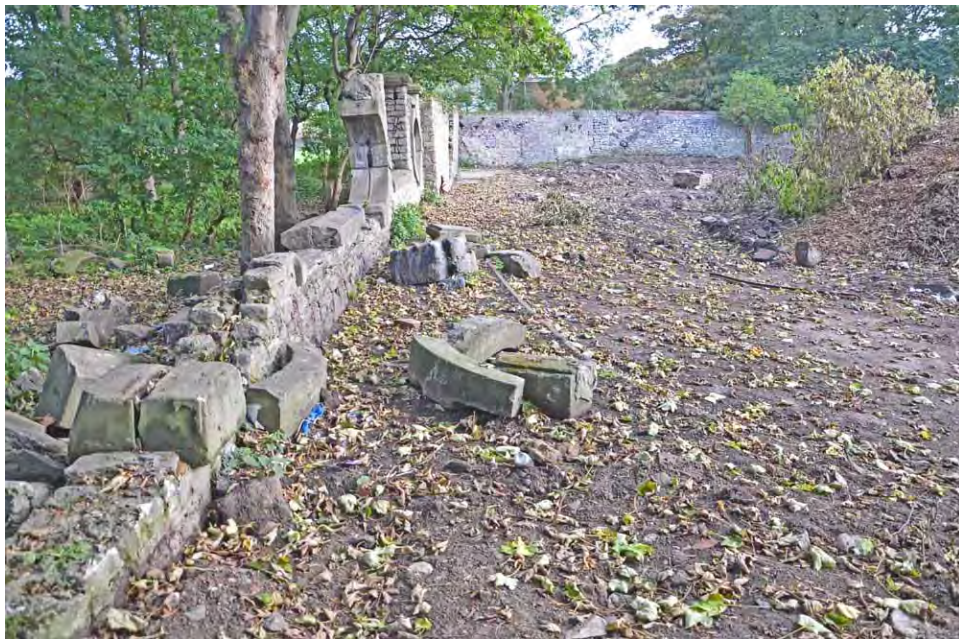
**Frontispiece:** View east towards the site of the former tithe barn in the north-east corner of the evaluation site.

**Frontispiece:** *View east towards the site of the former tithe barn in the north-east corner of the evaluation site.*

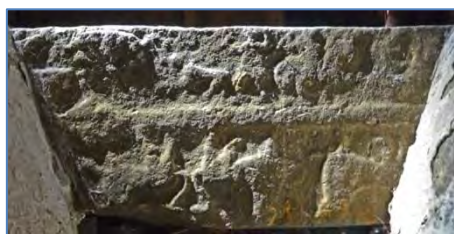
Grave Slab reused as a church tower lintel -  
HER Number 12215 –  
Photograph by R Carlton, October 2015

There is no direct evidence for human activity within the bounds of the assessment area from the prehistoric, Roman or early medieval periods and, although an earlier settlement at Whitburn is possible – as suggested by the presence of a possible pre-Conquest decorated stone inserted in 1868 in the 12<sup>th</sup> century church tower (Ryder 1994; Hart 2004 - see below) –

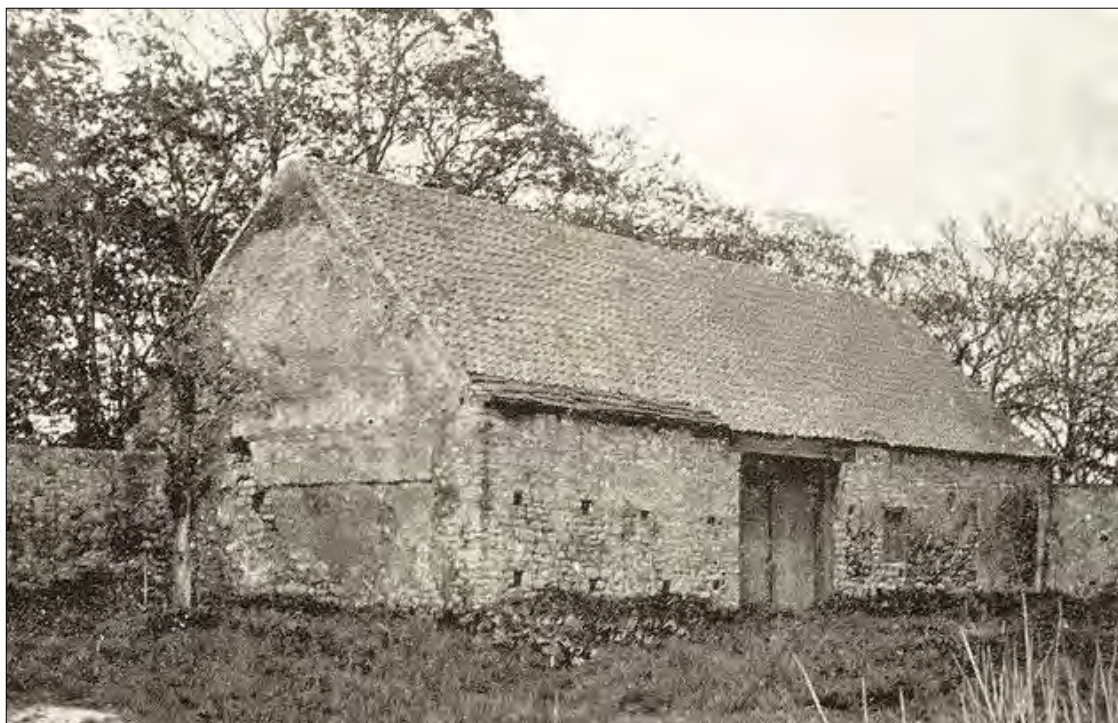
*Illus. 21: View of the tithe barn in 1905.*

The 1905 photograph (*Illus. 21*) shows a building, largely of coursed limestone rubble, with a roof of pantiles pitched at around 45°, with a partial course of stone slates to the eaves. In the south wall is a large threshing door, opposite that on the north, with to the west of it two ranges of square (rather than triangular) vents; there are other openings, not very clearly visible, to the east of the threshing door. The west gable seems to be partly rendered, and might have been partly rebuilt.

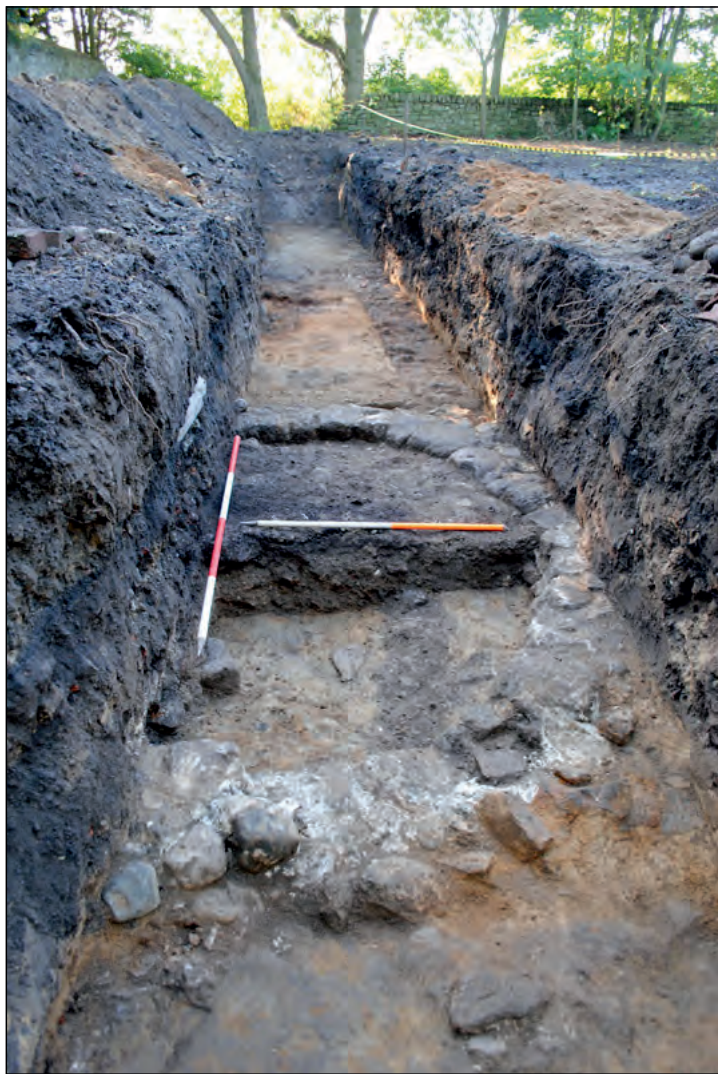
Photo 1

*Photo. 01: View from the north of the south part of Trench 1, showing circular stone feature [12].*

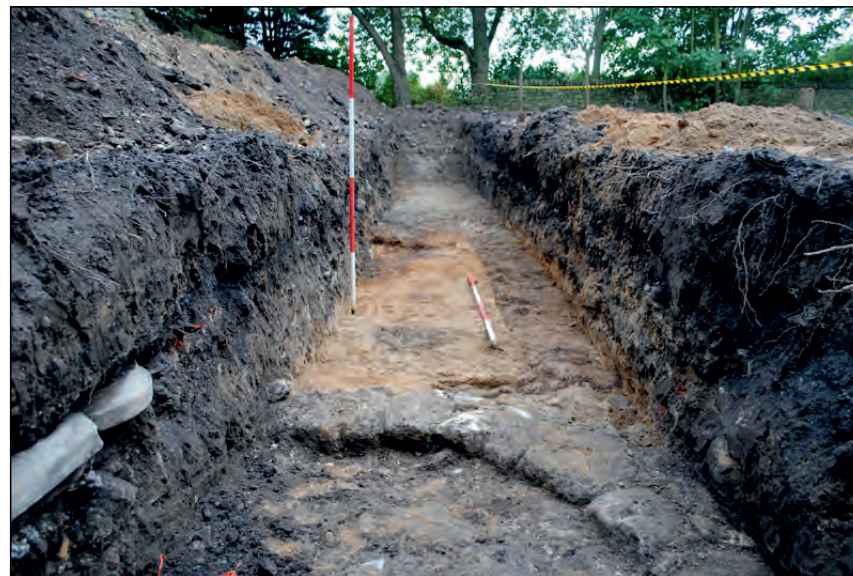
Photo 2

*Photo. 02: View from the north over circular feature [12] uncovered at the north end of the south part of Trench 1, showing sandy deposit south of the presumed gingham.*

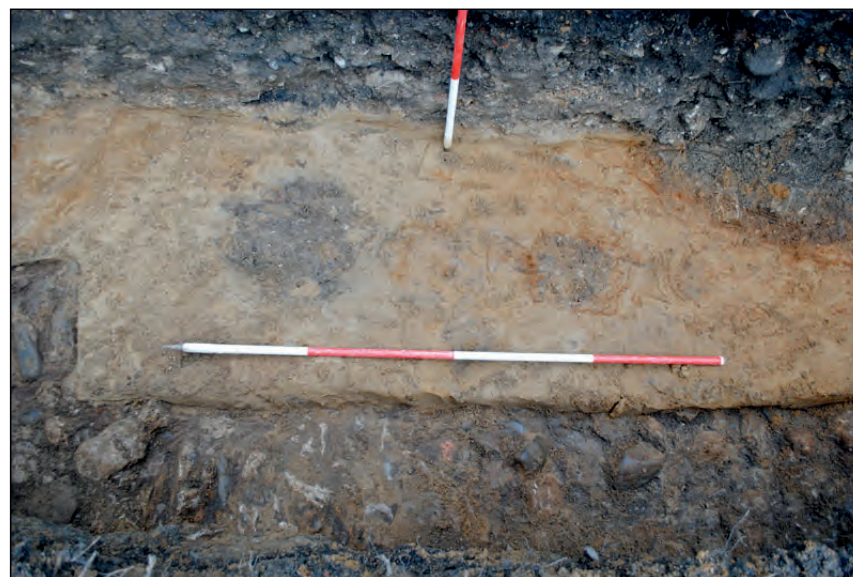
Photo 3

*Photo. 03: View from the west of possible post-hole incisions or post placements on or in the sandy deposit south of the circular feature in Trench 1.*

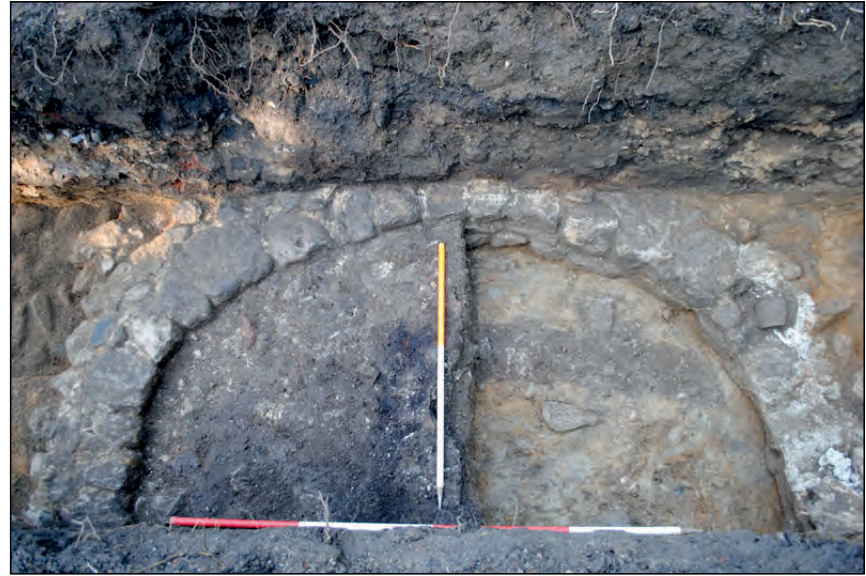
*Photo 5*

*Photo. 05: View from the east of circular feature [12] in Trench 1.*

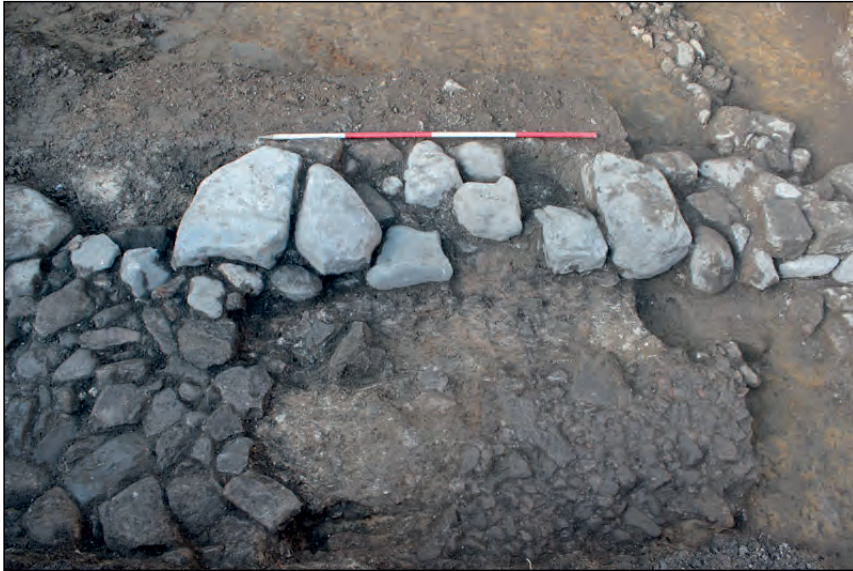
*Photo 10*

*Photo. 10: View from the south of wall [08] and stone surfaces [11] and [17].*

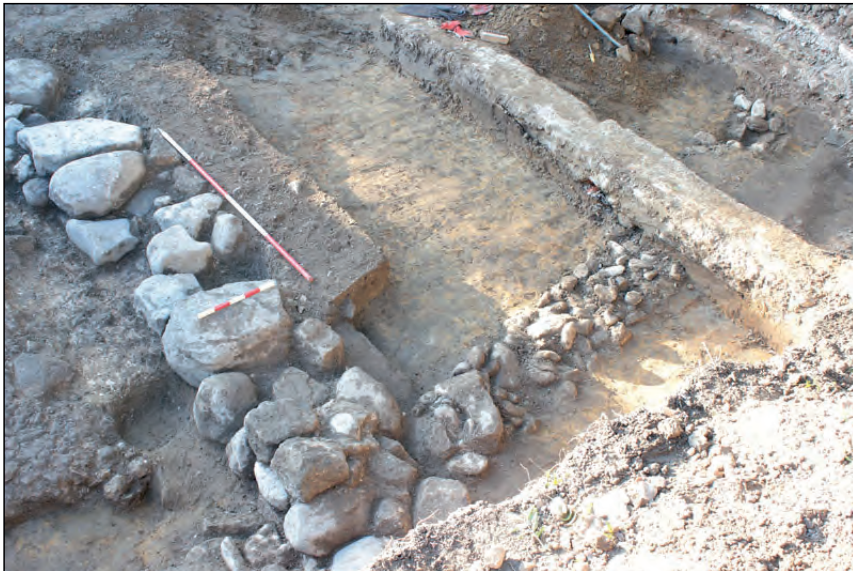
*Photo 11*

*Photo. 11: View from the south-east of wall [08] and drain [15] interrupted by modern brick footings.*

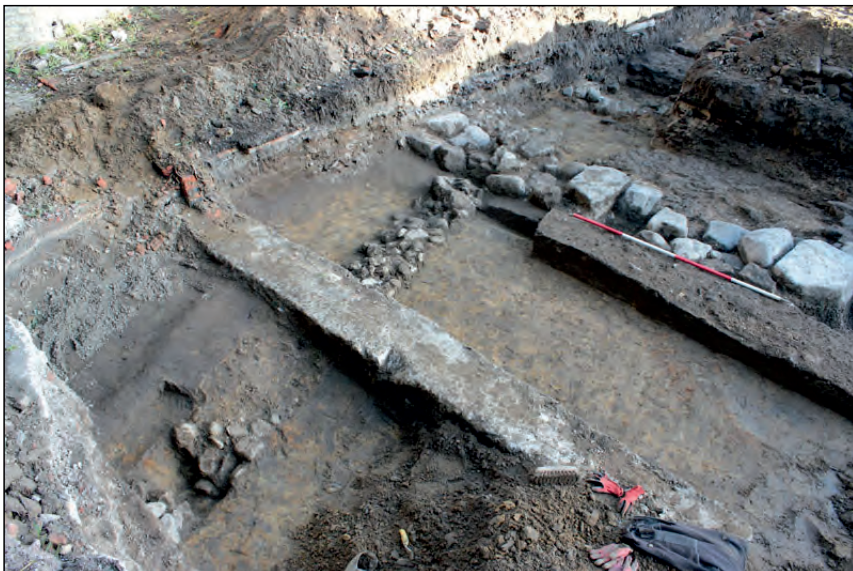
*Photo 12*

*Photo. 12: View from the north-west of wall [08] and drain [15] interrupted by modern brick footings.*

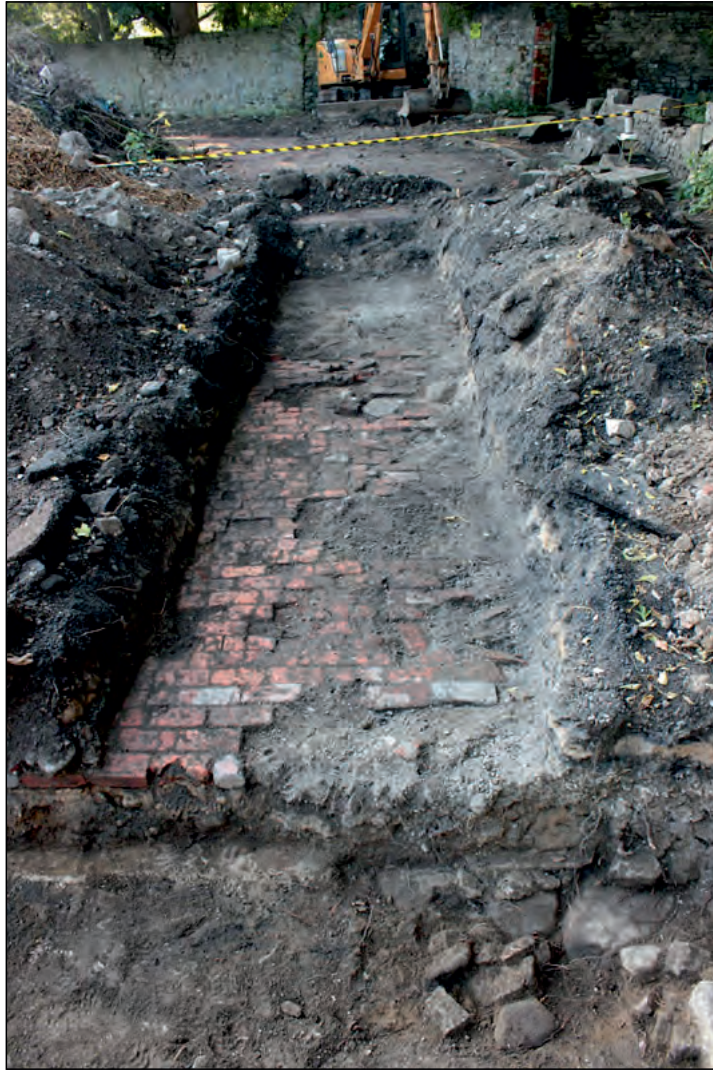
Photo 13

*Photo. 13: View from the east of the west branch of Trench 2, showing brick floor.*

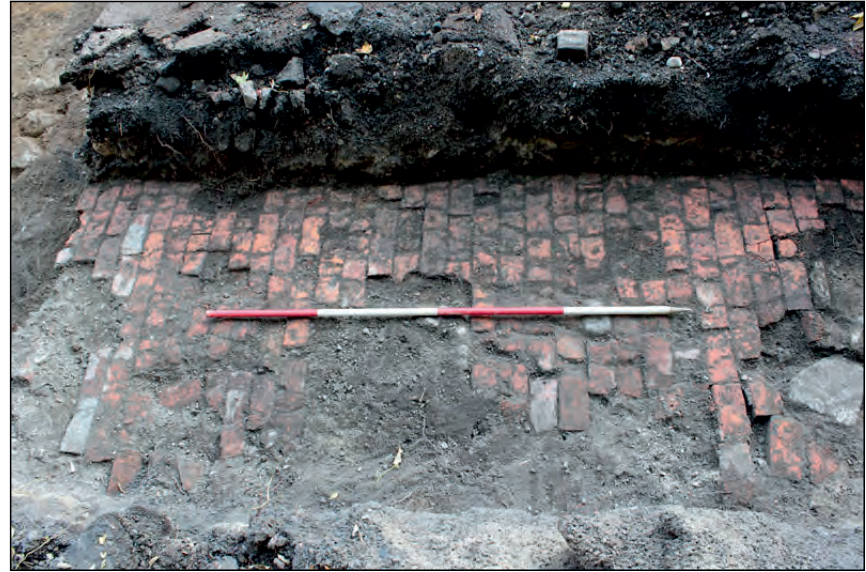
Photo 14

*Photo. 14: View from the north of brick floor in Trench 2.*

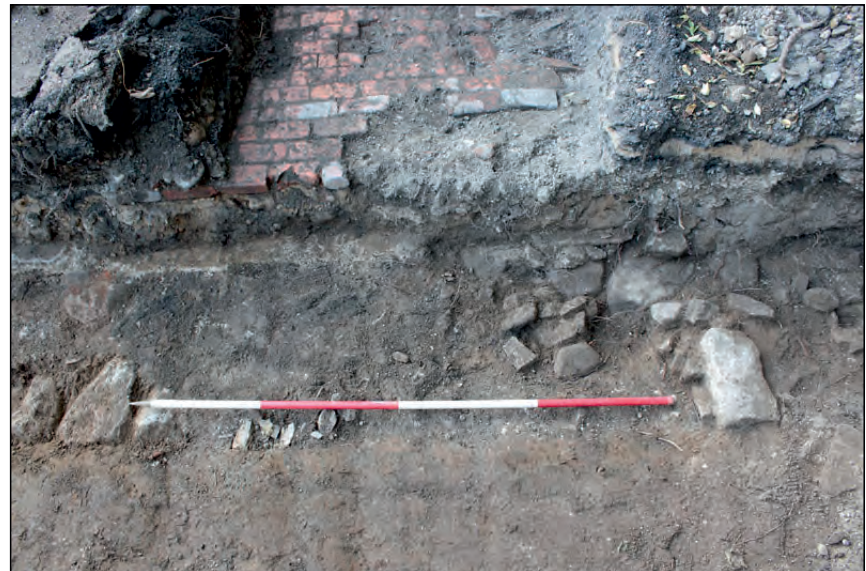
Photo 15

*Photo. 15: Detailed view from the east of brick floor, underlying flagging and cut for the E-W west end wall of the tithe barn.*

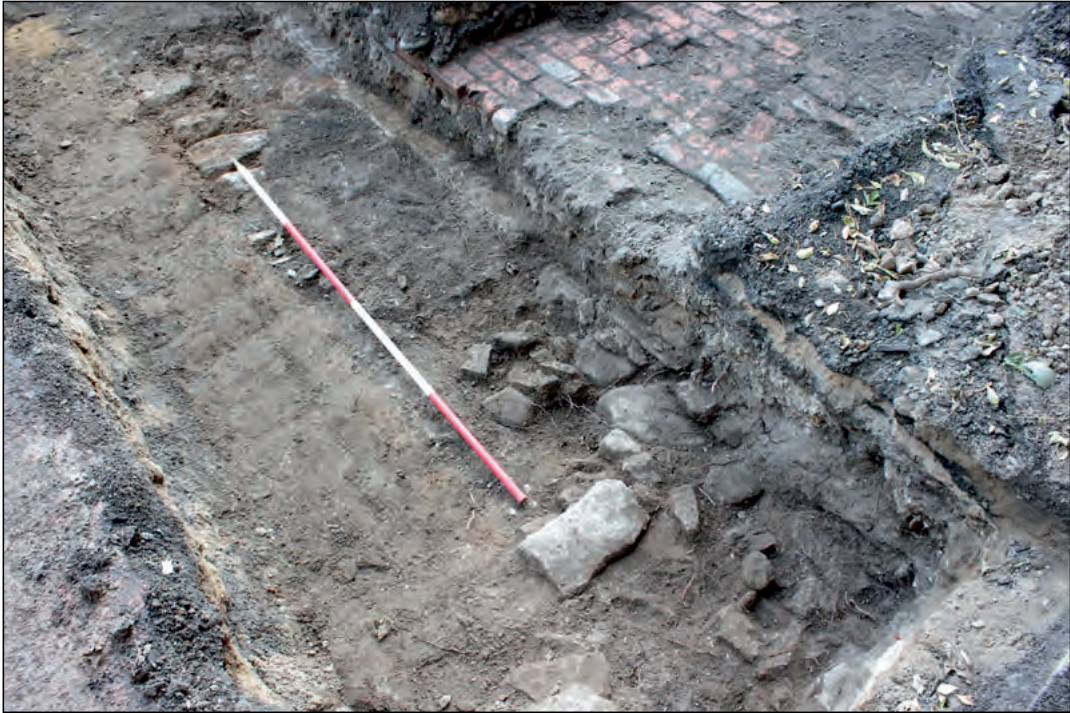
Photo 16

*Photo. 16: View from the north-east of the cut for the E-W west end wall of the tithe barn.*

- [01] Topsoil
- [32] TR#2. Wall. West end of tithe barn. 0.70 m wide, 10 m visible. Loose rubble and remaining wall footings. Unexcavated.
- [33] TR#2. Doorway through wall [32]. Sandstone socket stone. Sandstone flagstone threshold 1 m x 0.50 m, with riverine cobble flooring to the east.
- [34] TR#2. Brick floor west of [32]. Area of flooring extending 4.50m to the west of wall [32] made of house bricks, heavily disturbed.
- [35] Flagstone flooring underlying brick floor [34].
- [36] Deposit of mixed sandy-silt.

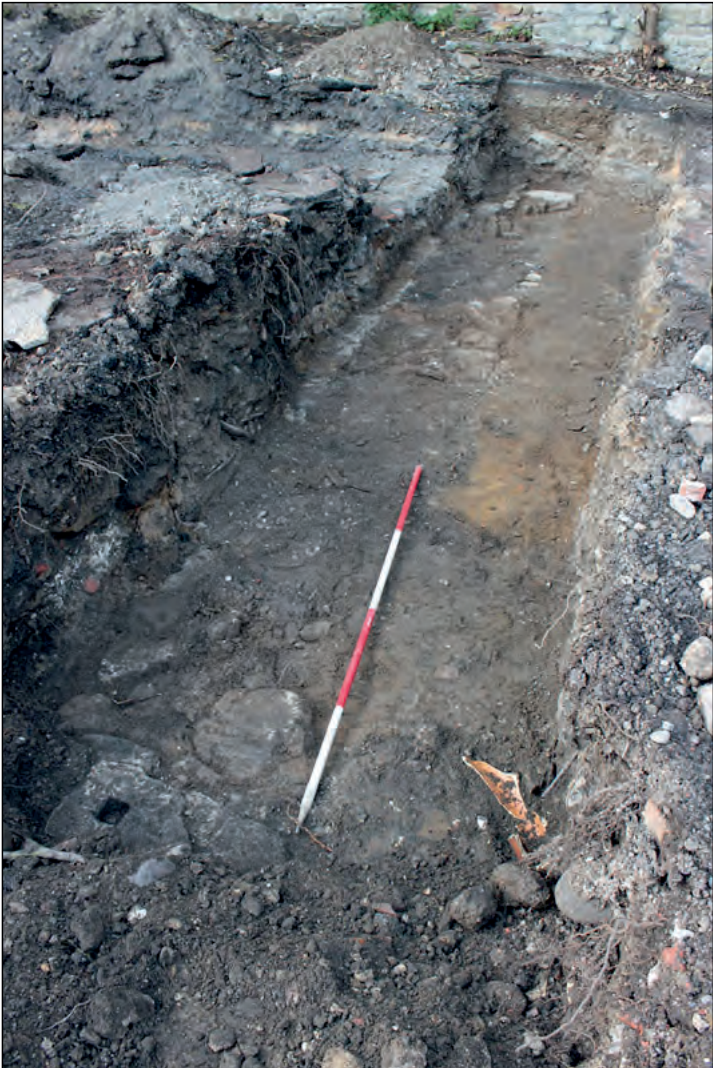
Photo 17

*Photo. 17: View from the south-east of the cut for the E-W west end wall of the tithe barn, its east return and flagging to the south of it disturbed by modern building works.*

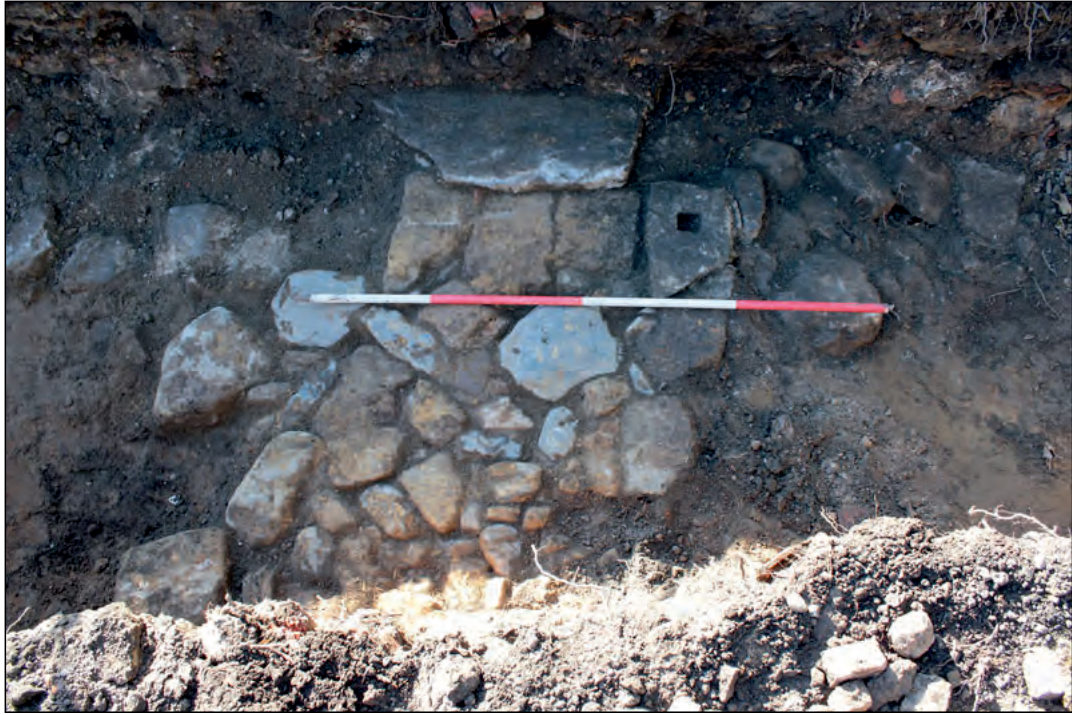
*Photo 18*

*Photo. 18: View from the east of the south-west corner of the tithe barn with socket for a doorway into a mid-19<sup>th</sup> century adjunct building to the south.*

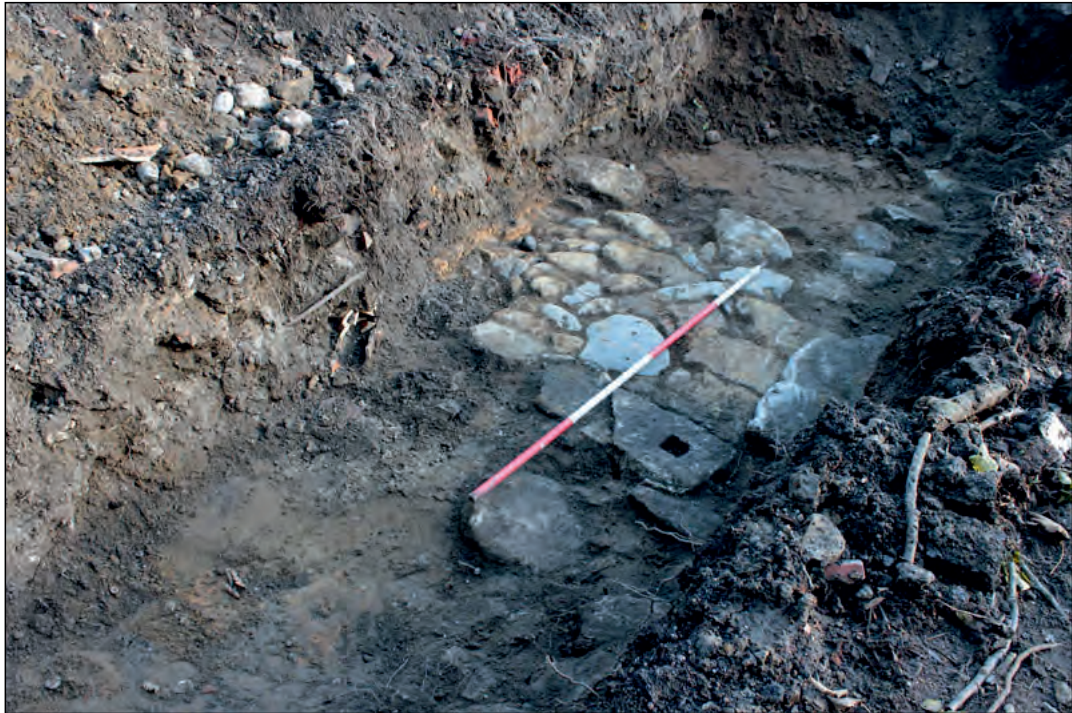
*Photo 19*

*Photo. 19: View from the north-west east of the south end of Trench 2, showing the south-west corner of the tithe barn with doorway socket and flagging to the south.*

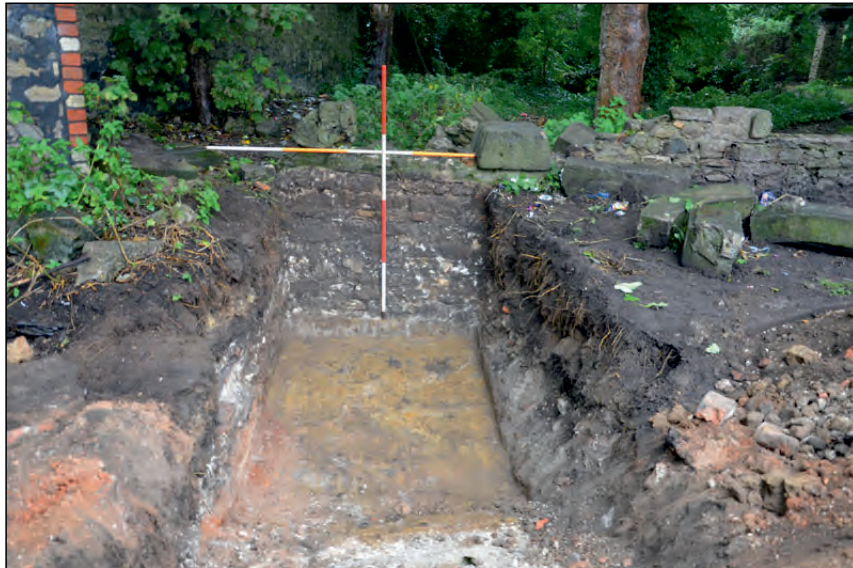
*Photo 20*

*Photo. 20: Trench 3 viewed from the south.*

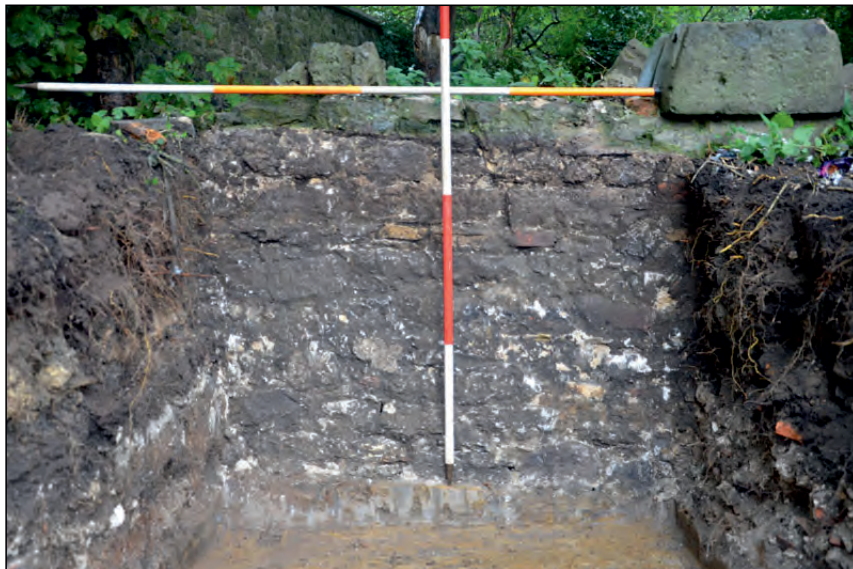
*Photo 21*

*Photo. 21: A section of the south-facing internal elevation of the north wall of farm buildings attached to the west end of the tithe barn.*

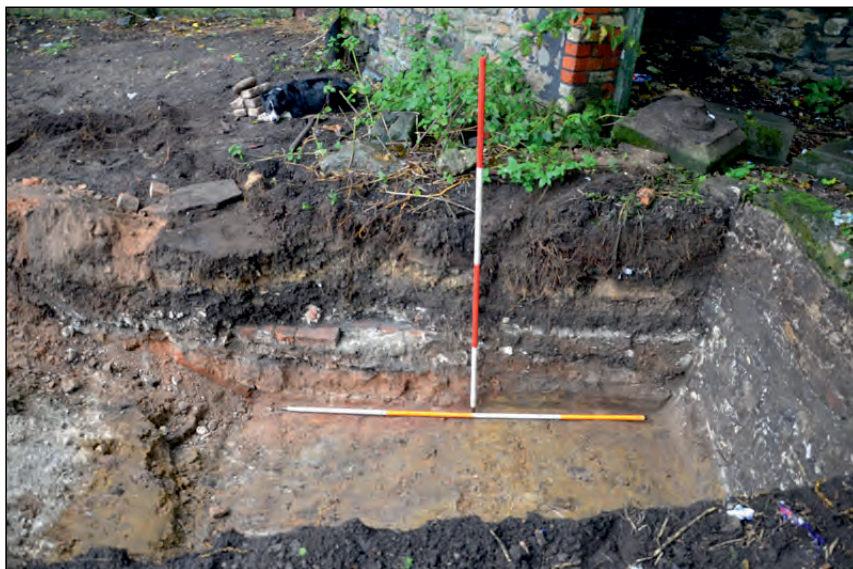
*Photo 22*

*Photo. 22: The east-facing elevation of Trench 2, showing remains of a brick floor at c. 0.75 m bgl.*
