## Briefing Note

### **Subject Harton Quay Office Building Supplementary Heritage Note**

#### **2.0 Mill Dam Wall**

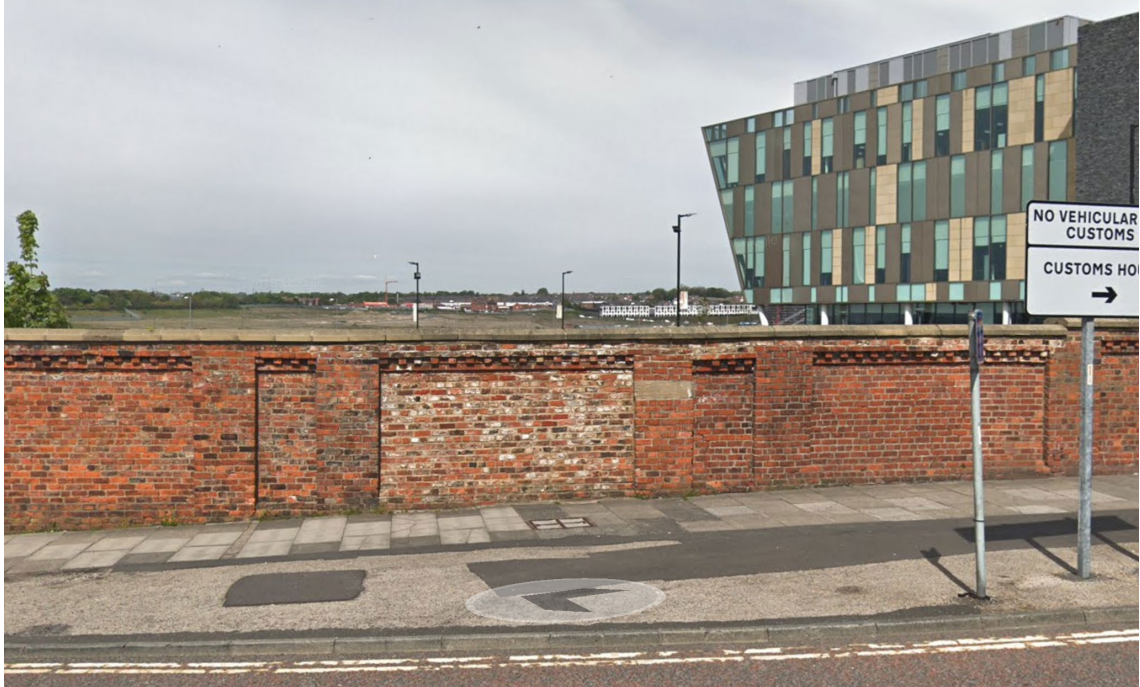
- 2.6 Comparison with modern imagery shows the opening of the former gateway, blocked by paler brick, flanked by paired piers. It is also possible to discern where upper courses of the wall to the right have been rebuilt following the removal of the eaves of the lodge building. The sandstone block within the pier to the right of the blocked entrance may have borne signage (painted or applied) but its function is not clear.
- 2.7 As set out in the Heritage Impact Assessment, the Mill Dam Wall is a surviving element of the industrial heritage of this area, indicating the enclosure of the wagonwright's workshop and the staithe site. It provides a very strong local feature within the Conservation Area.

Figure 3 Former gateway through Mill Dam Wall

- 2.3 The wall is built of red brick with pier-and-panel construction typical of its date. The section of the wall which formed the street frontage of Staithes House is identifiable by its blocked windows and doors. It makes decorative use of dentilled and dogtooth cornices and a nail-head detail to the window cills. The boundary wall east of this is simpler in detailing with a dentilled cornice to the panels. It is a feature of the blocking that they appear to have been consistently executed in a slightly paler brick than the original wall. Close to the junction of Mill Dam and Commercial Street is a panel, between two pairs of close-spaced piers, which is made up of this slightly paler brick.
