# Pre Development BS5837 Arboricultural Implications Assessment. V2

Michaelford September 2015

Produced For Blake Hopkins Architecture  
By Jim Richardson BSc For. HND Arb. M.Arbor.A.

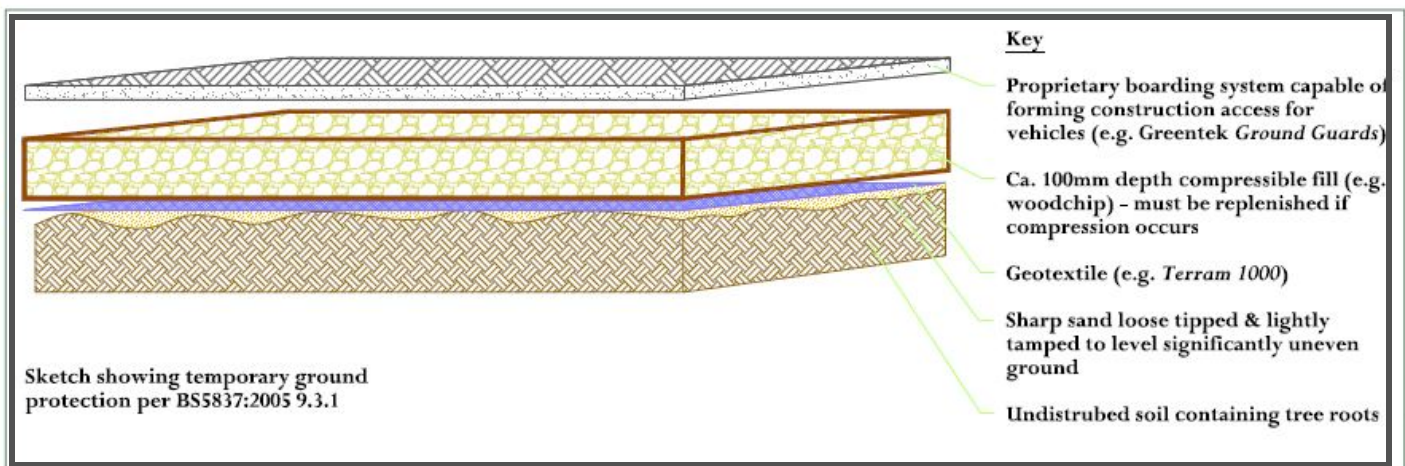
## Temporary Ground Protection Layers

- Base Layer – Undisturbed soil containing tree roots.
- Layer 1 – Sharp sand loosely tipped and lightly tamped to level uneven ground.
- Layer 2 – Geo-textile (e.g. *Terram 1000*).
- Layer 3 – Minimum 10cm depth of compressible fill (e.g. woodchip) – **must be replenished if on-going compression occurs.**
  - 10cm depth of compressible fill allowable for pedestrian access only.
  - 15cm depth of compressible fill allowable for up to 2t Gross Weight.
  - Traffic exceeding 2t Gross Weight requires base layer of ground guards in addition to other layers detailed here.
- Layer 4 - Top layer – temporary boarding system capable of forming construction access for vehicles (e.g. *Greentek Ground guards*). (or possibly lighter surfacing for foot access only)

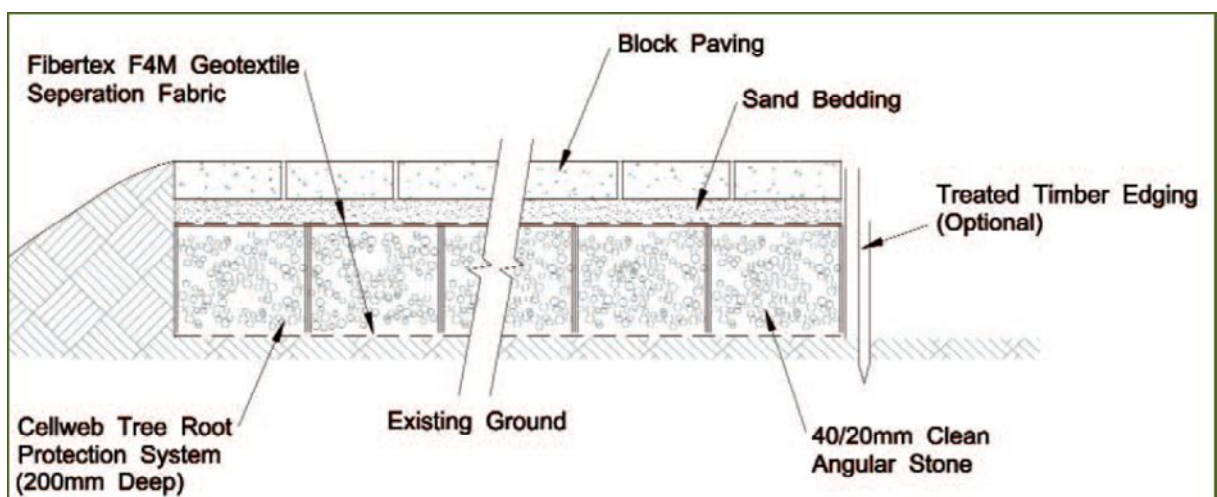
### New Surfacing Within Root Protection Areas (Example Diagram)

- 6.11.1. New surfacing such as re-surfacing and pathways must use a non-compacting porous surface such as Cell Web (from Geosynthetics) or a similar cellular confinement system. No changes to ground level should be allowed prior to installation of new surfacing which should be installed above the existing ground level.

- Place the final surface material. -
  - **Block Paving** – lay a second layer of Fibrex F4M Geotextile separation fabric over the in-filled Cellweb sections. Lay a sharp sand bedding layer compacted with a vibro compaction plate to recommended depth. Place paviors as per the manufacturer’s instructions. The use of porous blocks such as Aquaflow by Formpave are particularly tree friendly and allow natural rainfall to reach the rooting area.

- **Porous tarmac** – place 25mm surcharge of the granular material above the Cellweb system and lay the bitumen base and wearing course
  - **Loose Gravel**- Place a second layer of Geotextile separation fabric over the in-filled Cellweb sections. Place decorative aggregate to the required depth. A treated timber edge should be provided to restrict gravel movement

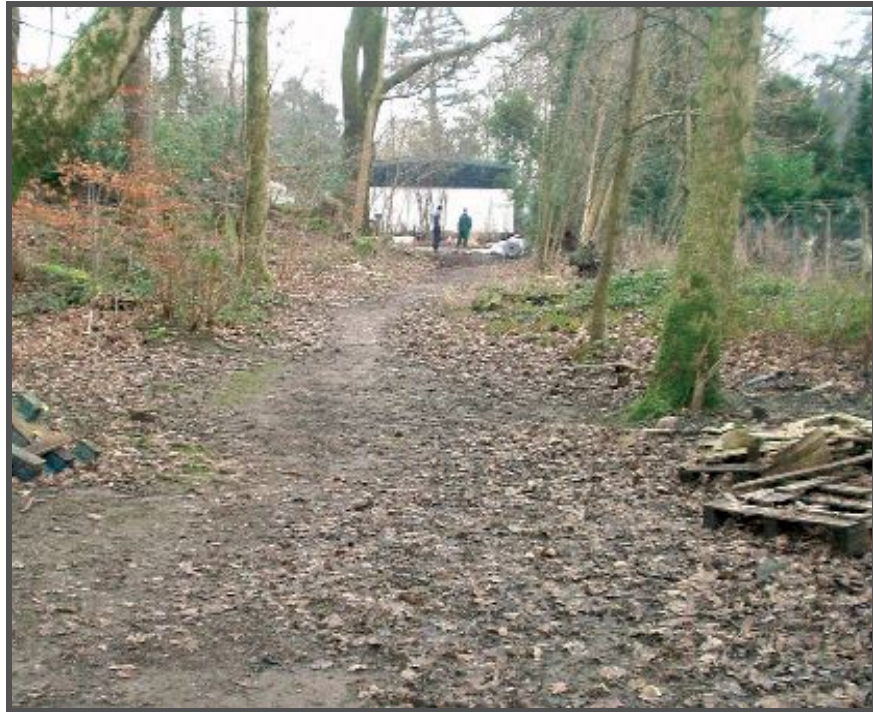
### Area For Installation Is Cleared and Marked Out

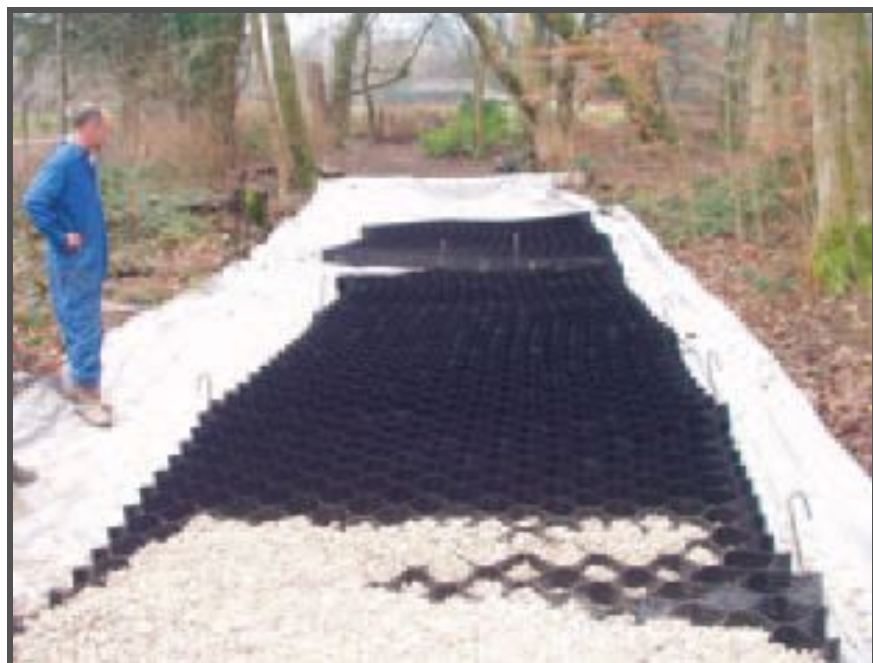
### Geotextile Layed Out and Cellular Confinement System Pinned In Place

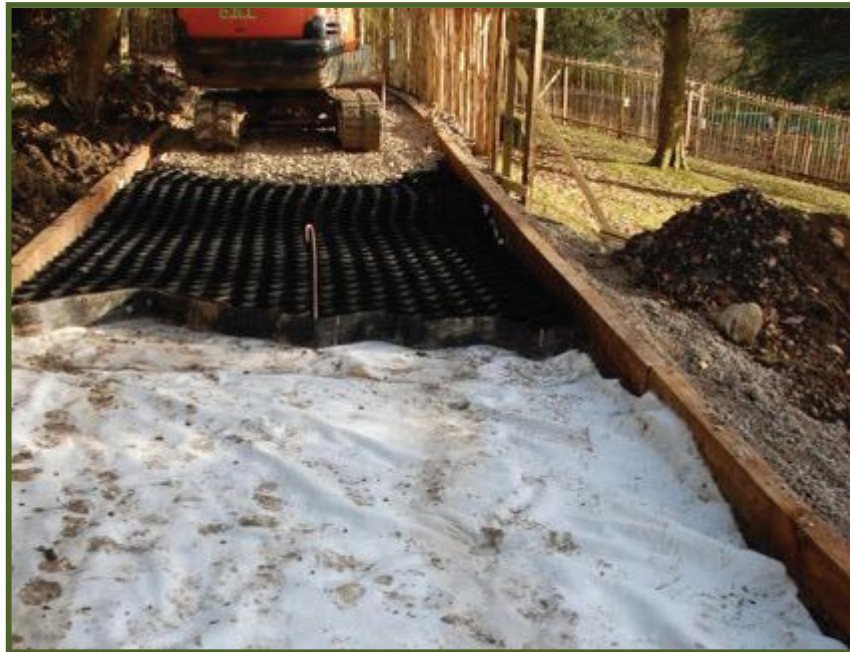
For Permanent Systems Edge Supports Are Installed

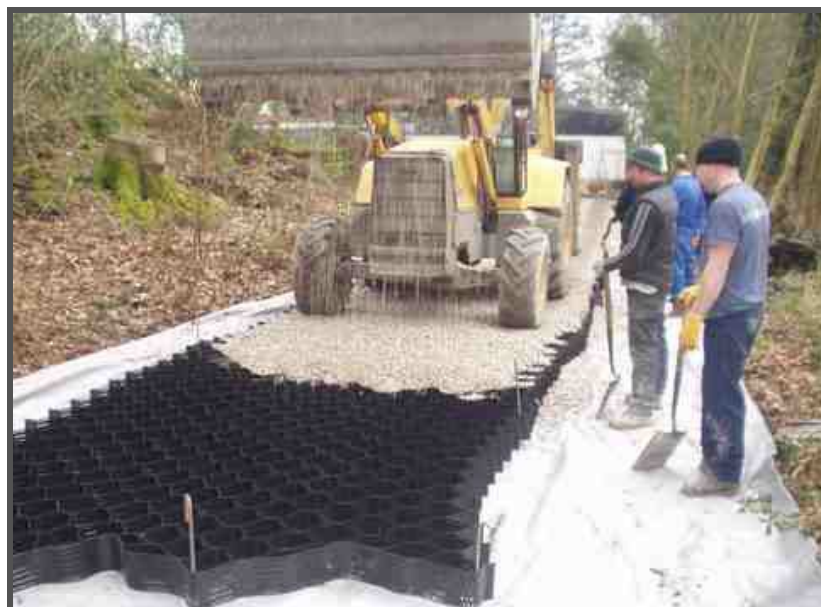
Aggregate Poured Into Cells – Once Full Access Over The Cells Is Allowable

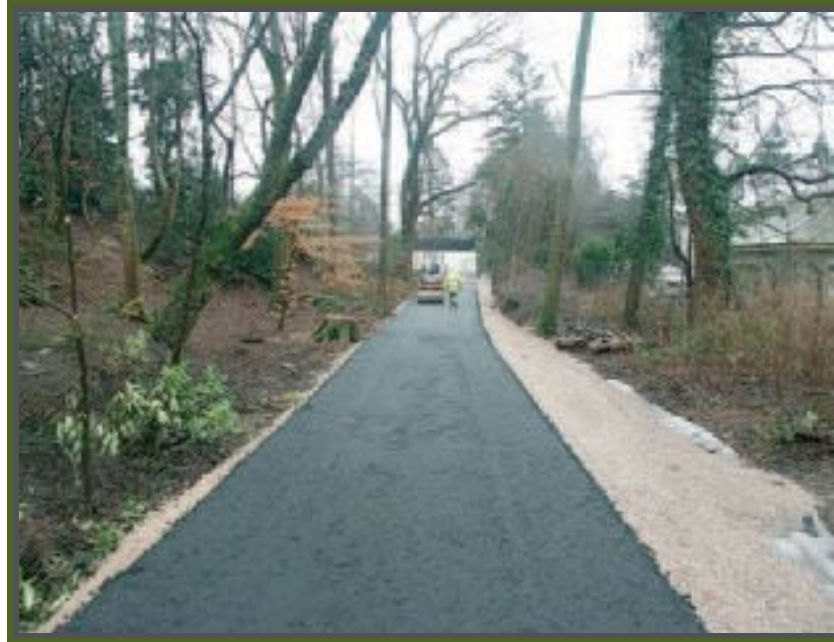
## Finished Surface (Porous) Is Installed

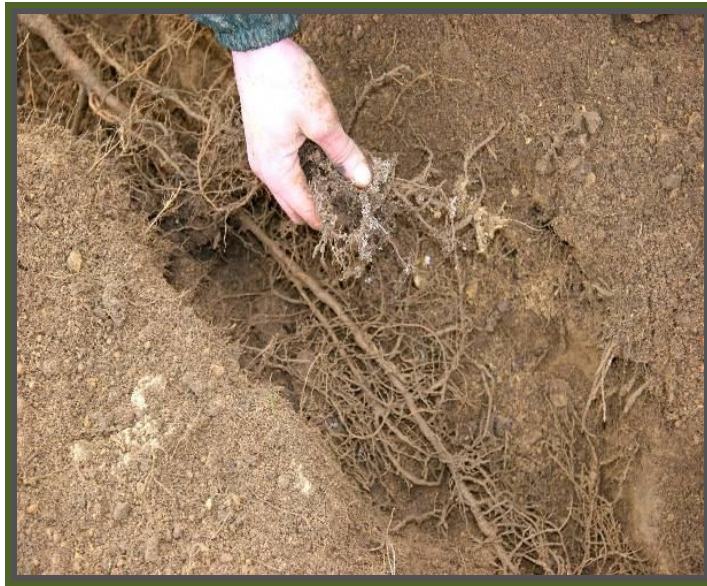
## Use of An Airspade Allows For Soil Investigations Whilst Retaining Fine Roots.

6.13.4. Hand Digging/Airspade - The objective of hand digging is to retain as many undamaged roots as possible. Hand digging within RPA must be undertaken with great care preferably using an air-spade, preferably under supervision from the sites Arboricultural Consultant. After careful removal of any hard surface materials digging must proceed with hand tools. Clumps of roots less than 25mm in diameter (including fibrous roots) should be retained in situ without damage. Throughout the excavation works great care should be taken to protect the bark around the roots.

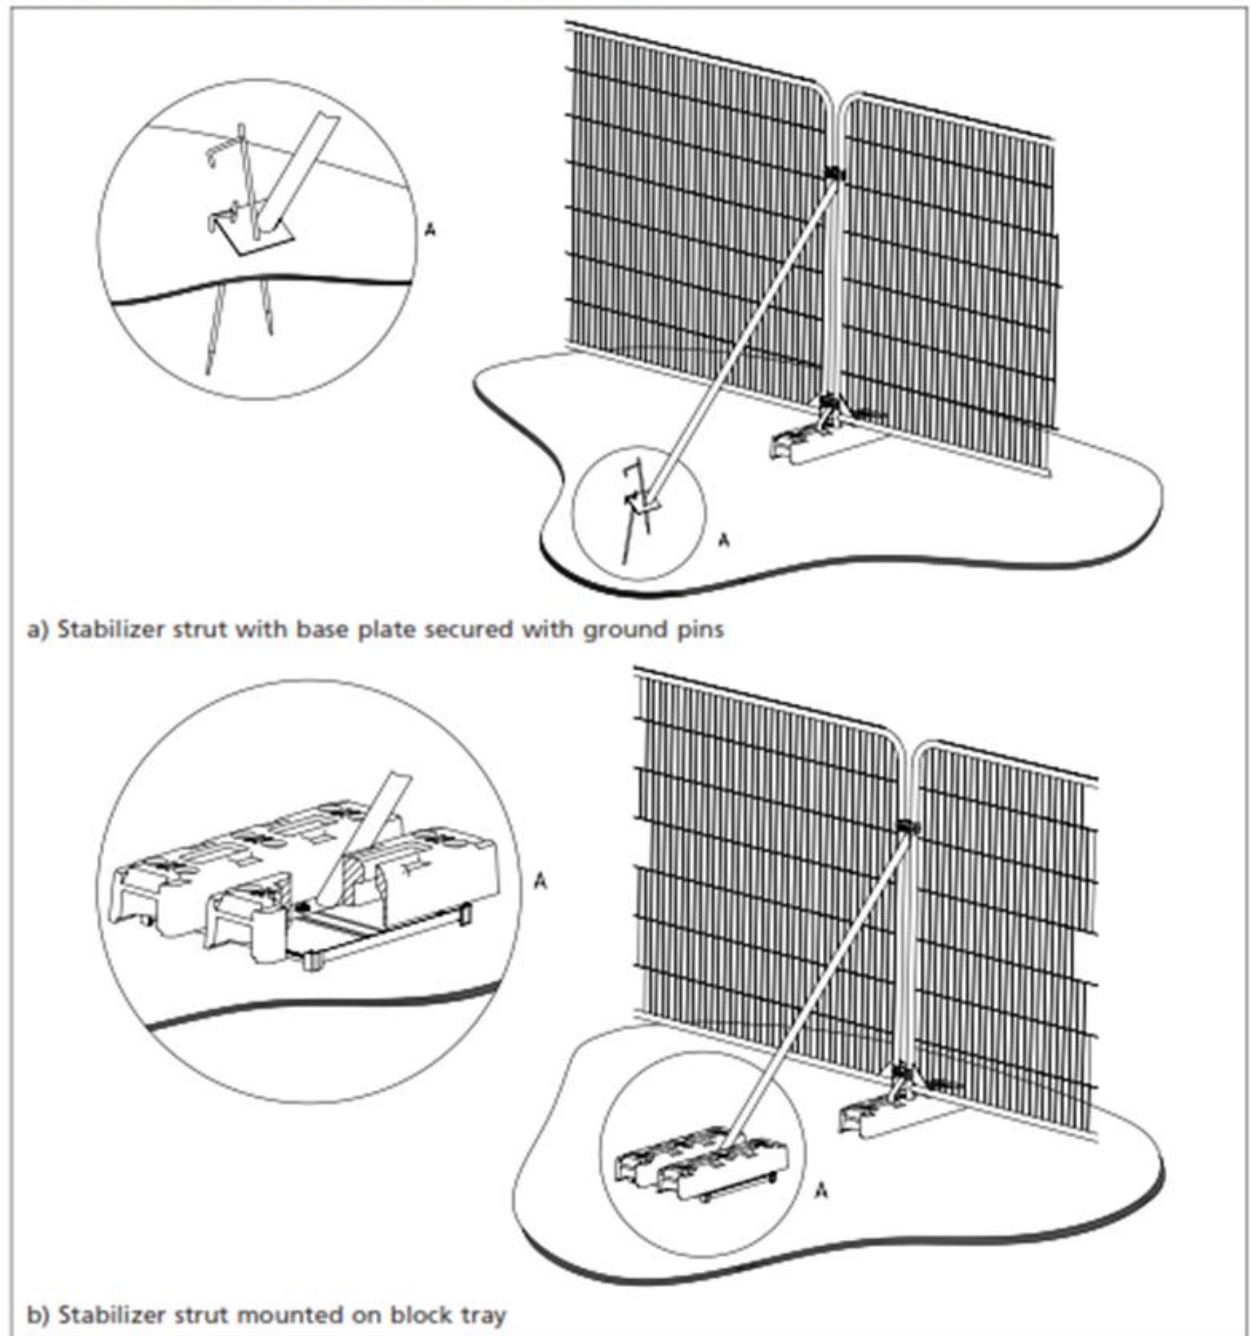
## V. Protective Fencing With Above Ground Stabilization

Figure 3 Examples of above-ground stabilizing systems
