W-08 Roof Overflow Details

South Shields Town Hall Refurbishment

Drawing: Stone Parapet Overflow Details

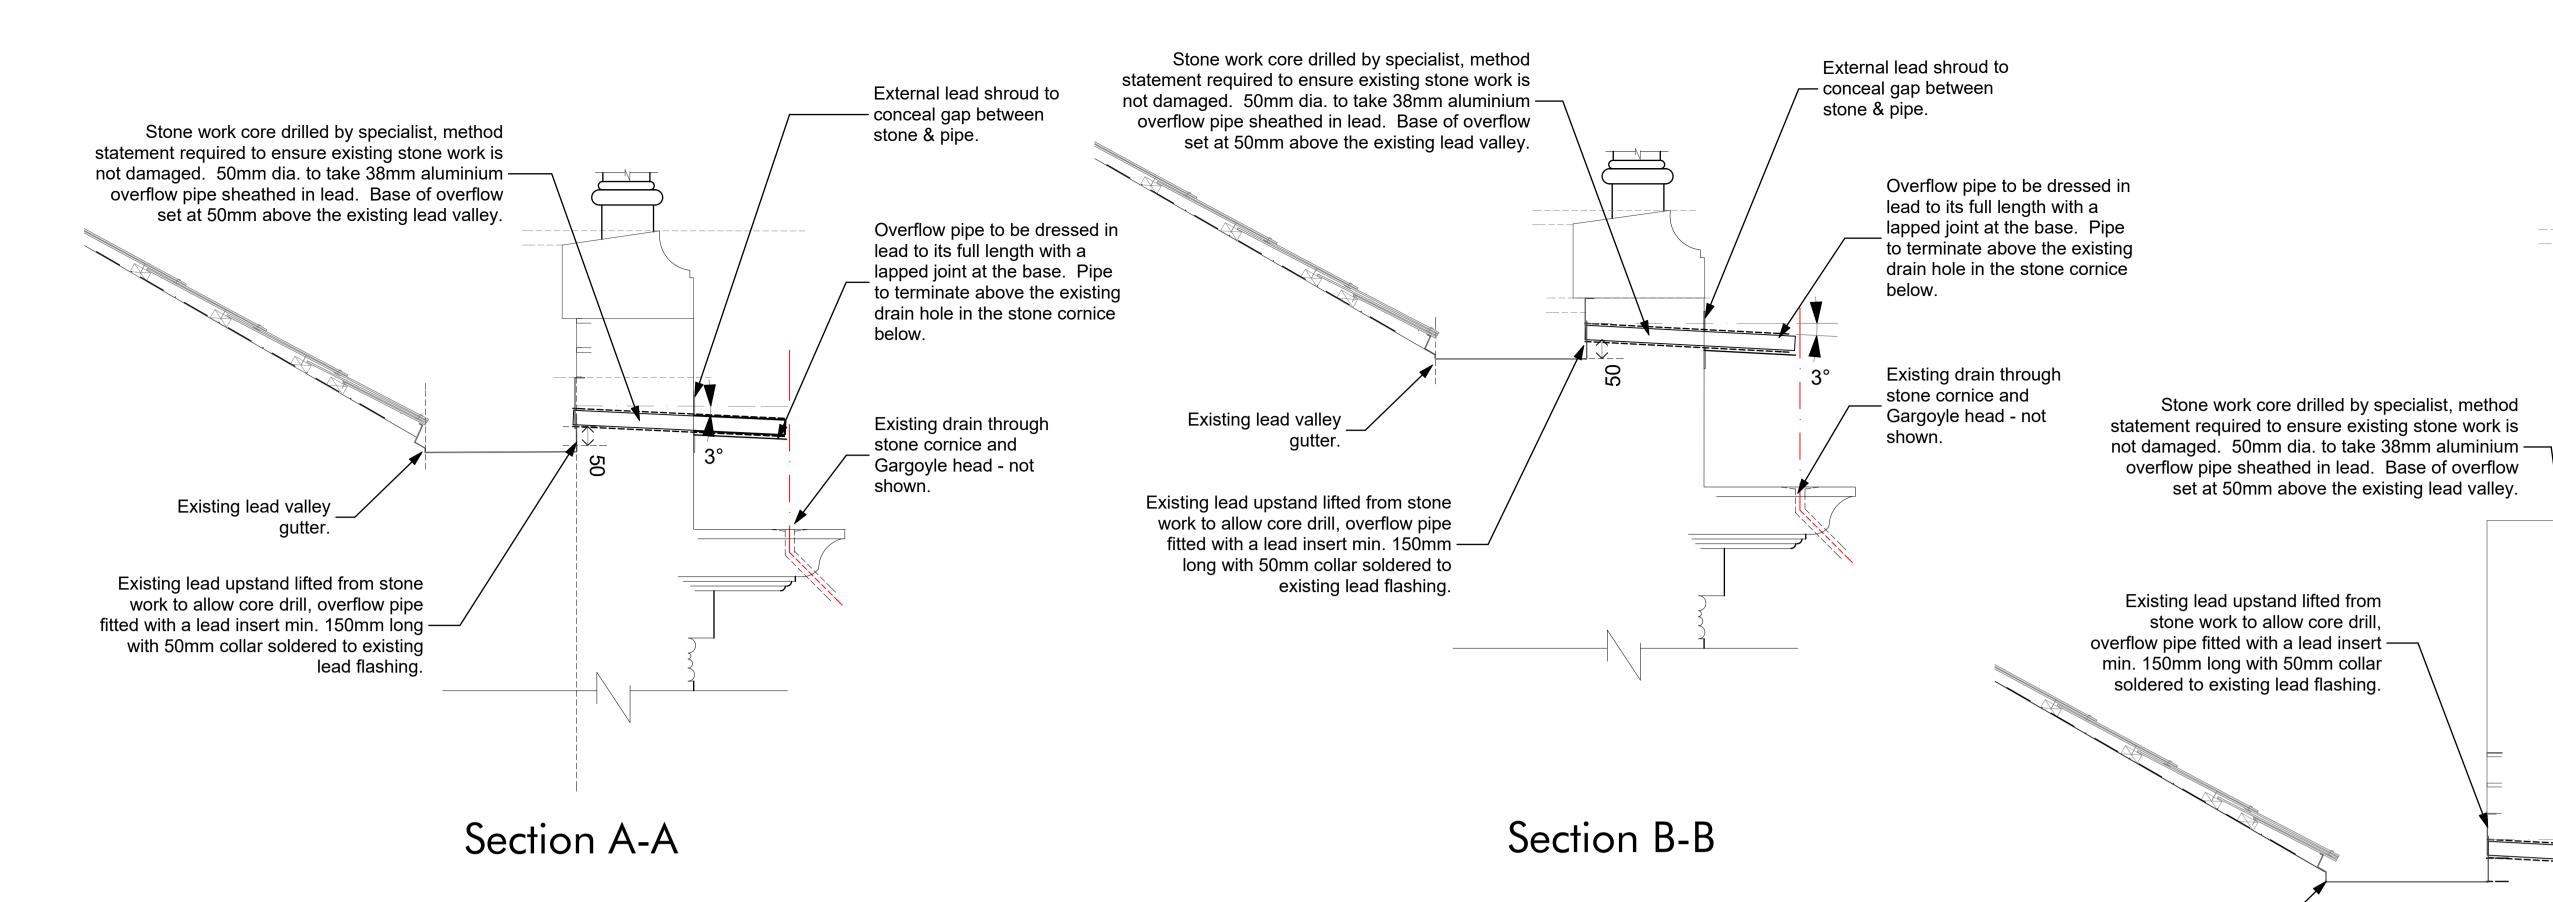
Overflow pipe to be dressed in lead to its full length with

– a lapped joint at the base. Pipe to terminate beyond any existing stone features.

Contractor to check location of pipe on site in relation to existing stone

features.

CORE DRILLING OF STONE WORK TO BE UNDERTAKEN BY A

SPECIALIST CONTRACTOR PLEASE REFER TO SEPARATE DETAILED

RAMS FOR THIS WORK.

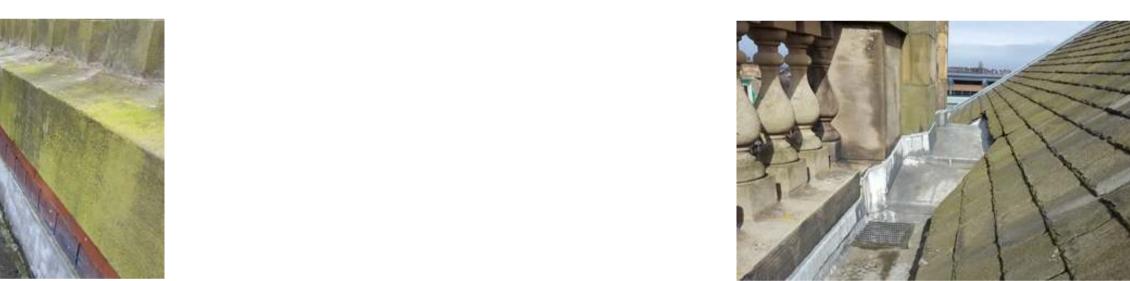
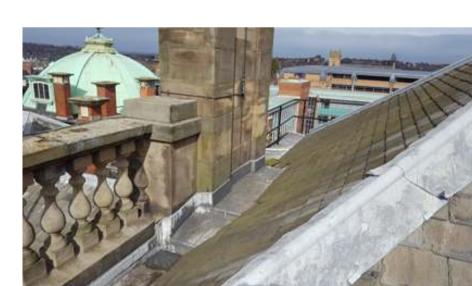
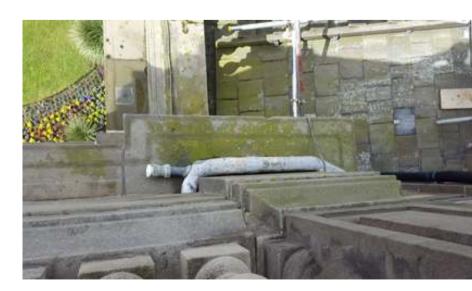
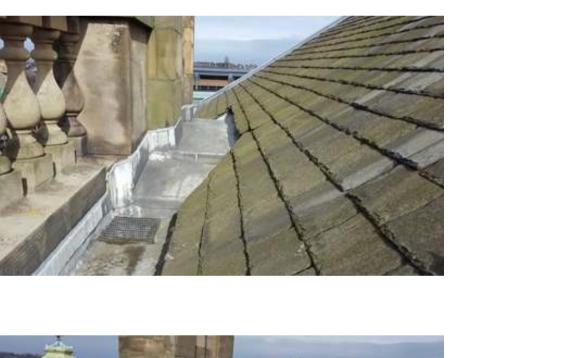
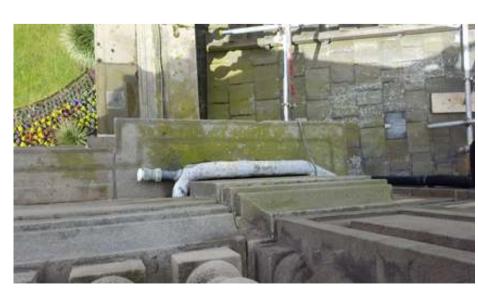
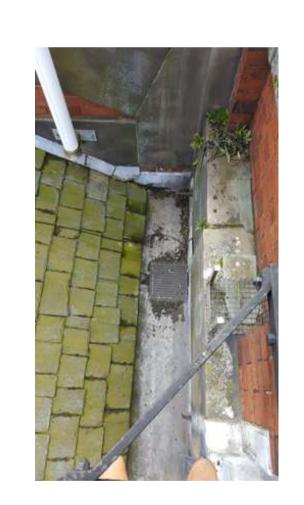
Existing lead valley

Section C-C

External lead shroud to

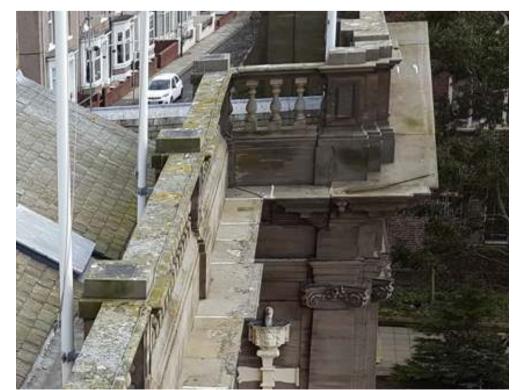
conceal gap between

stone & pipe.
