# SUDS Verification Report

## **Mortimer Community College Extension – Education**

08713-JKC-XX-XX-SP-C-  
0003

February 2026

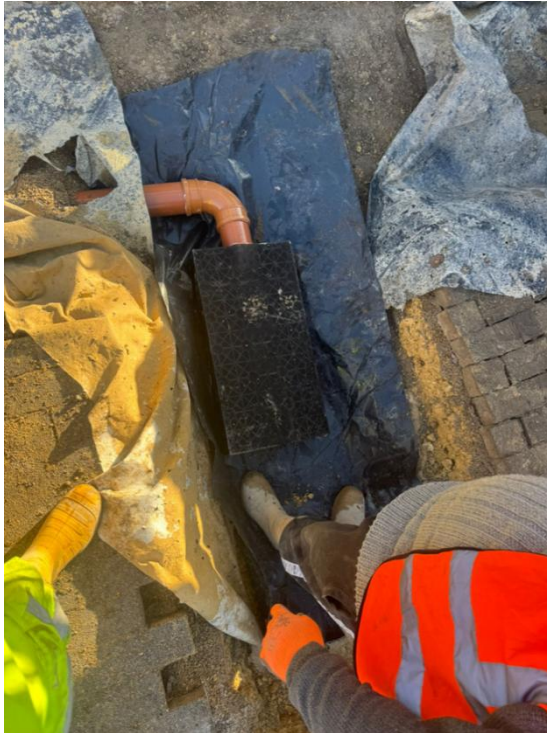
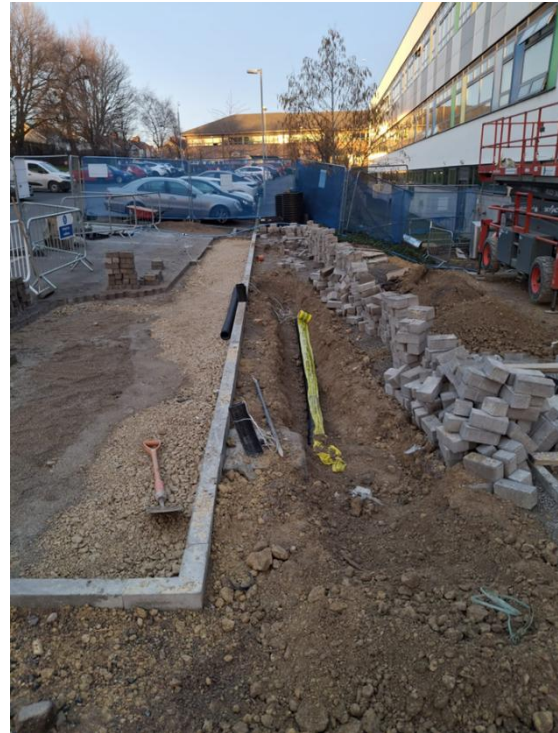
Two types of permeable paving have been proposed across the site, light and medium duty. The light duty, discharges from a single diffuser unit into manhole SW9, the medium duty discharges via multiple diffuser units into the proposed rain garden. For the light duty paving, the installed diffuser box can be seen in the first photo below. The second photo shows the permeable blocks being laid on top of the specified build up, the photo shows the larger type 3 aggregate and the finer crushed rock layers.

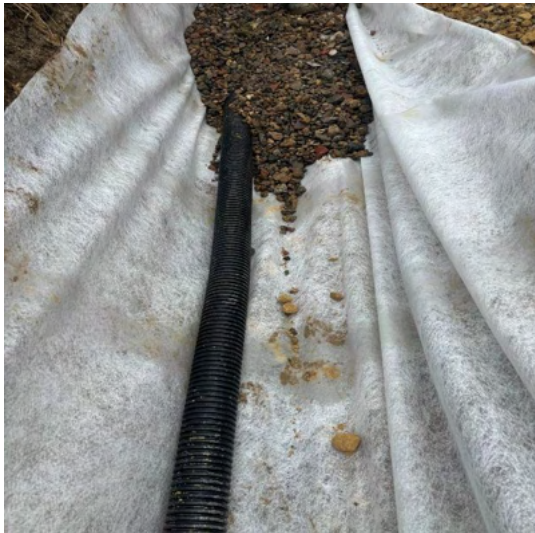
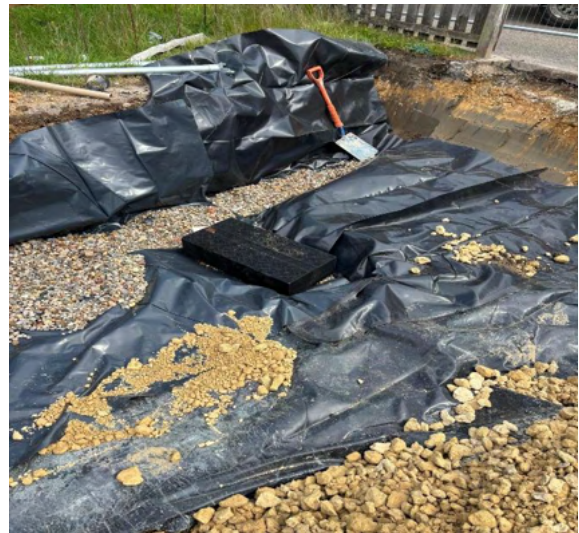
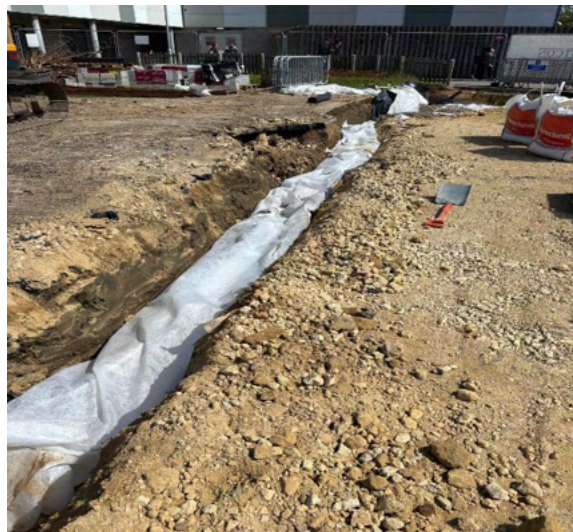
The below image shows pictures taken by the contractor during the installation of the Rain Gardens, these show the perforated pipe, being backfilled by type b filter material. The first picture shows the geotextile still be wrapped around the pipe and filter material, the second photos show it wrapped. The proposed drainage design has diffuser boxes connecting into the perforated pipe from the permeable parking bays, an example of these can be seen in the third photo.

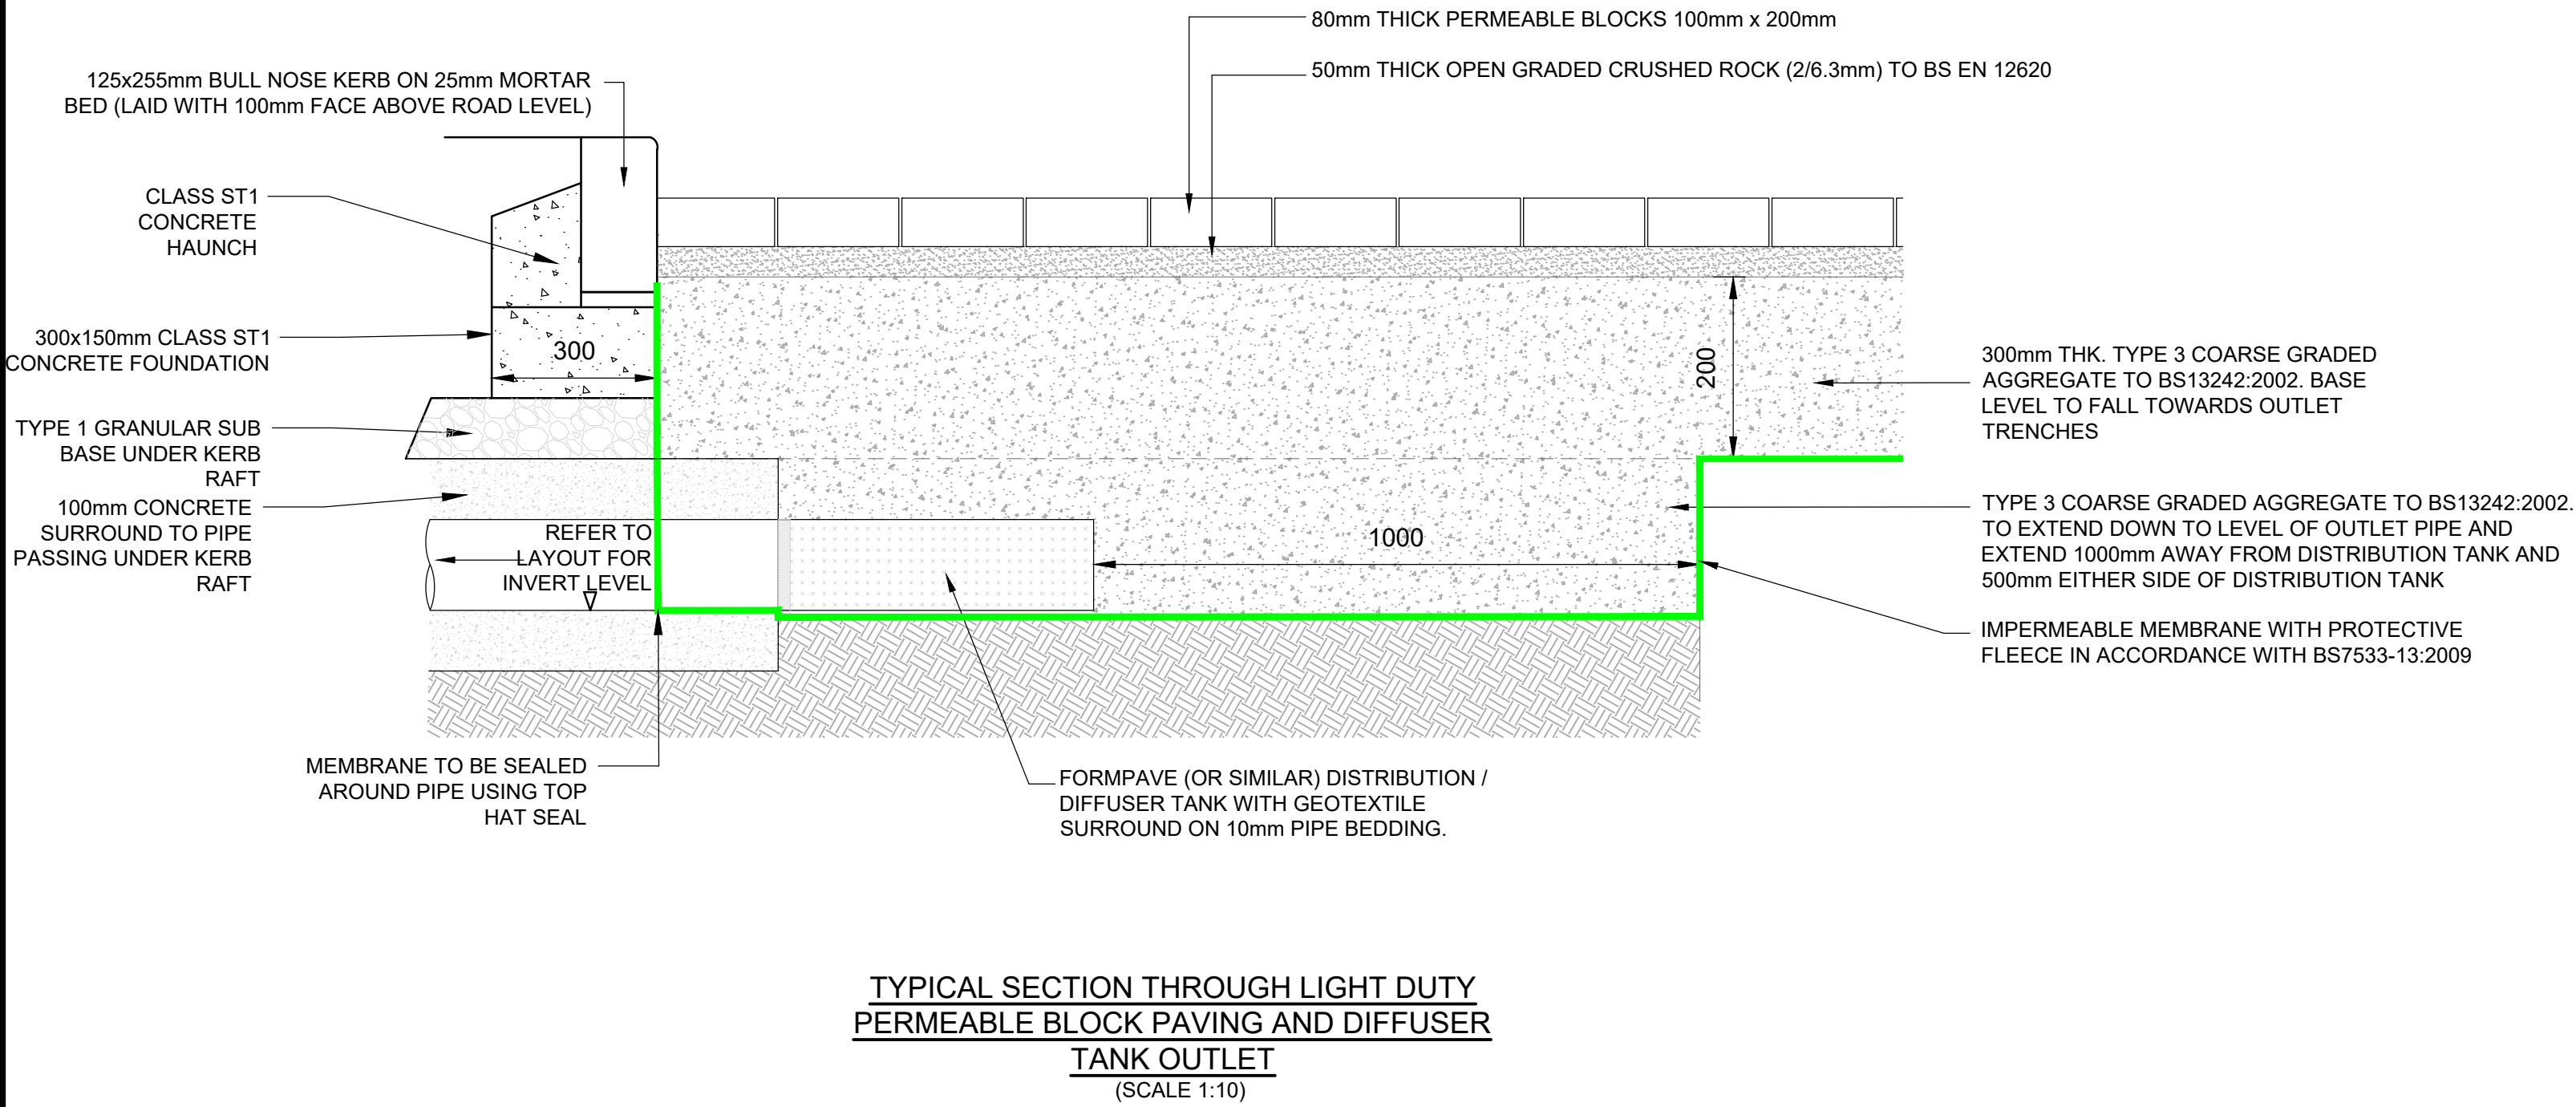
THIS BUILD UP IS PROVIDED BY MARHSALLS IF AN ALTERNATIVE MANUFACTURER / PRODUCT IS USED AND ALTERNATIVE BUILD-UP WILL BE REQUIRED

ASSUMED CBR OF 4%

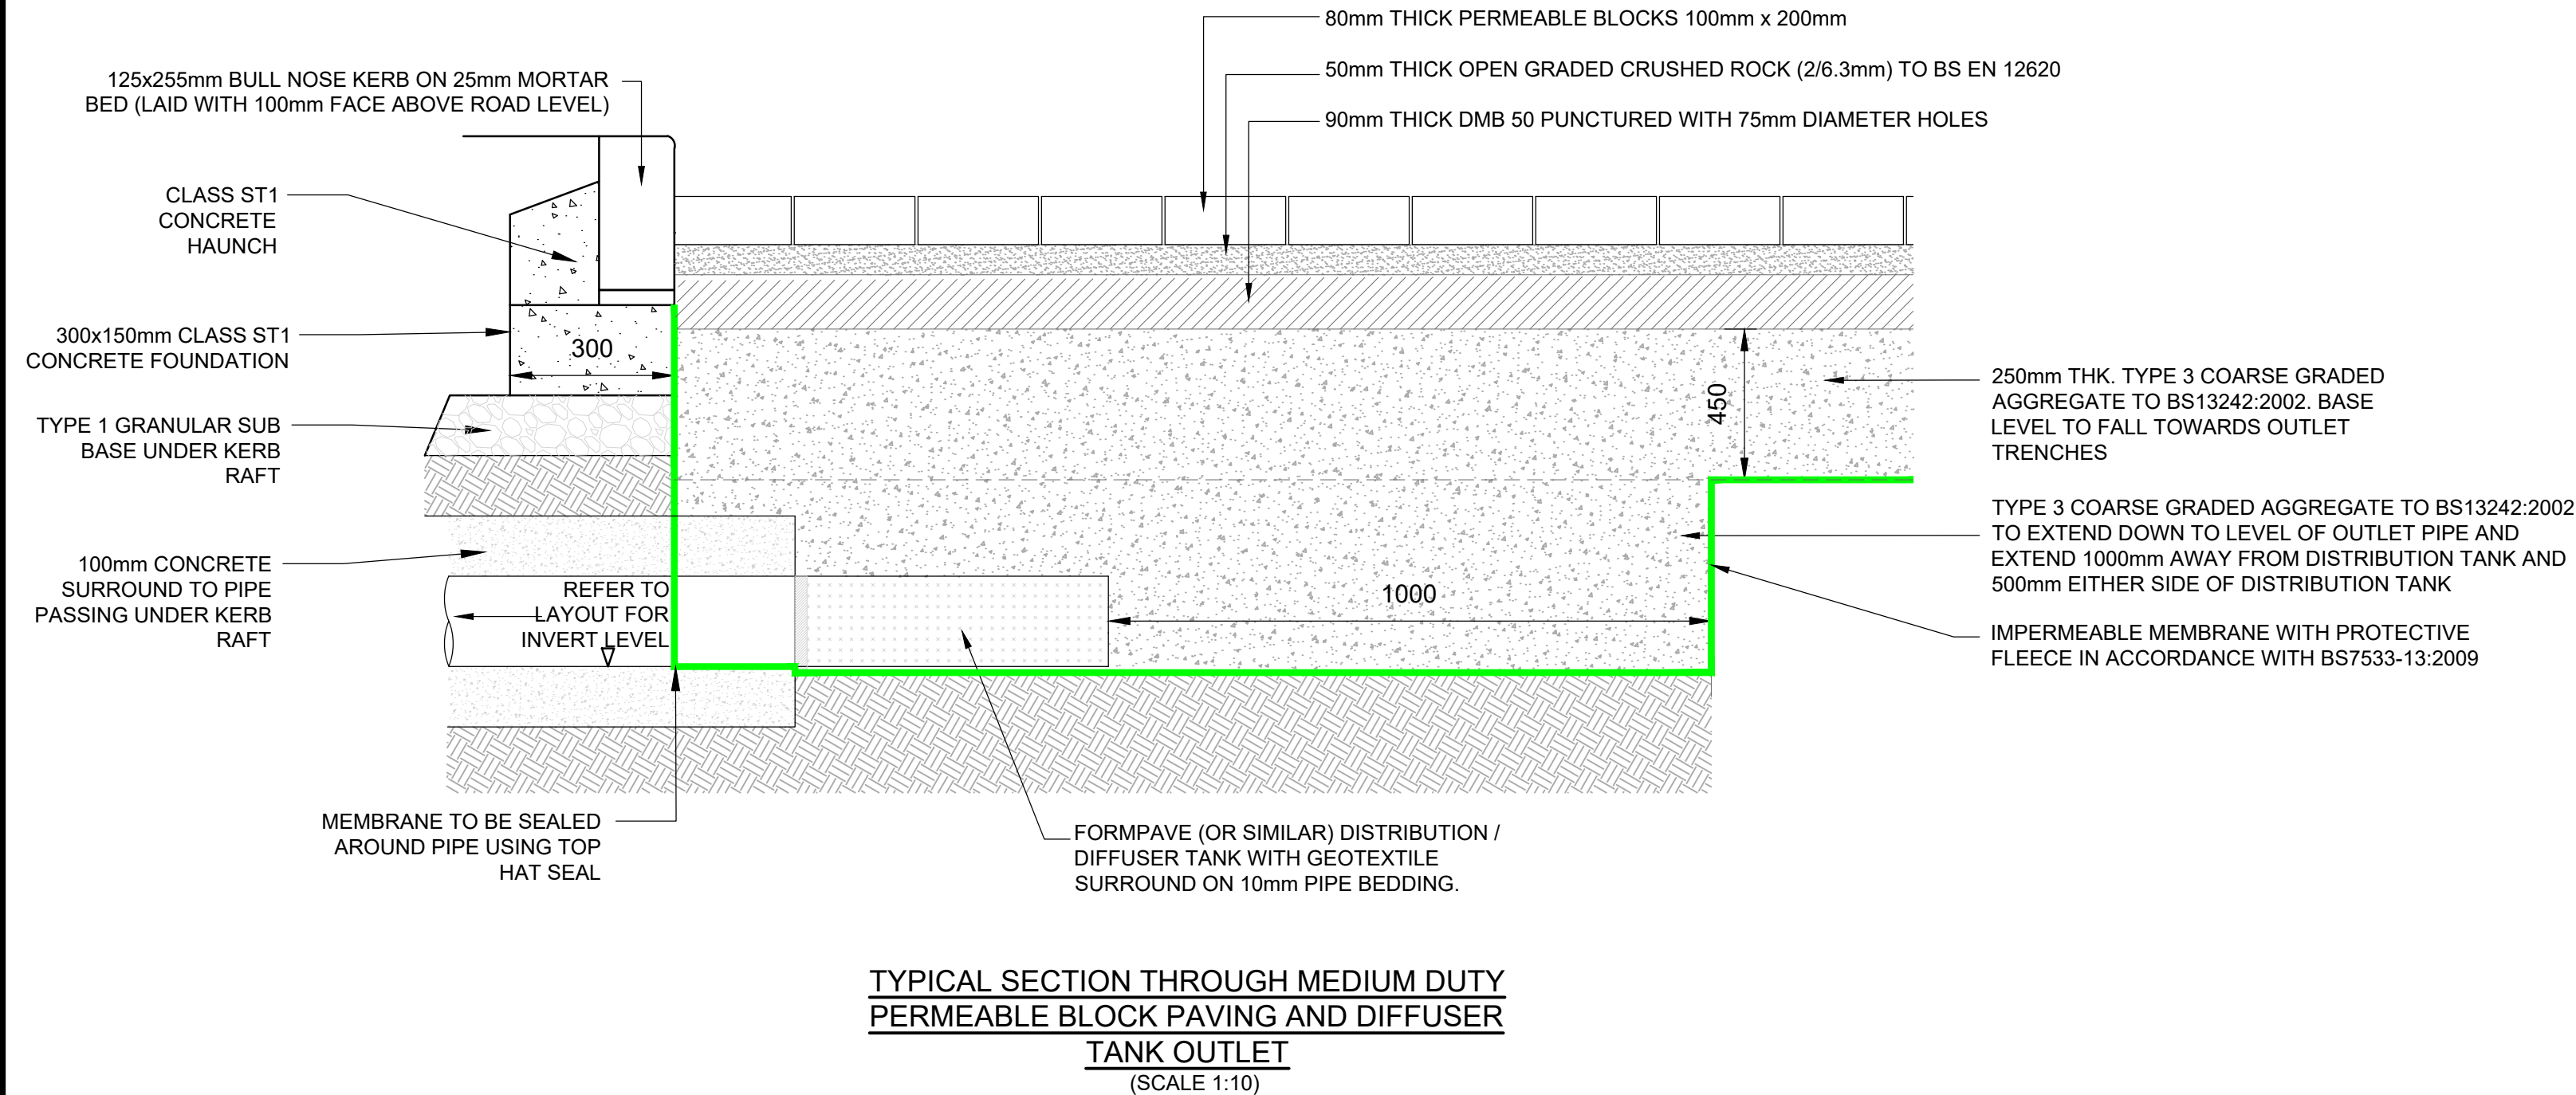
THIS BUILD UP IS PROVIDED BY MARHSALLS IF AN ALTERNATIVE MANUFACTURER / PRODUCT IS USED AND ALTERNATIVE BUILD-UP WILL BE REQUIRED

ASSUMED CBR OF 4%

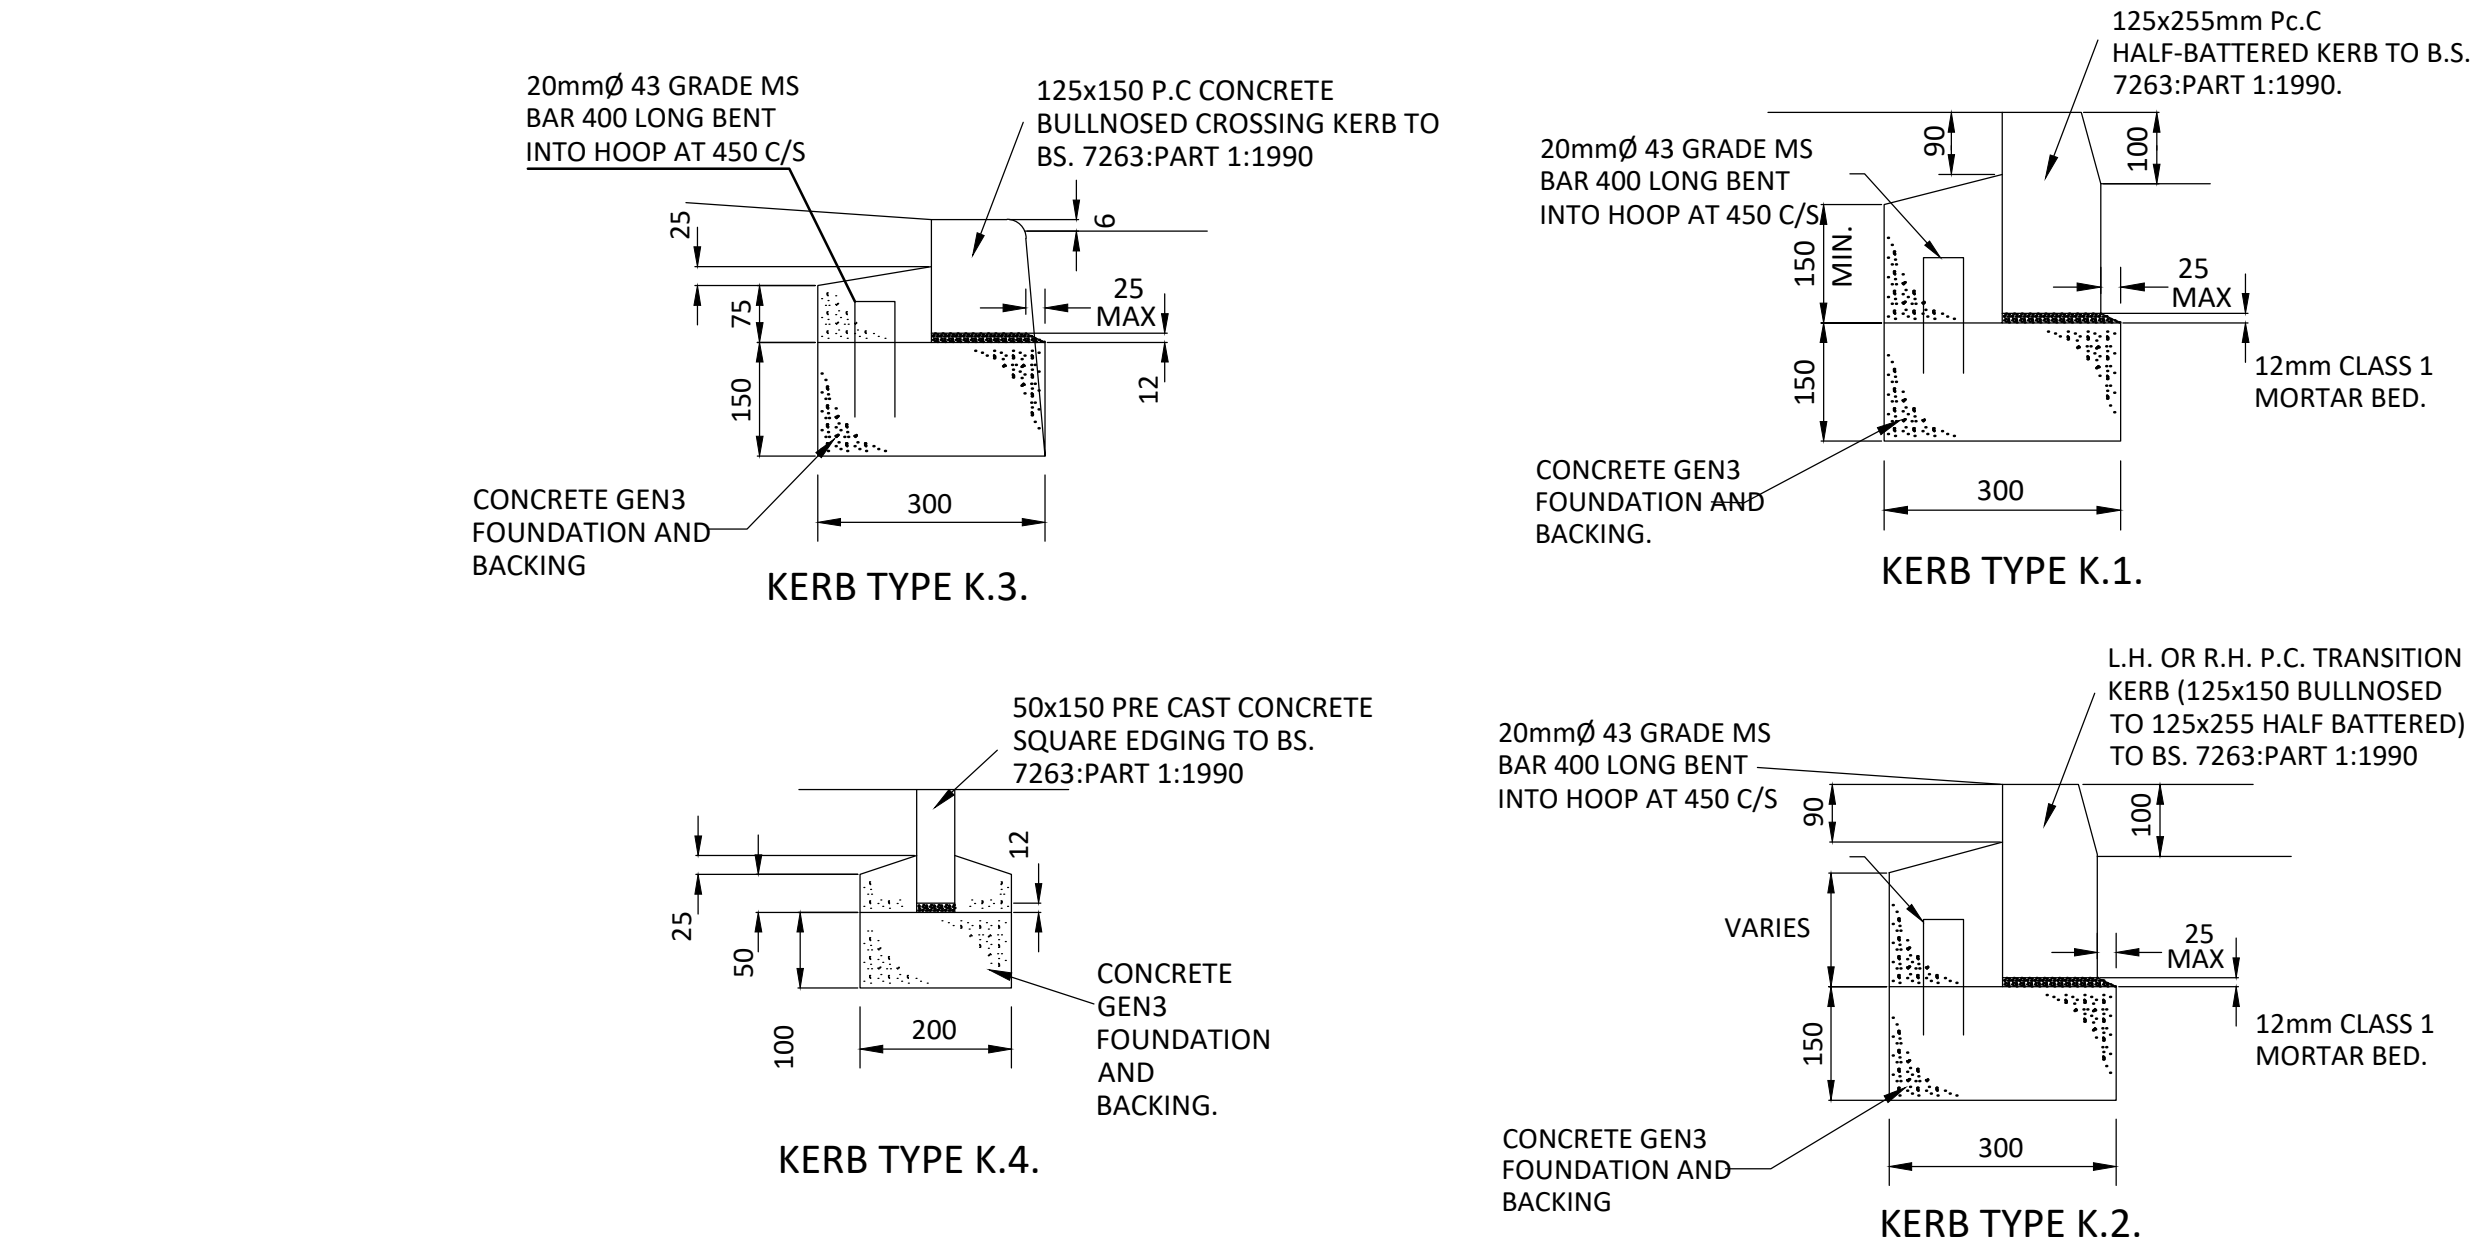
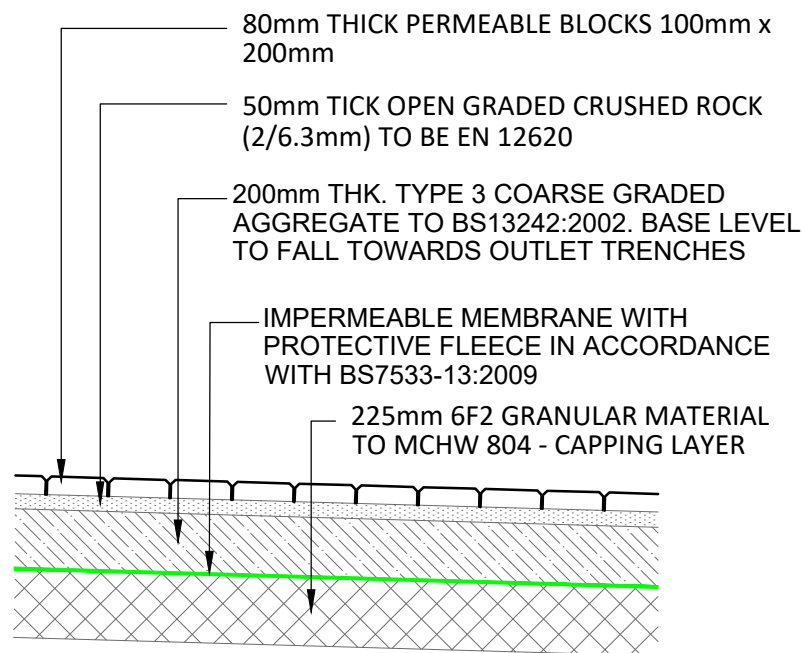
LIGHT DUTY PERMEABLE PAVING CONSTRUCTION

DESIGN CRITERIA:  
IT IS ASSUMED THAT THESE ROADWAYS WILL BE USED BY CARS ONLY  
DETAIL APPLICABLE FOR SUBGRADE CBR VALUES OF 3%. ADVICE TO BE SOUGHT IF SUBGRADE IS FOUND TO BE WEAKER.  
SUB BASE NOT DESIGNED TO BE TRAFFICKED BY CONSTRUCTION VEHICLES

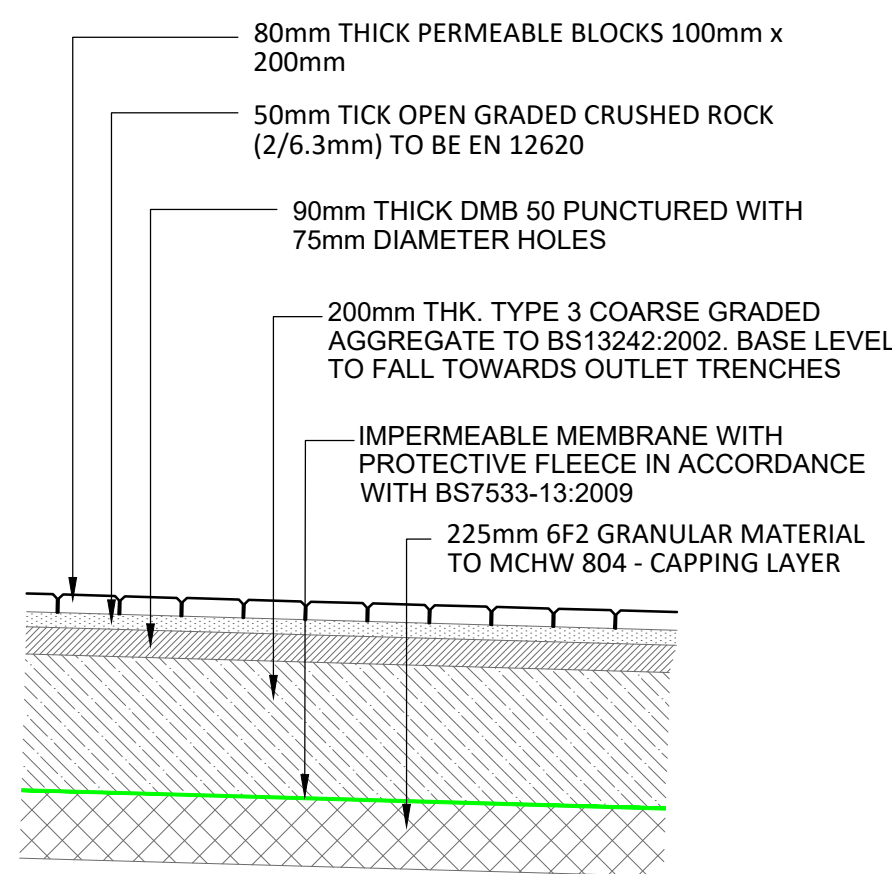
MEDIUM DUTY PERMEABLE PAVING CONSTRUCTION

DESIGN CRITERIA:  
IT IS ASSUMED THAT THESE ROADWAYS WILL BE USED BY CARS ONLY  
DETAIL APPLICABLE FOR SUBGRADE CBR VALUES OF 3%. ADVICE TO BE SOUGHT IF SUBGRADE IS FOUND TO BE WEAKER.  
SUB BASE NOT DESIGNED TO BE TRAFFICKED BY CONSTRUCTION VEHICLES

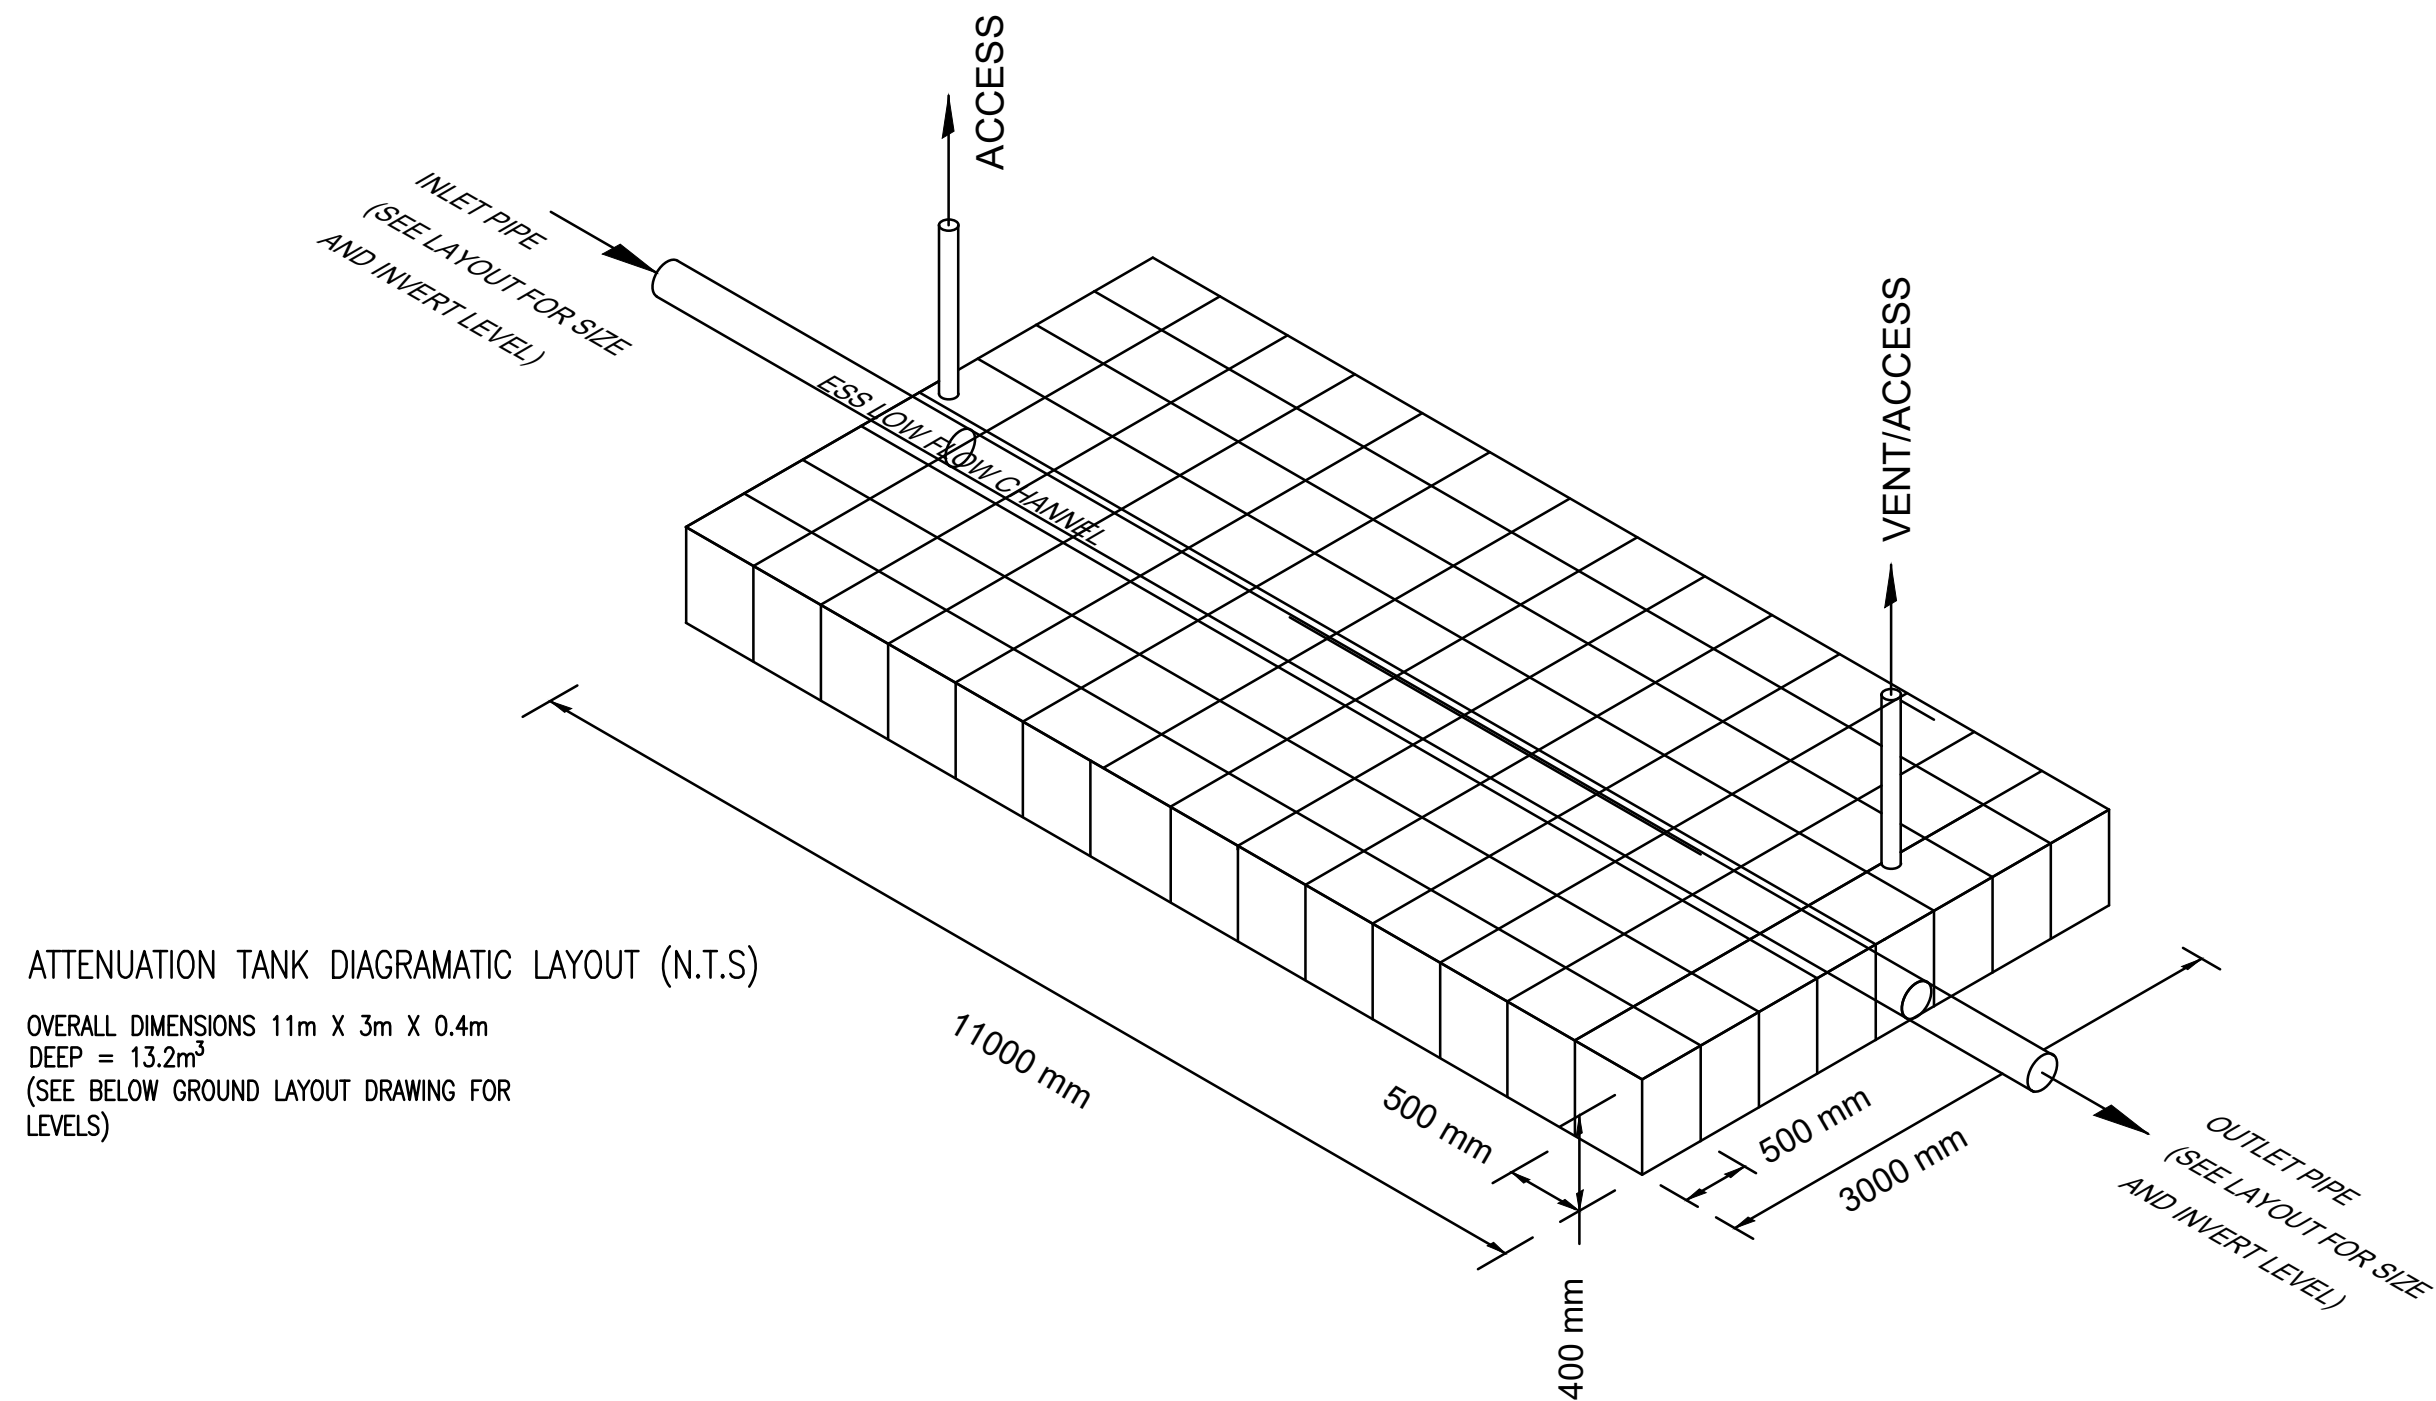
ATTENUATION TANK DIAGRAMATIC LAYOUT (N.T.S.)  
OVERALL DIMENSIONS 11m X 3m X 0.4m  
DEEP = 13.2m<sup>3</sup>  
(SEE BELOW GROUND LAYOUT DRAWING FOR LEVELS)

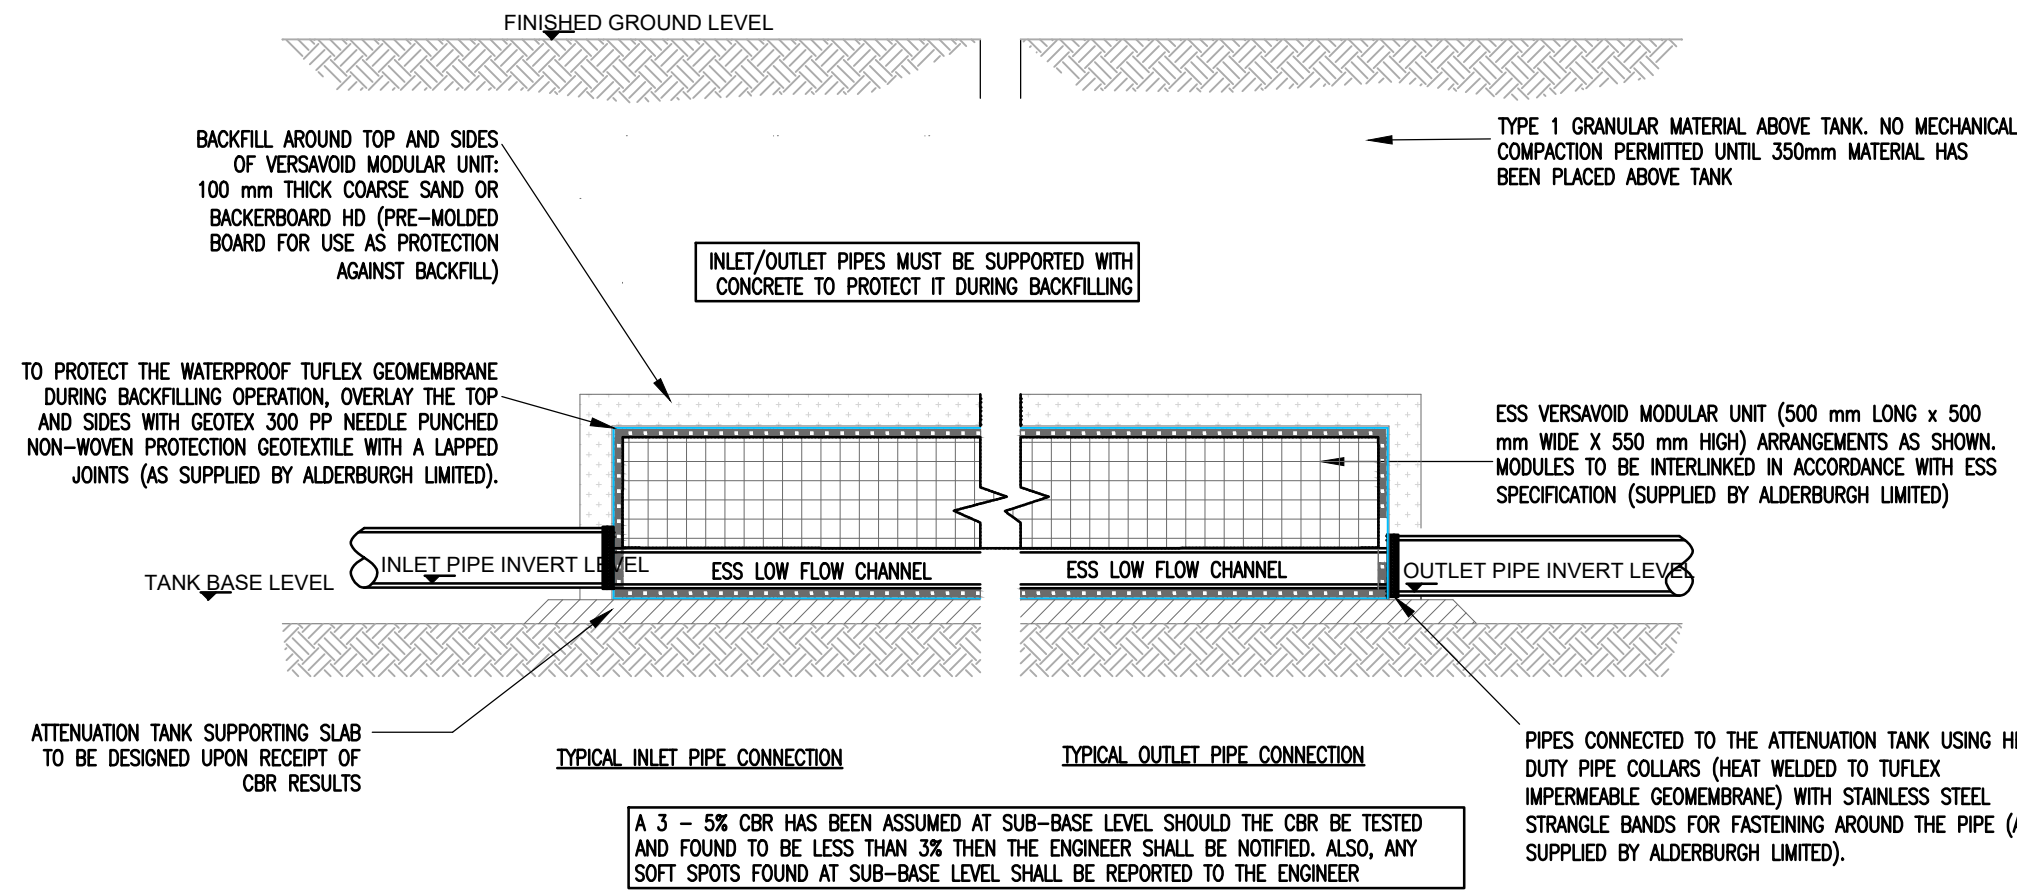
ATTENUATION TANK DETAILS USING VERSAVOID MODULAR UNITS (N.T.S.)

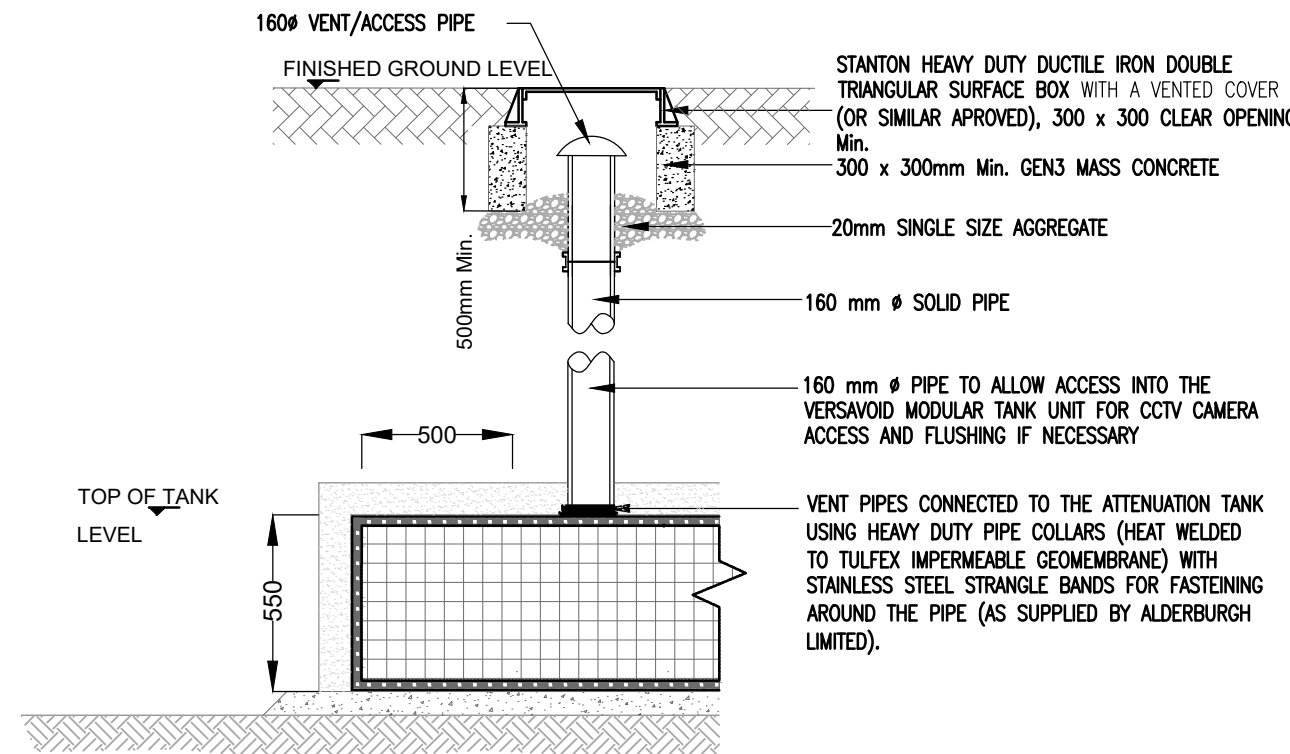
TYPICAL 160mm VENT / INSPECTION PIPE CONNECTION (N.T.S.)

THE CONTRACTOR SHALL PROHIBIT THE MOVEMENT OF CONSTRUCTION PLANT ACROSS THE STORAGE TANK AND WHERE NECESSARY PROVIDE ADDITIONAL SUPPORT AND PROTECTION TO THE STRUCTURE. PARTICULARLY POST CONSTRUCTION. TEMPORARY FENCING CAN BE USED TO PROHIBIT TRADE STOCKS, PILING MATERIALS, HEAVY PLANTS ETC.,

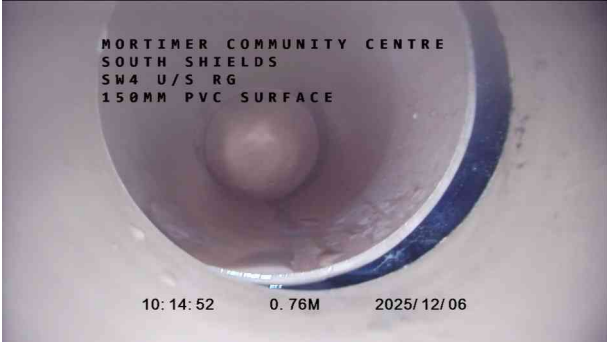
| X | 26/02/26 | OH | AS BUILT | FM | DH |
|---|---|---|---|---|---|
| Rev | Date | By | Description | Chk | App |

1, 00:00:07, 0.76 m  
Open joint, large
