## Arboricultural Impact Assessment & Method Statement For Trees At 6 The Leas, Whitburn

Andrew Mackenzie

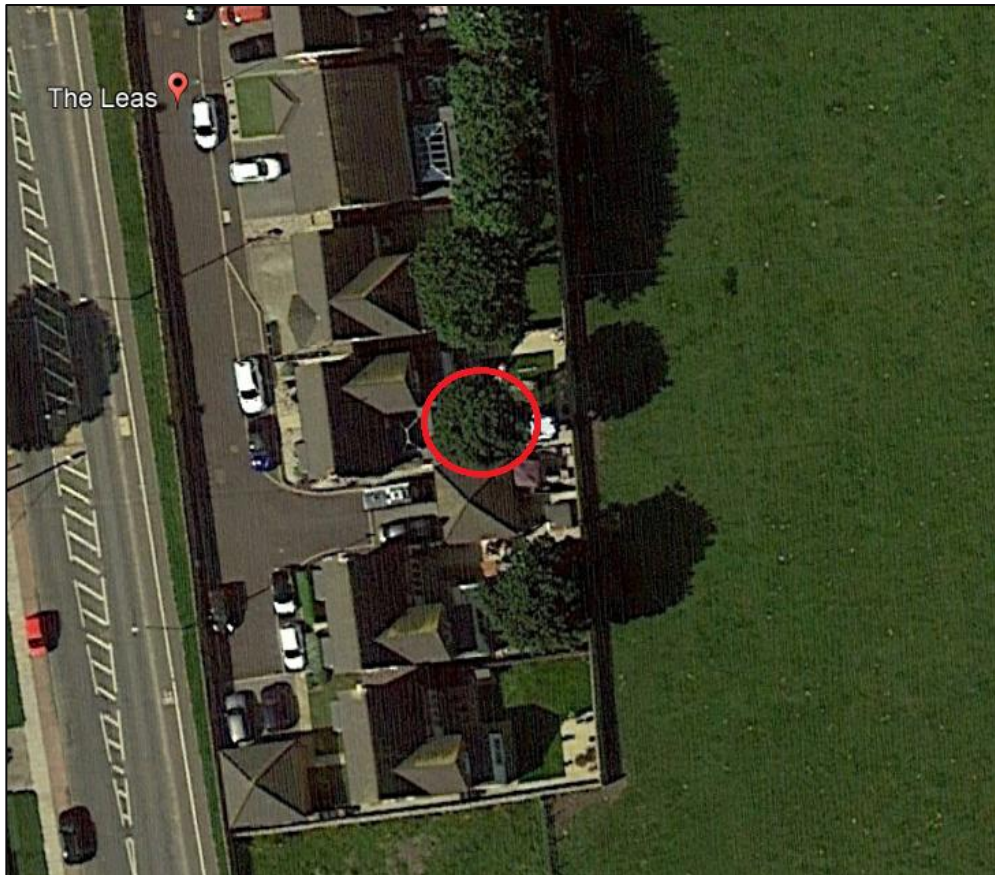
*Figure 1 – Tree 1 is indicated by the red circle, tree 2 is indicated by the yellow circle*

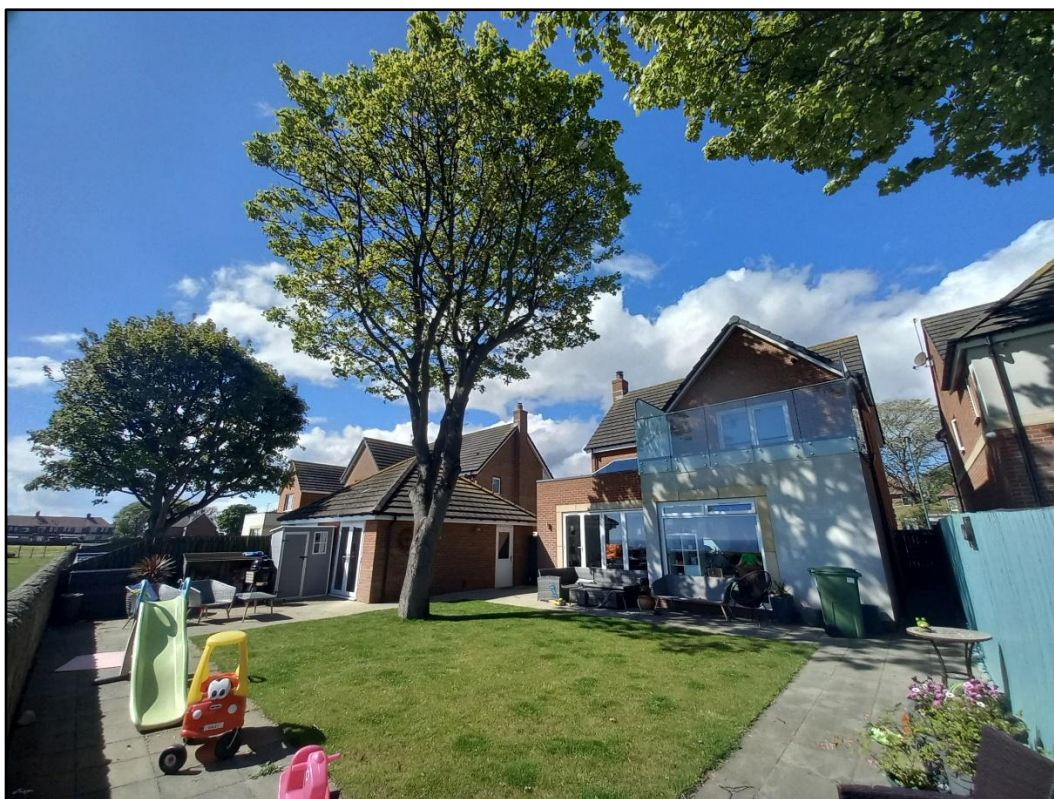
*Figure 2 – Tree 1, within the rear garden of 6 The Leas.*

4.3.1 Tree retained from former land use and incorporated into the garden of 6 The Leas. Now located within a small squared lawn flanked by hard surfacing.

The subject tree has been crown lifted in the past leaving a high canopy. The wounds are occluding at the margins with no evidence of significant decay from a ground level inspection.

Multiple hearts and names carved into tree stem – no evidence of any significant damage. Wounds fully occluded with no cambium exposure at time of inspection.

2x codominant stems from 2.0m. Stems further divide between 3.5 to 4.5m forming multi-stemmed canopy.

No major visible defects.

4.3.2 It is proposed to erect the conservatory foundation on a raft foundation, 450mm depth. All excavation for the foundation must be done so in accordance with the guidance found in section 5 of this document.

A protective barrier will be placed around the perimeter of the lawn to protect the unmade ground during construction. This must be erected as per the specification in section 5 of this document and erected in the position indicated by the blue line on the Tree Protection Plan (**TPP**).

The existing paving must be retained during works (with the exception of the portion in the conservatory footprint) to act as ground protection for any underlying roots.

It will not be necessary to conduct any pruning of the canopy to facilitate the proposals.
