Mechanical Inspection Report

at
McNulty Yard
for
Port of Tyne

Prepared for: Port of Tyne
Prepared by: P McKay
Reviewed by: P Appleton
Date: February 2013

Project No: 5570

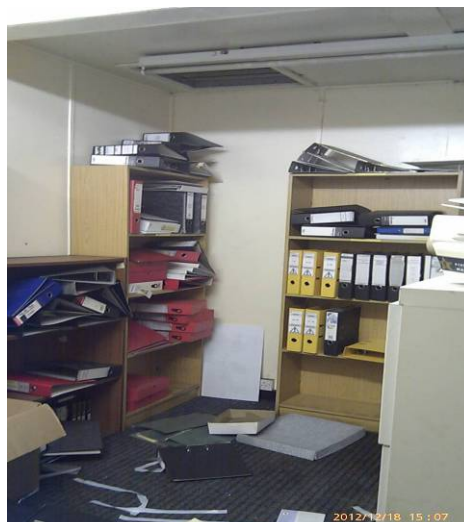
Vent. Grille

11.4 Ventilation: Yes. Central System. Condition. Poor

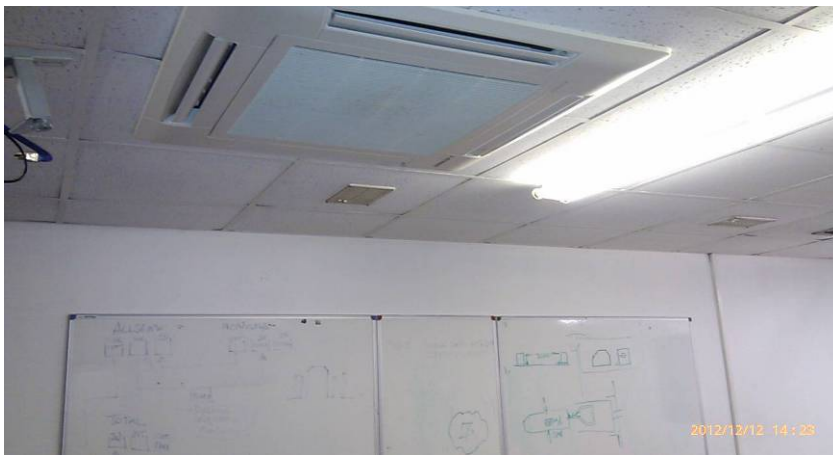
AC System

15.8 Air Conditioning: In Conference and meeting rooms Condition: Good

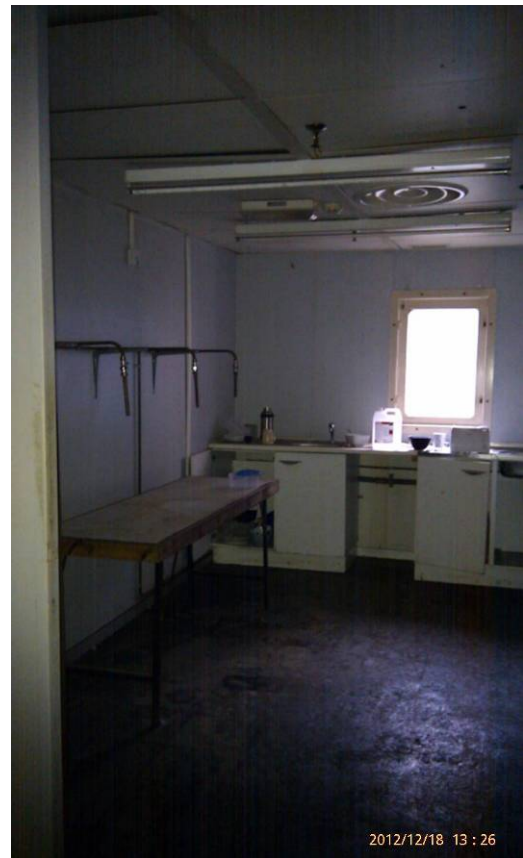
Water Heater

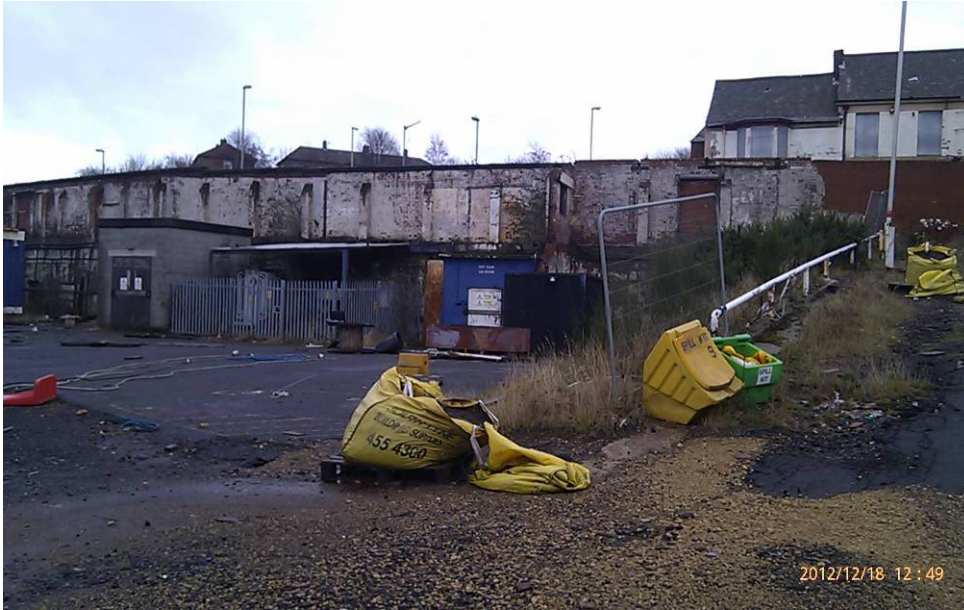
External

21.1 No Mechanical Services

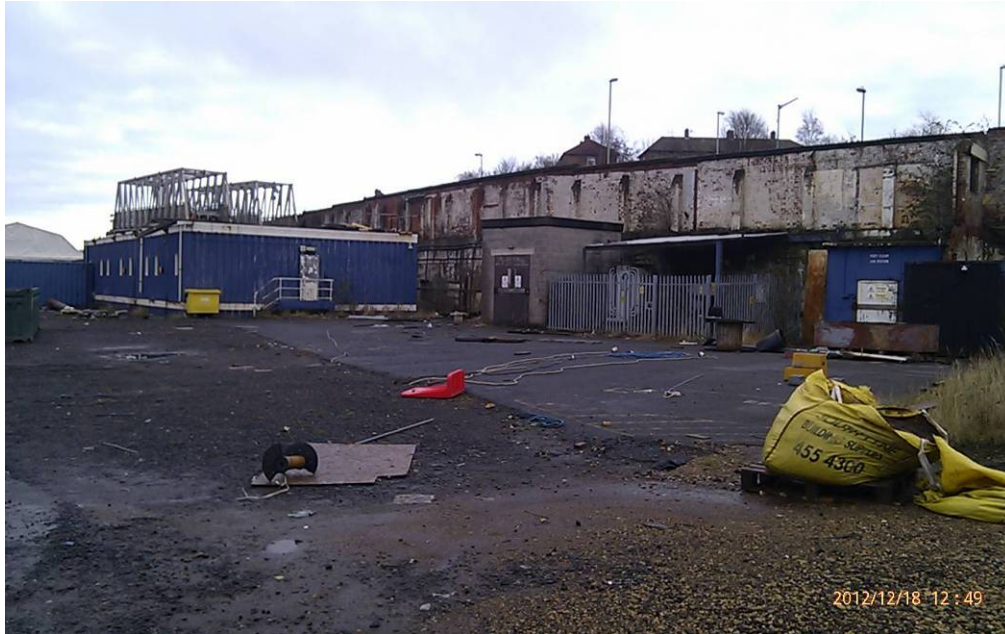
External

22.1 No Mechanical Services

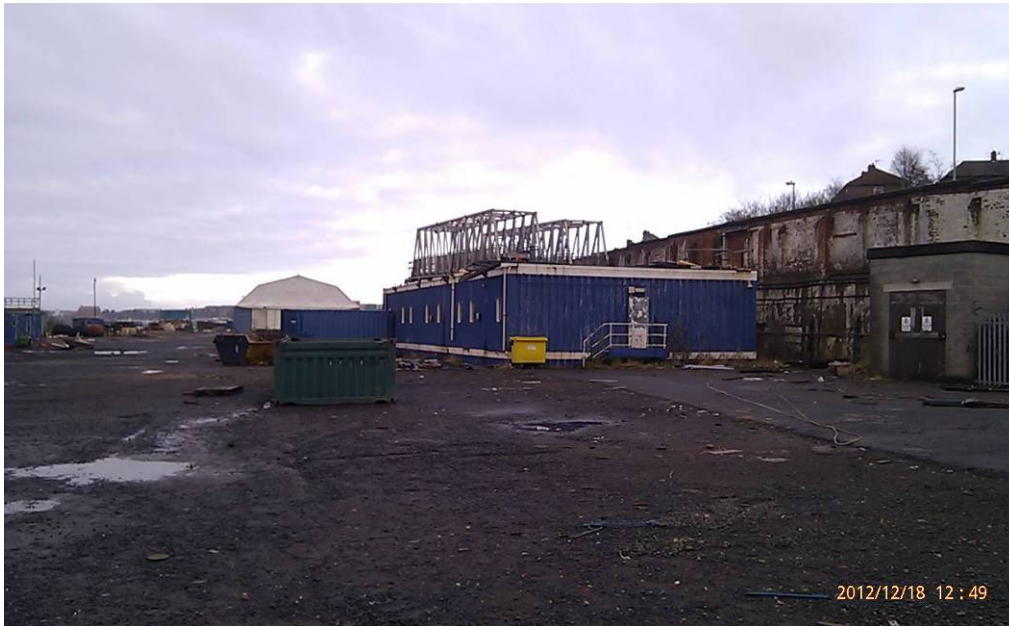
External

23.1 No Mechanical Services
