**CASTLE**

**16 BARRINGTON STREET  
SOUTH SHIELDS  
TYNE AND WEAR  
NE33 1AN**

**SPECIFIC DEFECT SURVEY**

**FEBRUARY 2026**

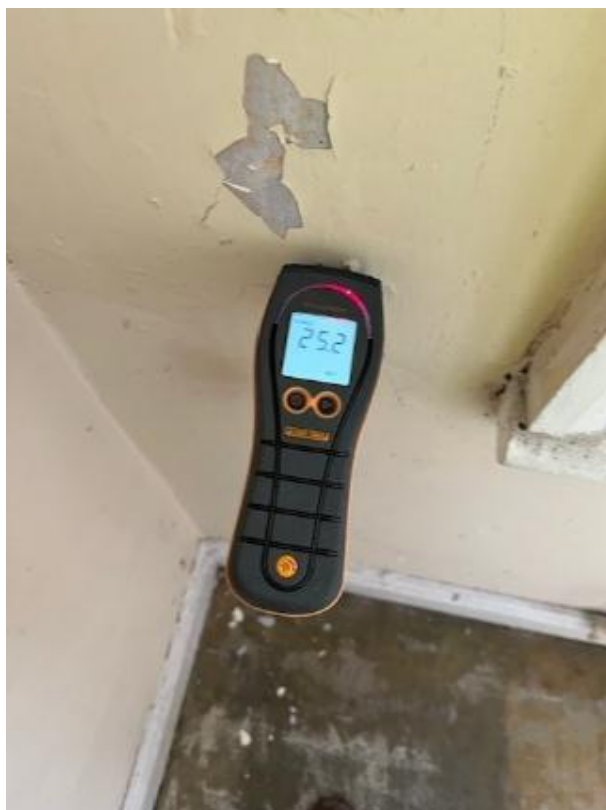
P4 – Store Room 25.2% m.c

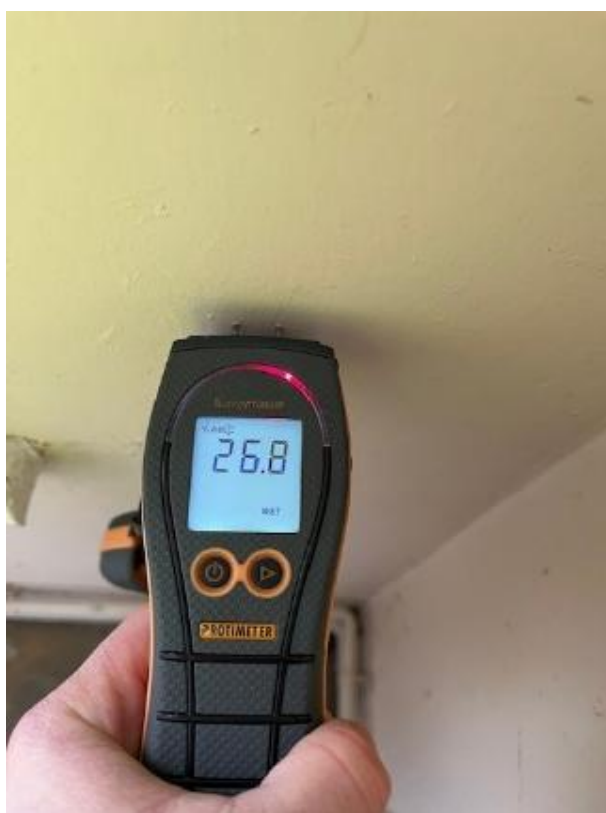
P5 – Store Room 26.8 % m.c

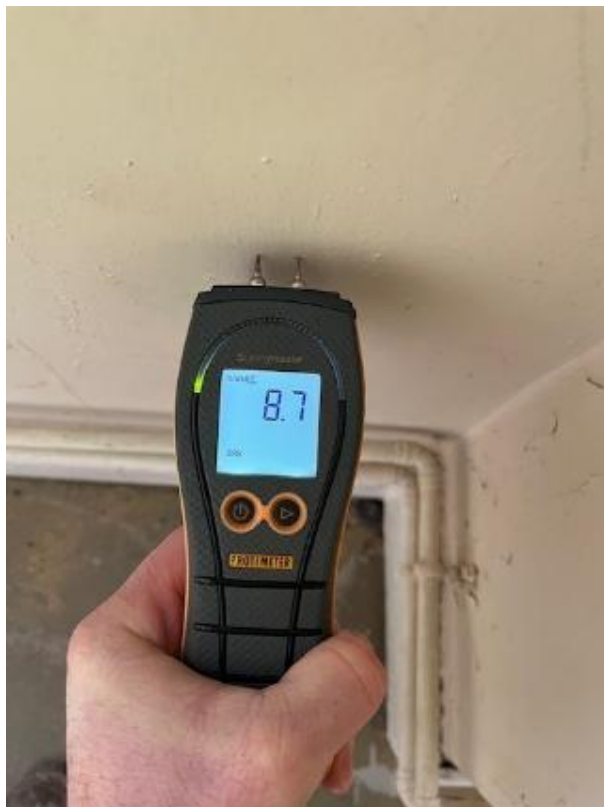
P7 – Store Room 8.7% m.c

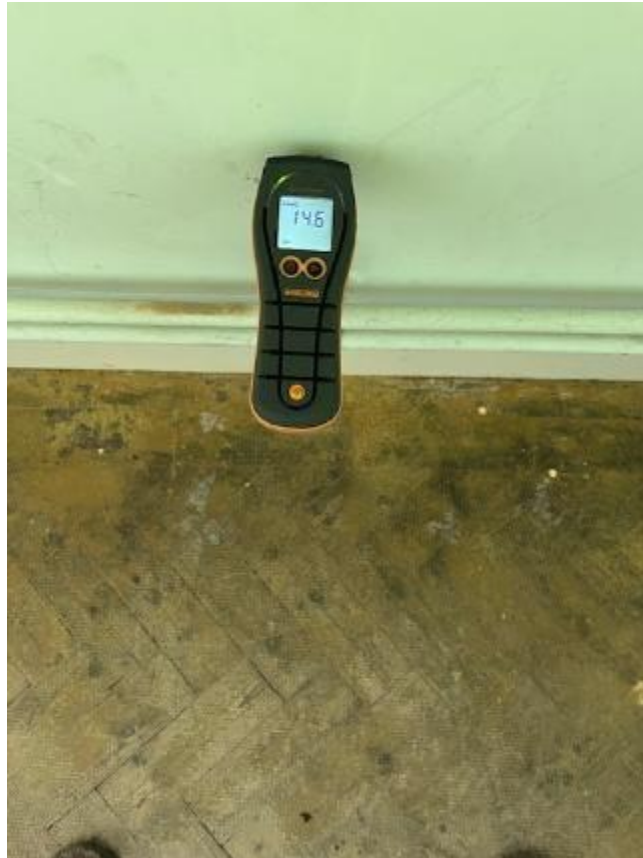
P10 – Estates A 14.6% m.c

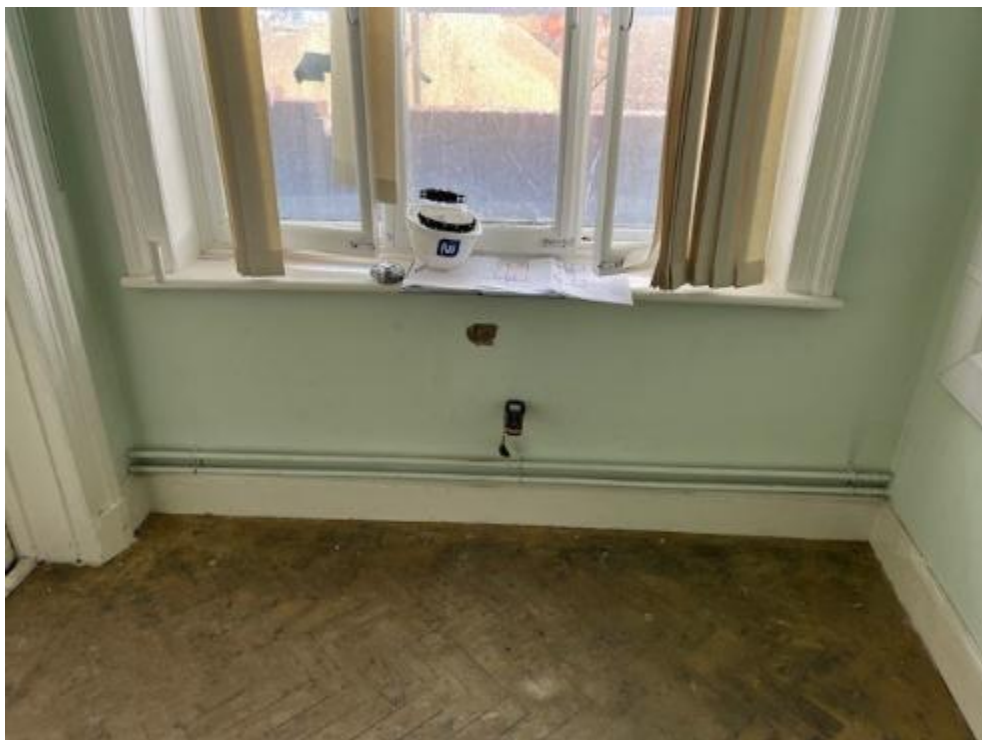
P11 – Estates A 14.6% m. c

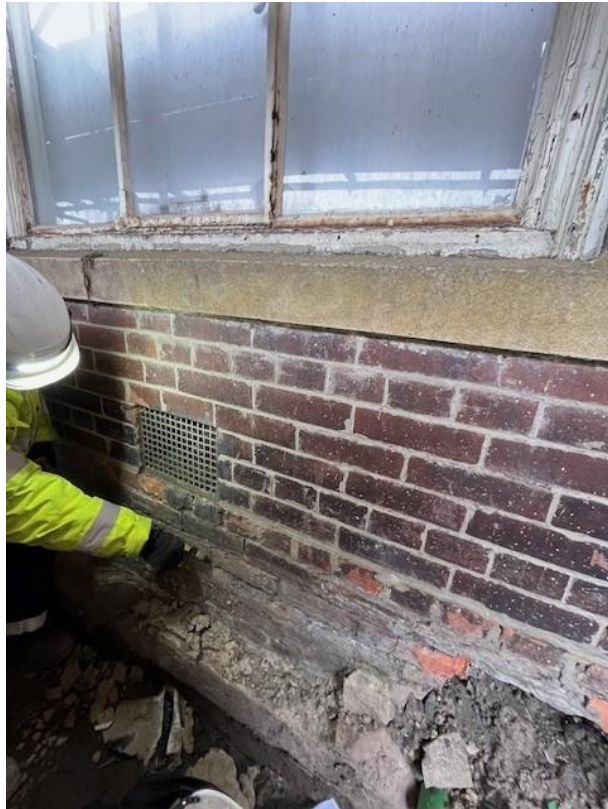
- 3.2 The localised area of higher external path to the east elevation has resulted in migration of moisture into the solid masonry from the build up hardcore/fill. Areas of reinstated ground (fill/paths) etc should be isolated from direct contact with the external walls by the introduction of a vertical damp proof membrane. A free draining gravel margin should also be introduced if possible to prevent rainwater splashing out up the brickwork and bridging/migration of moisture.

P12 – East Elevation approximate height of internal finished floor level indicated

- To prevent bridging and the transfer of moisture from the new path directly into the masonry walls it is recommended that a vertical damp proof course inserted as an isolating layer between the walls and the path; this is good practice and will eliminate the risk of any penetrating dampness. A sketch detail is enclosed in Appendix C and manufacturer's Product Details in Appendix E. It is also advised that a slight cross-fall is incorporated into the path to ensure surface water does not run towards the external wall
- Install vertical damp proof membrane collars around the below ground penetrating services

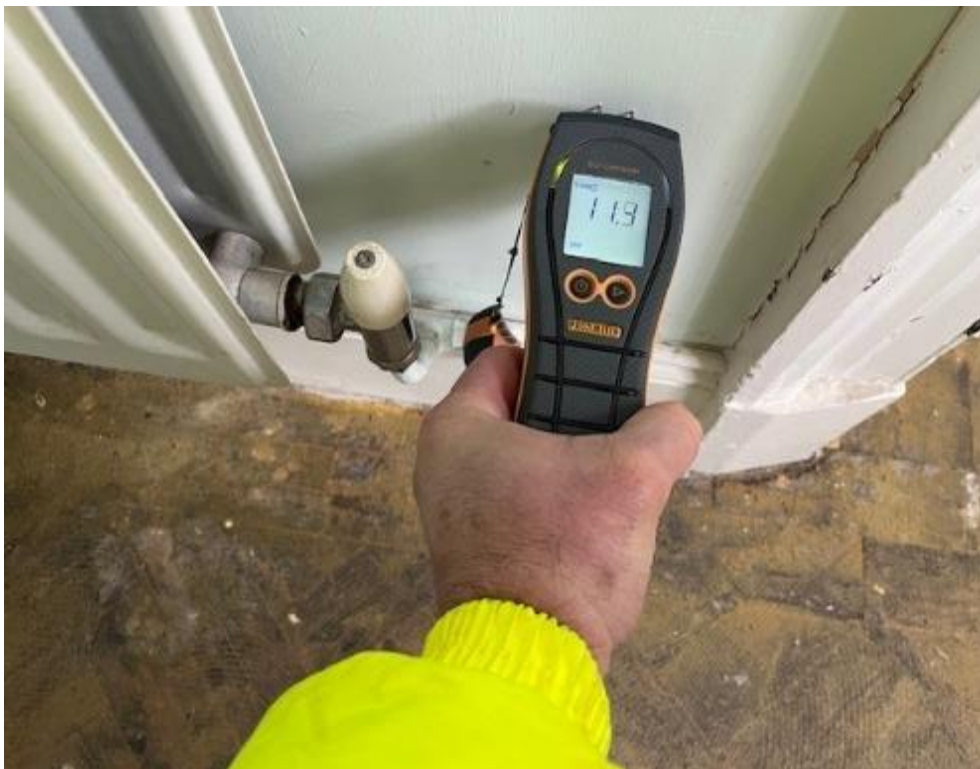
P15 – Estates A 11.9% m. c

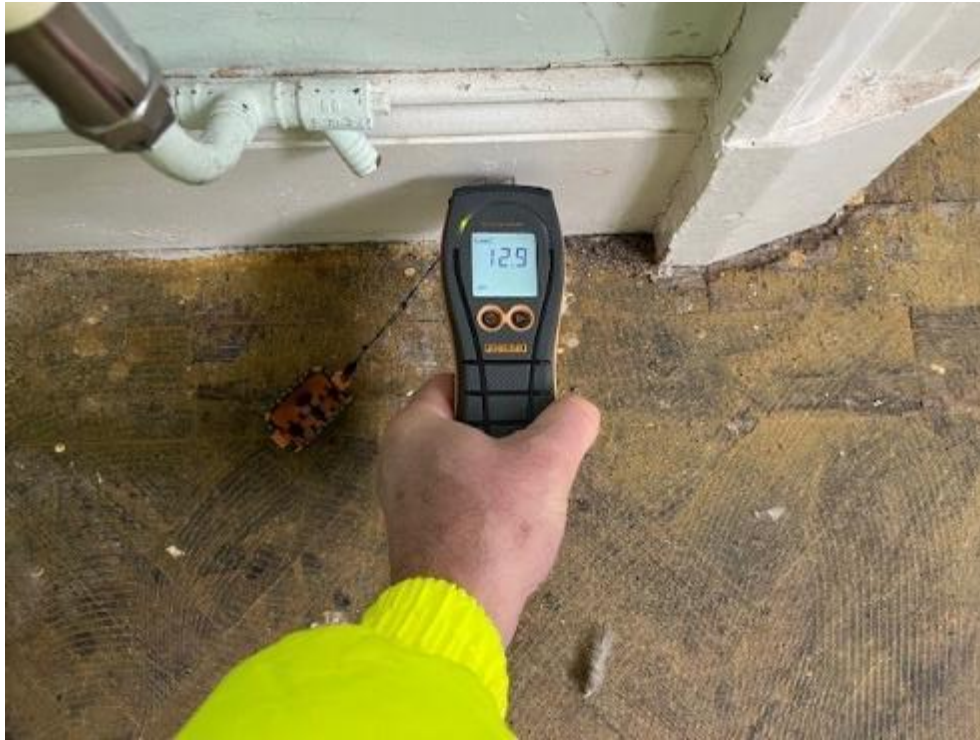
P16 – Estates A 12.9% skirting

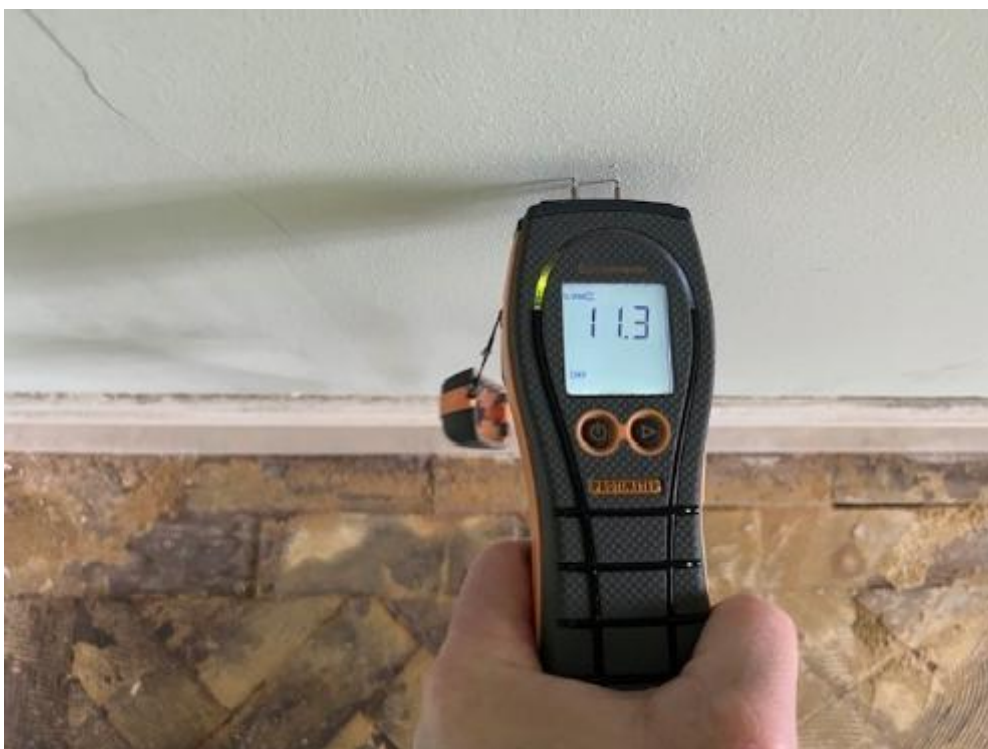
P17 – Estates A 11.3% internal wall

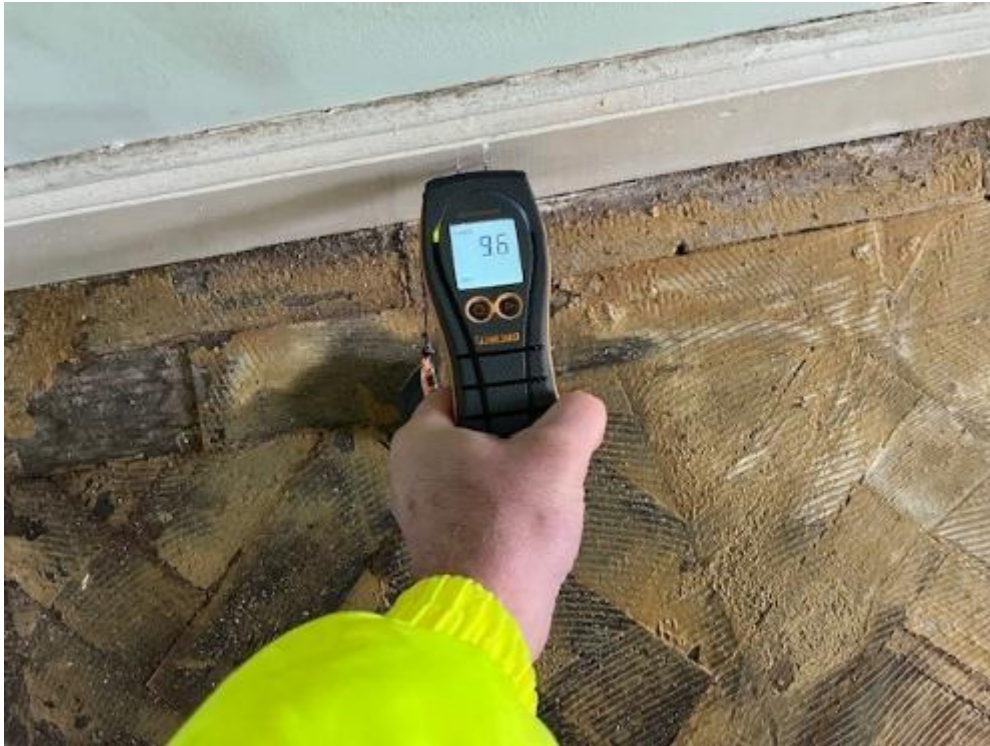
P18 – Estates A 9.6% skirting

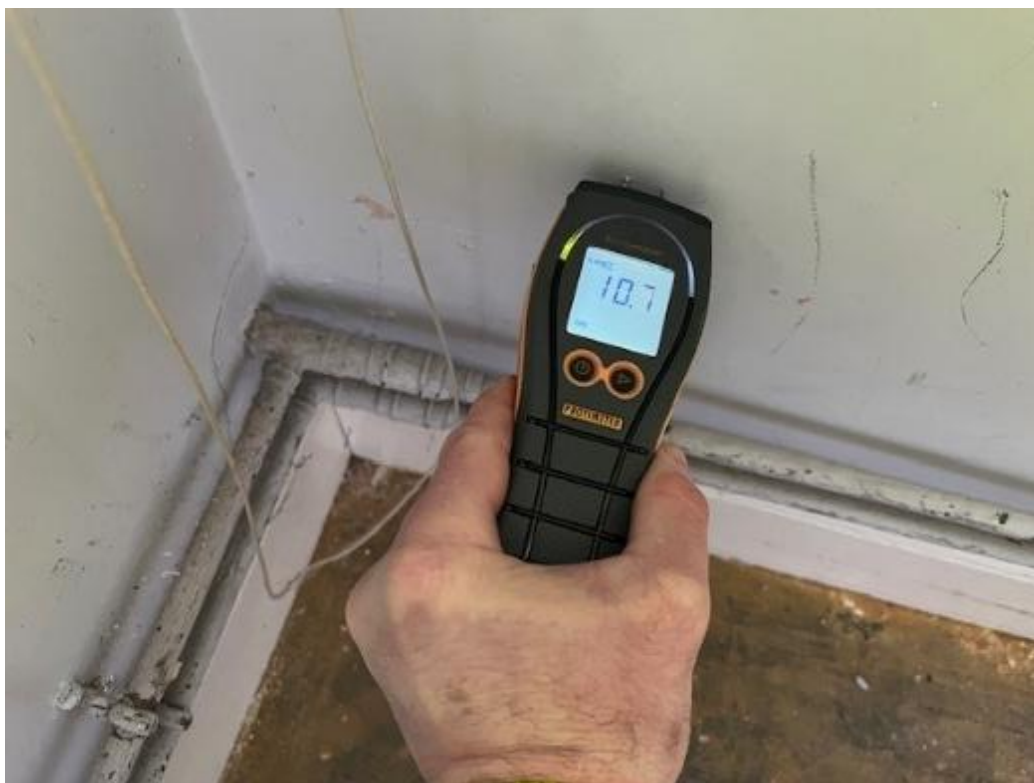
P19 – Estates B 10.7% m.c

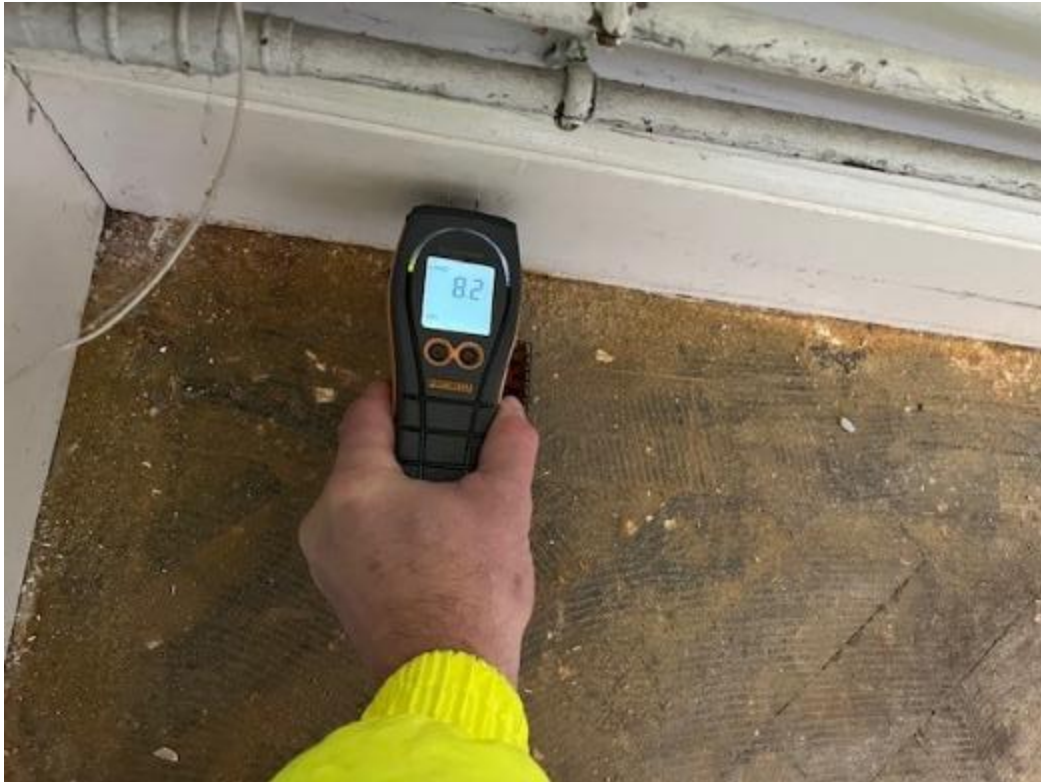
P20 – Estates B 8.2% m.c

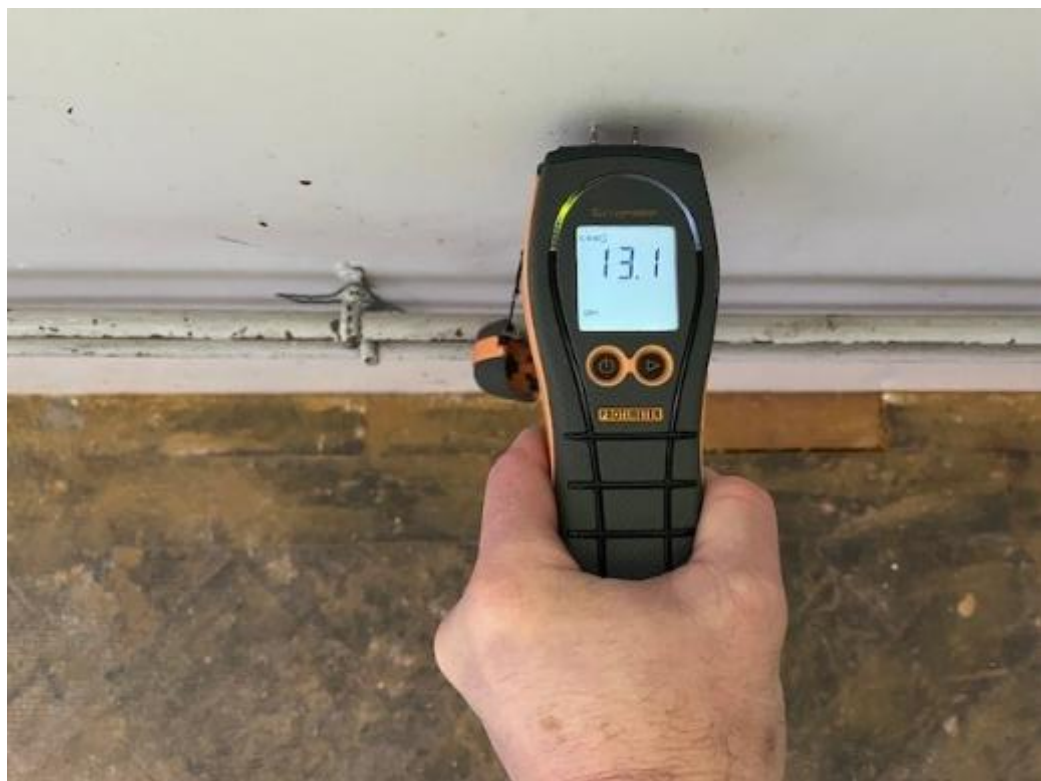
P21 – Estates B 13.1% m.c

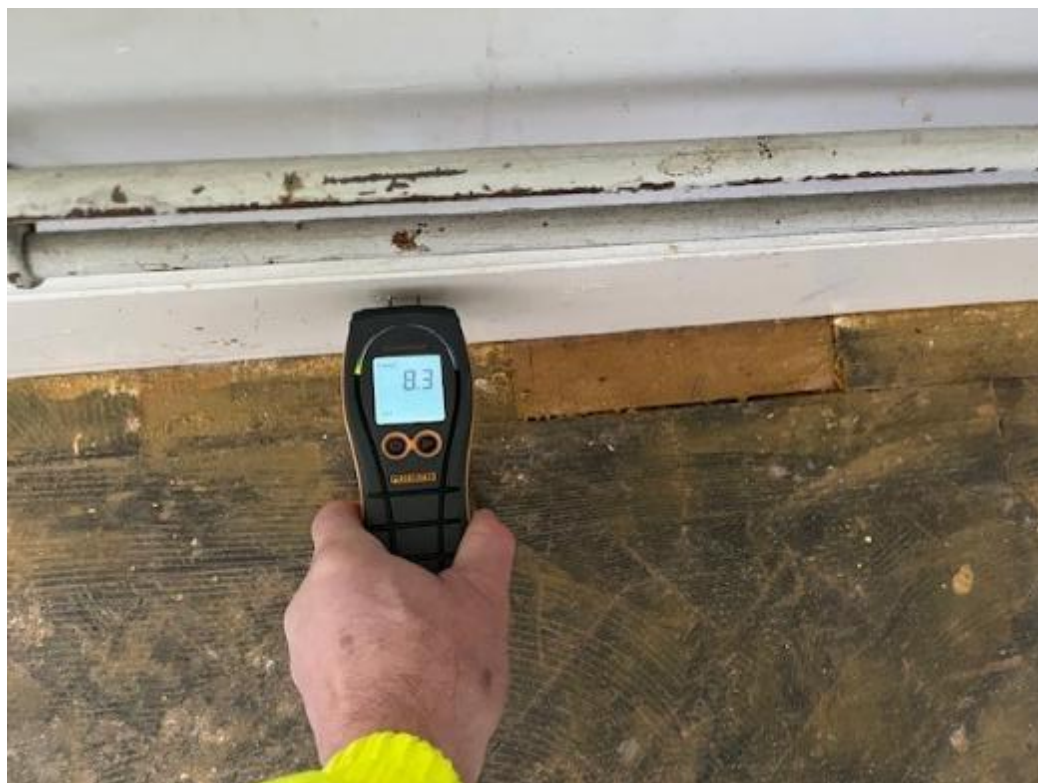
P23 – Estates B 8.3% skirting m.c

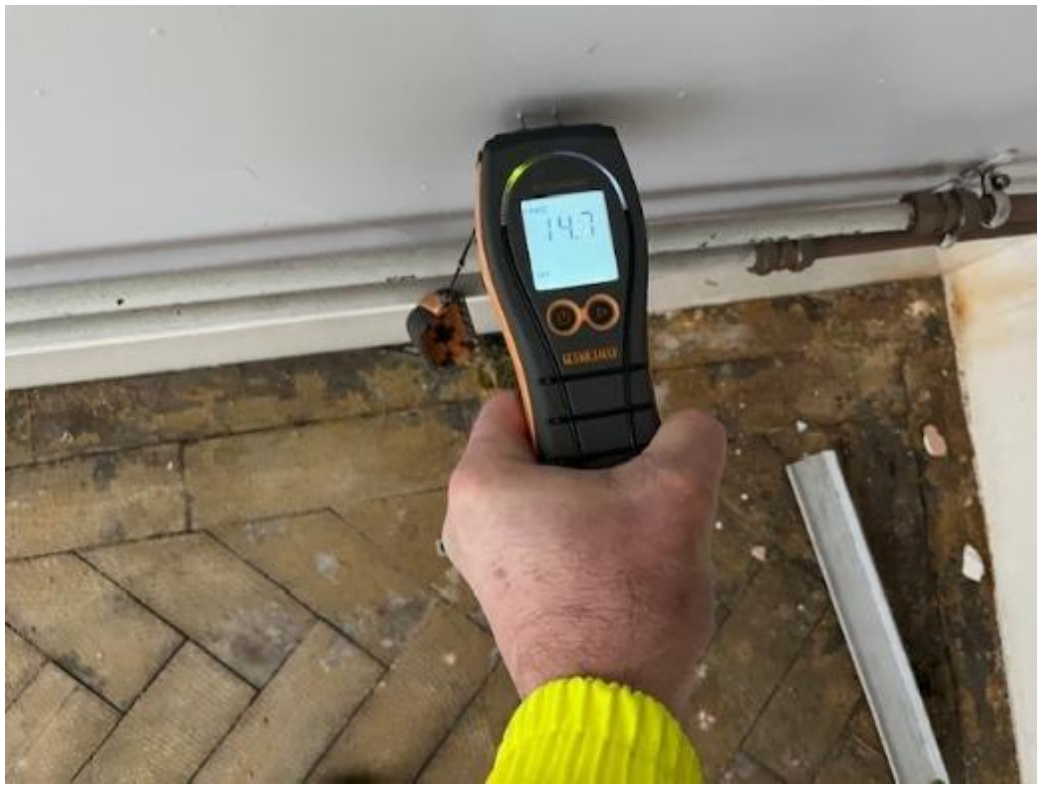
P24 – Estates B 14.7% m. c

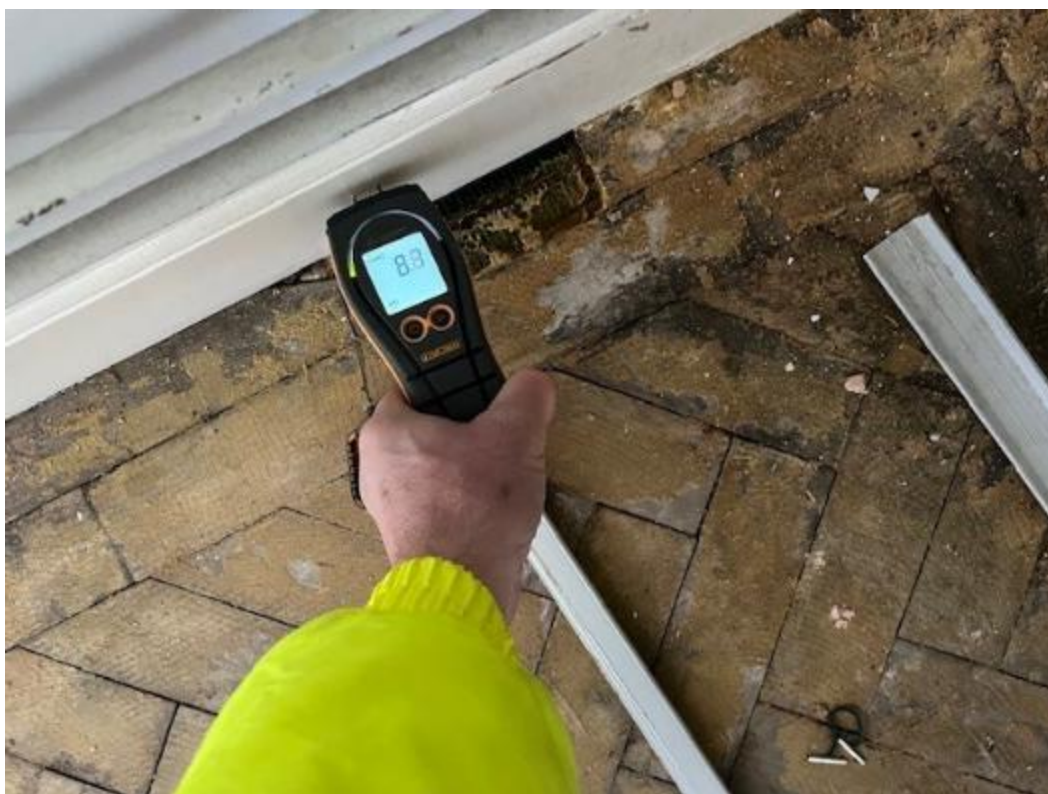
P24 – Estates B 8.3% m.c skirting

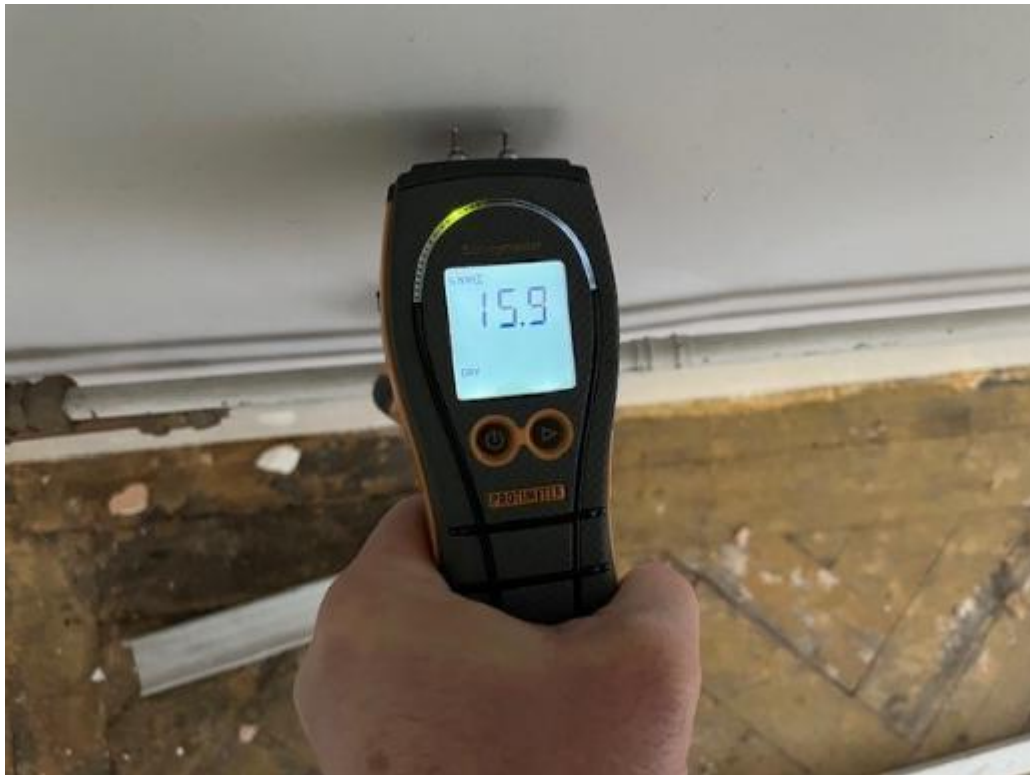
P25 – Estates B 15.9% m. c

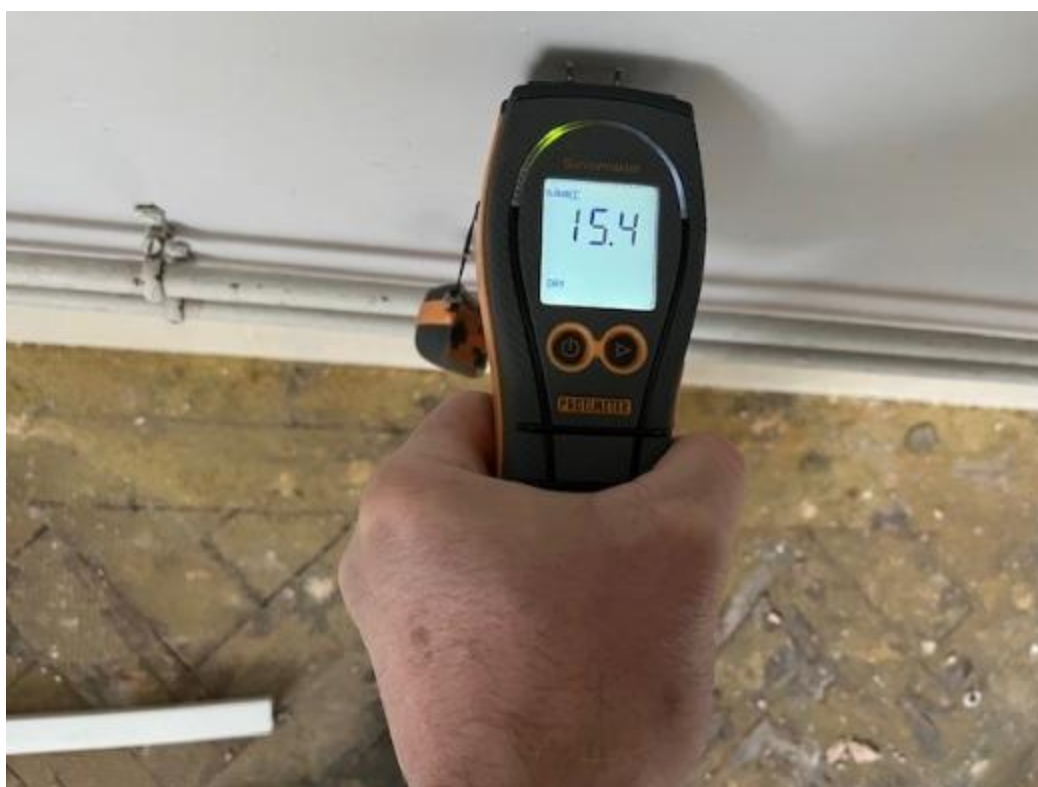
P26 – Estates B 15.4% m .c

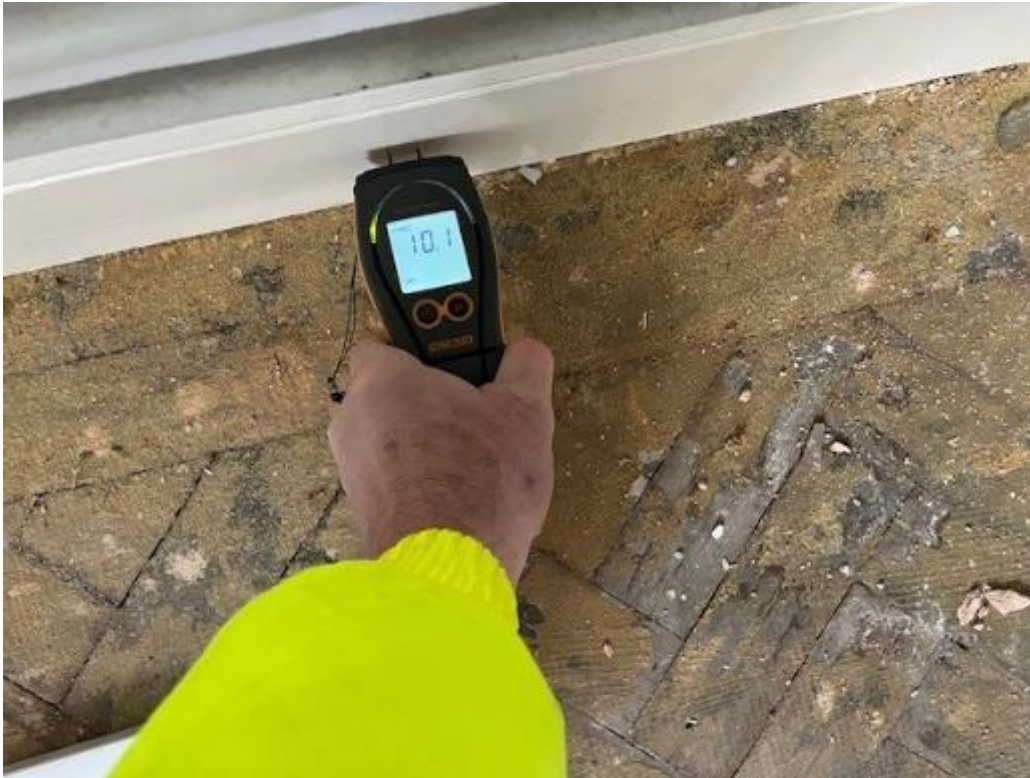
P27 – Estates B 10.1% skirting

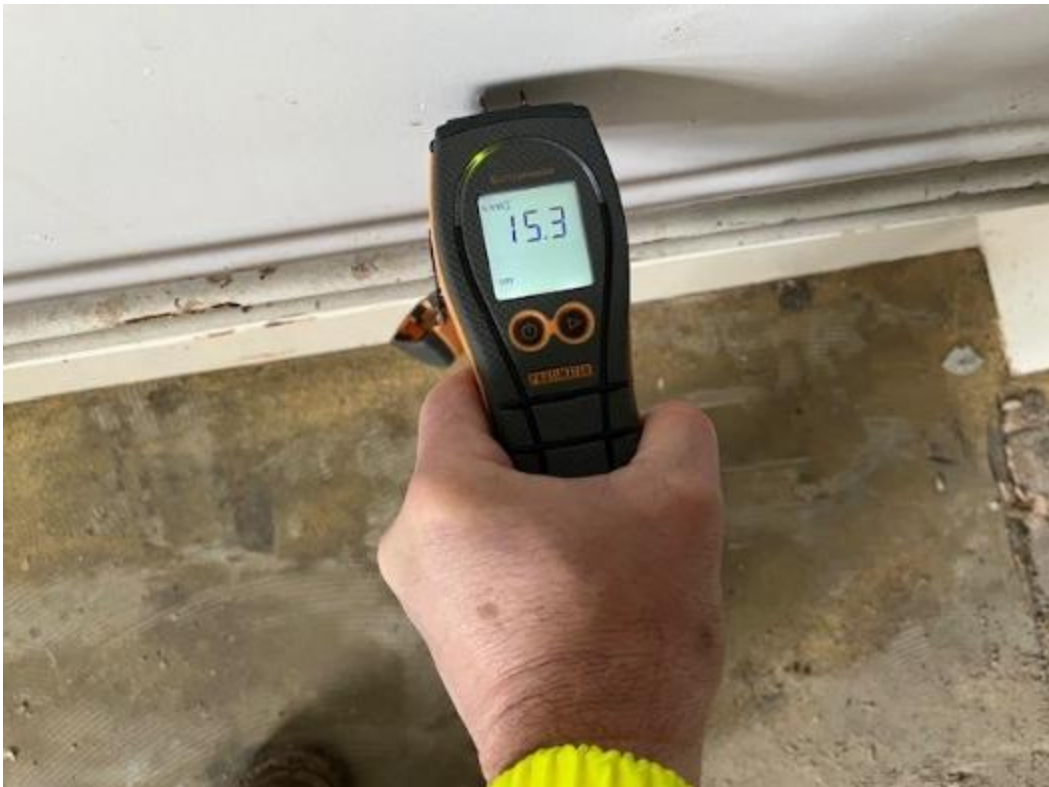
P30 – Estates B 15.3% m .c

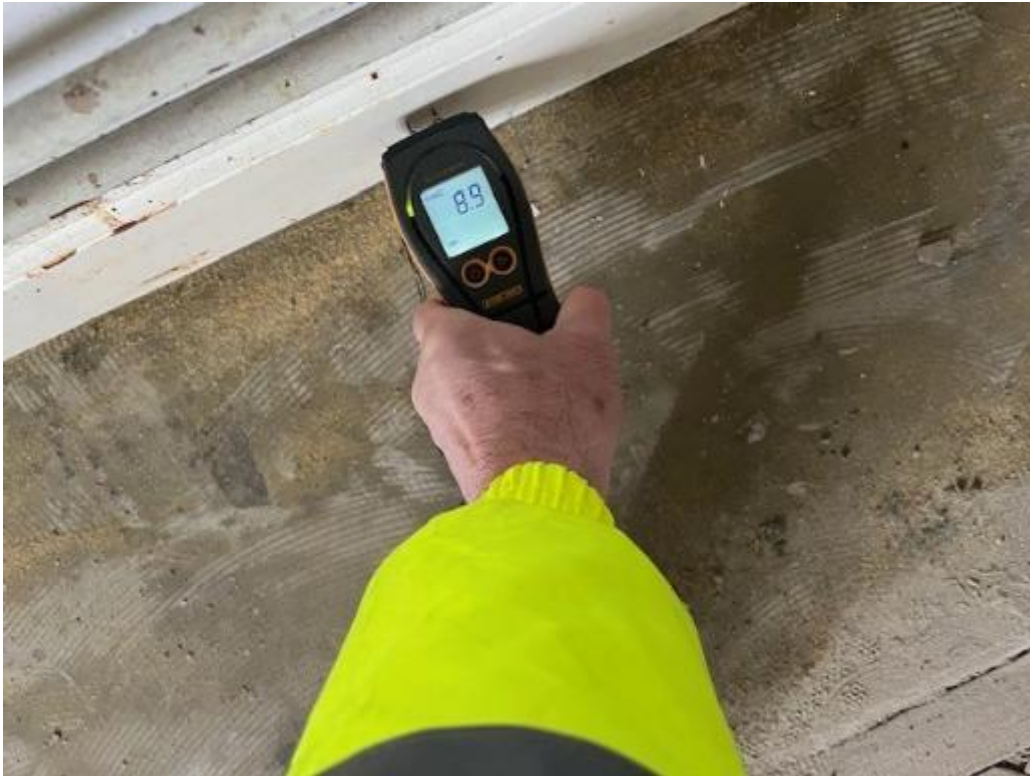
P31 – Estates B 8.9% skirting

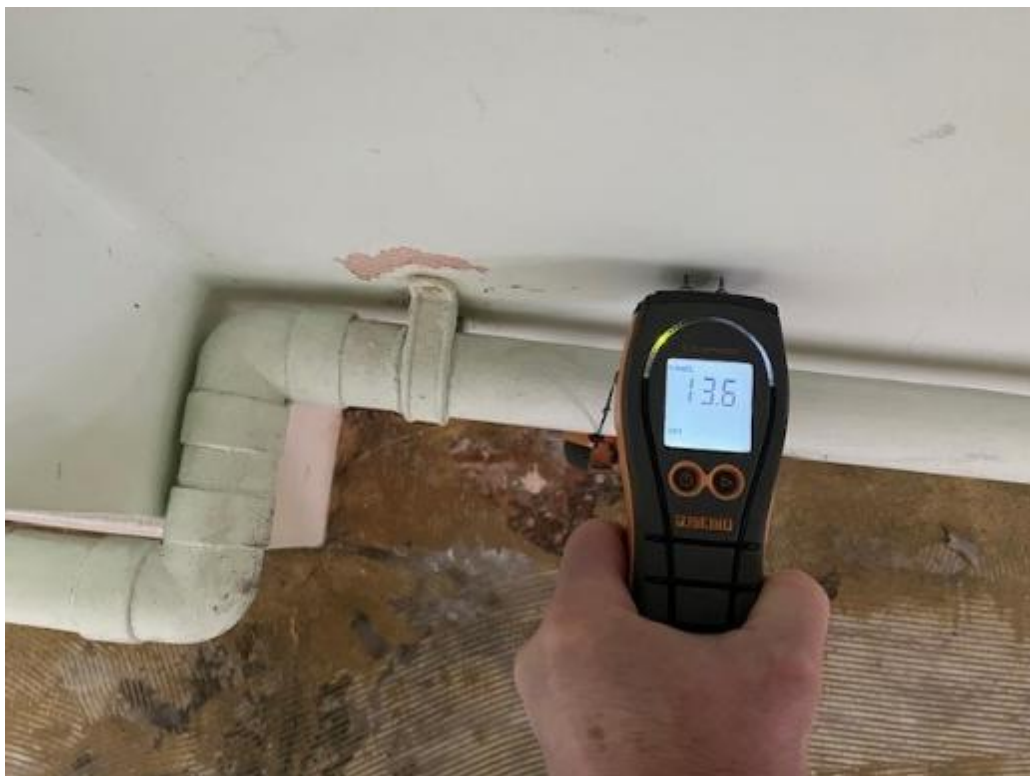
P32 – Director of Estates 13.6% m .c

- 2.8.3 It is not necessary to replace the plaster generally with slurry tanking however, in isolated areas i.e. the Director of Estates and WC Room where the wall is saturated the lightweight gypsum plaster (hygroscopic) should be cut out and replaced in a breathable lime plaster.

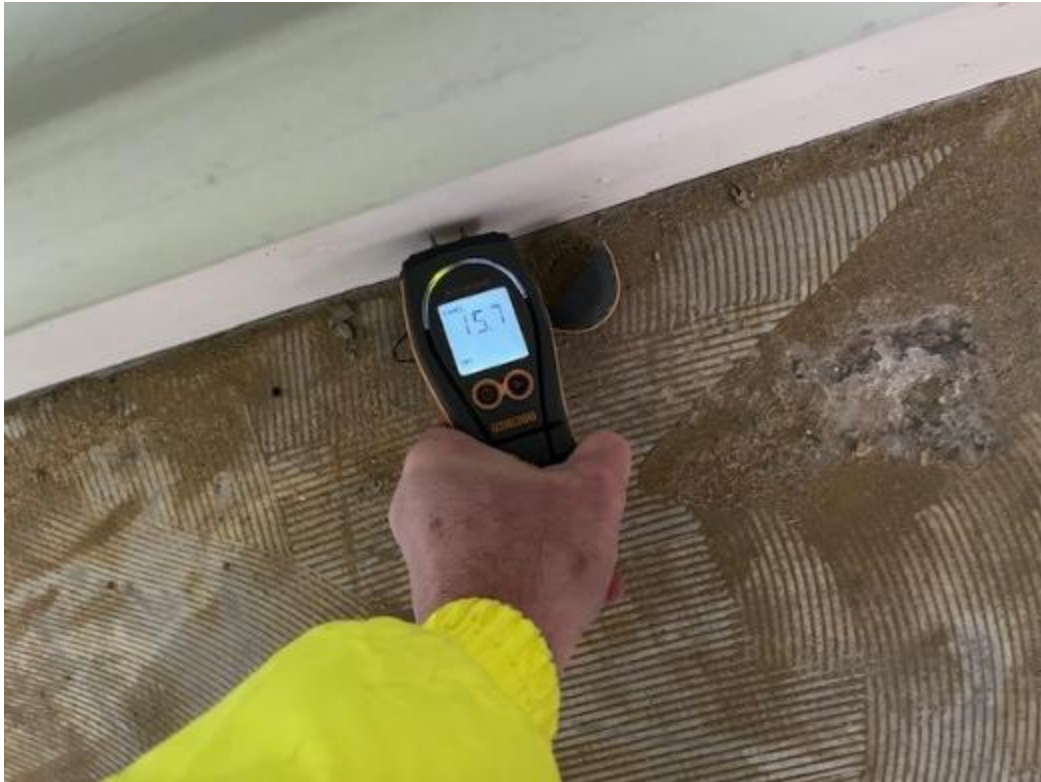
P33 – Director of Estates 15.7% Skirting

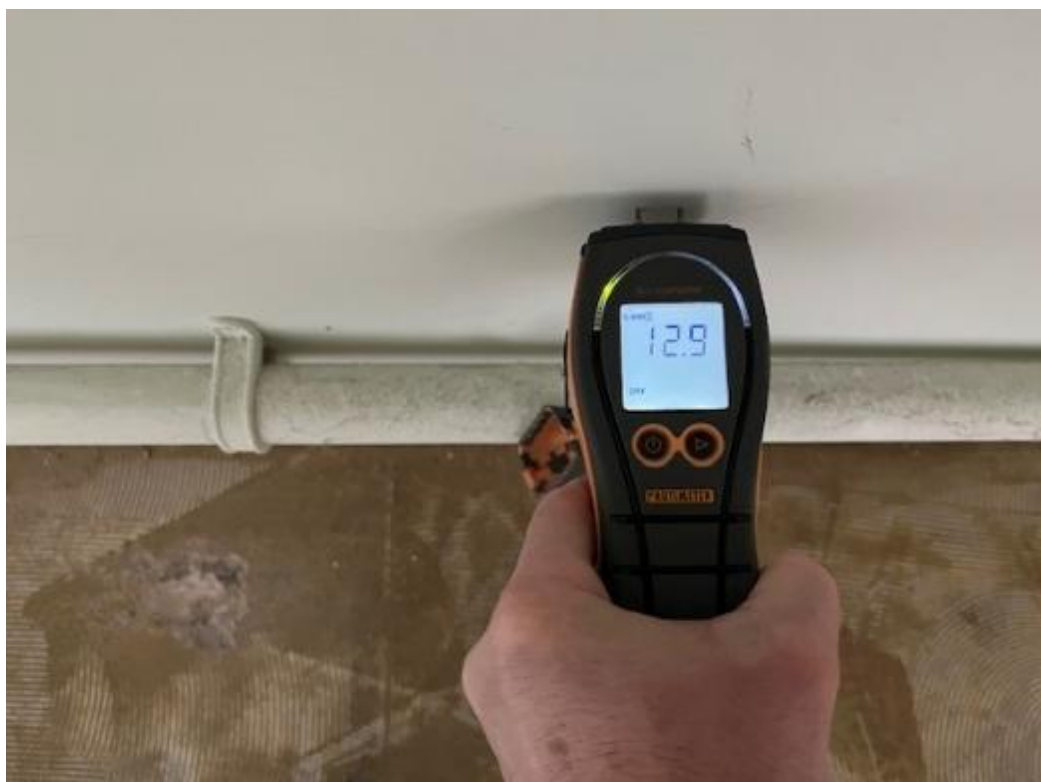
P34 – Director of Estates 12.9% m. c

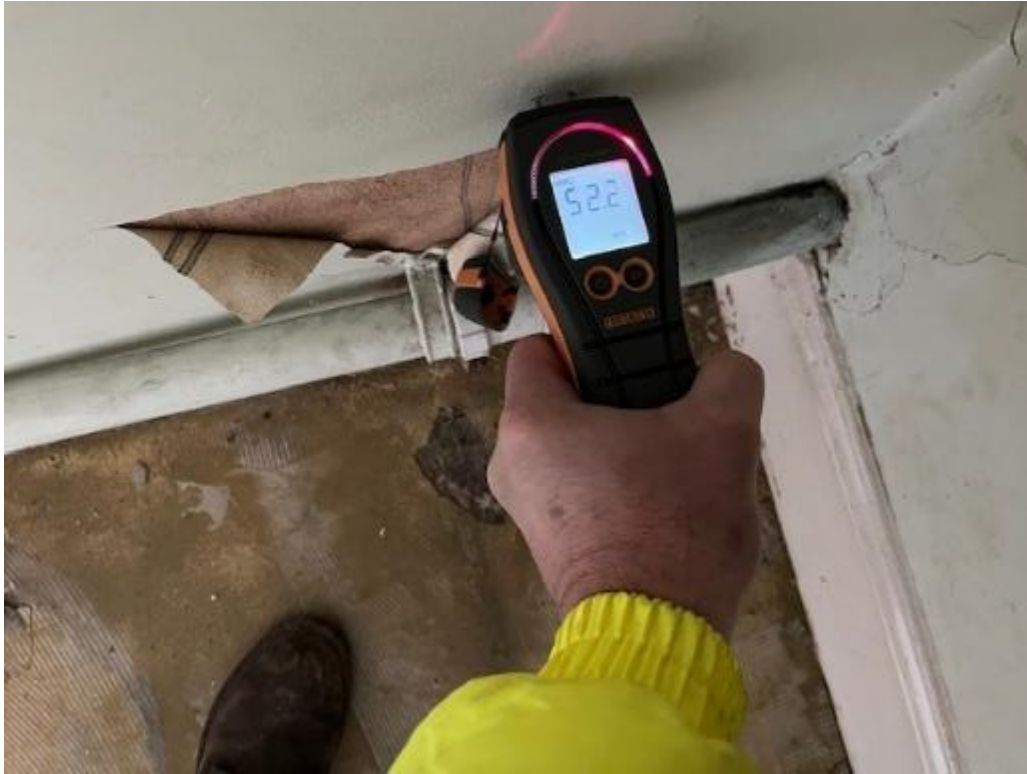
P37 – Director of Estates 52.2% m . c

- 2.8.4 The defective salt contaminated plaster should be removed to allow the masonry to breath immediately. It is also likely that once the building is in use and heated with natural ventilation, further drying out may result in efflorescence on the walls and this should be brushed and the walls redecorated as necessary.

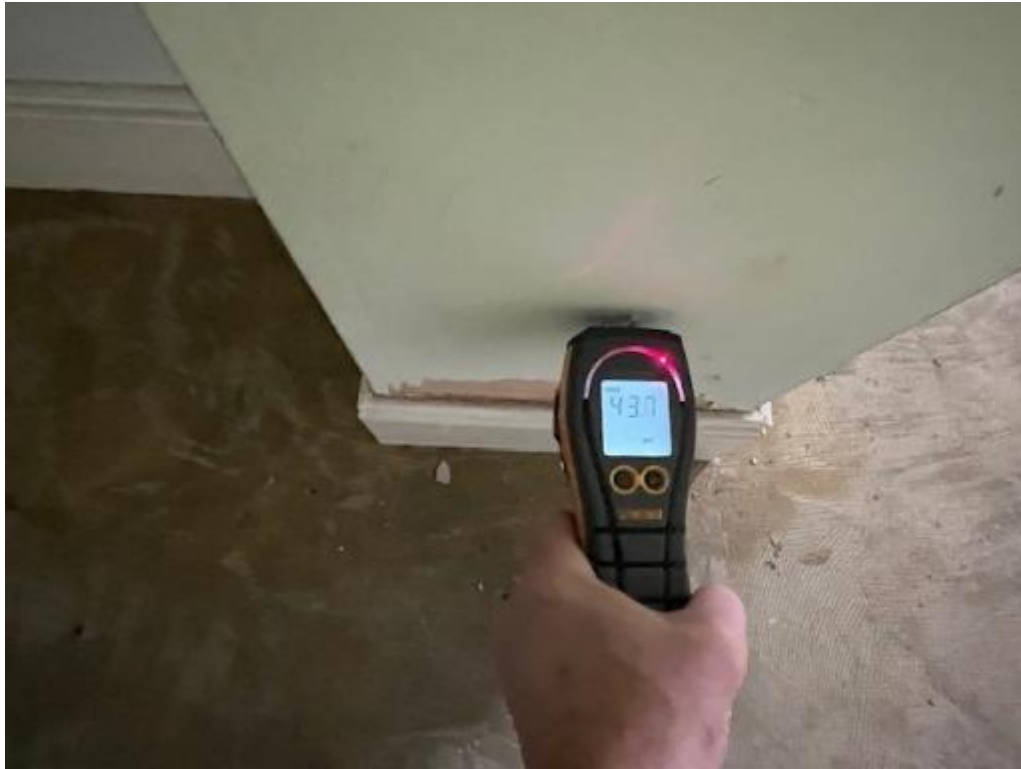
P39 – 43.7 m.c

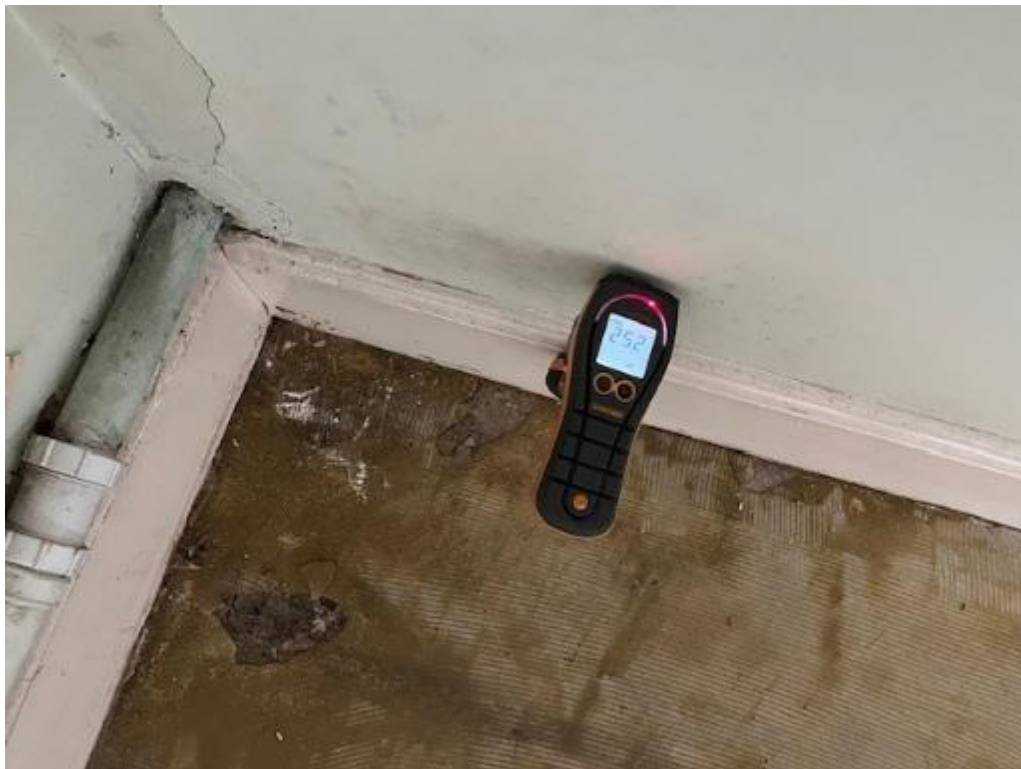
P40 – Director of Estates 25.2% m.c

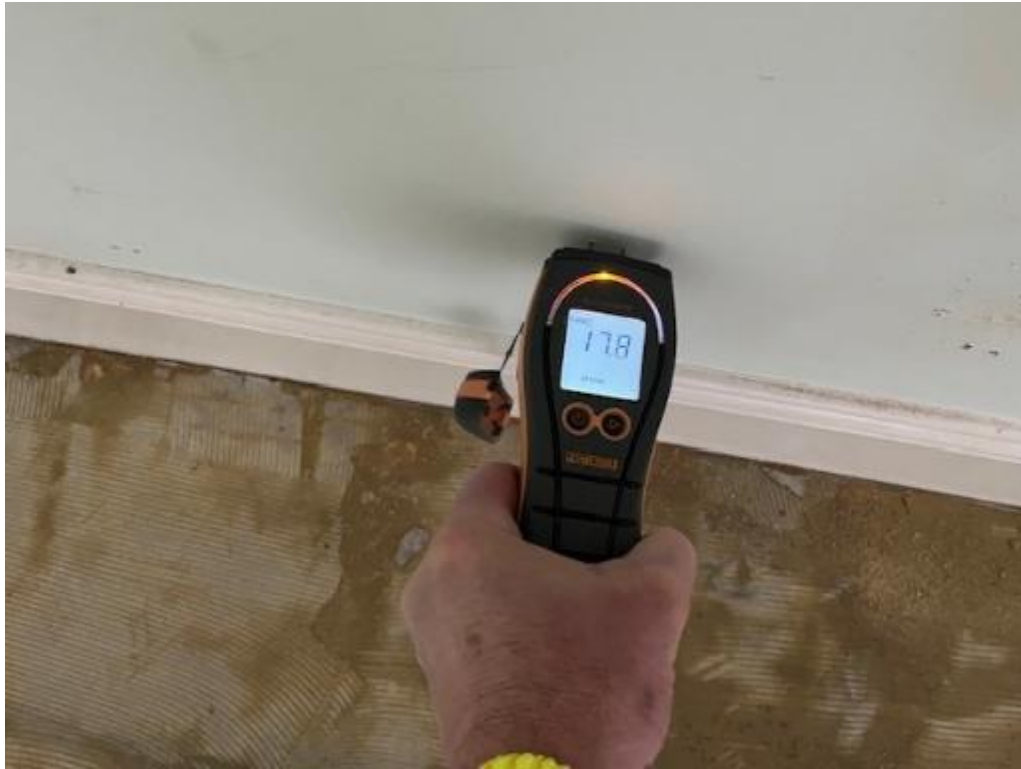
P41 – Director of Estates 17.8% m.c

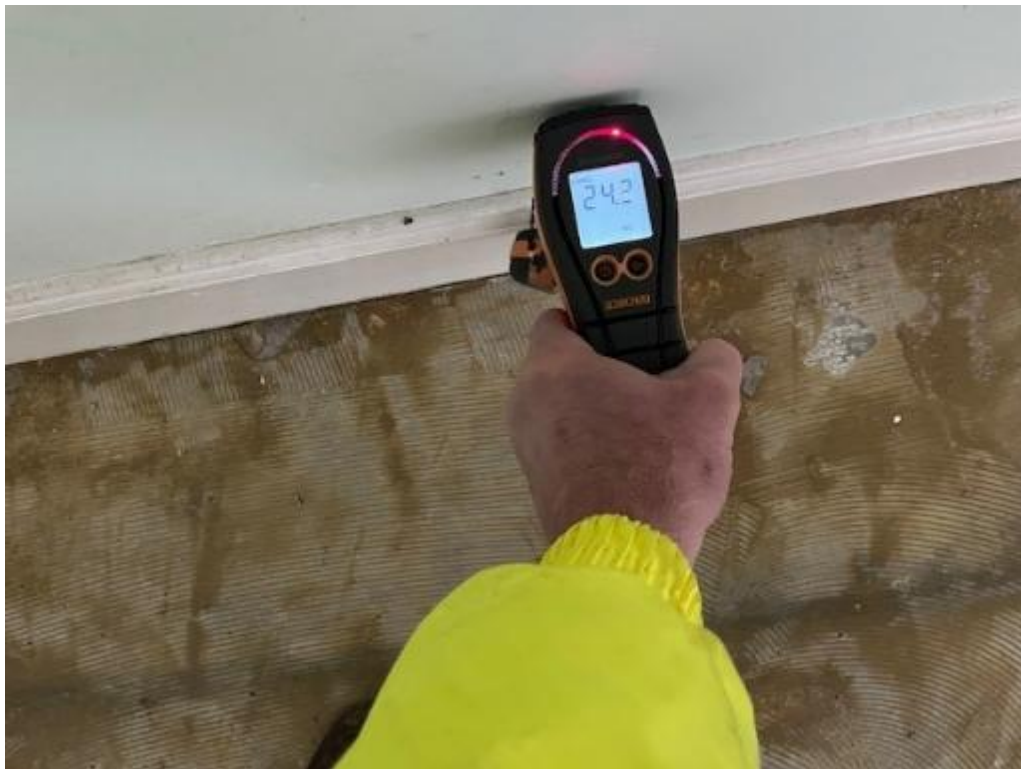
P42 – Director of Estates 24.2% m.c

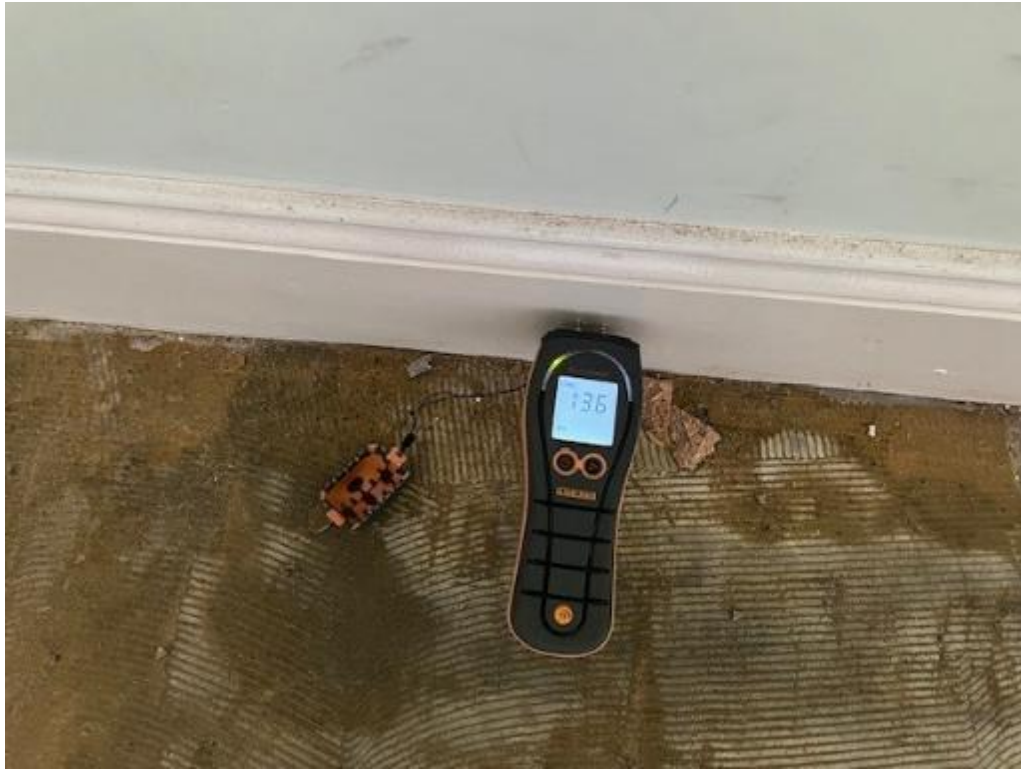
P43 – Director of Estates 13.6% skirting
